National Register of Historic Places
Registration Form

historic name Primrose Hill

other names/site number Primrose Farm, Young's Inn AA-169

AA-169
Primrose Hill
Anne Arundel County, Maryland

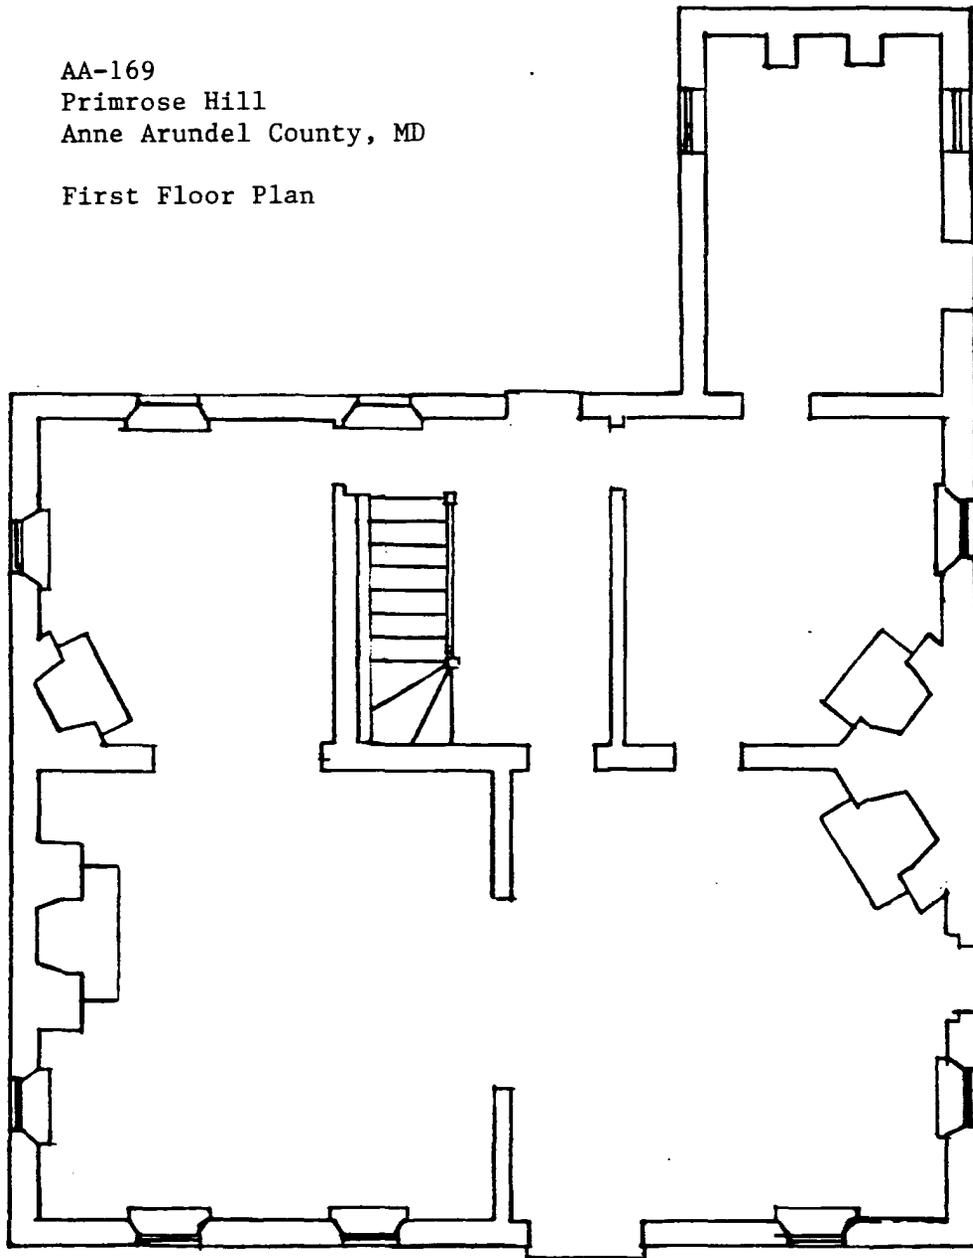
First Floor Plan

The first floor is divided into a four-room plan with a stairhall fixed between the rear two rooms. The southwest room served as the original entrance hall and is served by a corner fireplace. A portion of a later partition remains to partially divide the space in an effort to create a formal center passage plan during the early twentieth century. Original to the space is a built-in cupboard located in the southwest corner. The two-part corner cupboard is distinguished by raised-panel doors and flanking pilasters. The arched doors that enclose the top portion have three raised panels to each leaf, and fluted pilasters are fixed to each side. The interior is filled with a series of curved front shelves. The single-panel doors to the lower cupboard are framed by plain pilasters. Between the two sections is a mid eighteenth-century bolection molding. The arched header above the upper cupboard doors is enhanced by a molded key block. To each side of the cupboard are Federal nine-over-nine sash windows framed by early nineteenth-century surrounds featuring a narrow ovolo and cove backband profile. The projecting window seat

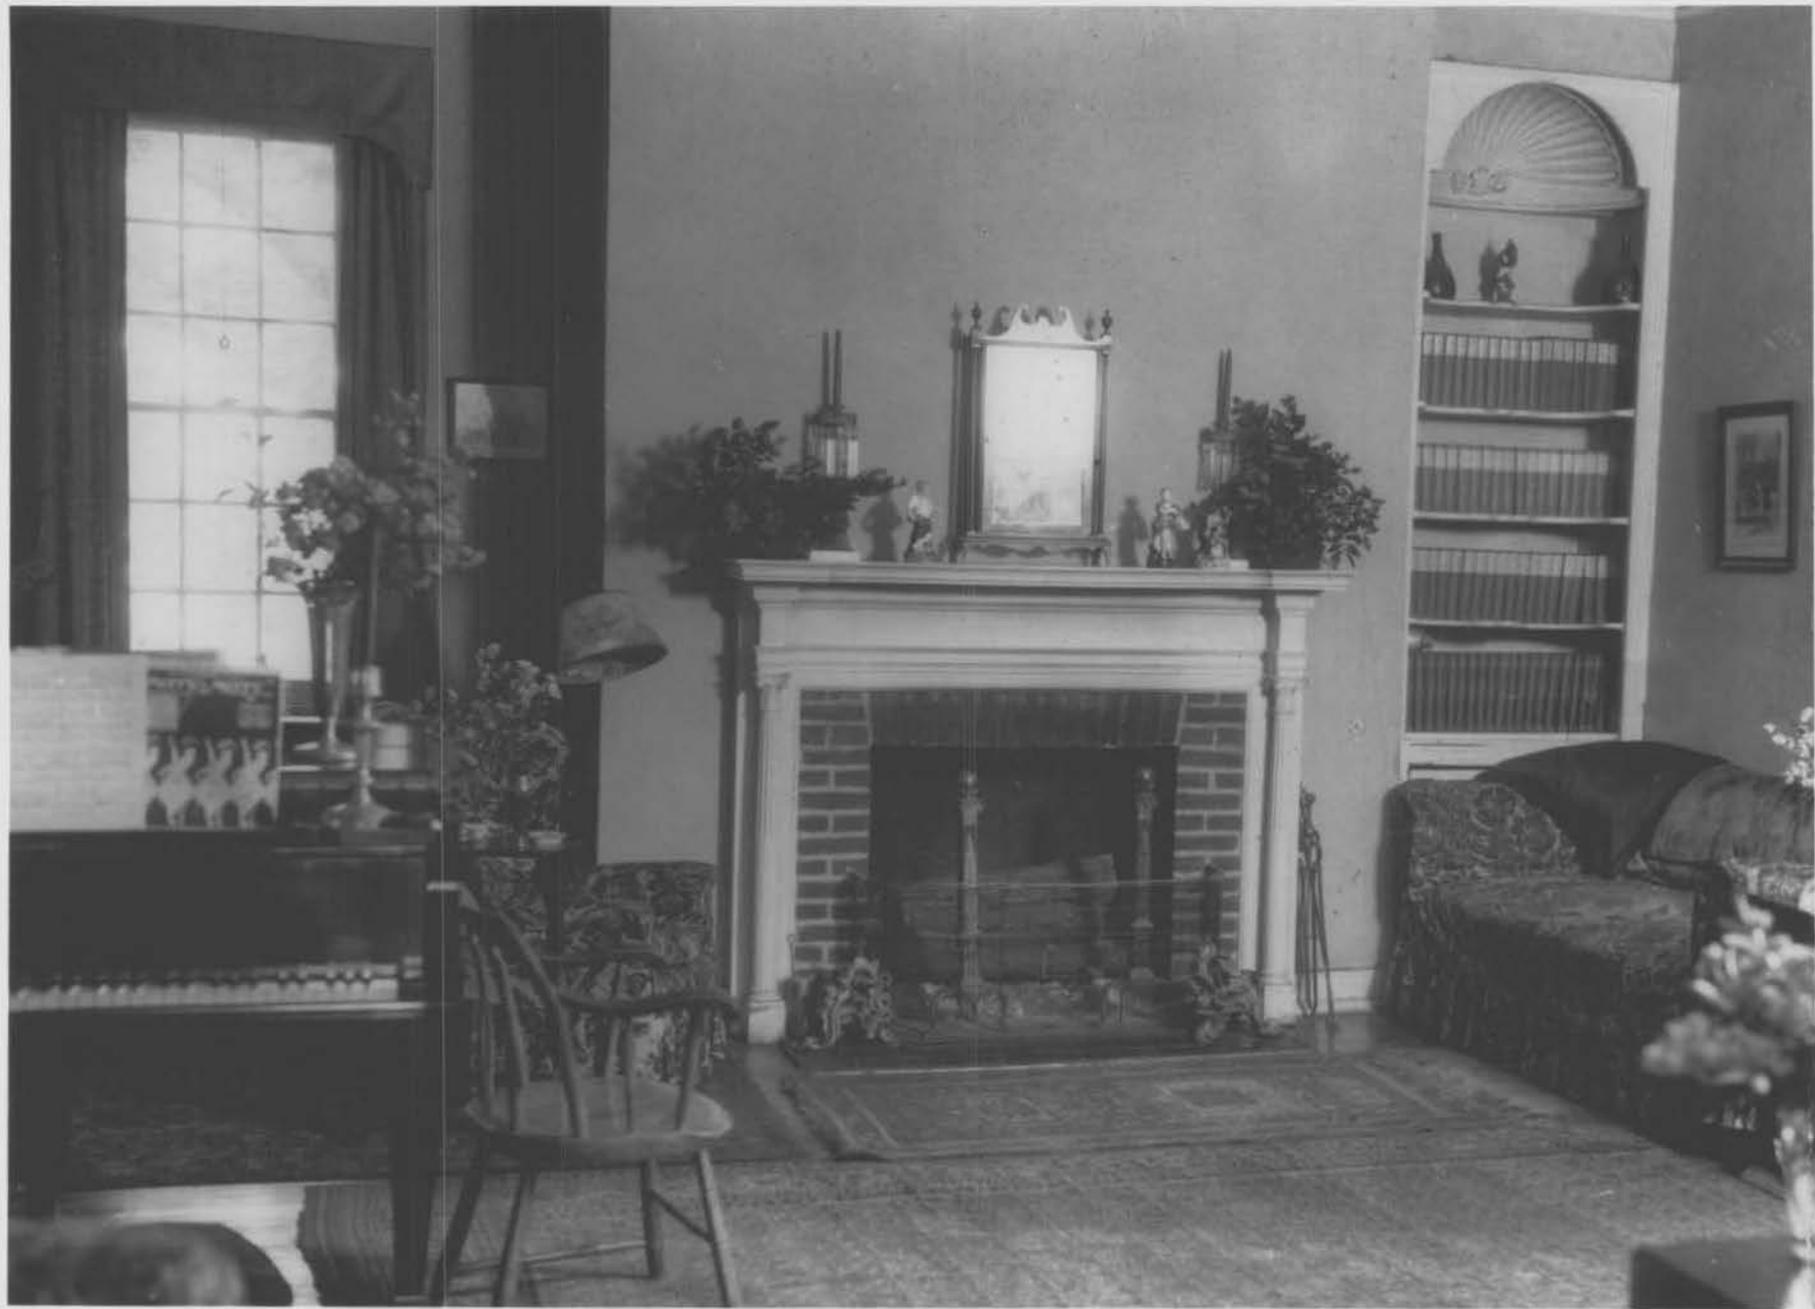
DOCUMENTARY PHOTOGRAPH OF PARLOR C. 1930

The parlor is distinguished by a combination of eighteenth-, nineteenth-, and twentieth-century woodwork as well. A Colonial Revival mantel frames the brick fireplace. Fluted Ionic columns rise to a molded entablature and broken profile shelf. Fixed in a niche to the right (east) of the chimney stack is an eighteenth-century, two-part cupboard with decorative shelving and a shell carved back within the arched opening, and a single raised-panel door covering the lower cabinet. Raised-panel window seats combine with Federal window moldings around each window opening. The door between the parlor and the northeast room (library) has been widened.

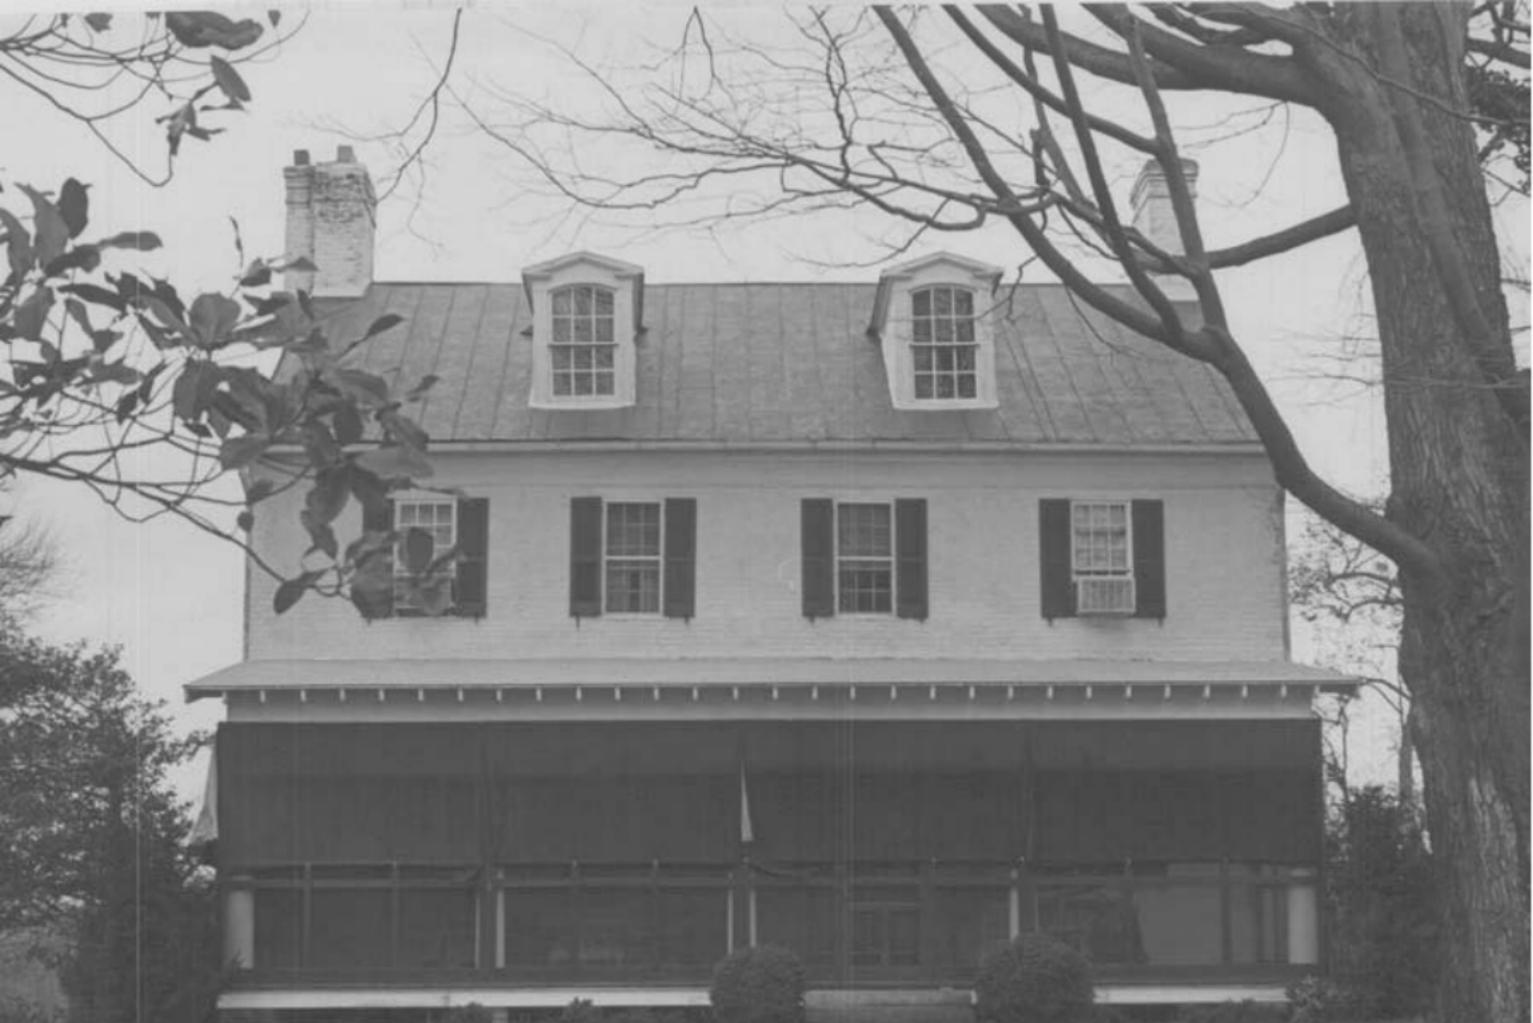
(map 24)

"Primrose Farm"
South Elevation

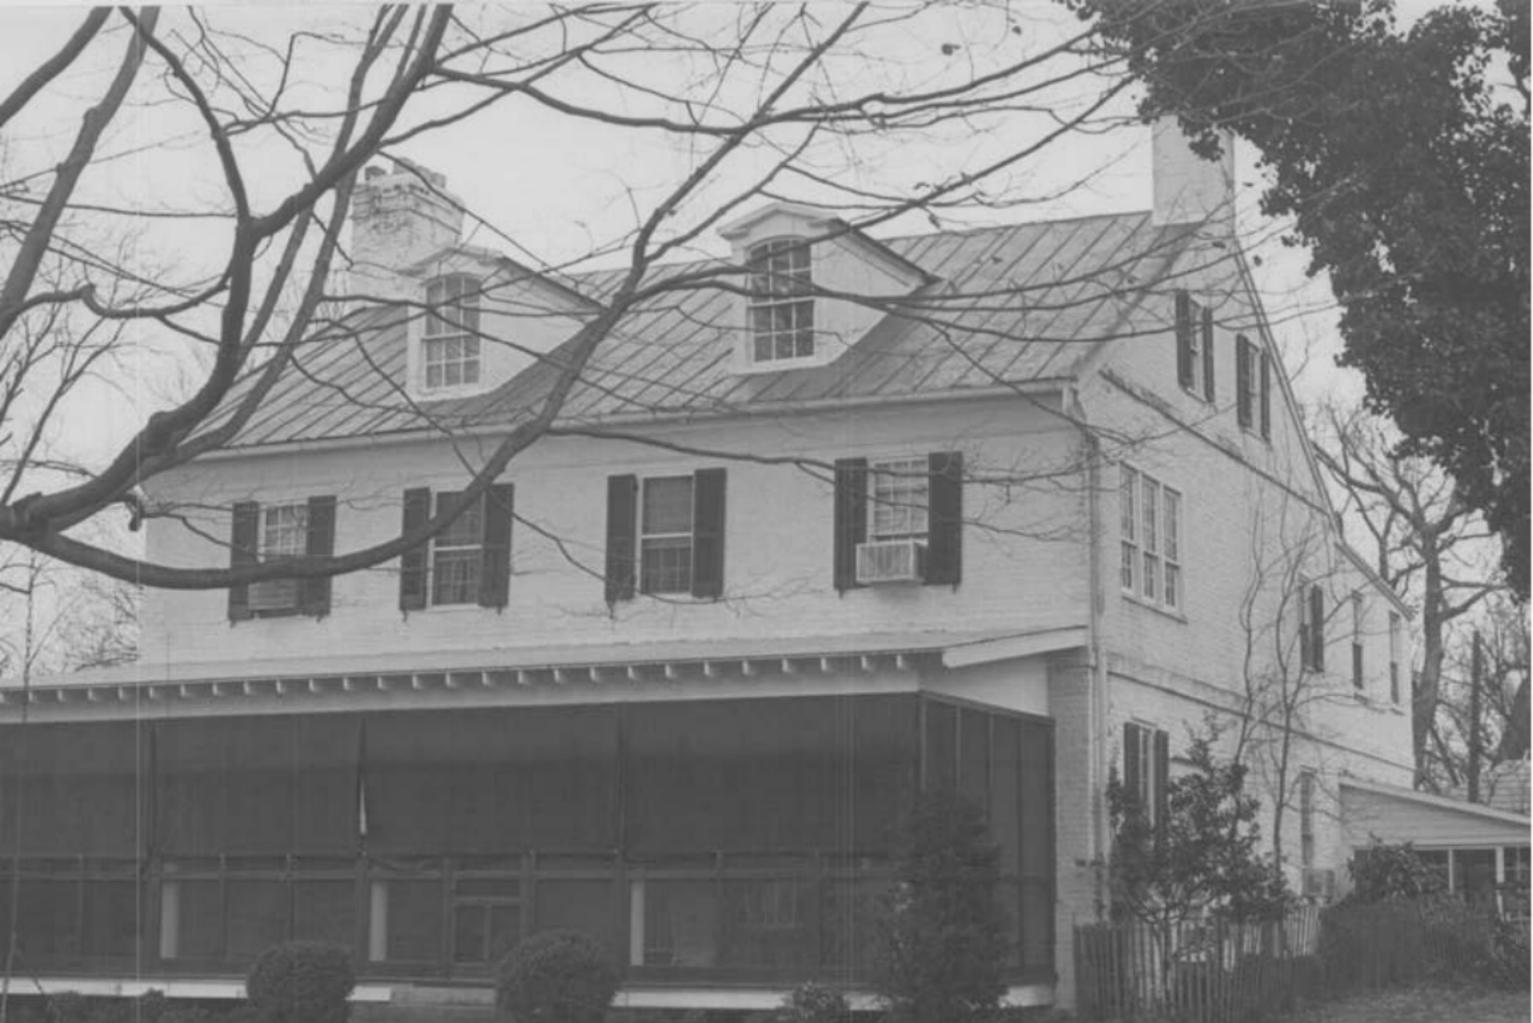
(map 24)

Ad-26-W-a
"Primrose Farm"
S.E. Corner
