23 Thompson Street
Annapolis
Private

1913-21

Maryland Historical Trust State Historic Sites Inventory Form

Survey No. AA 1888

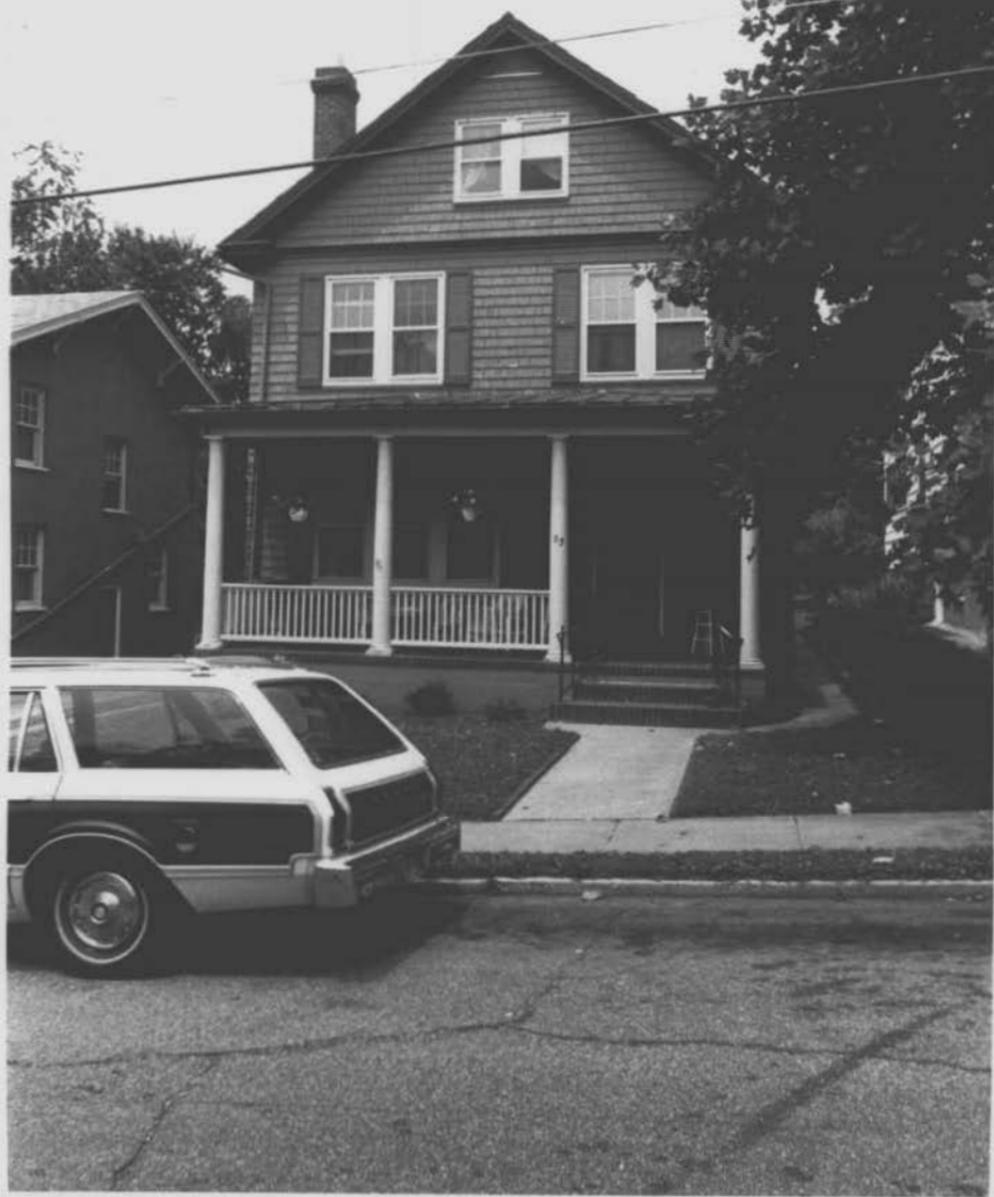
23 Thompson AA 1888
Annapolis, Anne Arundel County
Russell Wright July, 1982
Maryland Historical Trust,
Annapolis, Maryland
sc Elevation/camera facing nw
