Maryland Historical Trust State Historic Sites Inventory Form

Survey No. AA-198
Magi No.
DOE yes no

historic "Champ's Adventure"

and/or common "Elizabeth's Fancy"

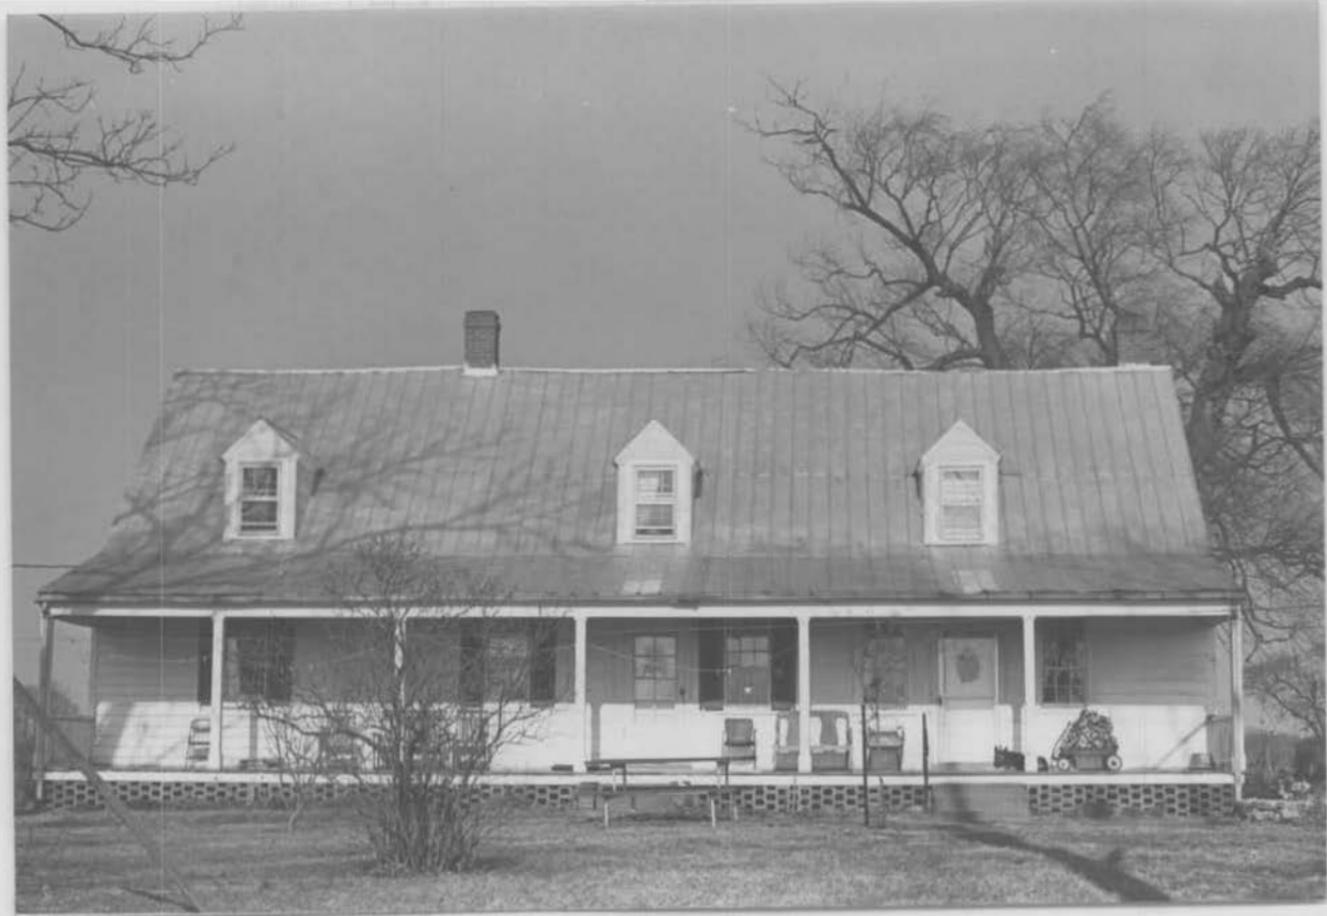
"Champ's Adventure"
South Elevation

With the continuous sloping roofs that extend over the length of the front and rear porches, the one and one-half story house is typical of early Tidewater architecture. The house faces south. There are two doors and five nine over six pane windows on the ground floor with three gable roof dormers above with six over six sash. All bays are symmetrically spaced. The more central door has six small paired panels over two larger panels. The panels have applied molding. The door to the east has two over four raised and molded panels. The siding on this facade has random width beaded weatherboard. The western end is a later addition and appears to be consistent with the profile of the original house. It has narrower uniform beaded weatherboard. There are two chimneys. An inside chimney on the east end and an interior chimney on the west centered in the peak where the original house ended. The addition enlarges the house by nearly one-third.

The porch has seven rather evenly spaced pillars with double molded caps and plain plinths. The porch ceiling has a shallow cove configuration. There are brick steps before the porch doors and honeycomb brickwork below the porch. The house and dormer roofs are of channel drain metal.

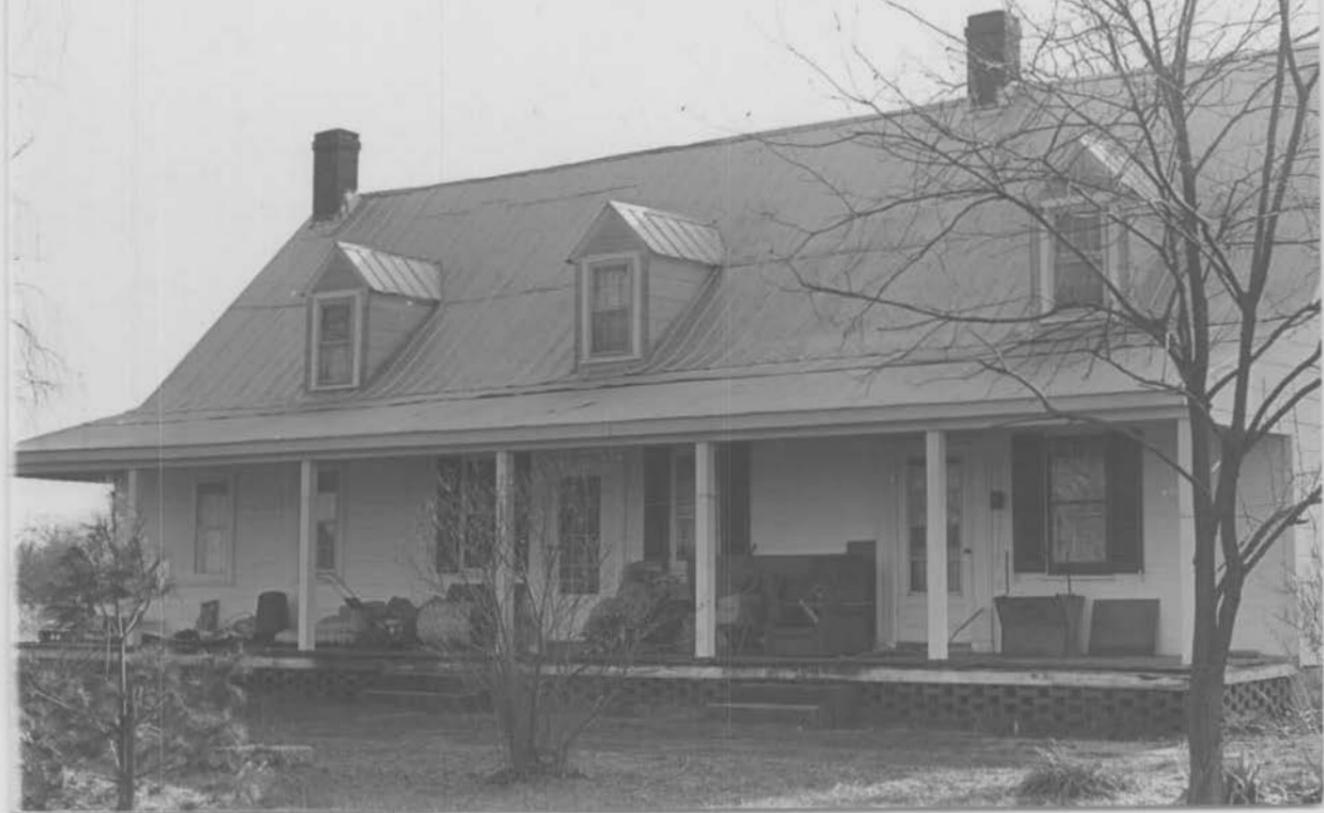
"Champ's Adventure"
North Elevation

The north side of the house reveals that the enclosed area covers nearly one-half of the left side. This affords an unheated entryway. The original two six over six windows of the old house have been installed on the outside of the recent enclosure according to the owner. They were replaced inside by a smaller one over one window on the left and a door on the right.

The back porch has details that reveal that this was the original principal facade. The main entrance has a molded architrave with patera corner blocks. The rebuilt porch has plain square pillars and a concrete floor. The remaining windows and dormers correspond with those at the front. The old siding is beaded and flush in the shiplap appearance.

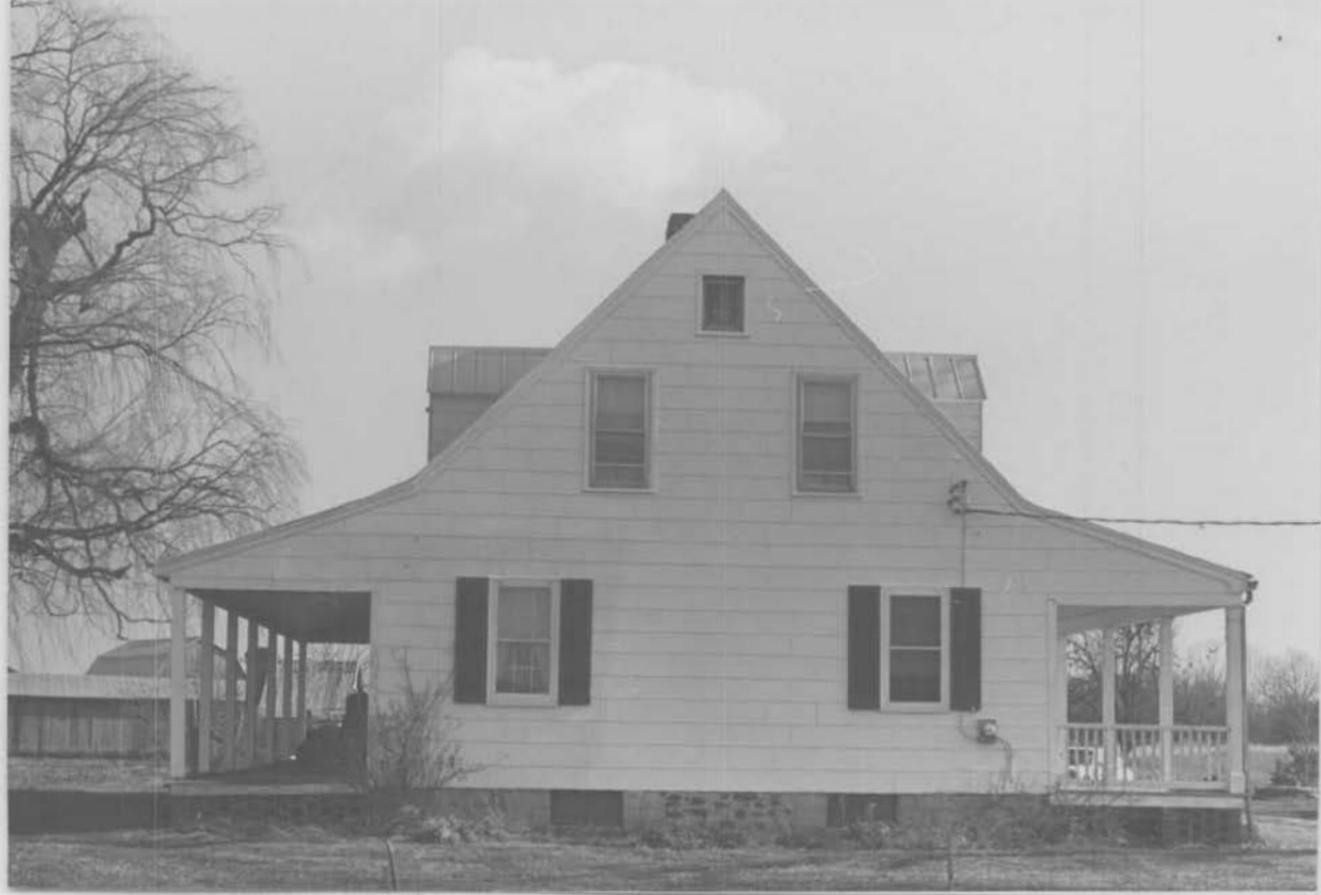
"Champ's Adventure"
West Elevation

The west end has two cellar windows. The foundation has cinder blocks on the sides with an older ironstone rubble center. The windows on the first and second floor match those of the east end. The gable window is centered. The east and west end have asbestos siding. All windows are trimmed with plain boards.
