MARYLAND HISTORICAL TRUST WORKSHEET

AA-269

COMMON:
 Old Colony Cove Farm House

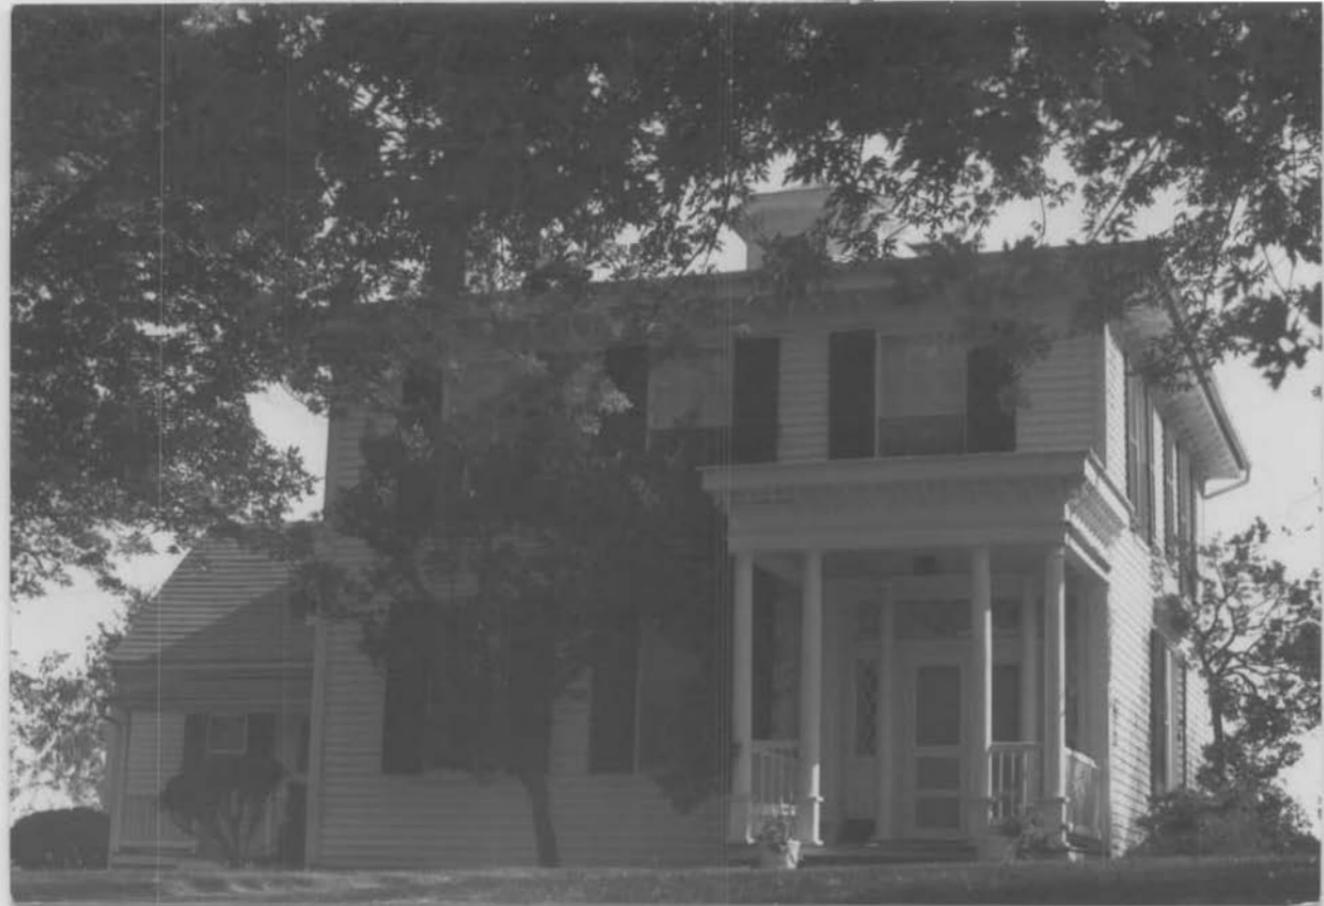
AA-
269

The eaves of the main roof have a similar bracket treatment. The entrance to the house, on the west side, has an elaborate wooden porch, supported by four plain, round columns. Each side is enclosed with a railing and has a low bench. The roof of the porch has a slight overhang decorated with closely-spaced scroll cut brackets. The front door is double. It is framed by two columns and diamond-pane transom and side lights. The east and west sides of the house have three bays each. The windows have large panes (6/6), with shutters. The south side has a large 3-part window in the middle of the first floor. This lights the stair and the hall. The center of the three parts is a standard 6/6 double-hung sash. The side parts are narrow, have a diamond-pane sash and are shuttered. The whole window is covered by a bracketed architrave with a slight overhang. There are two 6/6 pane windows and one 4/4 pane window on the second floor of the south side. The east side of the house has a wide screened porch covering the length of the first floor. It is probably a 20th century addition.

(map 34) aa-47-T-a
"Old Colony Cove
Farm House"
West Elevation

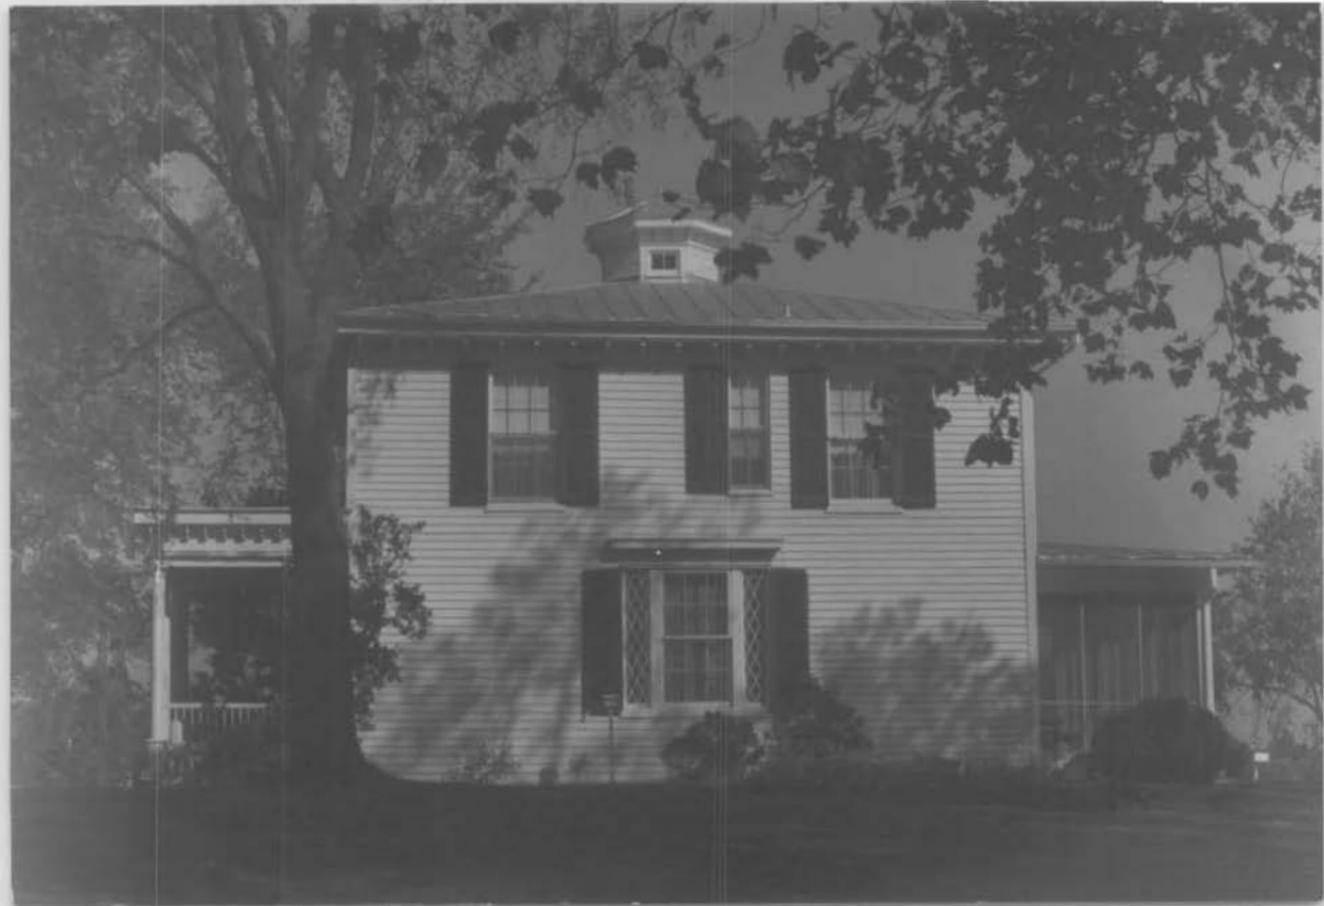
A.A.
269

South Elevation

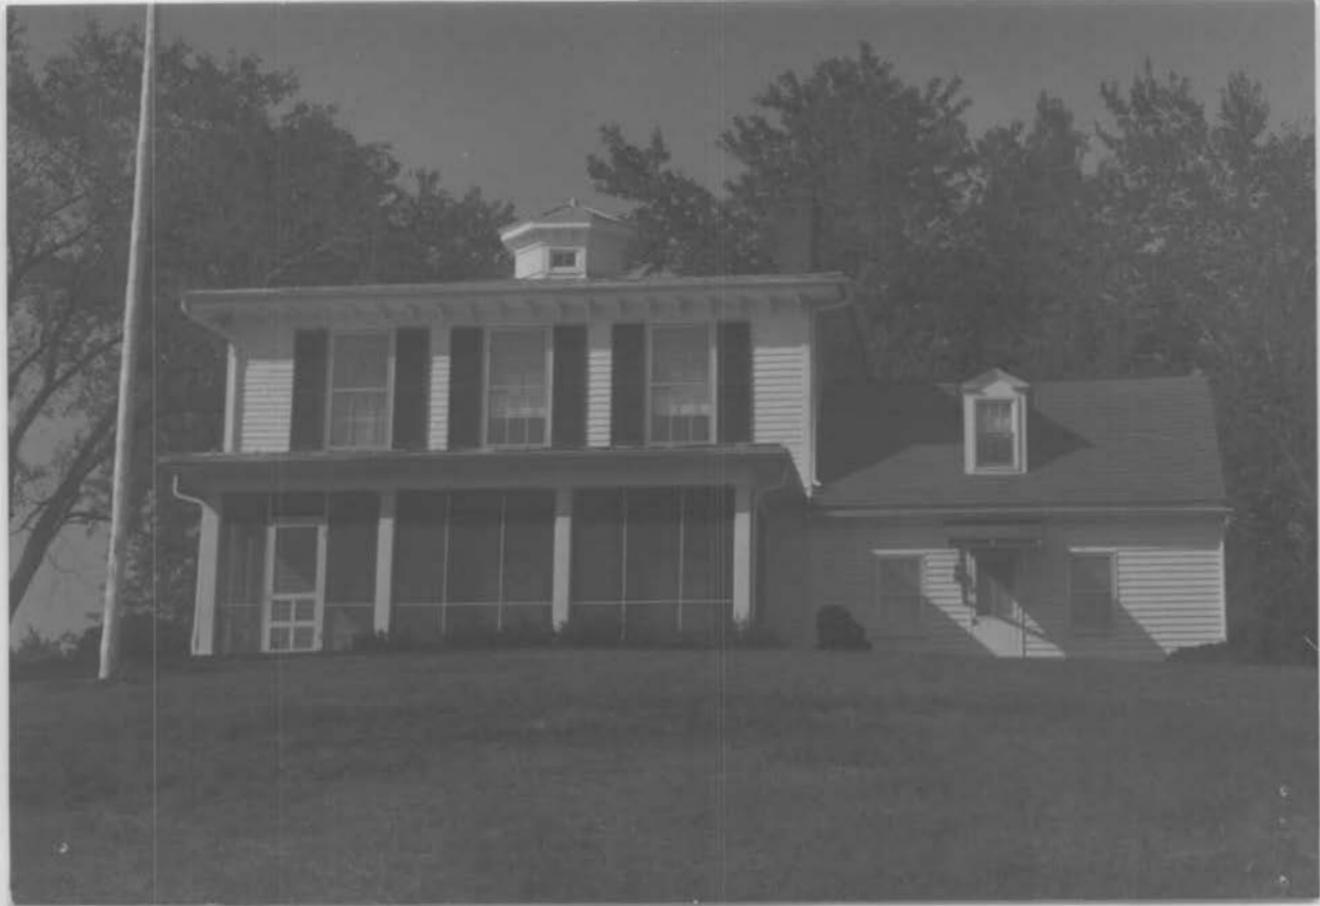
AA-
26a

(map 34) AA-47-T-a
"Old Colony Cone
Farm House"
East Elevation

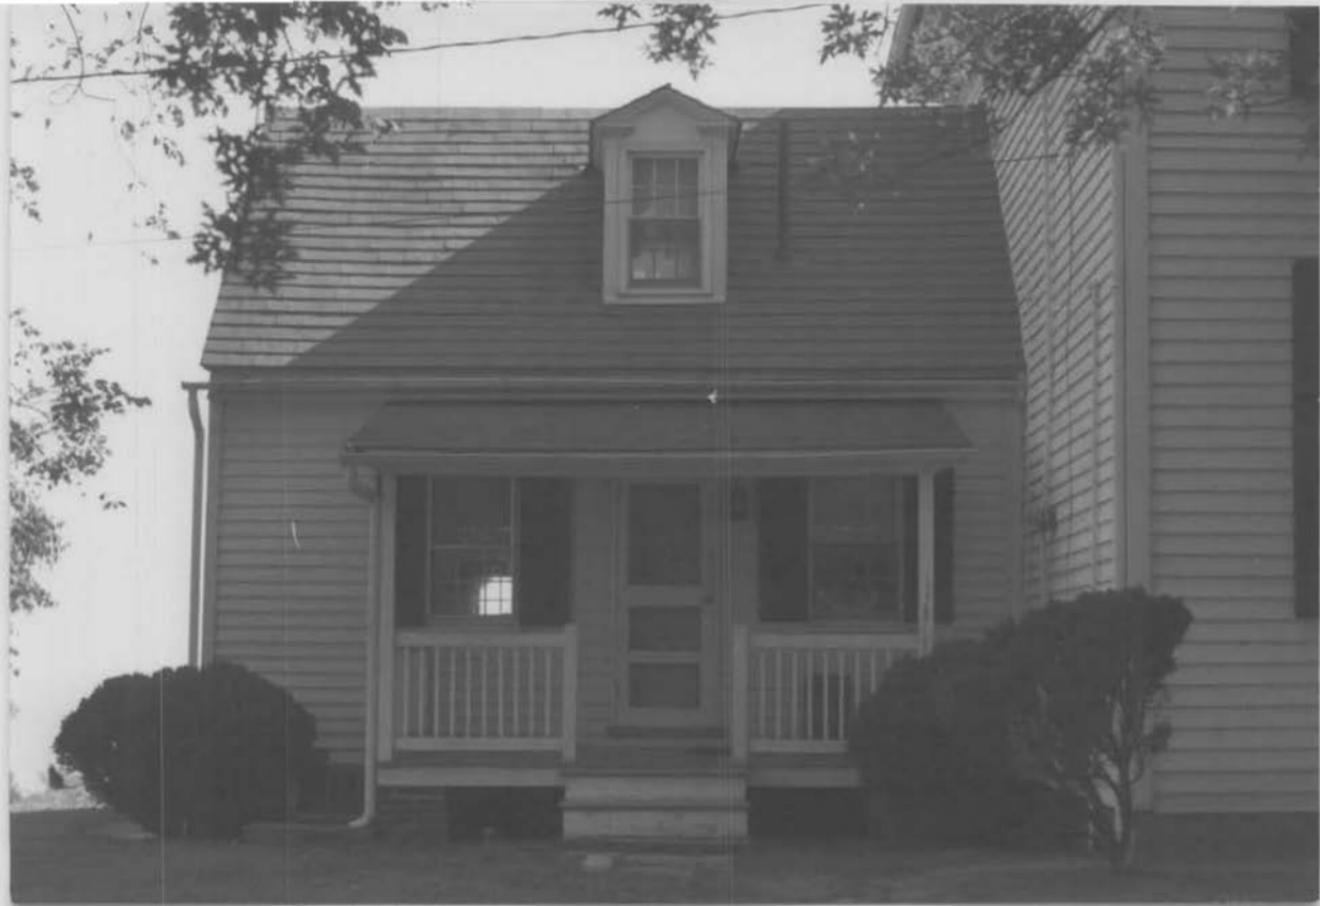
AA
269

There are two 6/6 pane windows with a door between them on either side of the kitchen. Over the openings on the west side there is a small porch with railings.

(map 34) aa-47-T-a
"Old Colony Cove
Farm House"
West Elevation
Kitchen
