**CAPSULE SUMMARY**  
**Farmers National Bank of Annapolis (AA-403)**  
**5 Church Circle, Annapolis**

# Maryland Historical Trust Maryland Inventory of Historic Properties Form

Inventory No. AA-403

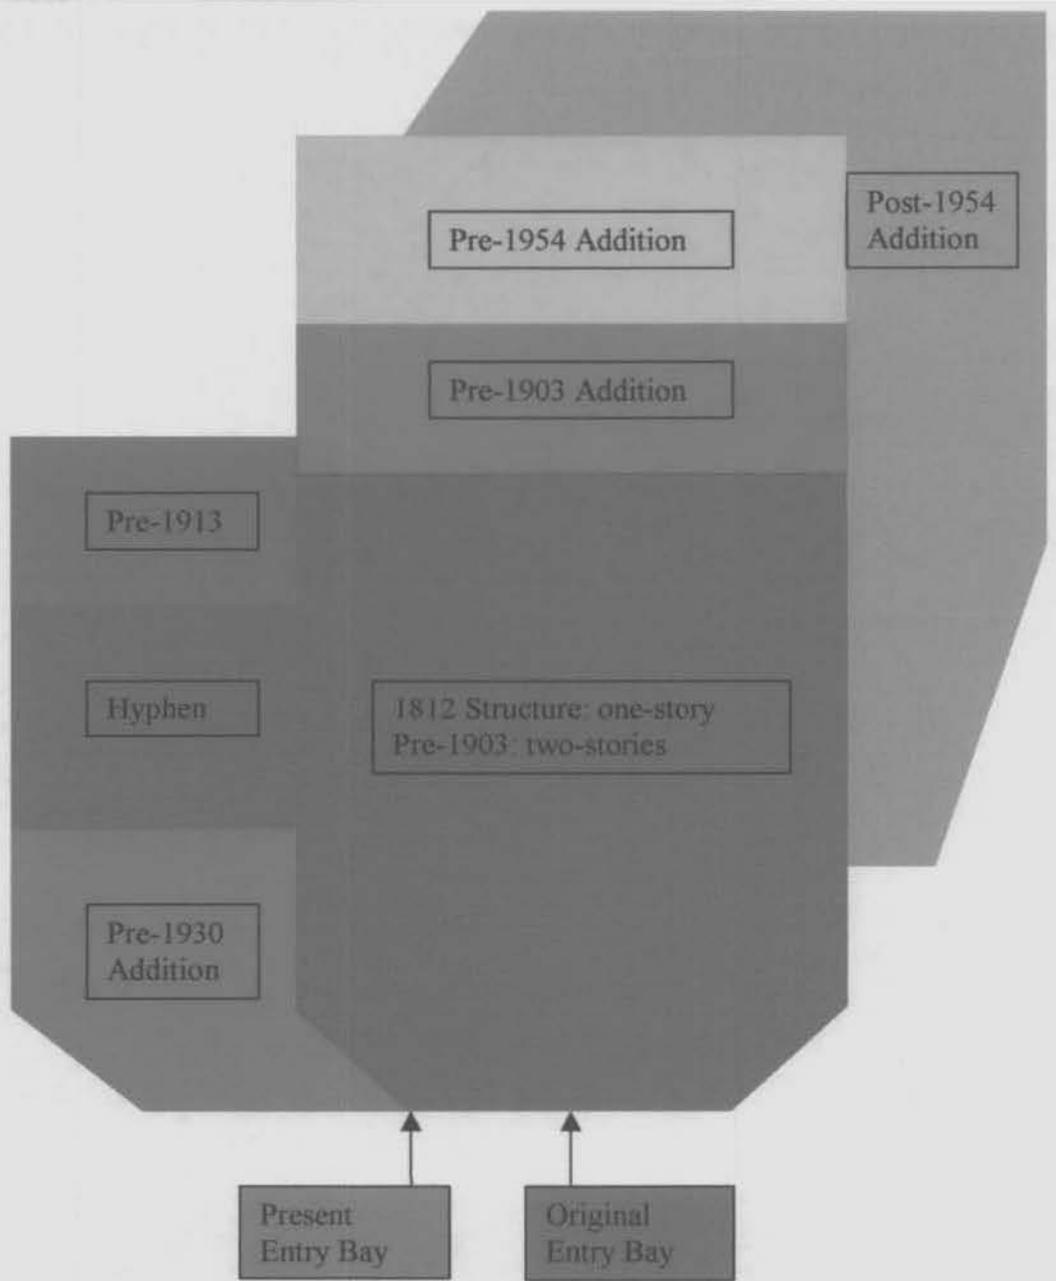
AA-403  
**Building Evolution**  
**Farmers National Bank of**  
**Annapolis**  
**5 Church Circle**

The Farmers National Bank of Annapolis at 5 Church Circle is a product of at least six building campaigns. It was originally constructed in 1812 as a one-story, hexagonal-shaped addition to the adjacent Reynolds Tavern (built ca. 1846), with interior detailing designed by cabinetmaker John Shaw. During the second phase, completed between 1897 and 1903, the original one-story structure was raised to two stories, and extended by two bays at the rear. At this same time, a new portico was applied to the main entry facing Church Circle and a new hipped roof with overhanging eaves and frieze with bas relief decoration was constructed. By 1913, the one-story hyphen erected as part of Reynolds Tavern was enlarged at the rear to provide additional office space for the growing bank. By 1930, the building was enlarged again, when the hyphen connecting it to Reynolds Tavern was completely absorbed by the bank. At this time, the façade on Church Circle was reorganized and the main entry moved over one bay. The final two phases included the pre-1954 addition to the rear of the bank, and the post-1954 addition along West Street. During this latter phase, the hipped roof covering the main block was removed and a brick parapet with a projecting cornice constructed. Based upon maps, historic photographs, and brickwork, it appears that three partial wall surfaces survive from the 19<sup>th</sup>-century period of construction. As it stands today, the Farmers National Bank building is a two-story, semi-hexagonal-shaped brick structure, primarily a product of the 20<sup>th</sup>-century, and reflecting a mid-20<sup>th</sup>-century Colonial Revival style of architecture.

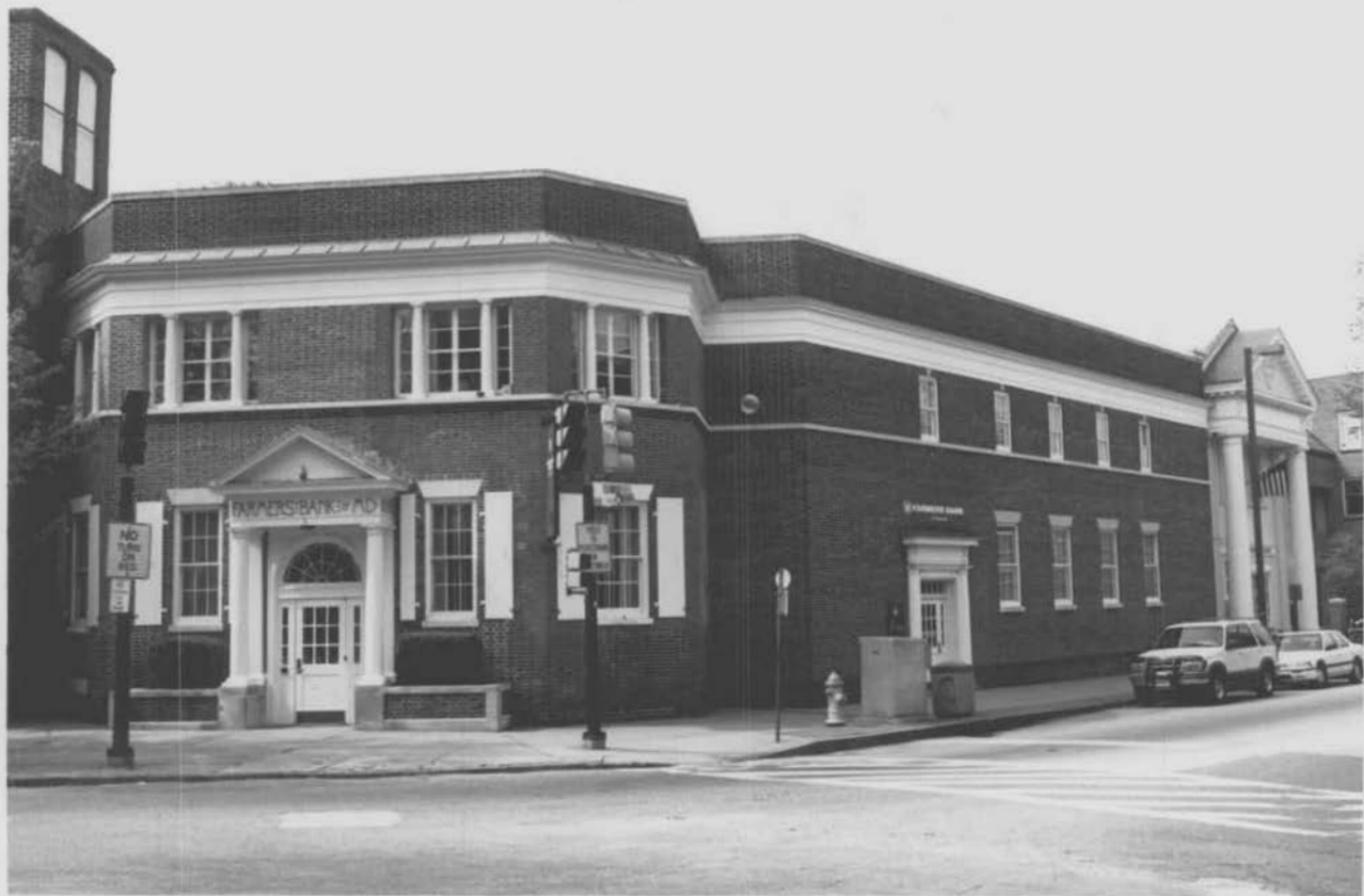
1 OF 6

The east elevation of Farmer's National Bank facing Church Circle is dominated by the three-bay front façade of the main block. The brick walls, with signs of significant re-working, are laid in Flemish bond and, though primarily from the pre-1930 phase, retain some of the original 1812 brickwork. It is ornamented by a centrally located Colonial Revival-style pedimented portico, also a product of the circa 1930 alterations. The portico features Doric wood columns atop concrete bases and wood wall pilasters. The columns support the entablature, with the building's name on it, and a full pediment above. The door itself is a wood and glass door with a fanlight above. Prior to this alteration, the entry was located in the bay to the north of the present door, an opening that now serves as a window, but retains vestiges in the brickwork of a pedimented portico above the window. Contemporary raised planting beds and 6/6 windows symmetrically flank the entry. All of the first story windows feature concrete sills and splayed concrete lintels. The second story includes pairs of four-light casement windows with small columns supporting the three-part frieze above. The second story windows sit upon a concrete belt course as if it were a sill. The windows are set into the brick walls and feature small columns that visually support the broad entablature above. Above the cornice rises a brick parapet wall, surmounted by a concrete cap, and constructed as part of the post-1954 addition.

EAST ELEVATION, LOOKING, SOUTHWEST

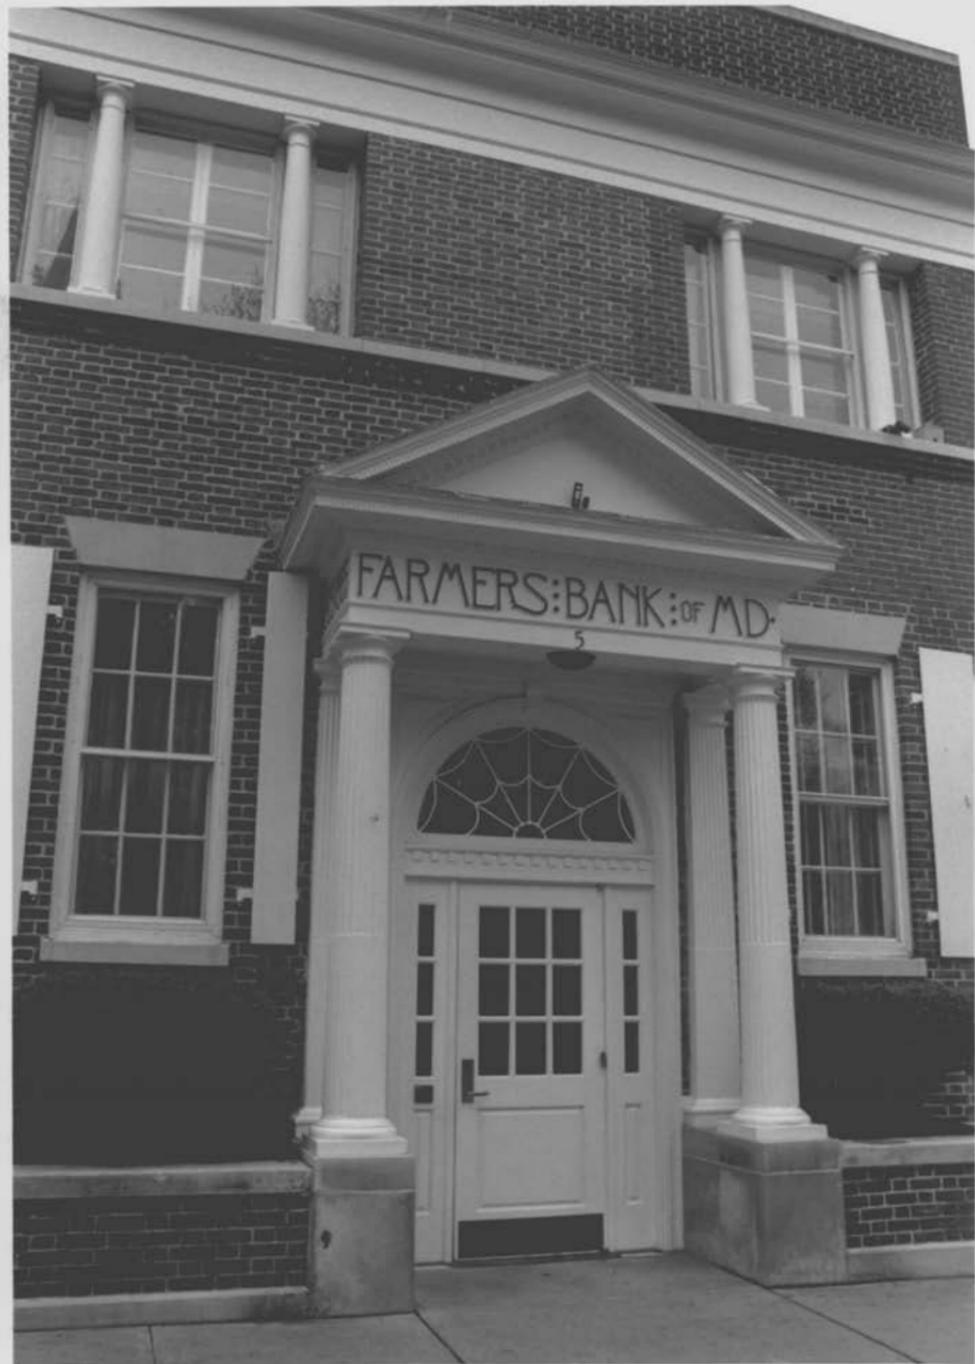
2 OF 6

To either side of this three-bay façade—to the northeast and southwest—are chamfered wall surfaces that contribute to the building's hexagonal footprint. Based upon maps, photographs, and brickwork, it appears that the northeast chamfered wall survives from the 19<sup>th</sup>-century structure. However, the brickwork on the first and second floors matches, here, indicating that prior to 1903 when the building was raised from one to two stories, the brick was either made to match the existing brick, or the original walls were rebuilt so it was all uniform.

NE ELEVATION, LOOKING SW

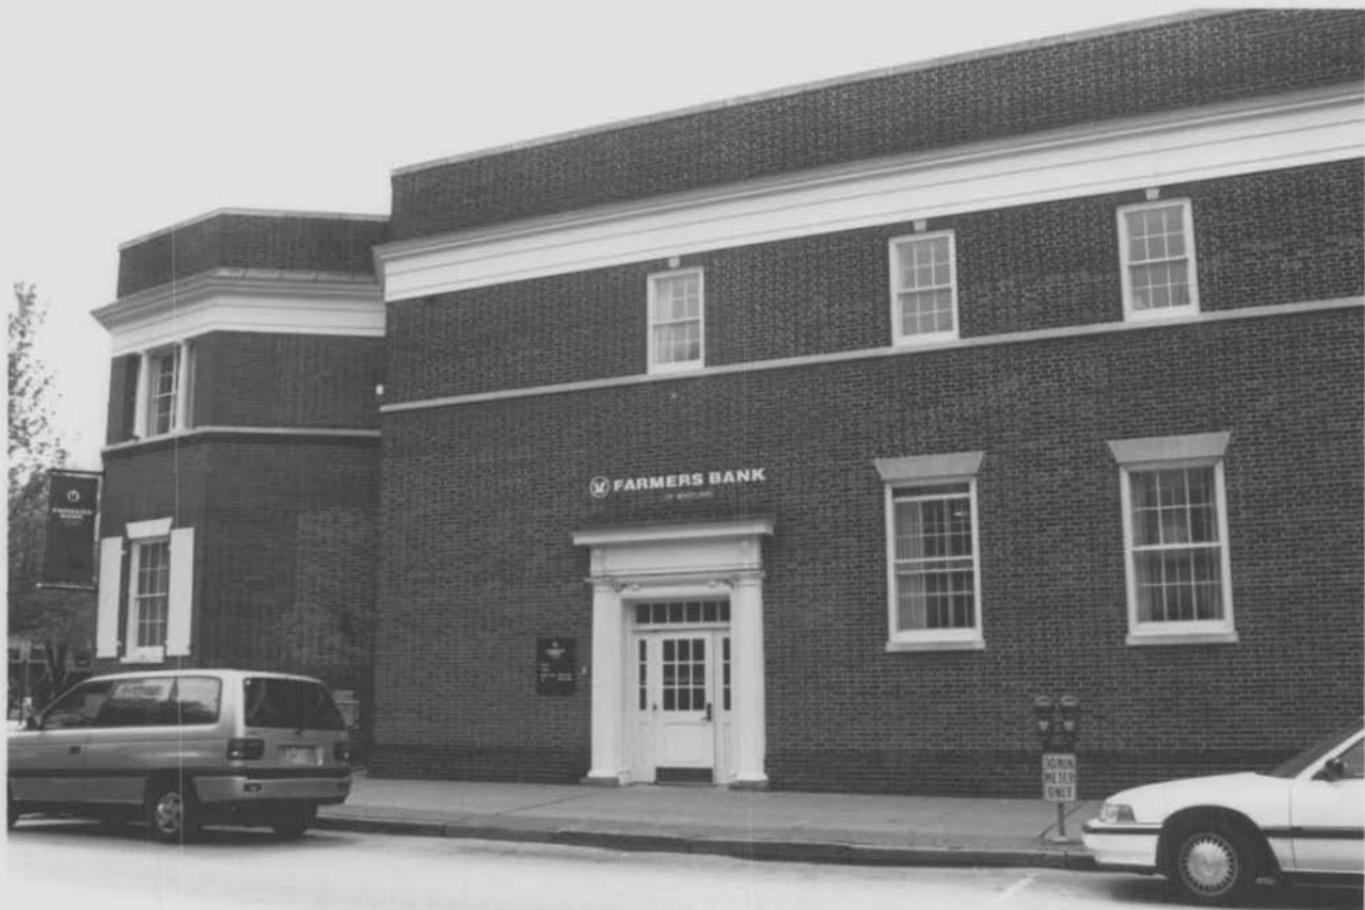
4 OF 6

Another chamfered wall surface to the north abuts the post-1954 five-bay-long wing extending along West Street. Like the northeast chamfered wall, this north chamfered wall appears to be part of the original structure. It abuts the main block of the building at an angle and has brick-filled window openings on the first and second stories.

NORTH ELEVATION, LOOKING SOUTHEAST

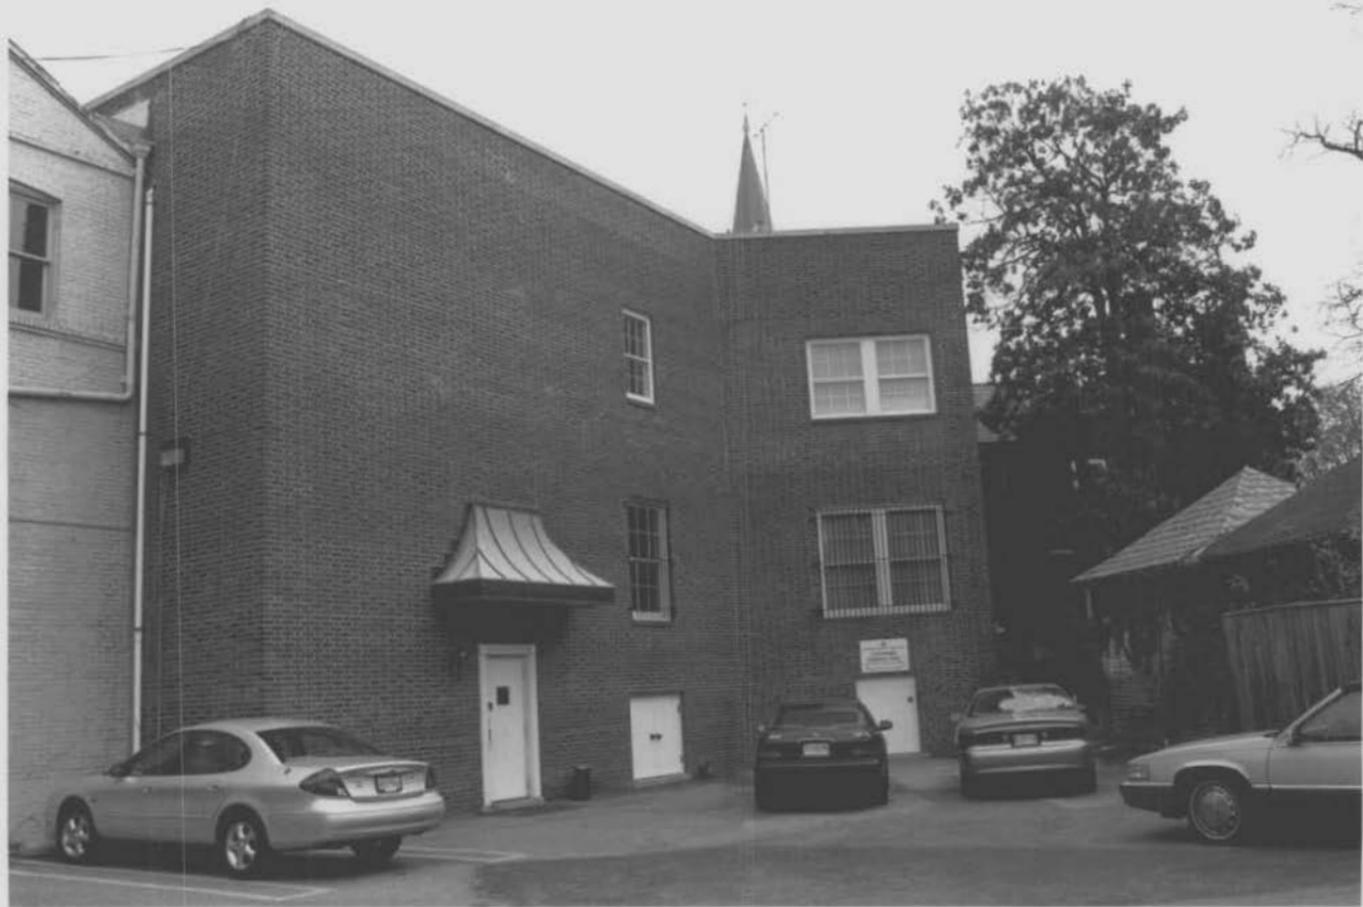
5 OF 6

The rear elevation of the building faces south onto a parking lot. The angled elevation is the product of the last two building campaigns. This includes the two-story rear addition constructed between 1930 and 1954 on the main block and the post-1954 addition running along West Street. This first addition, constructed of brick laid in Flemish bond, is just one bay wide with openings on three levels. A small opening has been cut into the ground story. Too short for pedestrian entry, the opening holds a flush metal door set on a concrete sill. The first story has paired 6/6 windows with rowlock brick sill and metal security bars. The second story, added when the West Street addition was constructed, has a smaller pair of 6/6 windows with a rowlock brick sill and storm windows. The rear of the West Street addition, also constructed of brick laid in Flemish bond, has similar fenestration. A short doublewide entry, with a flush metal door and concrete sill, is located at the ground level. The first and second stories are pierced with single 6/6 windows with rowlock brick sills. The first story opening is secured with metal bars. The second story is smaller and is covered with storm windows. Additionally, a single-leaf entry is located in the western end of the elevation. Set on a concrete sill, the flush wood door, with a small square light, is surrounded by square-edged casings with corner blocks. Over the entry is a massive metal hood, clad with standing seam metal.

SE ELEVATION, LOOKING EAST

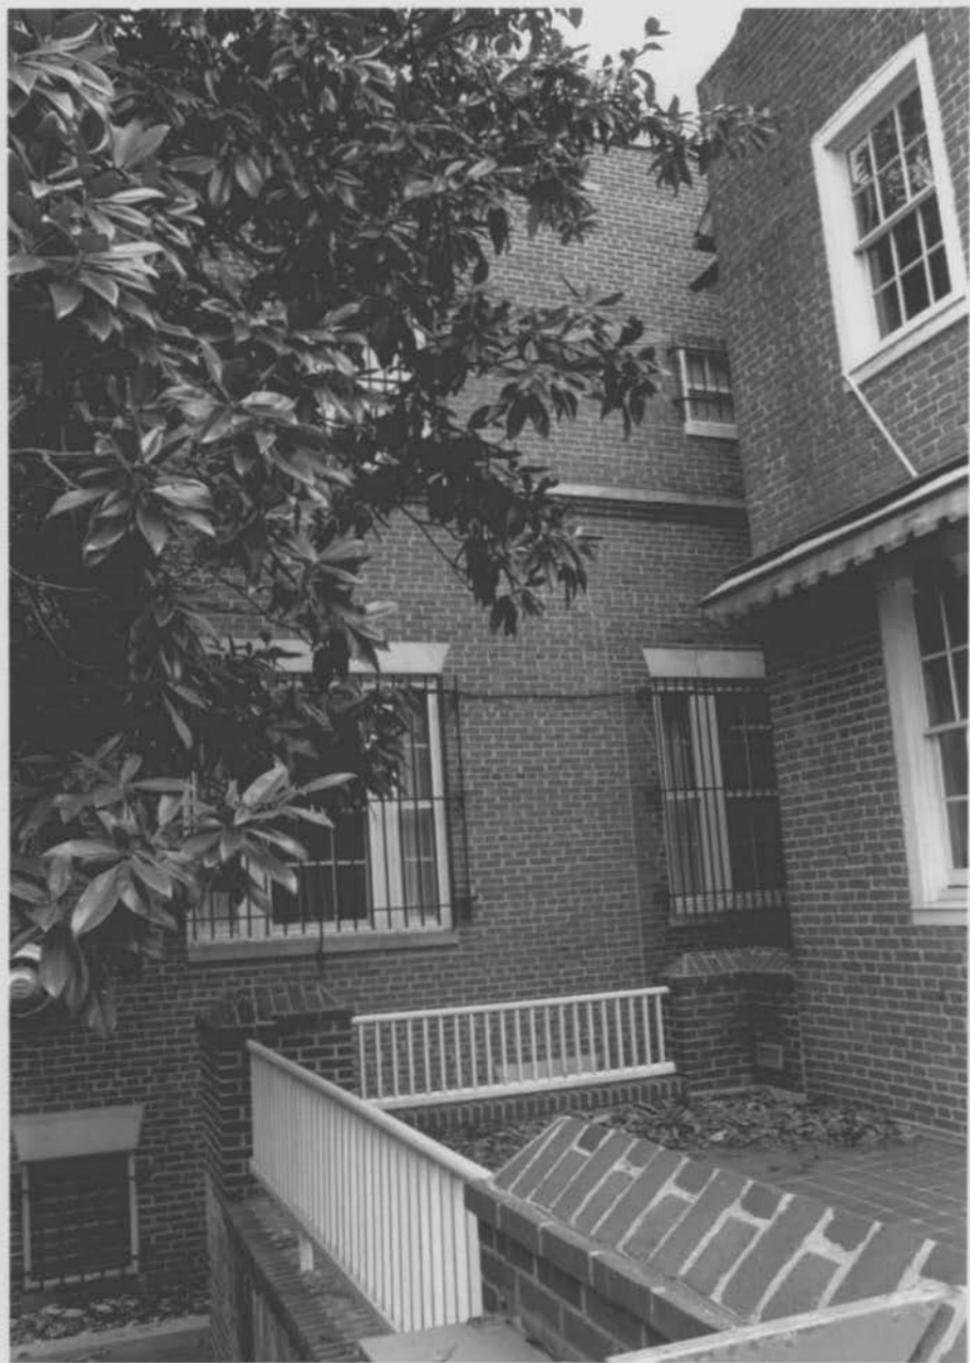
EAST ELEVATION, LOOKING NW
