HISTORIC SITES SURVEY FIELD SHEET
 Individual Structure Survey Form

COUNTY: Anne Arundel
TOWN: Annapolis
LOCATION: 189 Main St.
COMMON NAME: The Playhouse Theatre
FUNCTIONAL TYPE: Theatre Map 32 Par 249
OWNER: Playhouse Partnership ADDRESS: 122 Main St. Annapolis, MD 21401
ACCESSIBILITY TO PUBLIC: Yes (x) No () Restricted ()
LEVEL OF SIGNIFICANCE: Local (x) State () National ()

1. STATE Annapolis, Maryland COUNTY TOWN VICINITY STREET NO. 187 Main Street ORIGINAL OWNER ORIGINAL USE commercial PRESENT OWNER PRESENT USE movie house WALL CONSTRUCTION brick NO. OF STORIES 2 front, 3 rear	HISTORIC AMERICAN BUILDINGS SURVEY INVENTORY 2. NAME Playhouse Theater DATE OR PERIOD Late 19th C. STYLE Victorian commercial ARCHITECT BUILDER 3. FOR LIBRARY OF CONGRESS USE
---	---

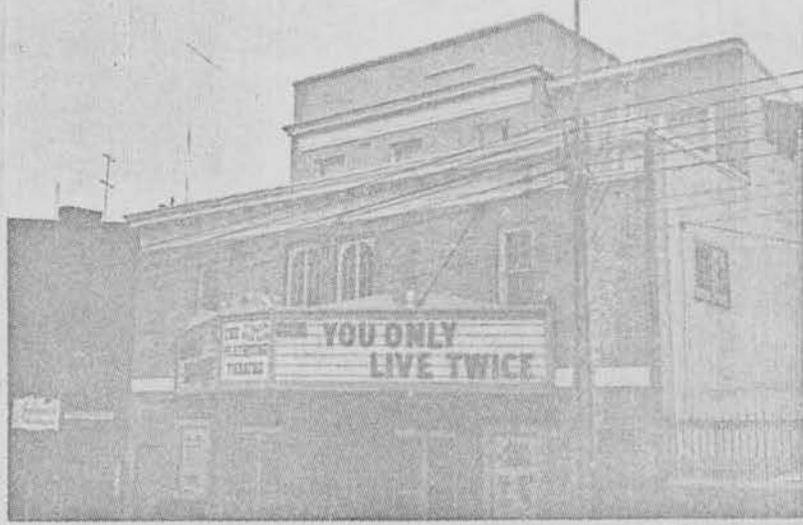
A fairly standard type of Victorian period commercial structure, the Playhouse Theater's facade is marred only by recent alterations (doorways, box office) and by the marquee. The front two storey section is topped by a very elaborate, fine modillioned cornice, with a whole row of reeding, plus swags. A third storey rises 10' or so back - two period cornices adorn it, Though not outstanding architecturally, could make good period building, etc. with removal of marquee, etc. (Back section looks older - is finer).

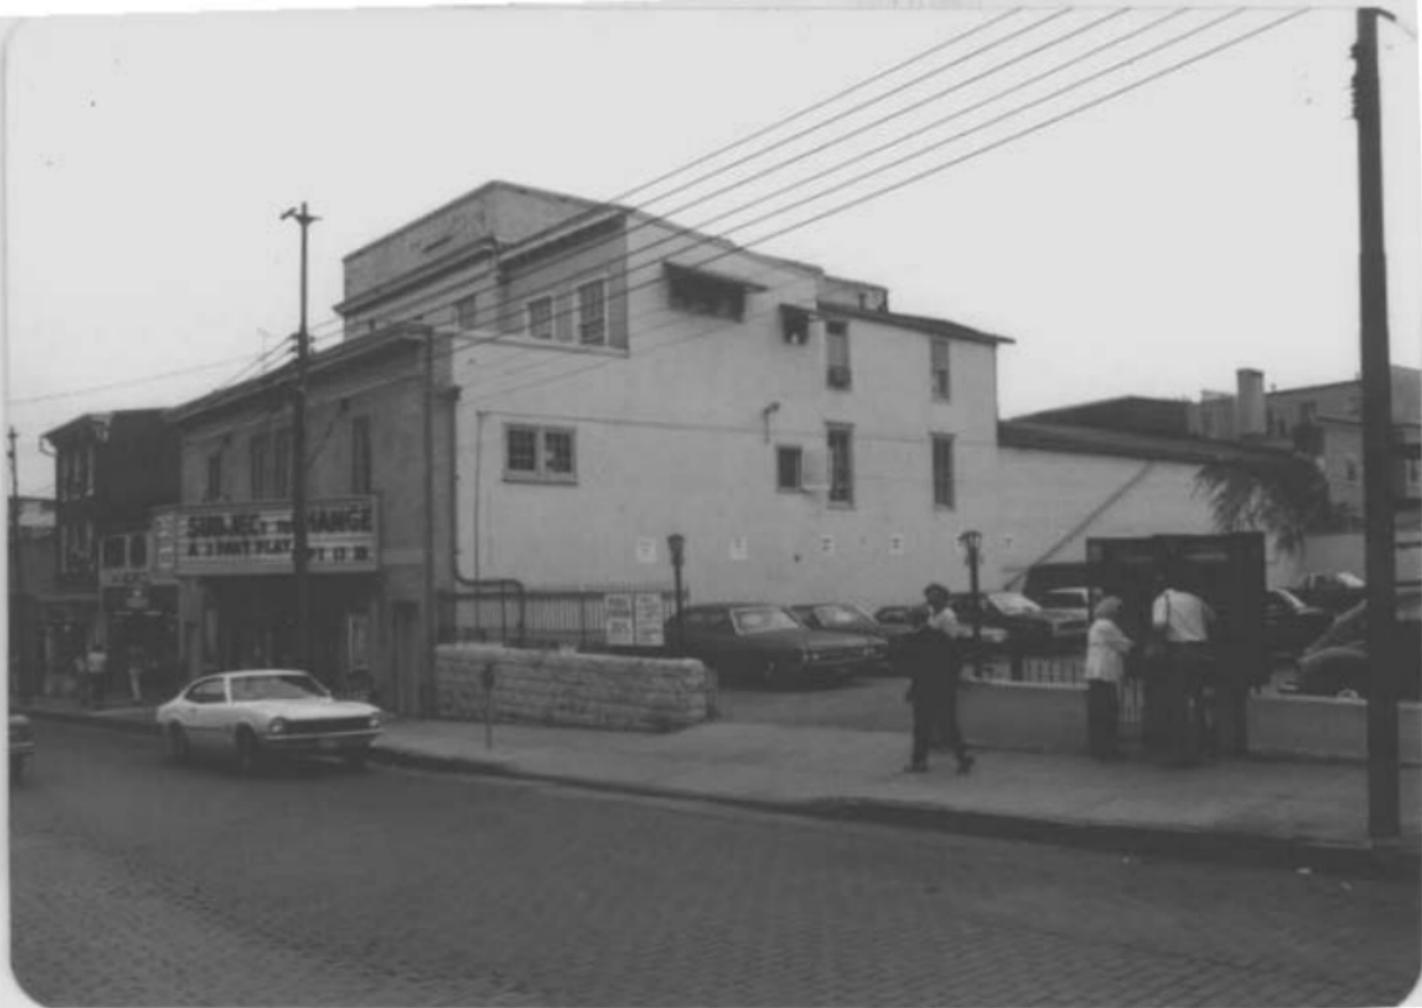
AA 572

Basically three buildings, two at the rear united by full width lobby addition at street. Front facade has modillioned cornice with plain frieze panel, paired casements with round headed windows in the center bay flanked by 4/4 sash at the second floor, belt course separates floors; ground floor altered for theatre entrance but exterior bays are probably original with later doors; marquee later. Rear buildings exposed at third floor only, with parapet wall at left structure and simple cornice, building at right has modillioned cornice.

NWElevation/camera facing SE
