AA-974

Morgue and Pump Houses

Crownsville Hospital Center

Maryland Historical Trust State Historic Sites Inventory Form

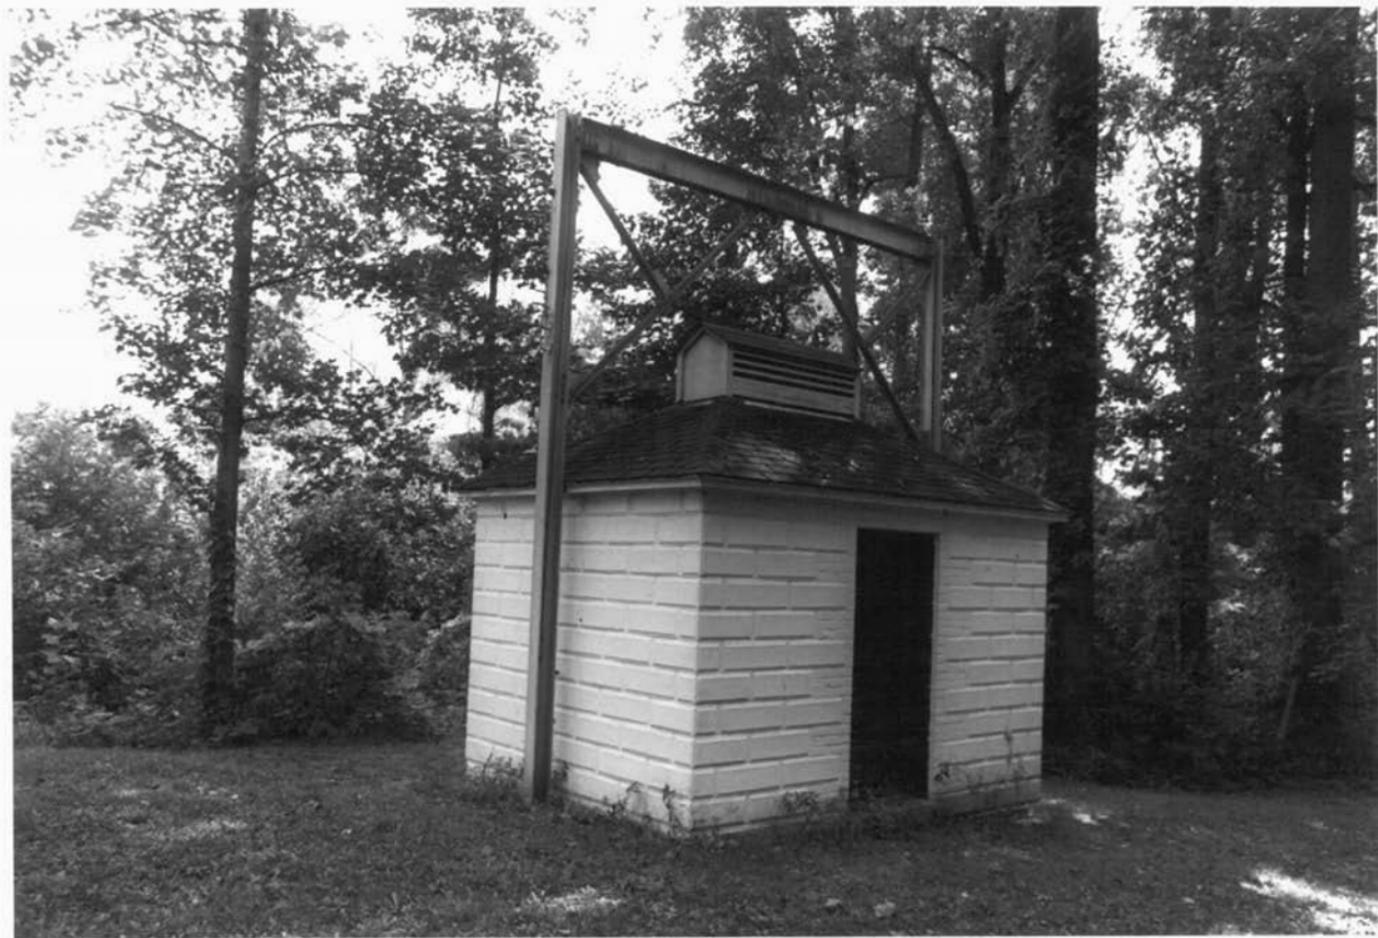
AA-974

The two pump houses have such similar appearances that one description will suffice for both. The simple structure is square, one bay by one bay. Rising one story in height, the pump house is constructed of the familiar molded concrete blocks. A slate covered hipped roof rises above the boxed cornice. Each building has two openings: one door and one window. The openings are decorated with brick Gibbs surrounds and vertical joint lintels. The french windows have brick sills as well. The southern pump house has a small wooden cupola of louvered sides and gable roof.

Pump House

NDRTH AND WEST
