B-3405 - B-3406

1001 - 1049 Riverside Ave. (East side)

INVENTORY FORM FOR STATE HISTORIC SITES SURVEY

1027-1049 Riverside Ave.

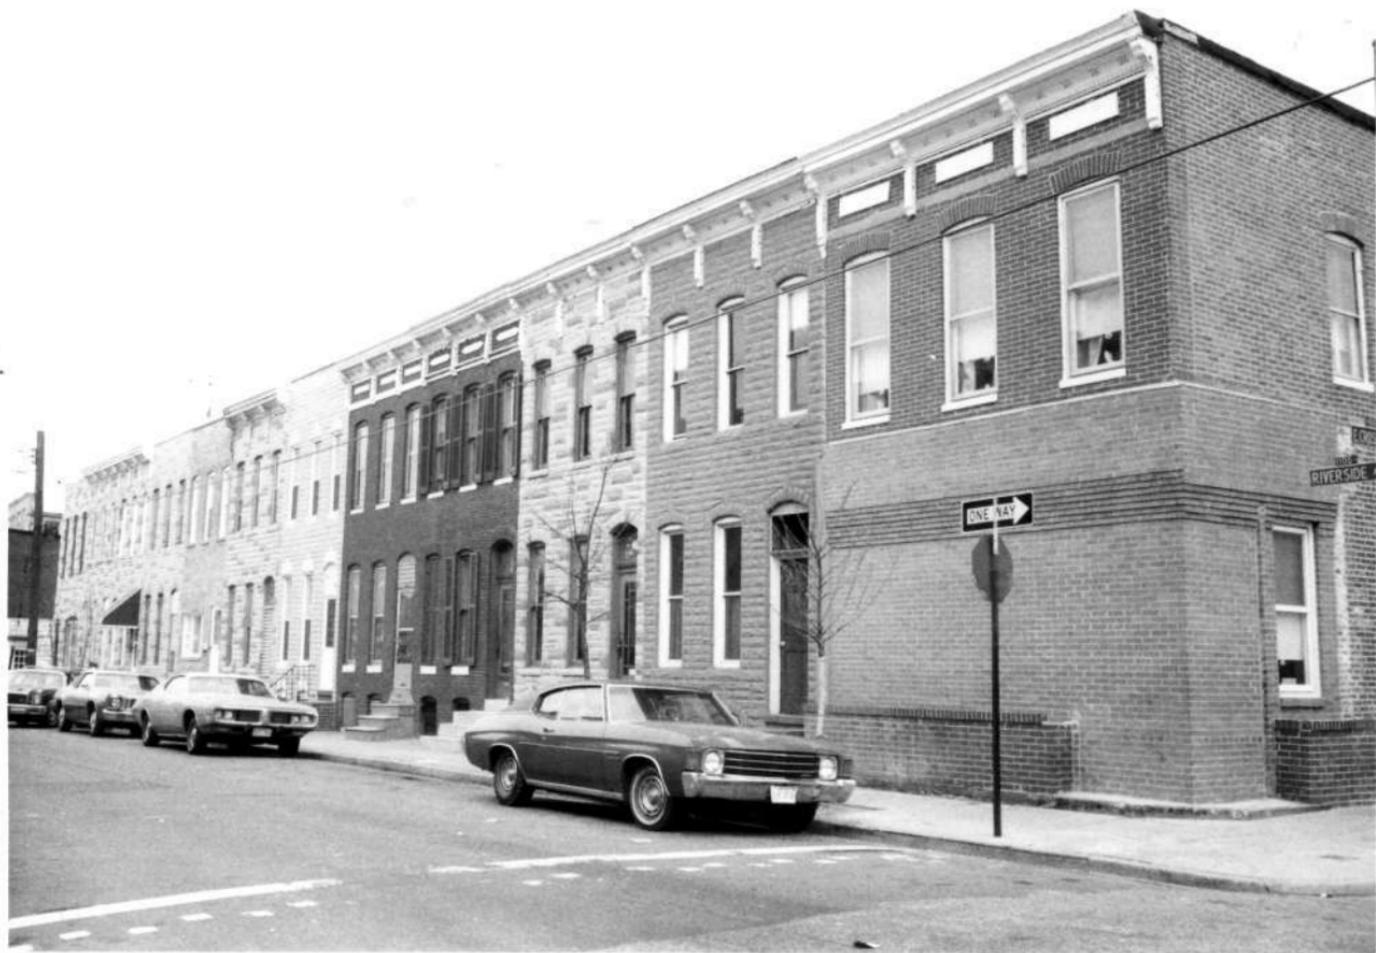
1027-1049 Riverside Ave.

West elevation

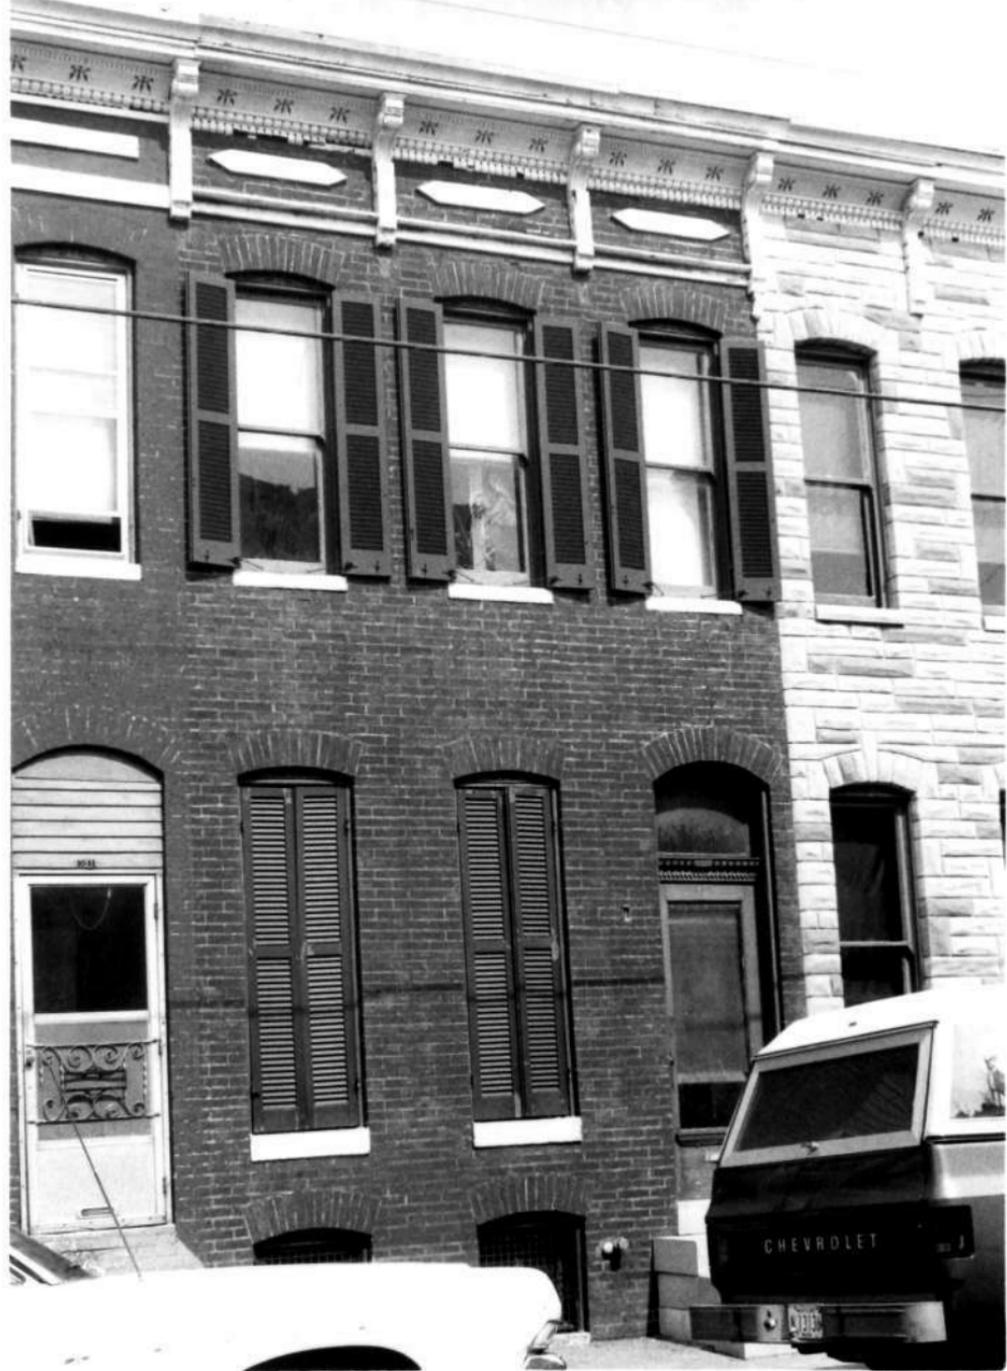
1043 Riverside Ave.

Decorative frieze with repeating motifs of three stylized 'M' or 'W' characters.

Second floor windows with dark shutters.

Ground floor arched doorways and windows with dark shutters. A Chevrolet car is parked in front of the building.

West elevation
