## MARYLAND HISTORICAL TRUST

## INVENTORY FORM FOR STATE HISTORIC SITES SURVEY

802-12, 840-44, 841, 843, 845, 846, 848, 850, 852, 858, 860, 863, 877, <sup>West</sup> Fairmount Ave.

B-4057

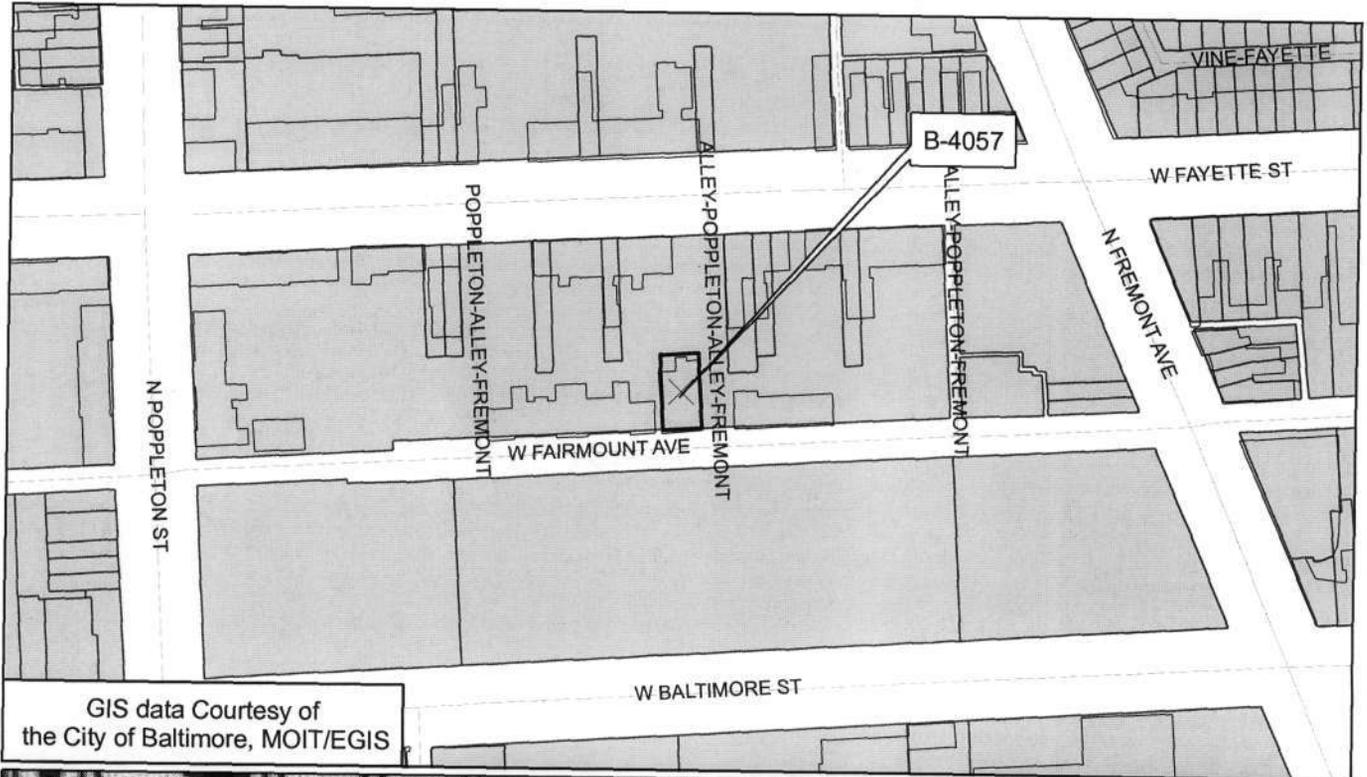
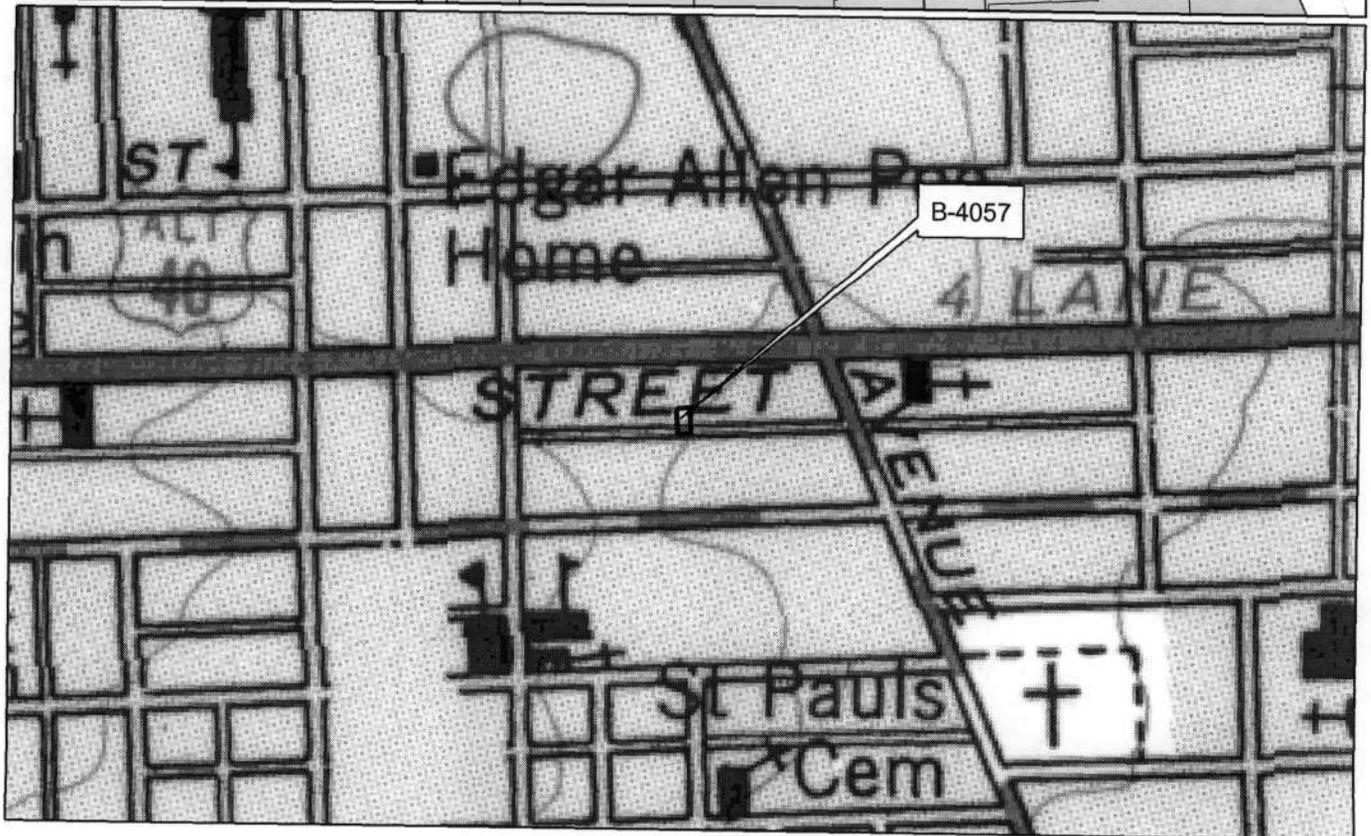
B-4057  
840-844 W. Fairmount Avenue  
Block 203  
Baltimore City  
Baltimore West Quad.

840-844 Fairmount Avenue is a one story garage structure, three bays wide and four bays deep. It is built of American common bond. The four windows on the east side have arched lintels composed of three rows of header bond. The windows are presently boarded up. Three large sliding doors are located in the front. A "boomtown" roof tops the front of the building.

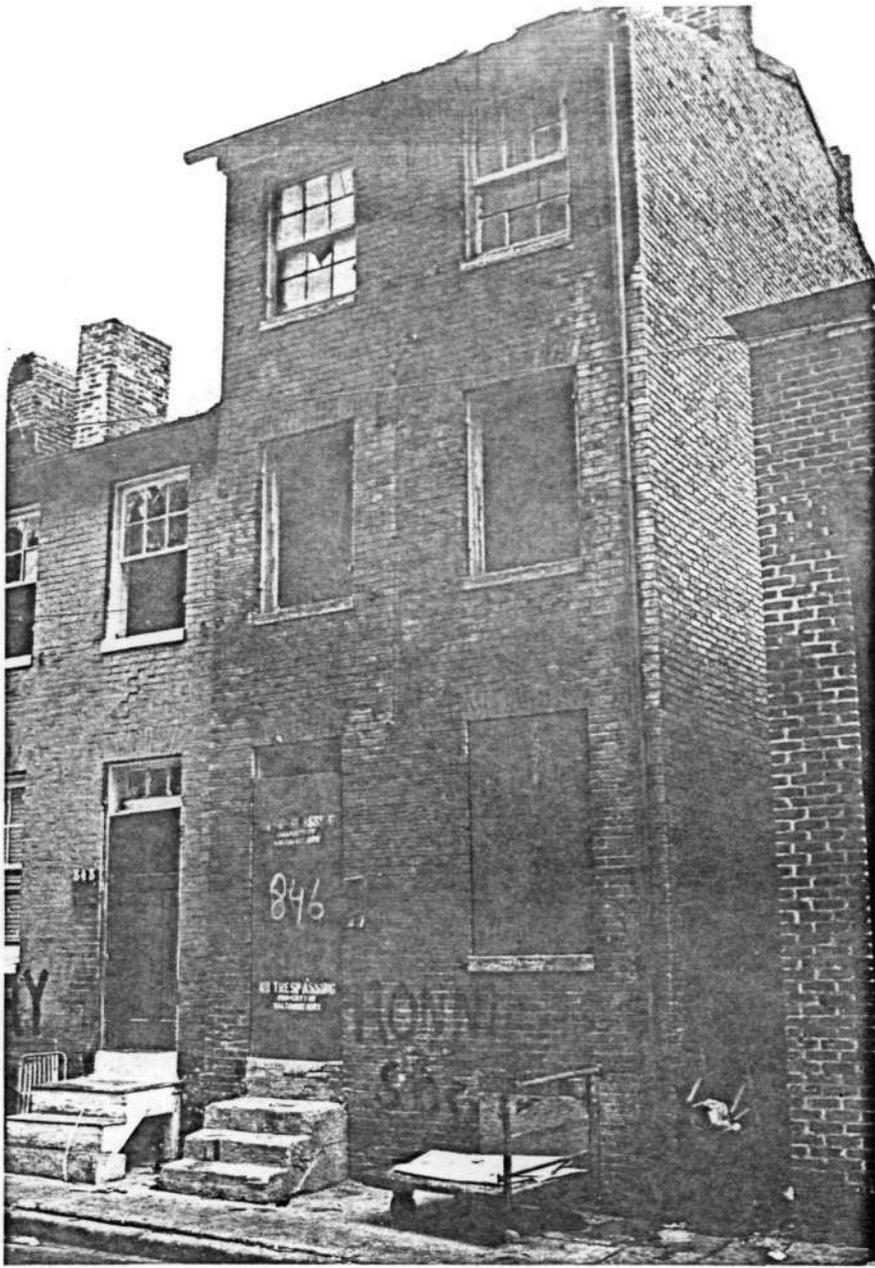
846 W. Fairmount Avenue

846 Fairmount Avenue is a three storey, two bay building with a gabled roof. The building is laid in American common bond with headers every ninth row. The windows have six-over-six lights and flat arched lintels. There is a small cellar window in the left bay. With the exception of the third storie windows, the remaining windows are boarded up. The single-leaf door is located in the left bay. It has a flat-topped transom with a flat arched lintel. The building has a simple brick cornice. 848 and 850 are similar in design as 846. They are two stories tall instead of three and their windows have six-over-one lights. 850 has a star detail in the center of the front facade. 848 and 850 are presently vacant.
