MARYLAND HISTORICAL TRUST

B-4060

INVENTORY FORM FOR STATE HISTORIC SITES SURVEY

802-12, 840-44, 841, 843, 845, 846, 848, 850, 852, 858, 860, 863, 877<sup>West</sup> Fairmount Ave.

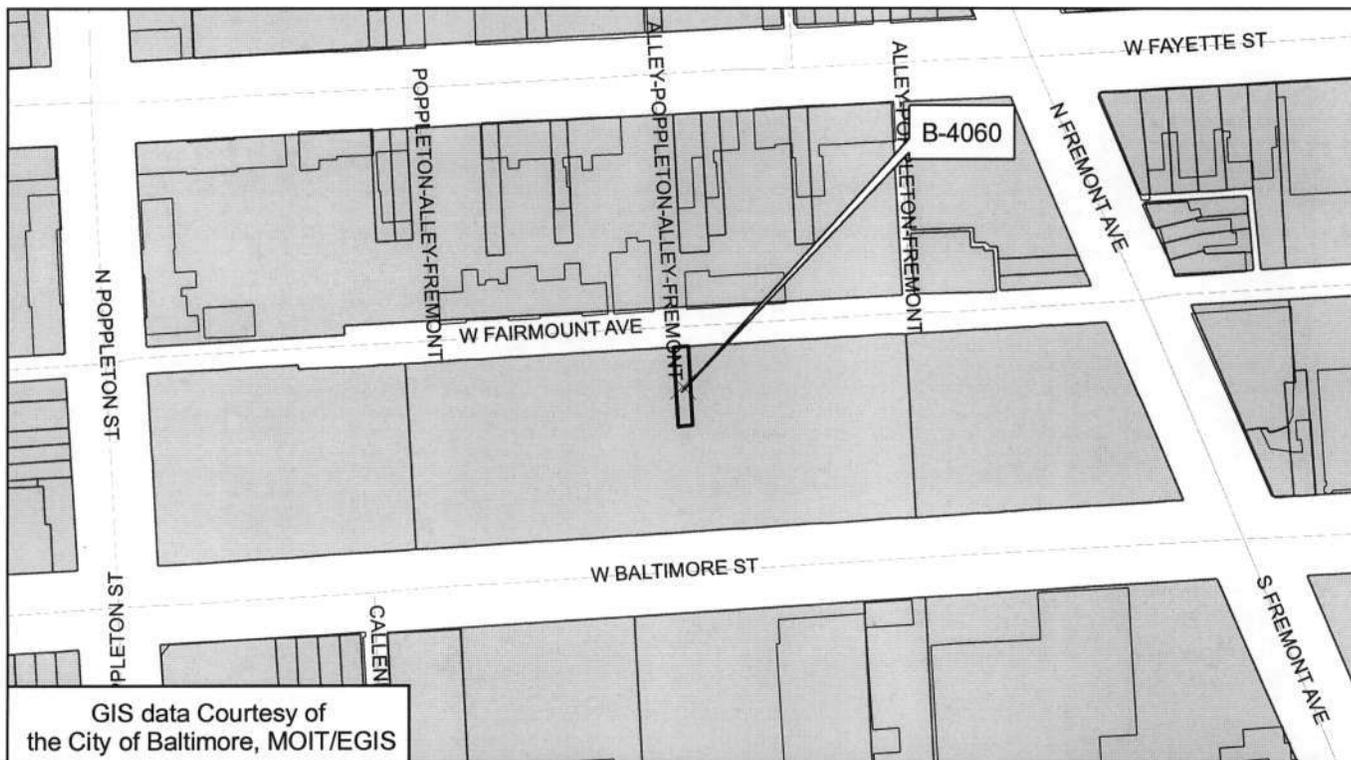
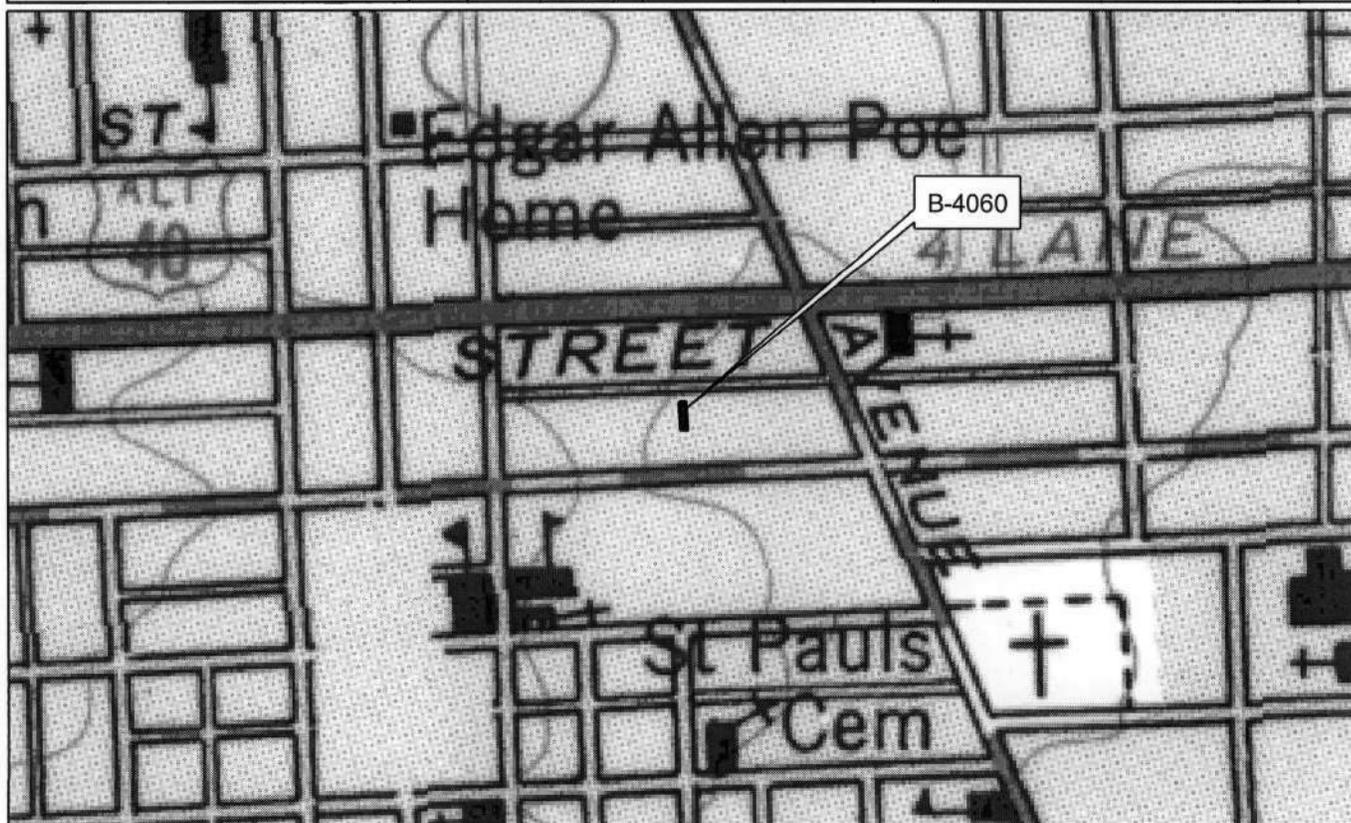
B-4060  
845 W. Fairmount Avenue  
Block 203  
Baltimore City  
Baltimore West Quad.

841, 843 and 845 Fairmount Avenue are three rowhouses, built of stretcher bond brick. They are two-and-a-half stories tall and two bays wide. Some of their elements suggest the Greek revival style. The foremost of these are the eyebrow windows of three-over-three lights just beneath the low gabled roof. The first and second story windows of 841 have six-over-one lights and those of 843 and 845 have one-over-one lights. A square window is located in the basement level of each building. All the windows have flat wooden sills and lintels. All three buildings have single-leaf doors with flat-topped transoms. A round-arched sallyport is located between buildings 839 and 841, and 843 and 845. A string course of brick runs beneath the third story window of 843 and 845. All three buildings are in considerable disrepair but they presently appear to be inhabited.
