Maryland Inventory of Historic Properties Form

Survey No. B- 4770

Historic 111 - 125 South Chapel Street
and / common

street & number 111 - 125 South Chapel Street
city, town Baltimore
state & zip code Maryland 21231 county

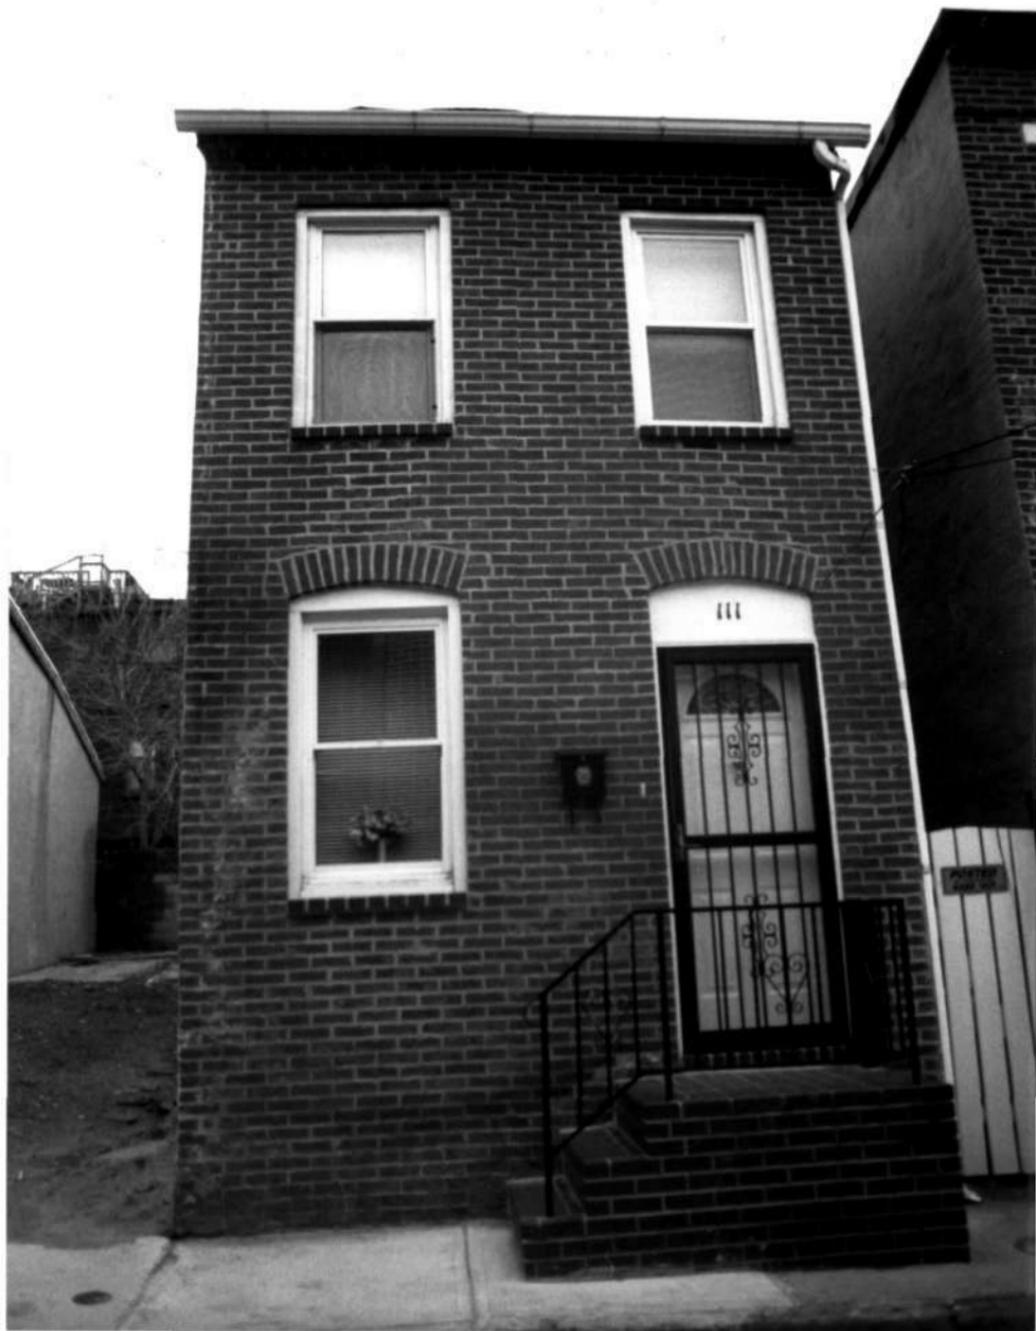
111 S Chapel

111 S. Chapel St. is a two-story, gable-roofed house constructed in running bond that was always painted. The very-low-pitched gable roof has a simple brick corbelled cornice. Door and window openings have segmentally arched brick lintels and brick sills. Window openings are filled with 1/1 replacement sash. The single-light doorway transom has been covered with aluminum siding and the door is a modern replacement. The house sits on a medium-height basement, with the entrance being reached by three brick steps, set parallel with the façade.

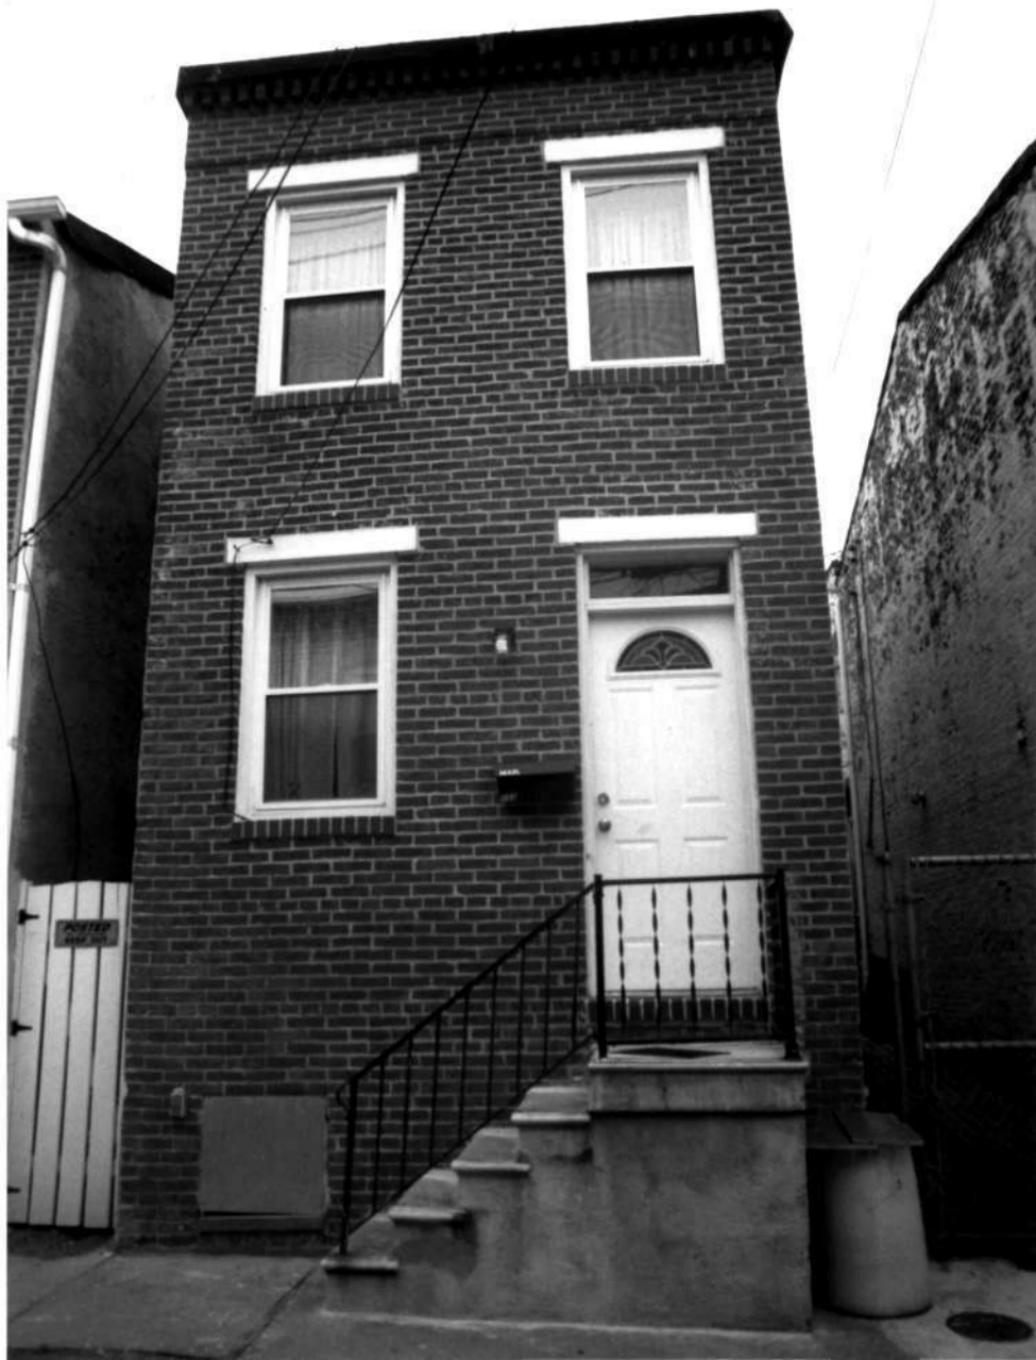
113 Schapel
FP7

113 S. Chapel St. is a two-story early Italianate-style house, built in the 1870s, with a shed roof and simple brick dentiled cornice. It is constructed in common bond that was always painted. Door and window openings have flat wood lintels and brick sills. Window openings are filled with 1/1 replacement sash. The doorway has a single-light transom and the door is a modern replacement, matching that of 111 S. Chapel St.. The house sits on a medium-height basement, with the entrance being reached by five concrete steps, set parallel with the façade.

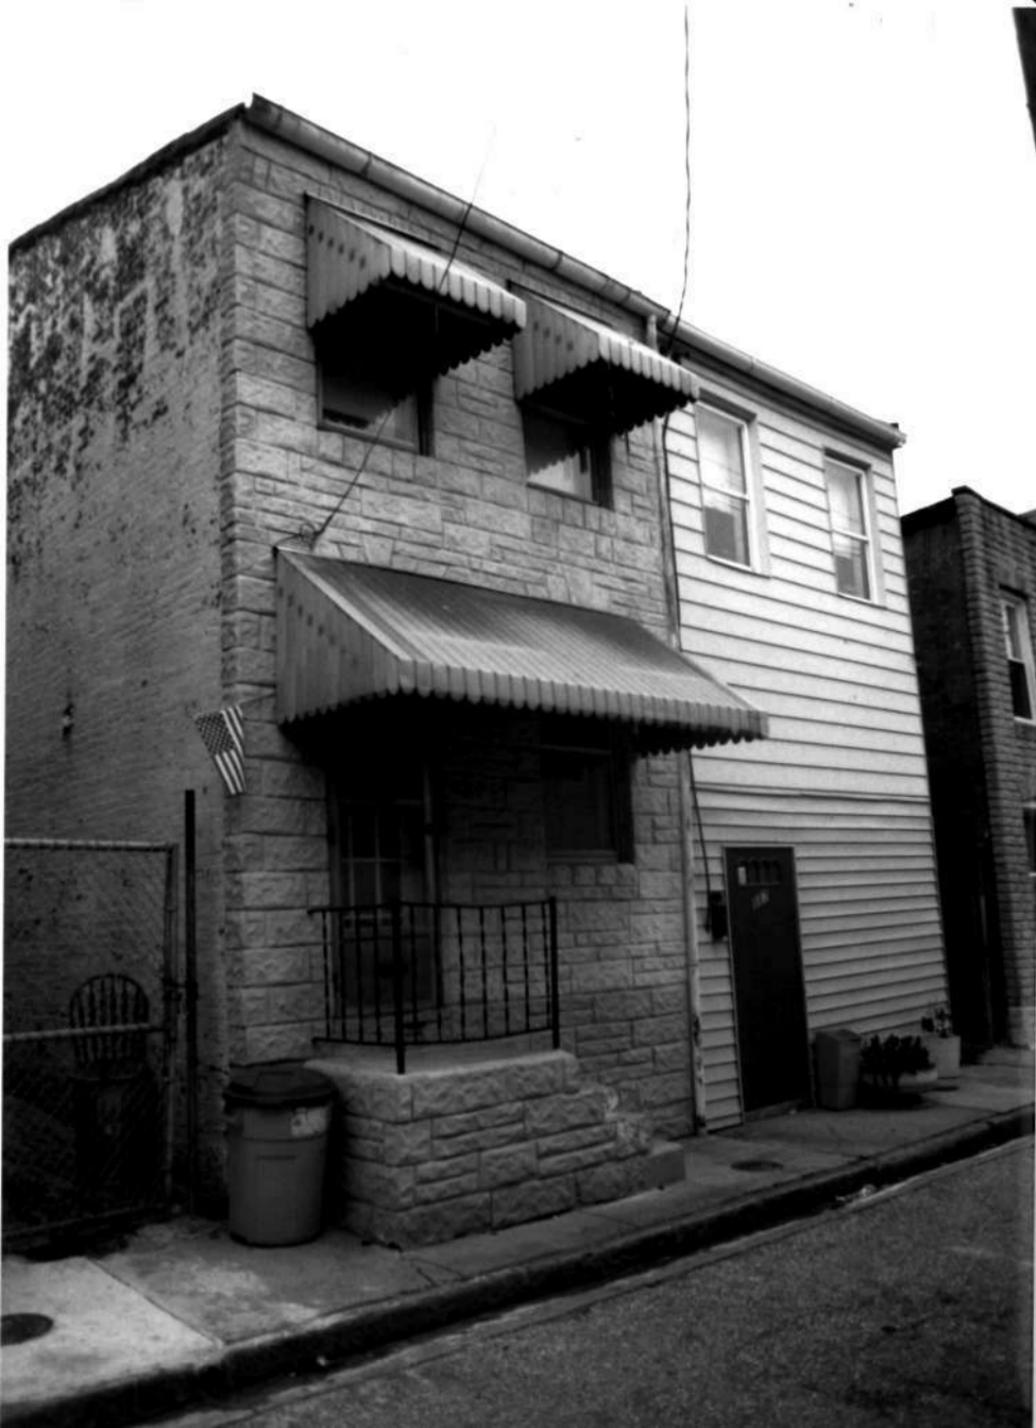
115-117 S Chapel

115 – 117 S. Chapel St. are a pair of two-story, gable-roofed houses that are now covered with formstone and aluminum siding so that all original details are obscured. The very-low-pitched gable roof has a simple brick corbelled cornice, also now hidden. Door and window openings probably had flat wood lintels and wood sills. Window openings are filled with 1/1 replacement sash. Original doorways have been remodeled and both doors are modern replacements. Both houses originally sat on medium-height basements, with the entrance being reached by four stone steps, set parallel with the façade; now 117 has had its façade remodeled so that the doorway opens directly off the street..

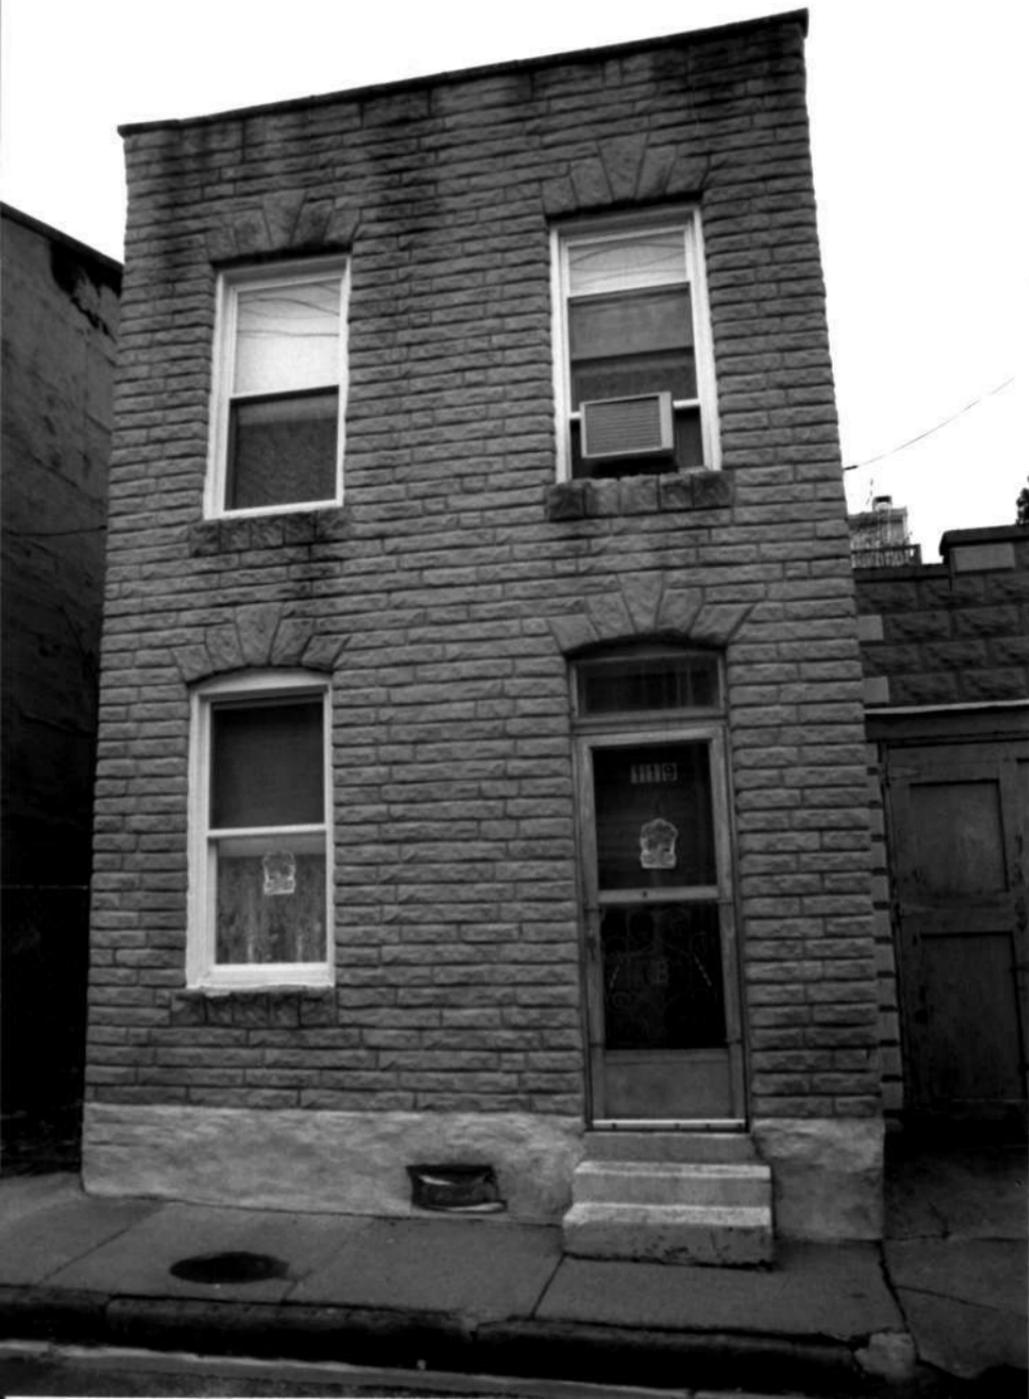
119 S Chapel

119 S. Chapel St. is a two-story early Italianate-style house, probably built in the 1870s, with a shed roof that has been covered with formstone. All original details, including the cornice, are obscured. Window openings are filled with 1/1 replacement sash. The doorway has a single-light transom and the door is a modern replacement. The house sits on a low basement, with the entrance being reached by two concrete steps.

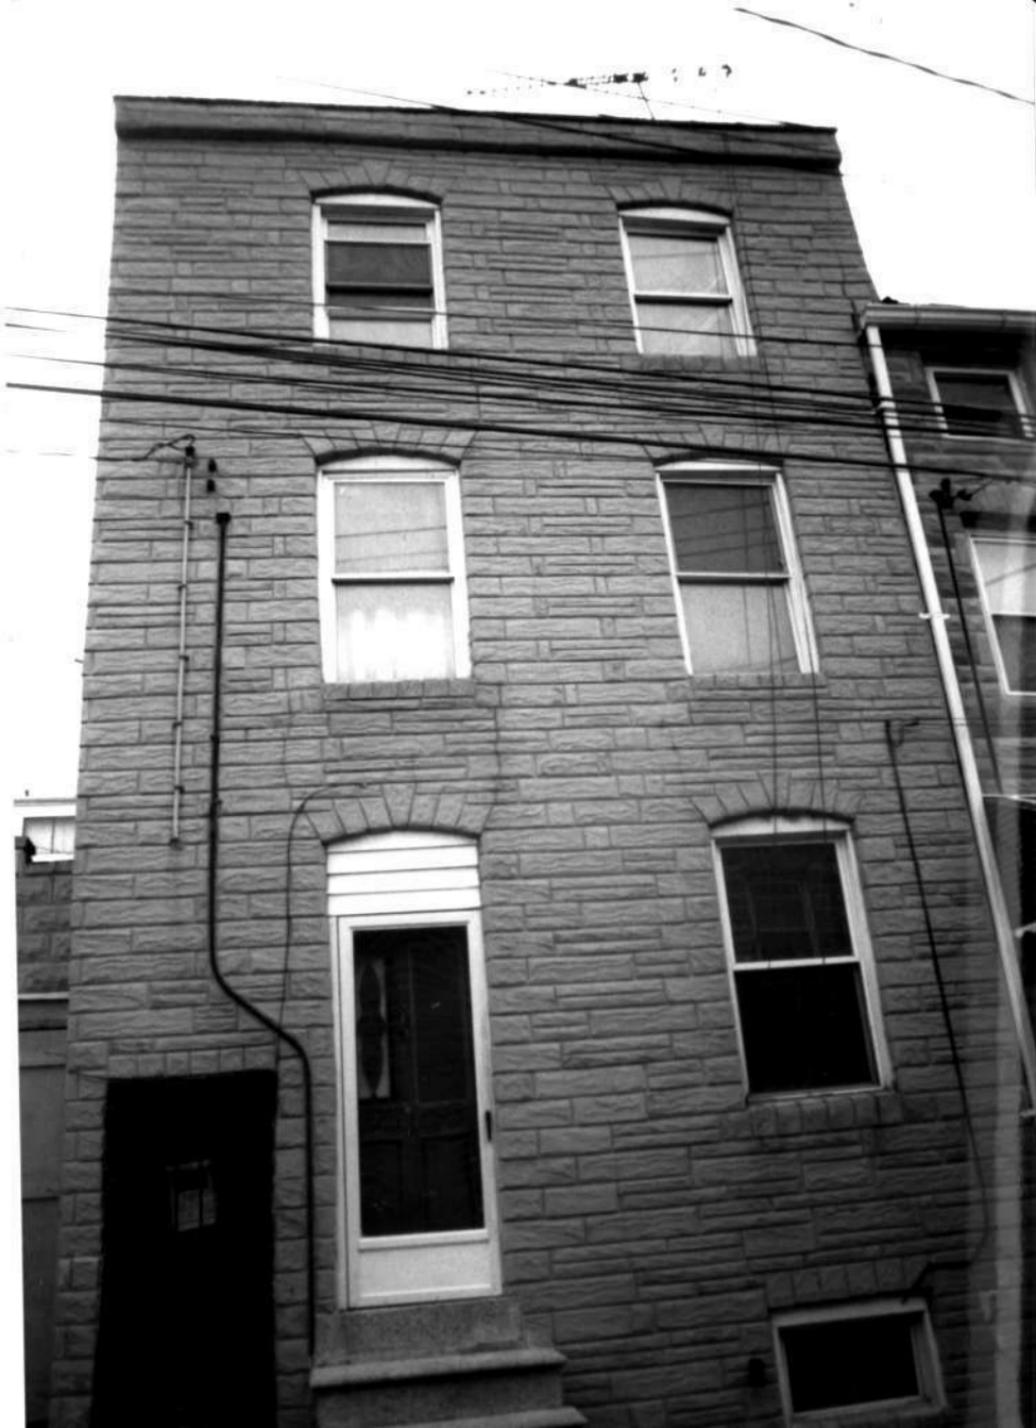
123 S Chapel

123 S. Chapel St. is a three-story house with a shed roof that has been covered with formstone. All original details, including the cornice, are obscured. Window openings are filled with 1/1 replacement sash. The doorway has a single-light transom, now covered with aluminum siding, and the door is a modern replacement. The house sits on a low basement, lit by a double-light sash, with the entrance being reached by three concrete steps. A flat-linteled sallyport runs back along the northern portion of the house.

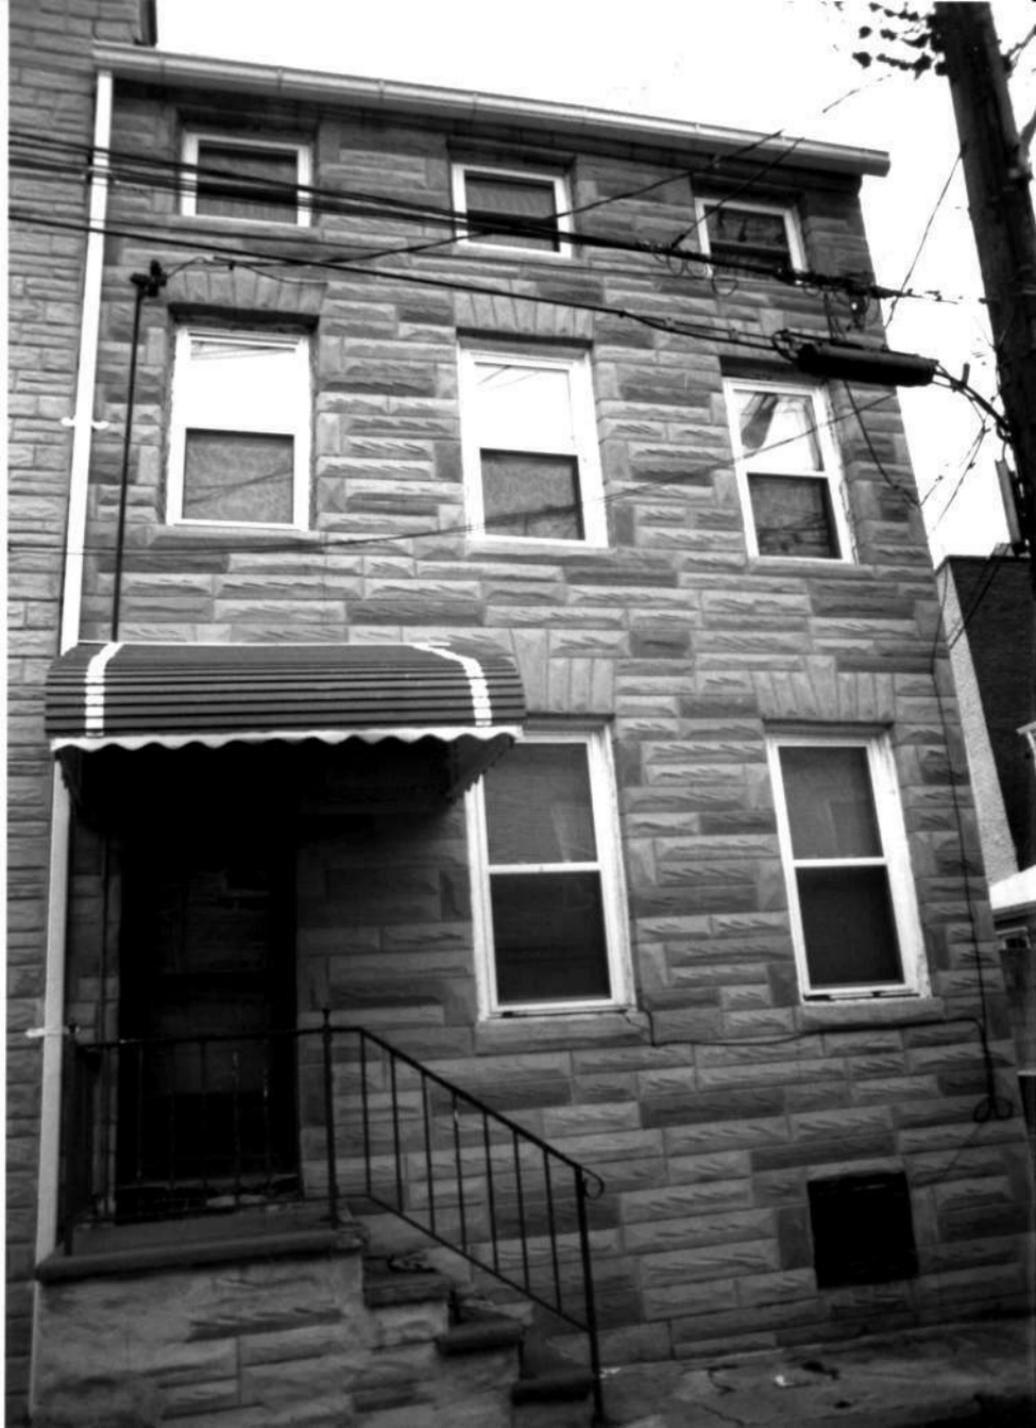
125 S Chapel

125 S. Chapel St. is a three-bay-wide, two-story-and-attic house with a low-pitched gable roof that has been covered with formstone. All original details, including the simple, corbelled brick cornice, are obscured. Window openings are filled with 1/1 replacement sash. The doorway has a single-light transom, now covered with aluminum siding, and the door is a modern replacement. The house sits on a medium-height basement, lit by a double-light sash, with the entrance being reached by four concrete steps, set parallel to the façade.
