Arlington Methodist Episcopal Church South  
B-5265  
4820 Reisterstown Road  
Baltimore  
Date of Construction: 1869, 1956  
Access: Private

# Maryland Historical Trust Maryland Inventory of Historic Properties Form

Inventory No. B-5265

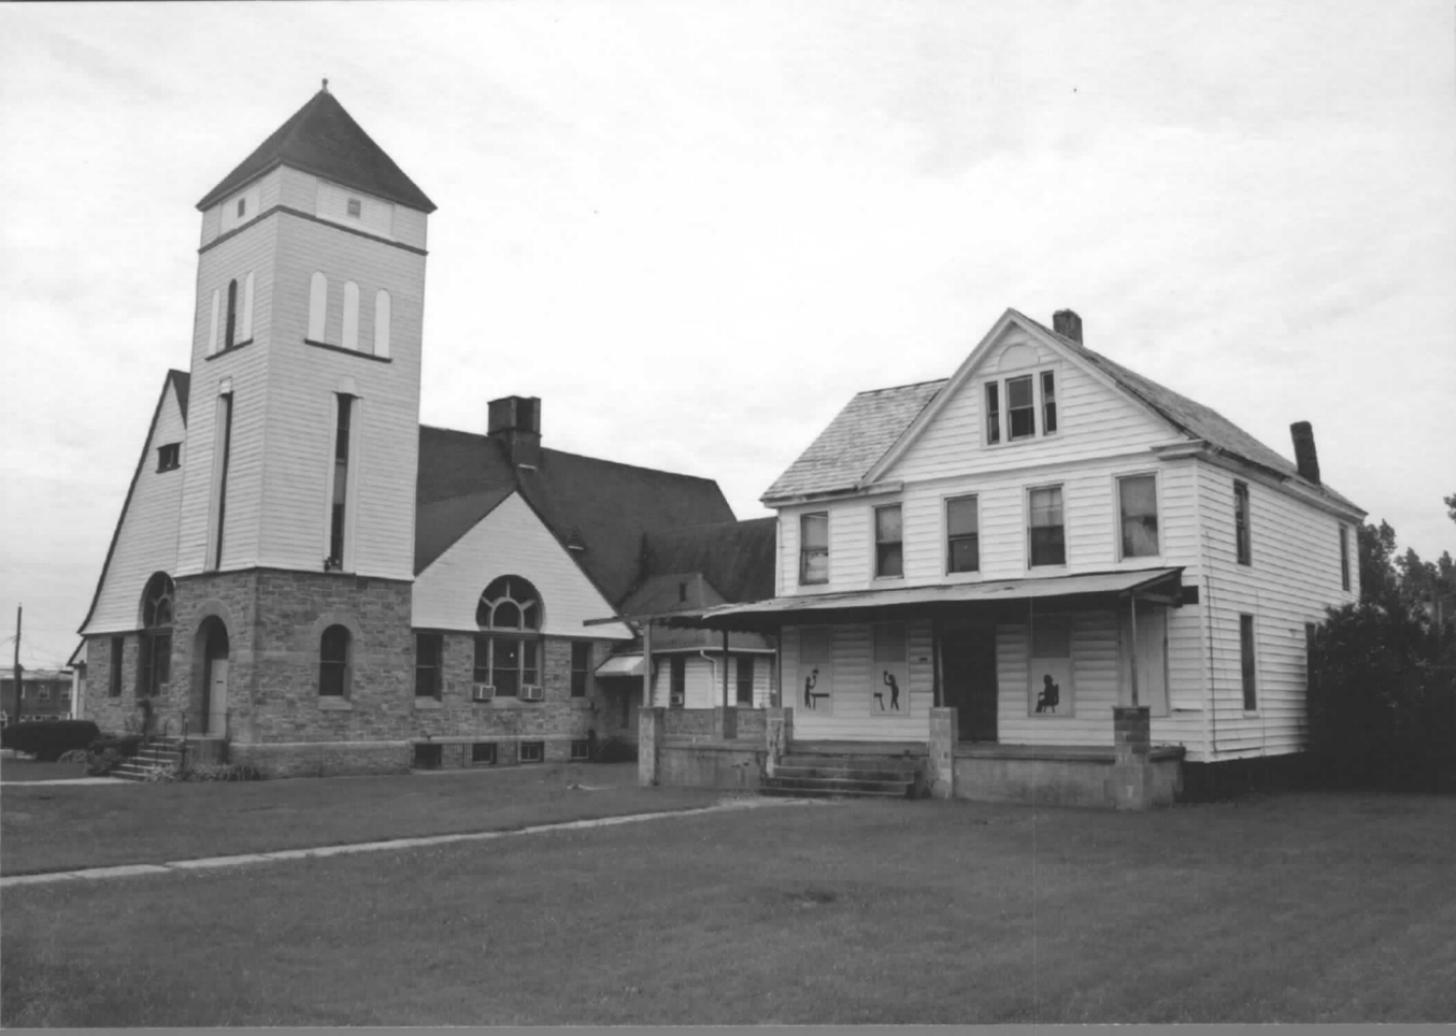
#1 OF 7

ARLINGTON METHODIST EPISCOPAL CHURCH SOUTH AND RECTORY, NORTH ELEVATION (LEFT)  
AND WEST ELEVATION (RIGHT), LOOKING SOUTHEAST.

The front gable fenestration is symmetrical (Figures 1 and 2). A large, arched eight-light stained glass window is centered on the façade. It is flanked by two double-hung stained glass windows and is surmounted by an eyebrow gable vent with a pair of louvered vents. Four windows aligned with the windows on the first floor light the basement. All of the windows on the gable have stone sills. To the east of the gable is an enclosed porch under the main roof line. This porch has a front-facing entrance with a double door and rectangular transom. It is accessed by a six concrete stairs with metal railings. To the right of the center gable section is a three-story entrance tower with a pyramid shaped roof with a conical finial. The north side of the tower has a pair of vertically stacked narrow rectangular windows in the second stage and three narrow, round-arch windows on the third stage surmounted by a belt course and a louvered vent. The first-floor entrance is recessed under a round arch with a large stained glass tympanum. The double door is accessed by six concrete stairs with metal railings. At the bottom of the arched portion of the door surround, a stone belt course adds horizontal emphasis to the tower. A water table unites the tower with the front gable and porch. Recessed from the main elevation, the southwest wing has two bays. The first is composed of a double door with five-panel wooden doors surmounted by a metal awning. The second bay has a single, one-over-one, double-hung stained glass window. These two bays are under a hipped roof. Six concrete stairs with no railing provide access to the doorway.

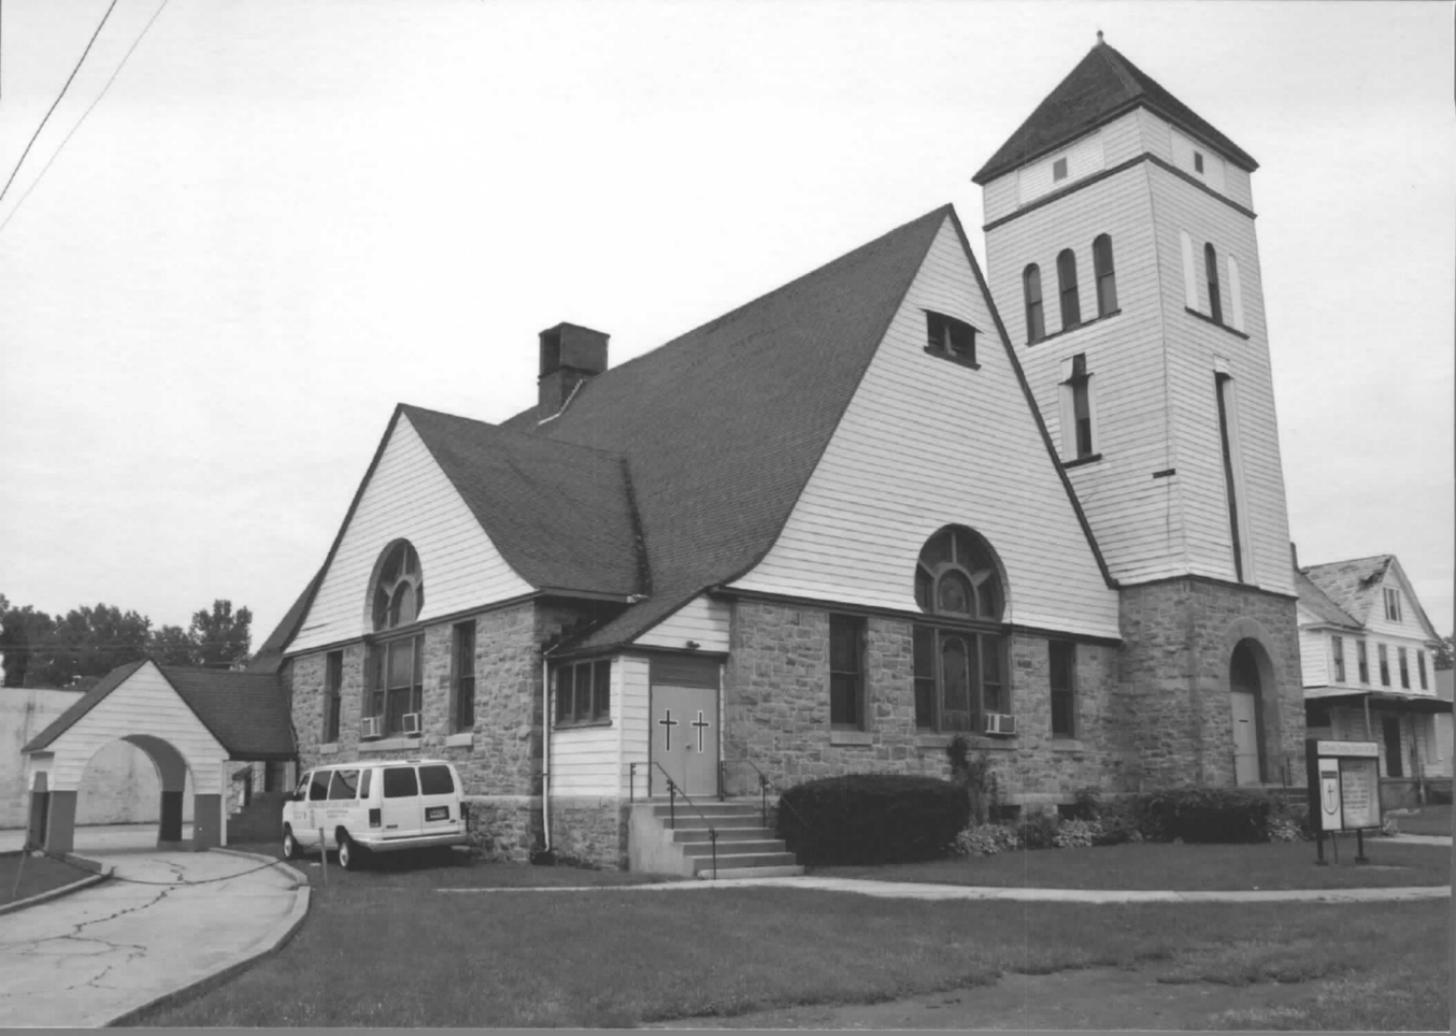
#2 OF 7

ARLINGTON METHODIST EPISCOPAL CHURCH SOUTH, EAST ELEVATION (LEFT) AND NORTH  
ELEVATION (RIGHT), LOOKING SOUTHWEST.

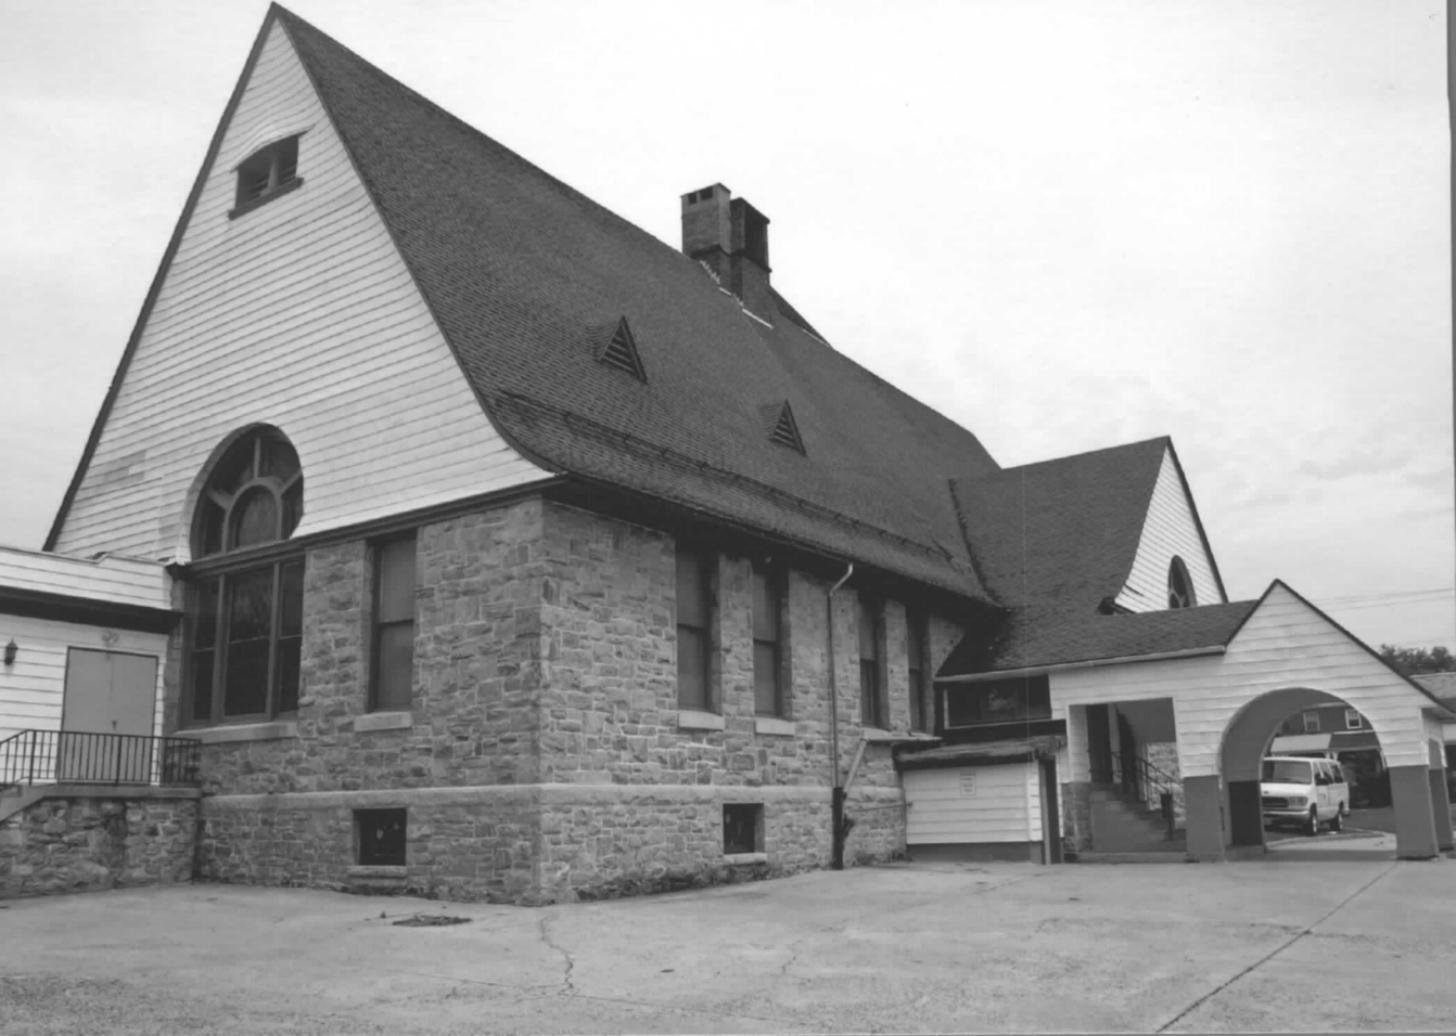
# 3 OF 7

ARLINGTON METHODIST EPISCOPAL CHURCH SOUTH, SOUTH ELEVATION (LEFT) AND  
EAST ELEVATION (RIGHT), LOOKING NORTHWEST.

The east elevation faces Lewins Avenue and has seven bays (Figure 3). The first two bays on the south end of the building have two one-over-one double-hung windows with stone sills on the first story and a gabled louvered roof vent above. The first bay has a single three-light window on the basement story, but the second bay basement fenestration is obstructed by the addition of a shed with a below-grade doorway, likely providing access to the basement. An enclosed porch with an affixed, gabled Porte Cochere composes the third bay. The third-bay porch is under the roofline of the cross gable and has a double door accessed by six concrete stairs. The porch is connected to the Porte Cochere by a covered walkway. The cross gable is composed of the fourth, fifth, and sixth bays. It is identical to the front gable, being fenestrated with a large arched window flanked by two stained glass double-hung sash windows. The pitch of the roof, however, is moderate. The seventh bay contains a triple rectangular stained-glass window with a wood sill. The east elevation of the tower, located behind the mass of the main roof, has the same fenestration on the third stage as on the north elevation. The second stage, however, has only one narrow rectangular window.

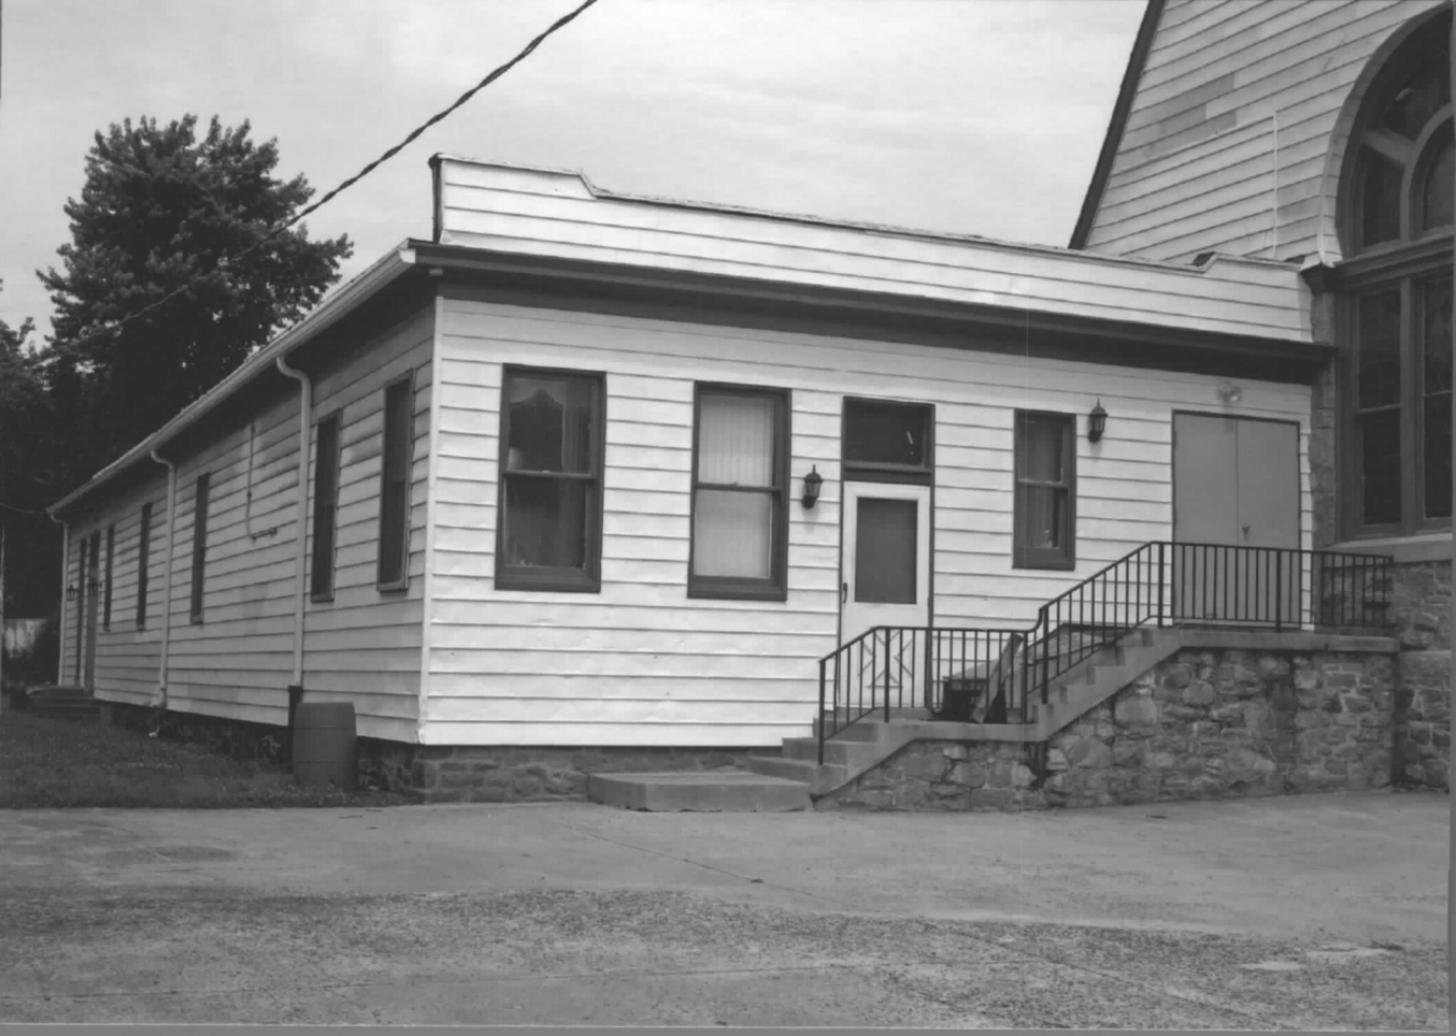
#4 of 7

ARLINGTON METHODIST EPISCOPAL CHURCH SOUTH, REAR ADDITION, SOUTH ELEVATION  
(LEFT) AND EAST ELEVATION (RIGHT), LOOKING NORTHWEST.

Fenestration on the south gable is partially obstructed by the one-story addition affixed to the southwest corner of the main block (Figure 4). The large arched window surmounted by the eyebrow vent is centered on the gable. A single double-hung window with a stone sill is visible to the east of the arched window. On the basement story, a single, three-light window with a stone sill is aligned below the first-floor double-hung window. The south elevation of the tower is identical to the east elevation.

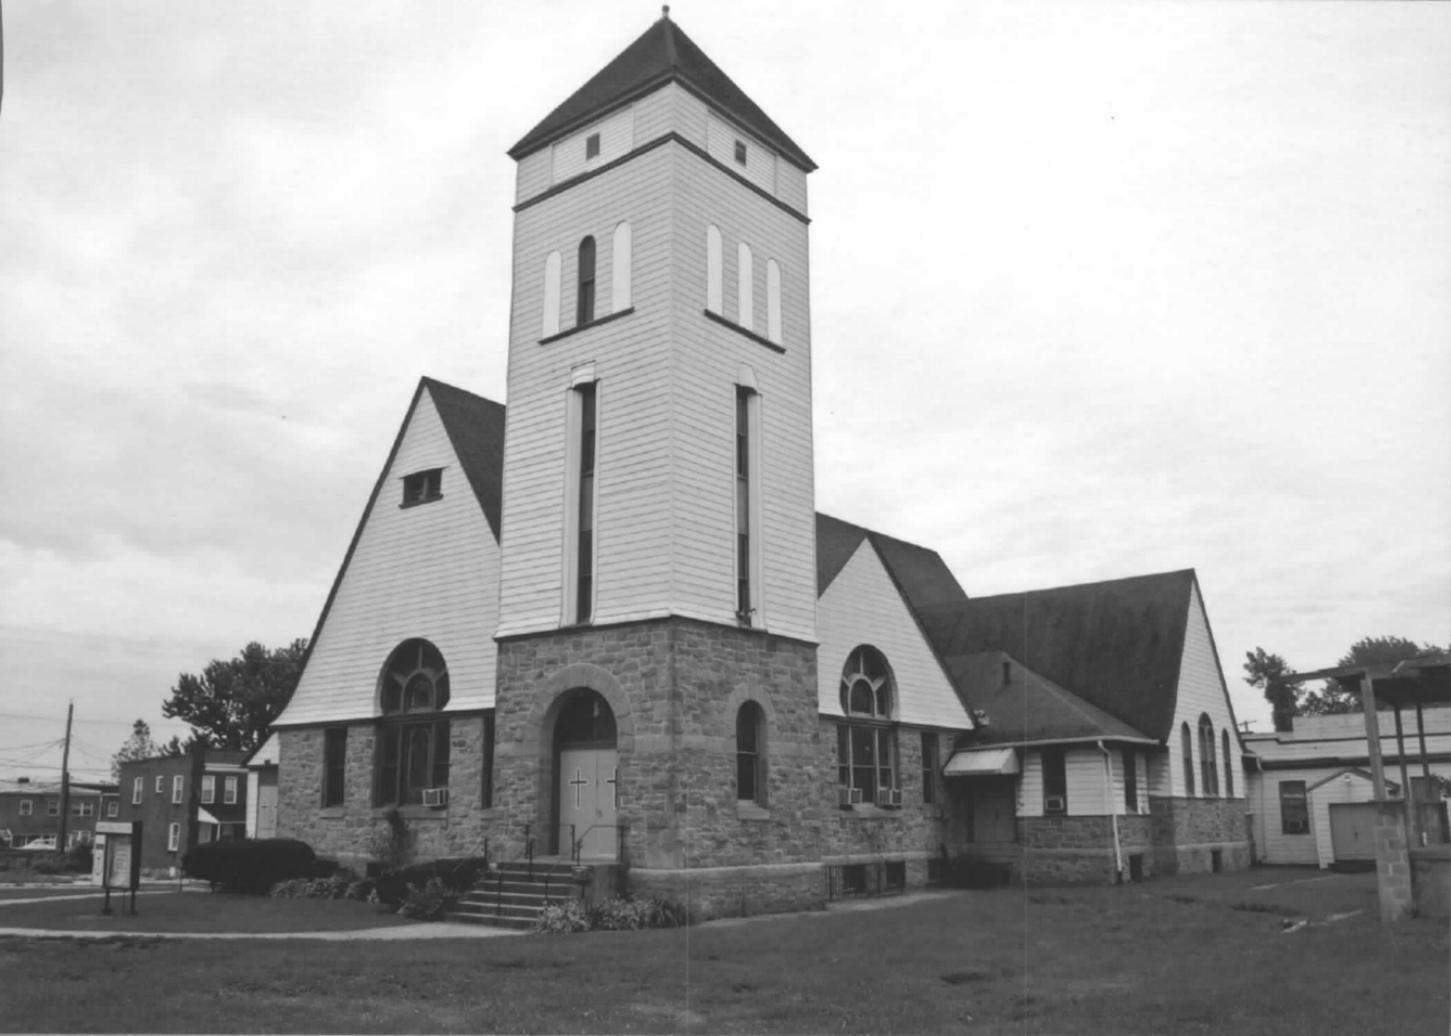
#5 of 7

ARLINGTON METHODIST EPISCOPAL CHURCH SOUTH, NORTH ELEVATION (LEFT) AND WEST ELEVATION (RIGHT),  
LOOKING SOUTHEAST.

The west elevation of the church is composed of the tower, the cross gable, and the gable of the southwest wing, which projects out from the main form of the building. The projecting gable end of the southwest wing has a cross-gabled and hipped roof. The gable is steeply pitched with flared eaves, and the two flanking hipped portions of the roof are asymmetrical. A single rectangular window on the first floor surmounting a three-light basement window flanks the southwest wing gable. The gable itself has three bays. A single, centered three-light window lights the basement. A large, three-light arched window flanked by two identical one-over-one double-hung windows with round heads is centered above the basement window. The first-floor fenestration on the three-bay cross gable is identical to that of the east elevation, having a large arched window flanked by two double-hung sash windows above four regularly fenestrated basement windows. The roofline, however, is truncated by the southwest wing and the tower and thus does not have flared eaves. Of the four basement-level windows, the first is replaced with a five-panel door providing access to the basement. A below-grade stair with a metal railing leads to this door. A gabled, louvered roof vent is aligned with the chimney on the west-facing slope of the roof of the main block. The fenestration on the tower in the second and third stages is identical to that of the north elevation, having two vertical, narrow, rectangular windows on the second stage and a triple arched window surmounted by a louvered vent in the second stage. Different from the north elevation, the first stage has a single rounded head, double-hung window with a stone sill.

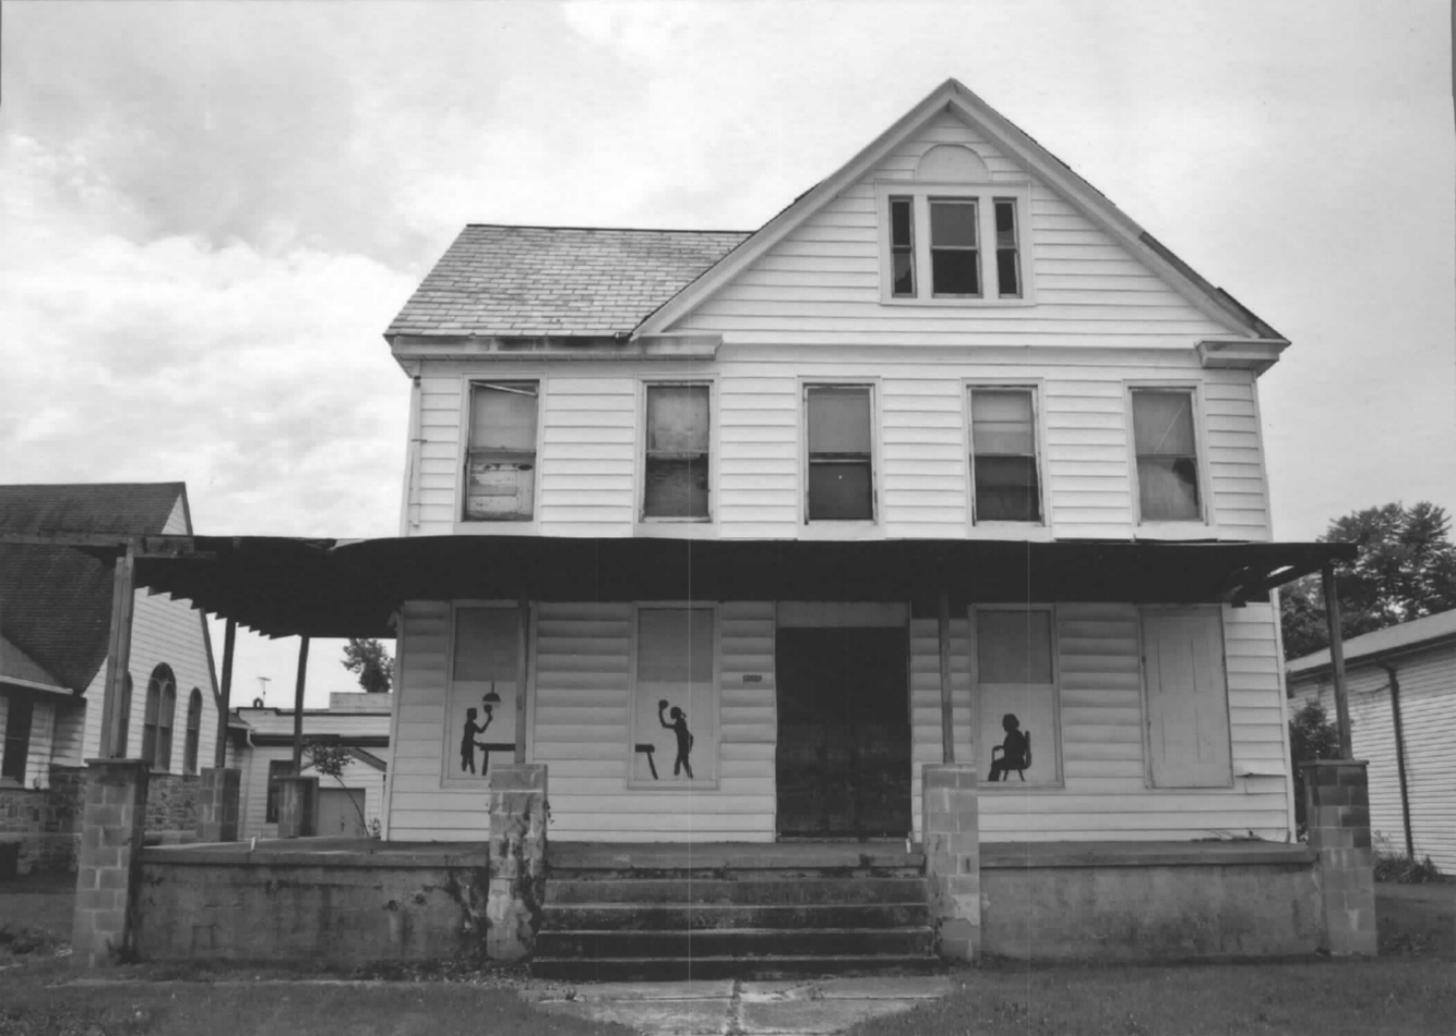
#6 OF 7

ARLINGTON METHODIST EPISCOPAL CHURCH SOUTH RECTORY, MAIN FACADE, LOOKING SOUTHEAST.

The five-bay main elevation has a cross gable roof with gable returns. A central door with sidelights is flanked by two symmetrical bays with a single, double-hung sash window in each. The second story has five double-hung sash windows that are aligned with the fenestration of the first floor. The attic story is lit by a centered, double-hung Palladian window with a half-round panel above.

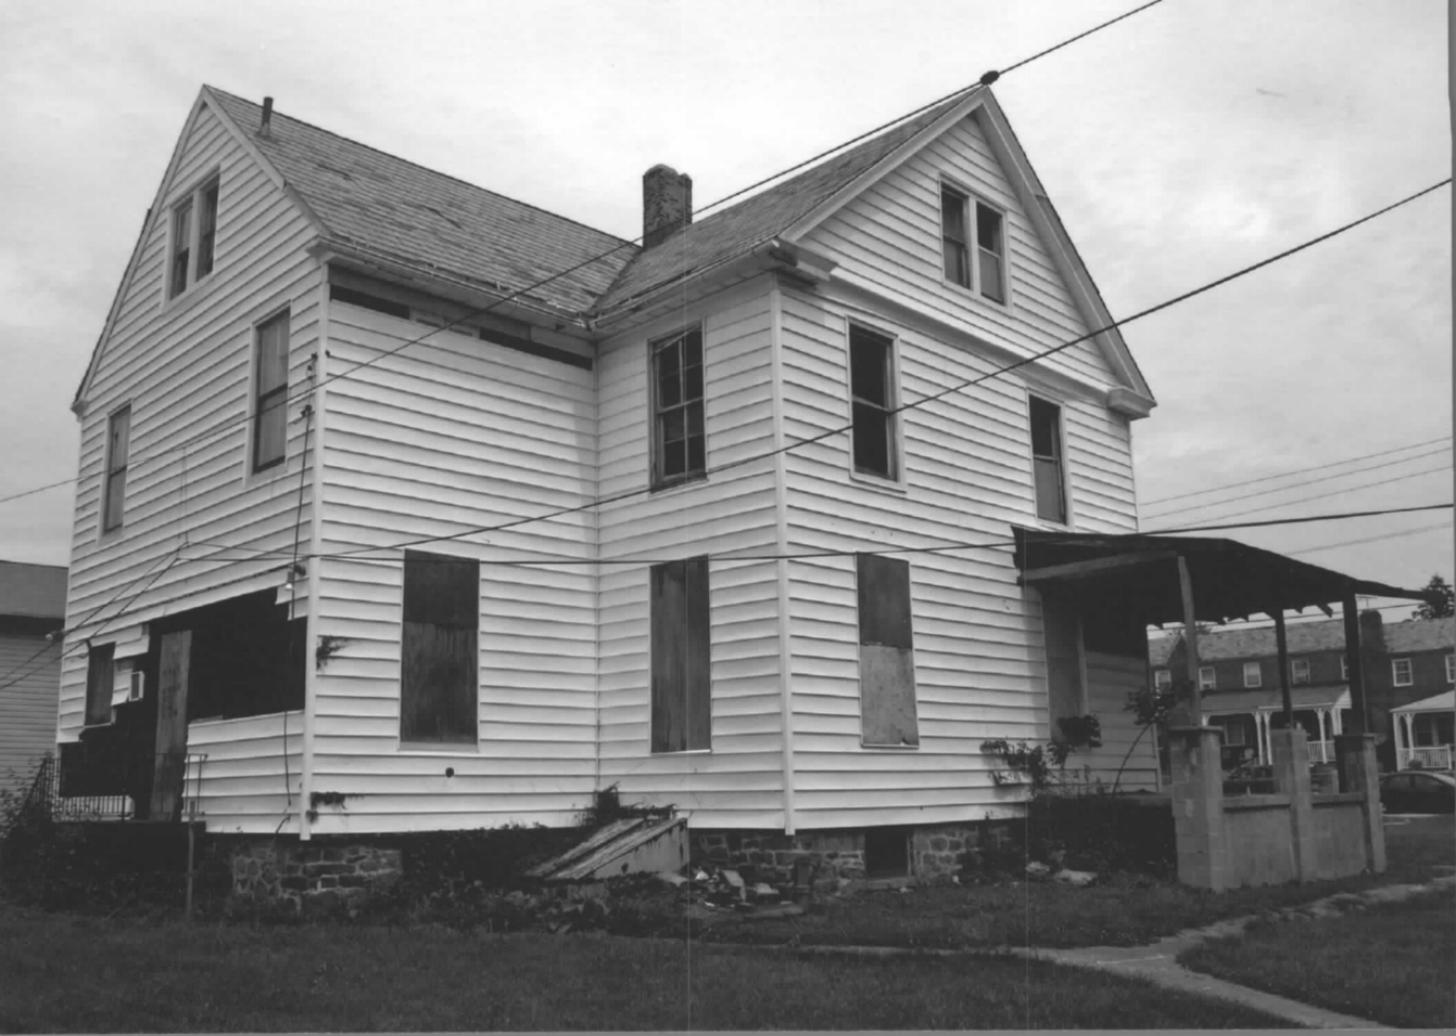
#7 of 7

ARLINGTON METHODIST EPISCOPAL CHURCH SOUTH RECTORY, SOUTH ELEVATION (LEFT) AND EAST  
ELEVATION (RIGHT), LOOKING NORTHWEST.

With an L-shaped ground plan, the two-and-one-half story rectory is west of the Arlington Methodist Episcopal Church South at 4844 Reisterstown Road (Figure 7). Like the church, it faces Reisterstown Road and sits on a raised stone foundation. The side-gabled structure is clad with aluminum siding, but shingles are evident beneath the modern siding materials. The cross gable roof is clad with slate shingles and has a simple box corniced. Two chimneys pierce the roof. One is centered on the ridge, and the other is on the west-facing slope of the roof toward the rear of the structure. A replacement porch is supported by cinder block piers and wooden posts. It wraps around the left side of the structure and terminates in the middle of the gable. Four concrete stairs lead up to the porch on the main façade.
