#114 W. JOPPA ROAD

INVENTORY FORM FOR STATE HISTORIC SITES SURVEY

Bungalow (Witts Bungalow site)

114 W. Joppa Road

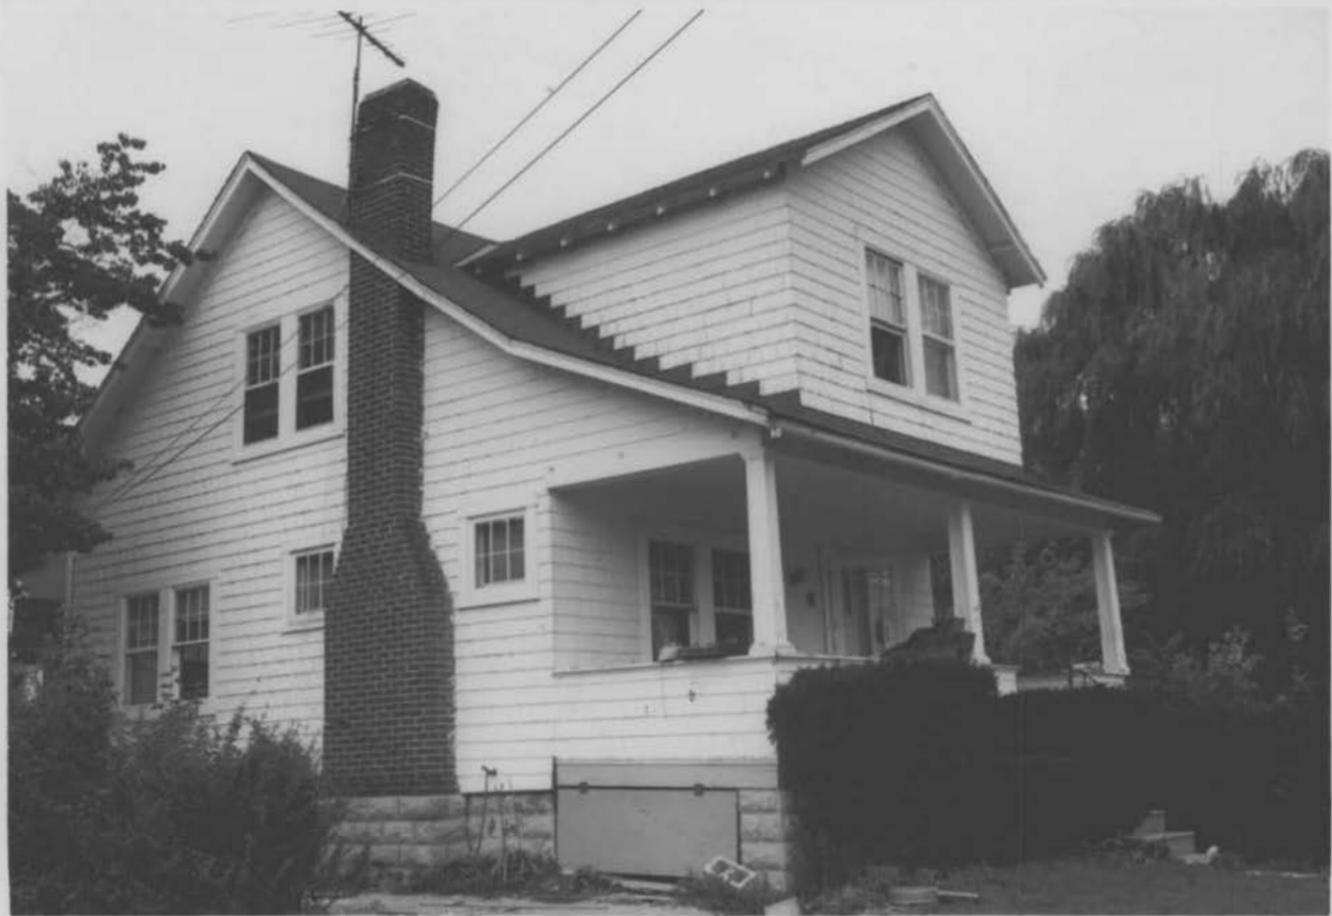
BUNGALOW
#114 W. Joppa
S. W. CORNER

The ends of the building are the most irregular. The west end is dominated by the brick chimney which is shouldered for a fireplace. The east end is broken up by the placement of windows about the stairline and a ground level basement entrance in the south bay. Both ends have six light casement windows which light the cellar.

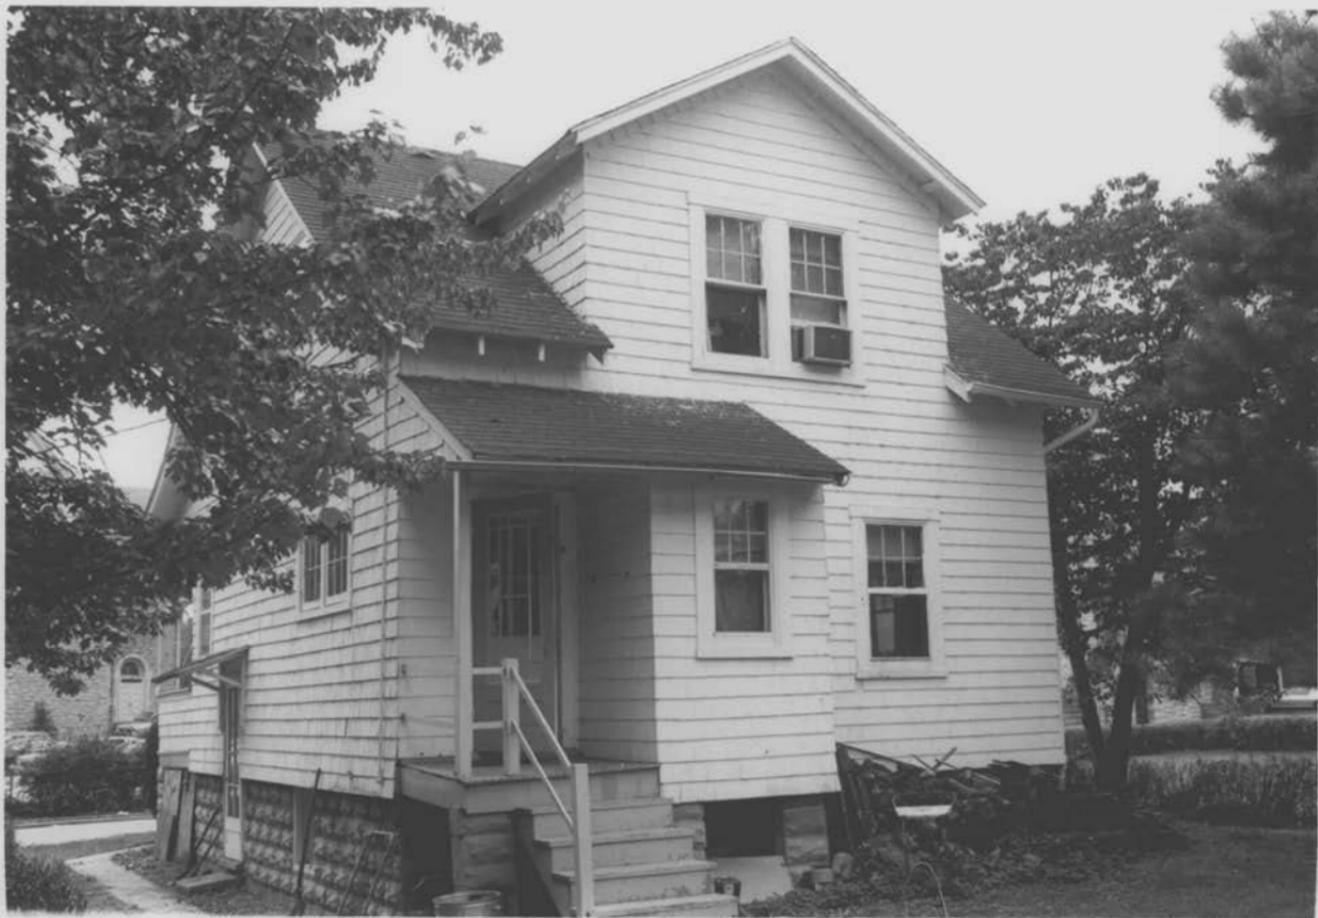
BUNGALOW
114 W. SOPPA RD.
N.E. CORNER

On the north facade (back) there is a single story, single bay shed roofed porch containing an enclosed pantry and partially enclosed entrance.
