## #17 PENNSYLVANIA AVE.

INVENTORY FORM FOR STATE HISTORIC SITES SURVEY

17 West Pennsylvania Avenue, *Smith Building*

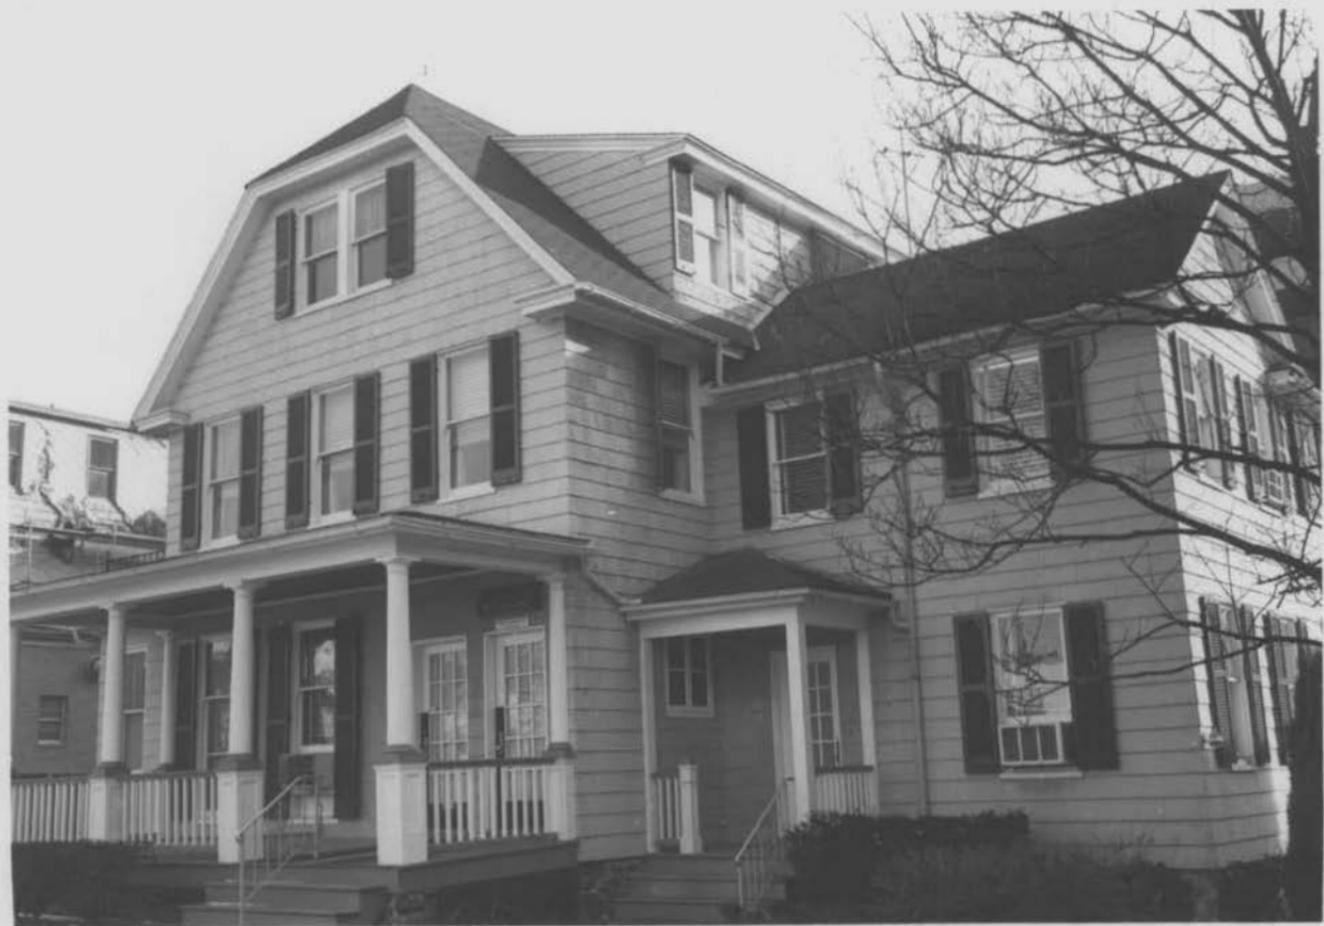
17 W. PENN A. AVE  
N.

The North facade is five bays wide, including the 1935 addition. The addition is two bays wide, and is set back one bay from the front of the house. The original part of the house has a porch on the first story that is three bays wide. The four supporting columns are doric and the pedestals are paneled. Under the porch there is lattice work, and three stairs for reaching the two side-hall entry doors. There are two long, triple-hung windows beside the two doors. One door may not be original, since the building has been converted into first and second story offices. The doors are identical. They are long, fifteen paned glass doors. Above the porch, on the second story there is regular fenestration in the three, 1/1 sash windows, In the gable, there are two side by side 1/1 windows smaller than those on the second floor. There are deep cornices on the front gable. There is a small, one bay addition to the Northeast of the main part. It is one story tall, with one 1/1 sash window, and a balcony for the second story French door. Its foundation has been covered with rock-faced form stone. On the Northwest side of the main form is the 1935 addition. It has a one bay porch; as on the large porch, it has three steps leading up to it. There is one 1/1 sash window to the West of its door, and two similar windows on the second story. All of the windows with the exception of the window on the very small addition, have shutters.

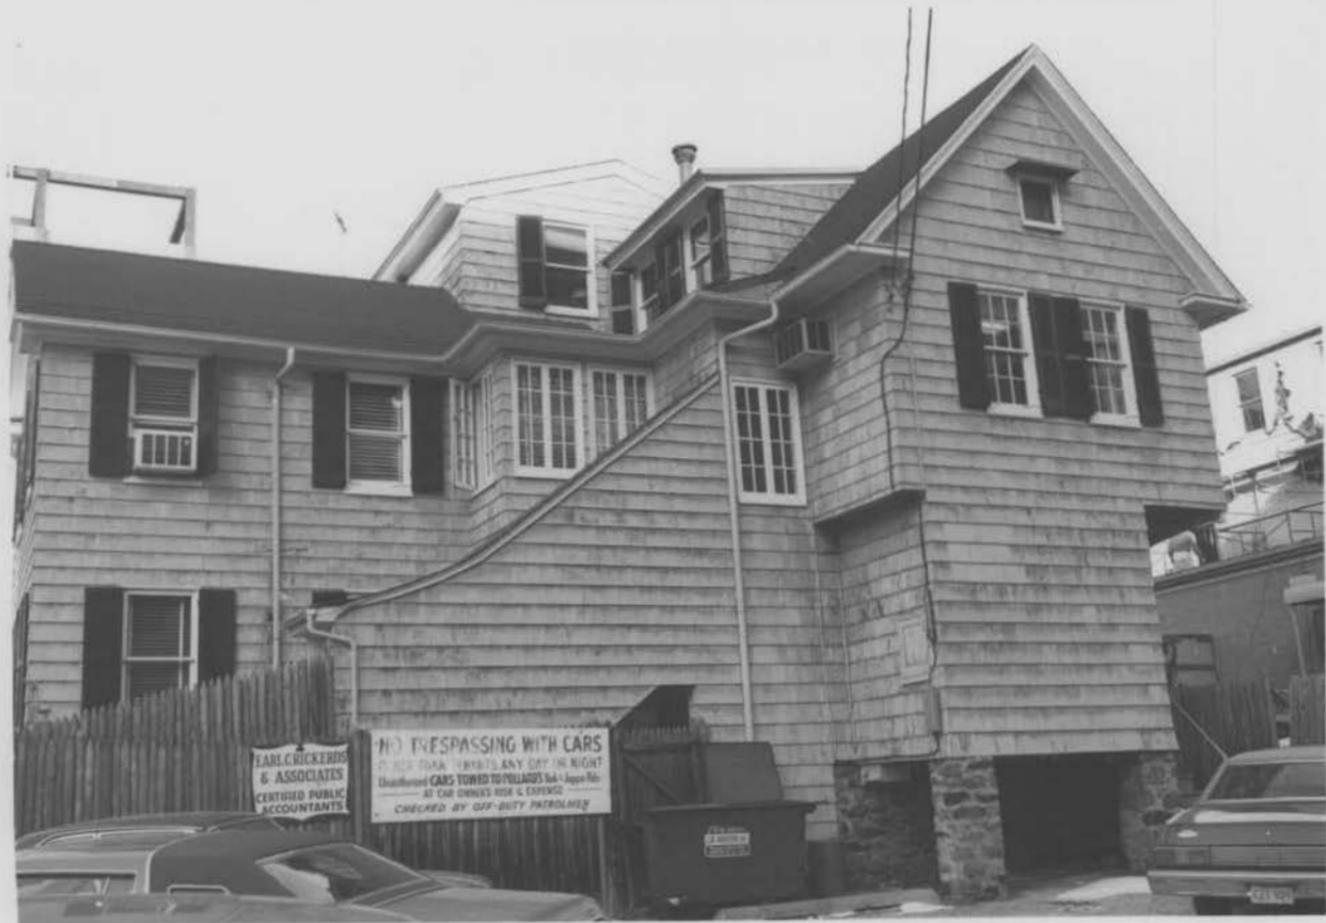
17 W. PENNA. AVE.  
S.

The South facade is also very irregular in plan. The Southwest portion is the back side of the addition and it is two bays wide. On the first floor, there are two 1/1 sash windows, identical to the two 1/1 sash windows on the second floor. To the East of this, on the second story are two pairs of 8-paned casement windows. Above this, on the South side of the large dormer is a 1/1 sash window. The cat slide roof is seen in profile. To the East of this is the back side of the main part. It has no windows on the first story. On the second story, there are two 6/6 sash windows. In the deep-corniced gable there is a small single paned window. This portion of the house is supported by stone piers. There is a door on the Southeast corner and steps leading up to it. There is a pair of 8-paned windows on the side projection between the main part of the house and the addition.
