527 YORK ROAD

INVENTORY FORM FOR STATE HISTORIC SITES SURVEY

527 York Road

BA-1453

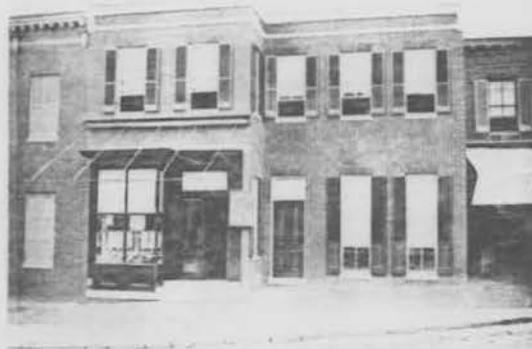
Undaunted by the fire, August Loose rebuilt his tailoring shop on York Road. The business had begun in a frame building on the flatiron at the intersection of Joppa and York.

These brick buildings directly across York Road from the present Towson Theater were probably photographed in the late teens. York Road was still unpaved, but sidewalks and cut-stone curbing had been added.

According to Towson: A Picture History of a Maryland Town, the entire 500 block of York Road was leveled in a fire in 1878. Thus, number 527 cannot predate this event. At this time the property was owned by August Loose. A passage in the same book tells how Loose rebuilt his tailoring business after the fire. The following picture shows the building as it appeared sometime in the nineteen-teen's:

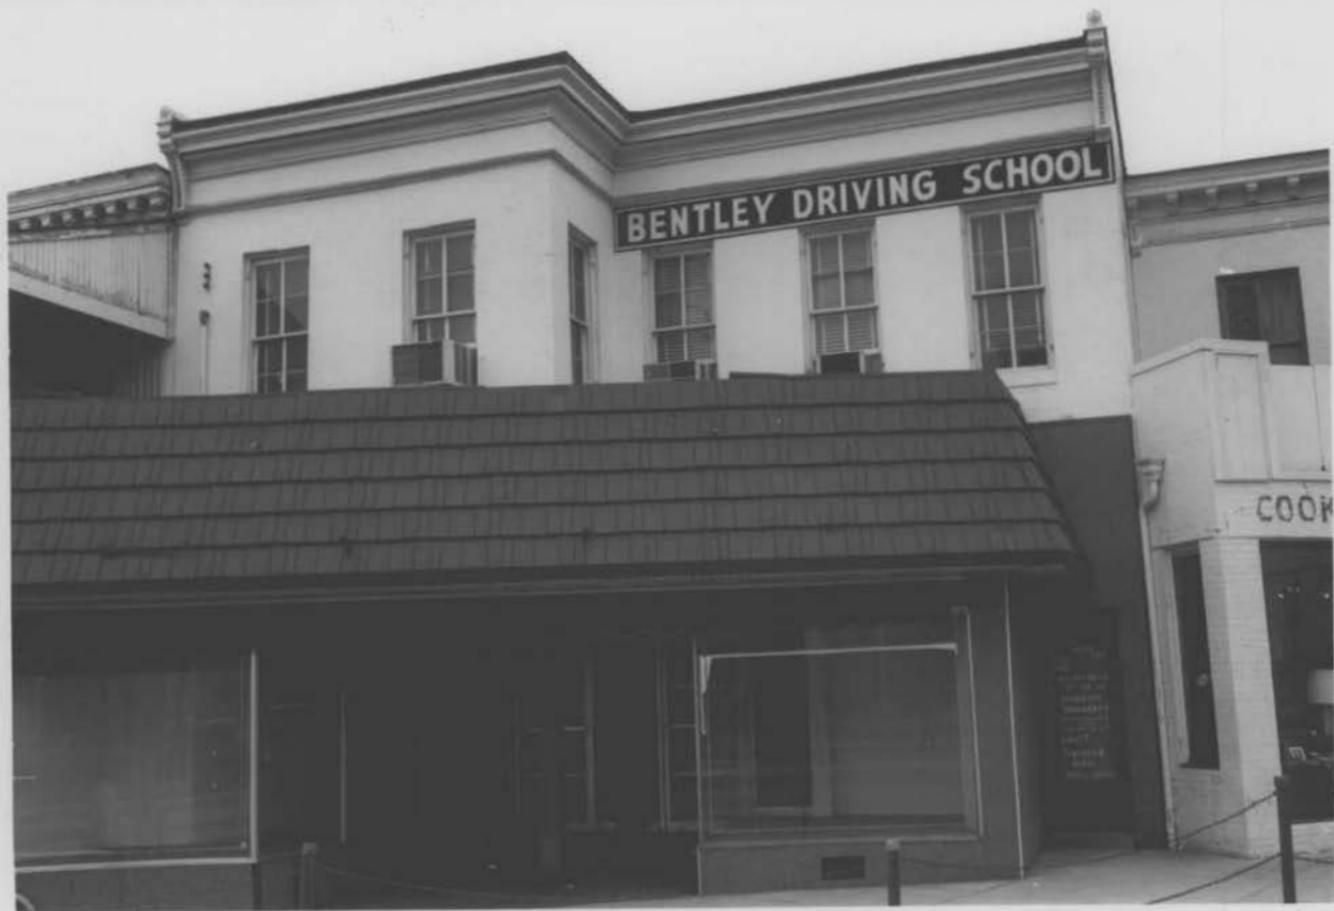
527 YORK RD
E. FACADE

The building at 527 York Road is a 2-story brick building, of common bond, flush with two other buildings on the north and south. The roof is flat.

The original east facade was L-shaped. This is no longer obvious on the first floor where a modern store front has been added. The second story retains its original character and is 5 bays wide.

There is a pair of double doors in the modern storefront, and a single door on the northern end which gives access to the second floor. Fenestration of the second story is regular. Running south to north there is: two 4/4 sashes (facing east), one 4/4 sash (facing north - possible because of the L-shape), three 4/4 sashes (facing east). Windows have plain trim and flat arches.

Decoration is restricted to the area between the roof and the second story windows. There are two wooden belt courses and the cornice is capped by a third course of wood. Both the north and south ends of the facade have a decorative corbel at the roof line. Both corbels are concave with dentils, and are topped by an egg shape with a central carved rosette.
