INVENTORY FORM FOR STATE HISTORIC SITES SURVEY

Carter House

119 Susquehanna Ave.

BA-1487

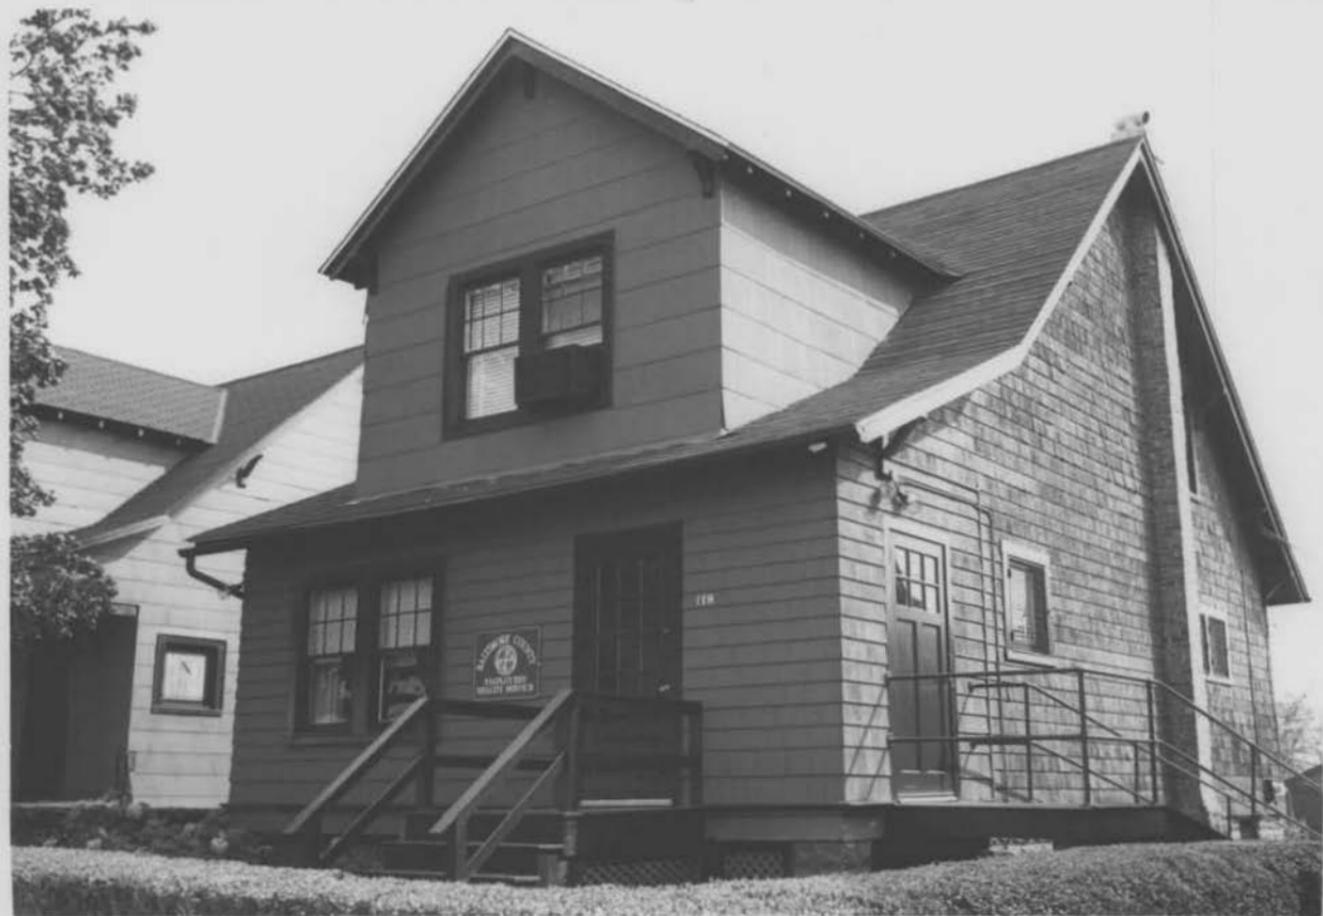
BA-1487

Generally, this building is a 1½ story frame structure covered with brown wooden shingles, resting on a high rock-face formstone foundation rising 36" off the ground. It is three bays wide and the equivalent of three bays deep. The gable-end roof is accentuated with deep overhanging eaves.

The north side of the house faces the street. The most prominent feature is the oversized dormer, centrally located above the porch roof. This dormer is vented by a pair of 6/1 sash windows, and has a gable-end roof. Modern asbestos shingles now cover this dormer.

The porch, an essential part of the bungalow style, rests on rock-face formstone piers. The space between the porch and ground is filled with lattice.

The west facade is characterized by the irregular fenestration. There is a single 6/1 sash in the upper south bay, a casement window on the first level providing light for the staircase within, a single casement for the cellar and a cellar entranceway.

119 SUSQUEHANNA AVE.
N.W CORNER
