**MARYLAND HISTORICAL TRUST
NR-ELIGIBILITY REVIEW FORM**

Property Name: Hereford United Methodist Church Inventory Number: BA-1549

Project: Hereford Tower Project Agency: FCC

INVENTORY FORM FOR STATE HISTORIC SITES SURVEY

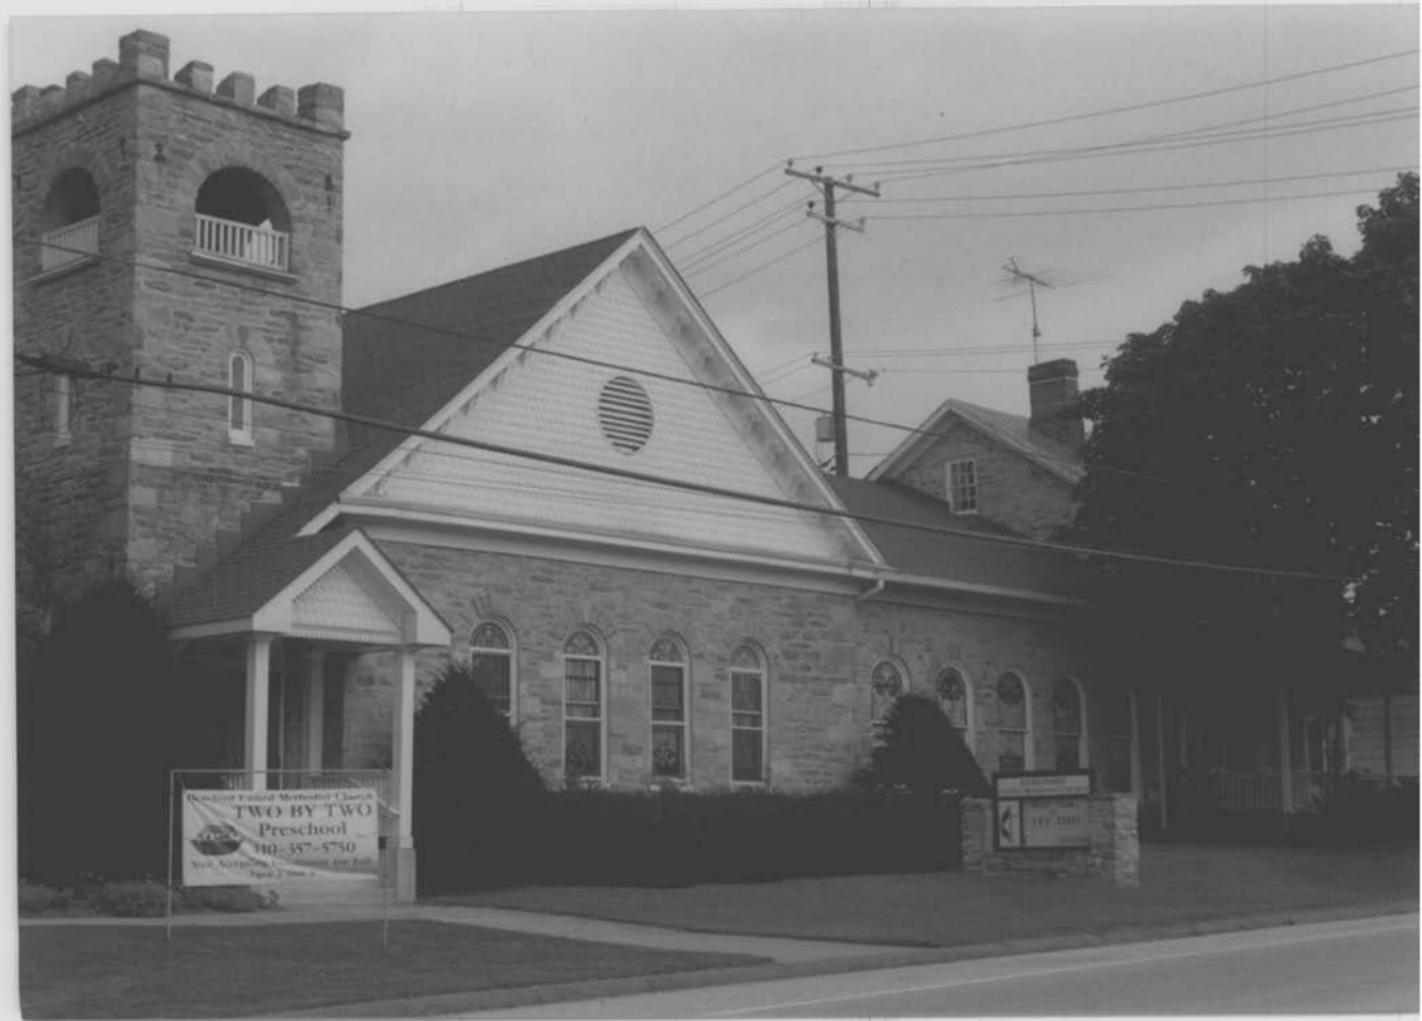
BA-1549

View of the Hereford United Methodist
Church, to the east.

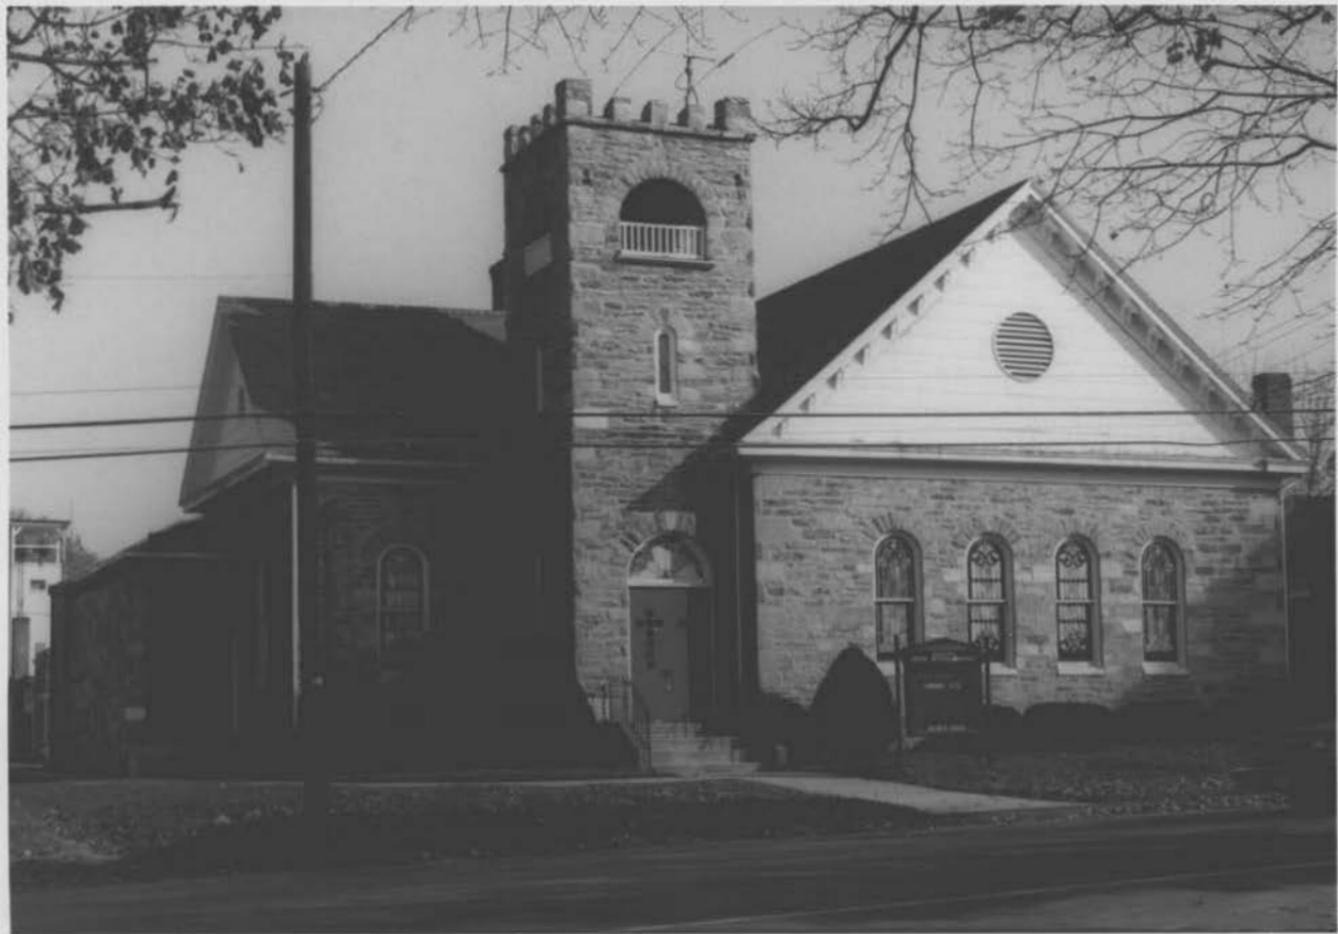
HEREFORD UNITED METH. CH. BA1549
Baltimore County, Maryland
J. McGrain, March 1980
Neg. located at MHT
Main (west) & north facades

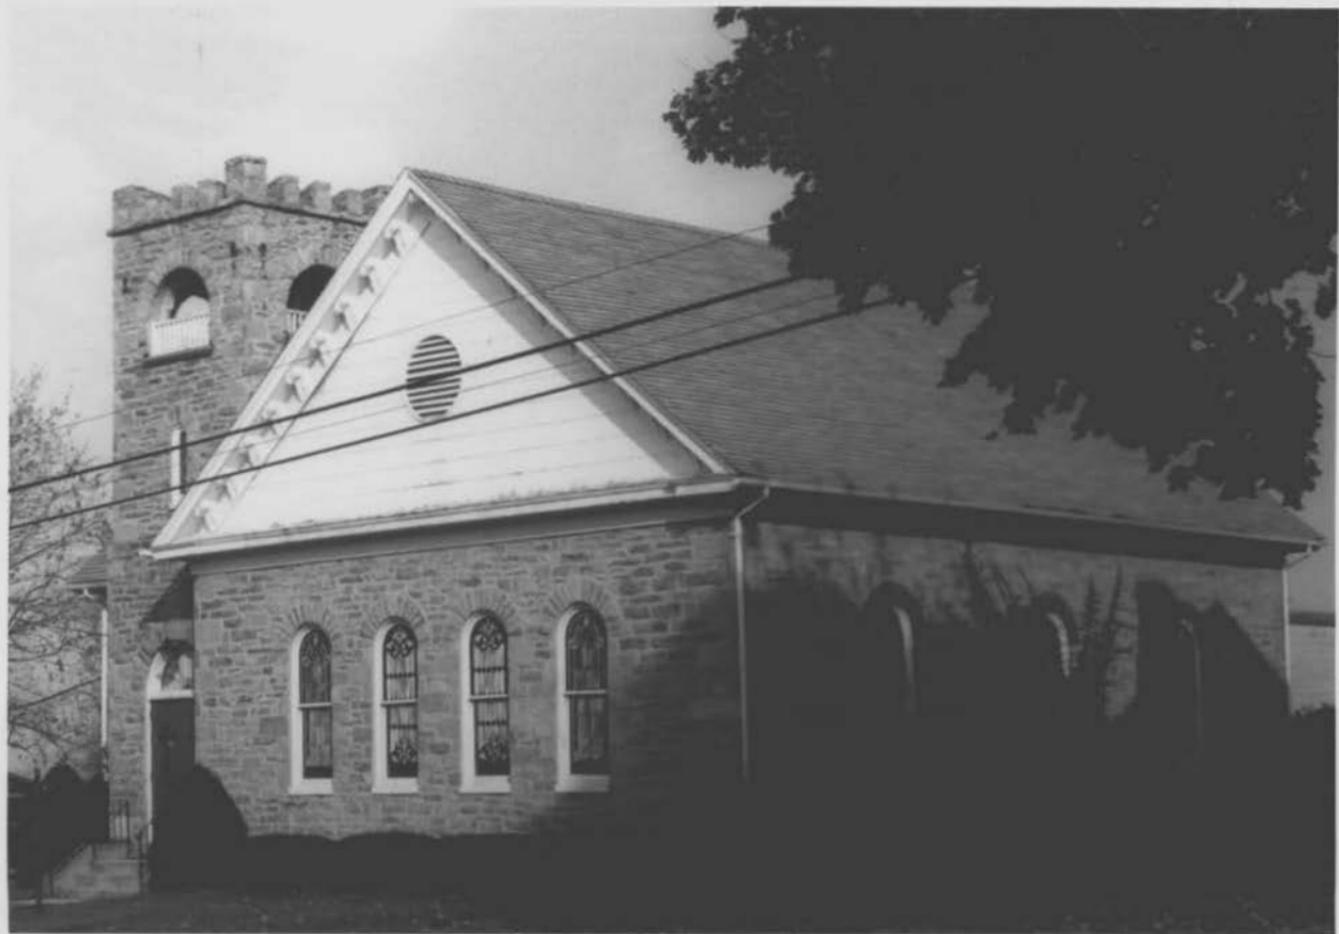
HEREFORD UNITED METH. CH. BA 1549
Baltimore County, Maryland
J. McGrain, October 1979
Neg. located at MHT
Main (west) and south facades

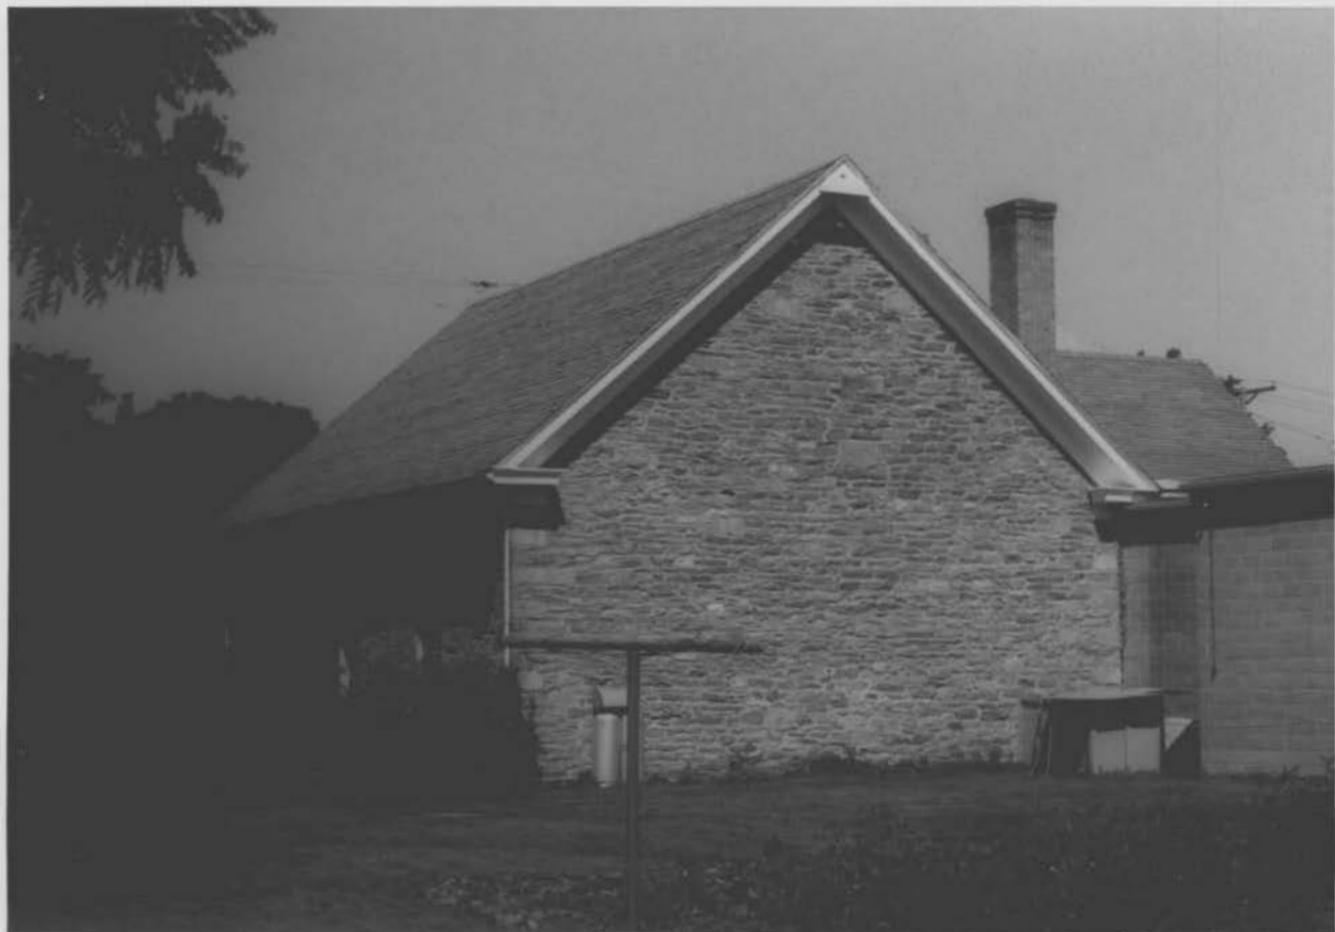
HEREFORD U.M. CHURCH BA-1549
Baltimore County, Maryland
J. McGrain July 1981
Neg. located at MHT
Rear (e) of church from east
