Brooklandville Tenant Houses  
Brooklandville  
Maryland  
Private

INVENTORY FORM FOR STATE HISTORIC SITES SURVEY

BROOKLANDVILLE TENANT HOUSES #1, #2, C#3

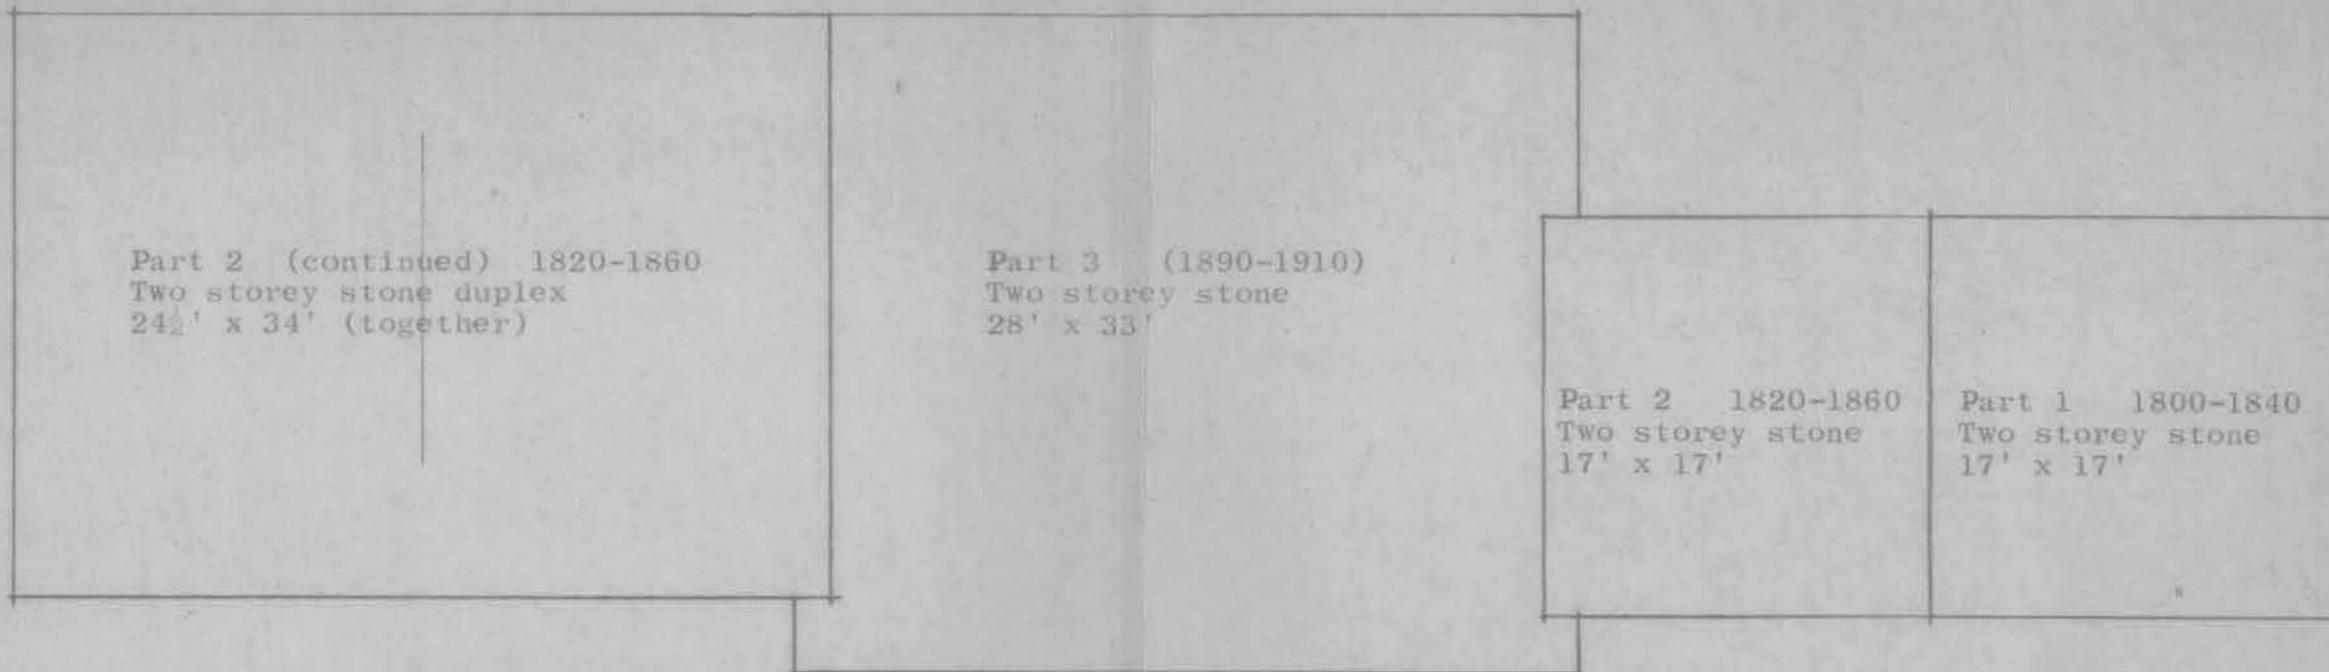
BROOKLANDWOOD TENANT HOUSE NUMBER 1

BA-1594

Scale: 1/8" = 1'-0"

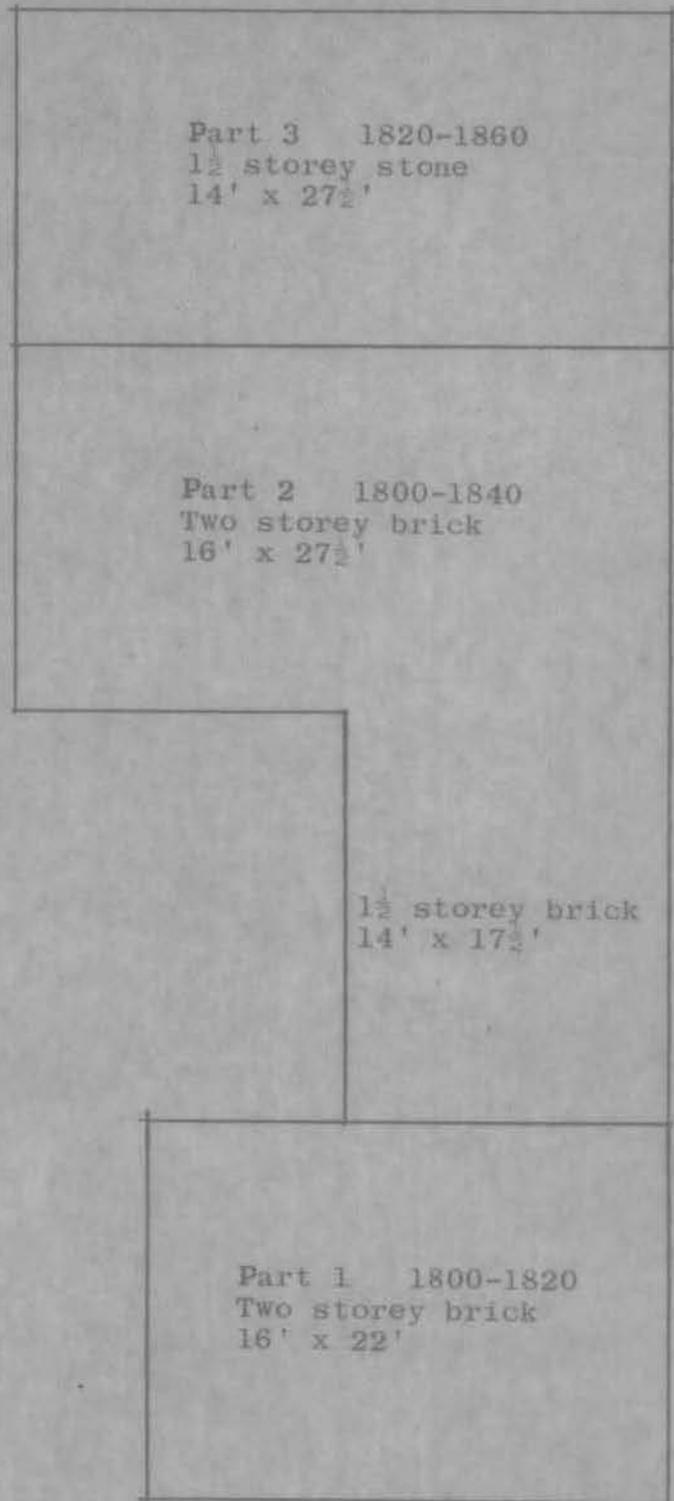
BROOKLANDWOOD TENANT HOUSE NUMBER 2

Part 3 1820-1860  
1 1/2 storey stone  
14' x 27 1/2'

Part 2 1800-1840  
Two storey brick  
16' x 27 1/2'

1 1/2 storey brick  
14' x 17 1/2'

Part 1 1800-1820  
Two storey brick  
16' x 22'

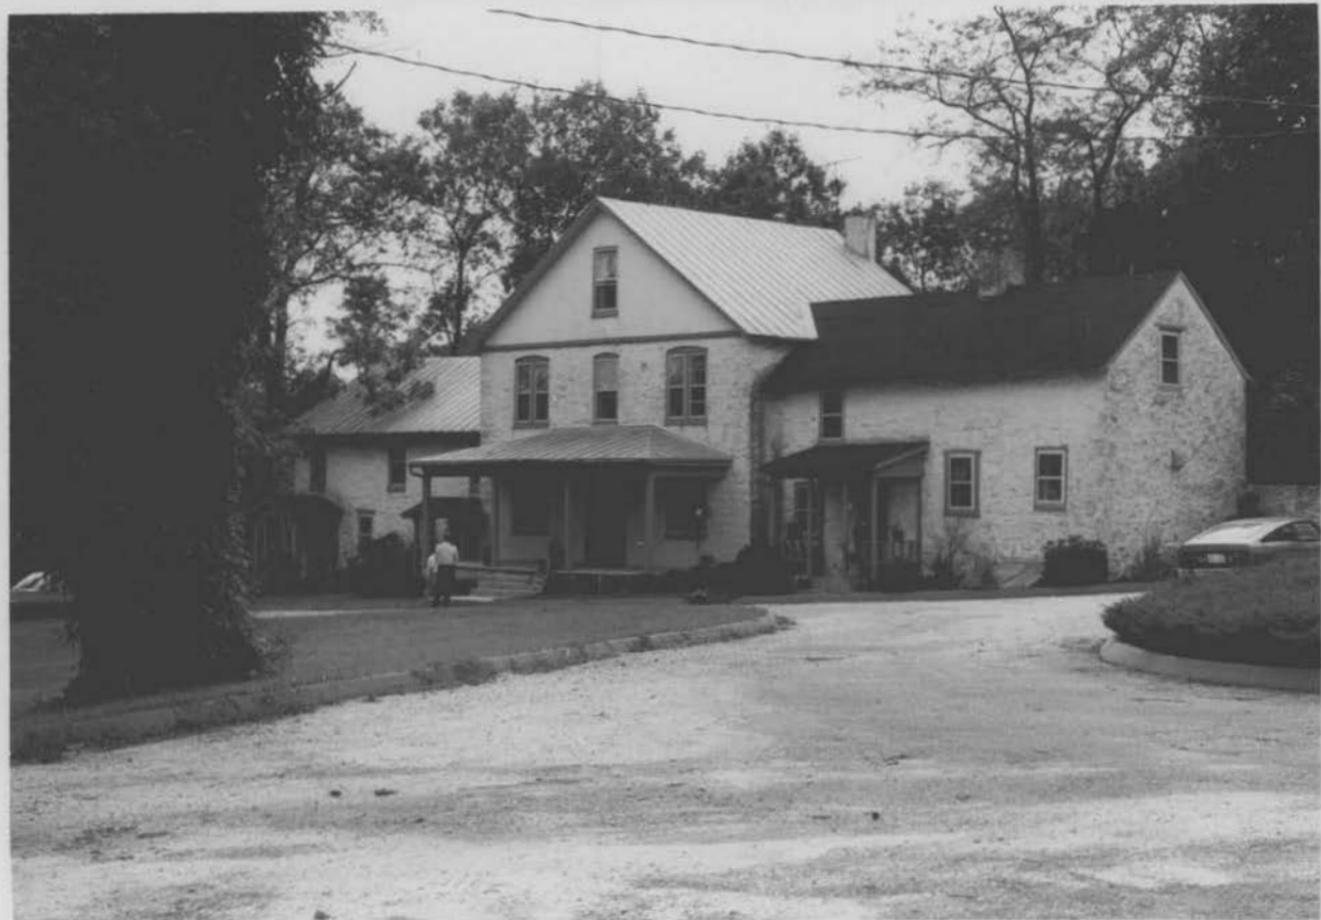
BA 1594 #1 *1 - closed to road*  
Brooklandvil *JW 9/13/79*  
le Tenant Hs *11-16*

GSVHD  
Gr. Spn. Vly.  
JTW  
9-13-79  
Md. Hist. Tr.  
from NE

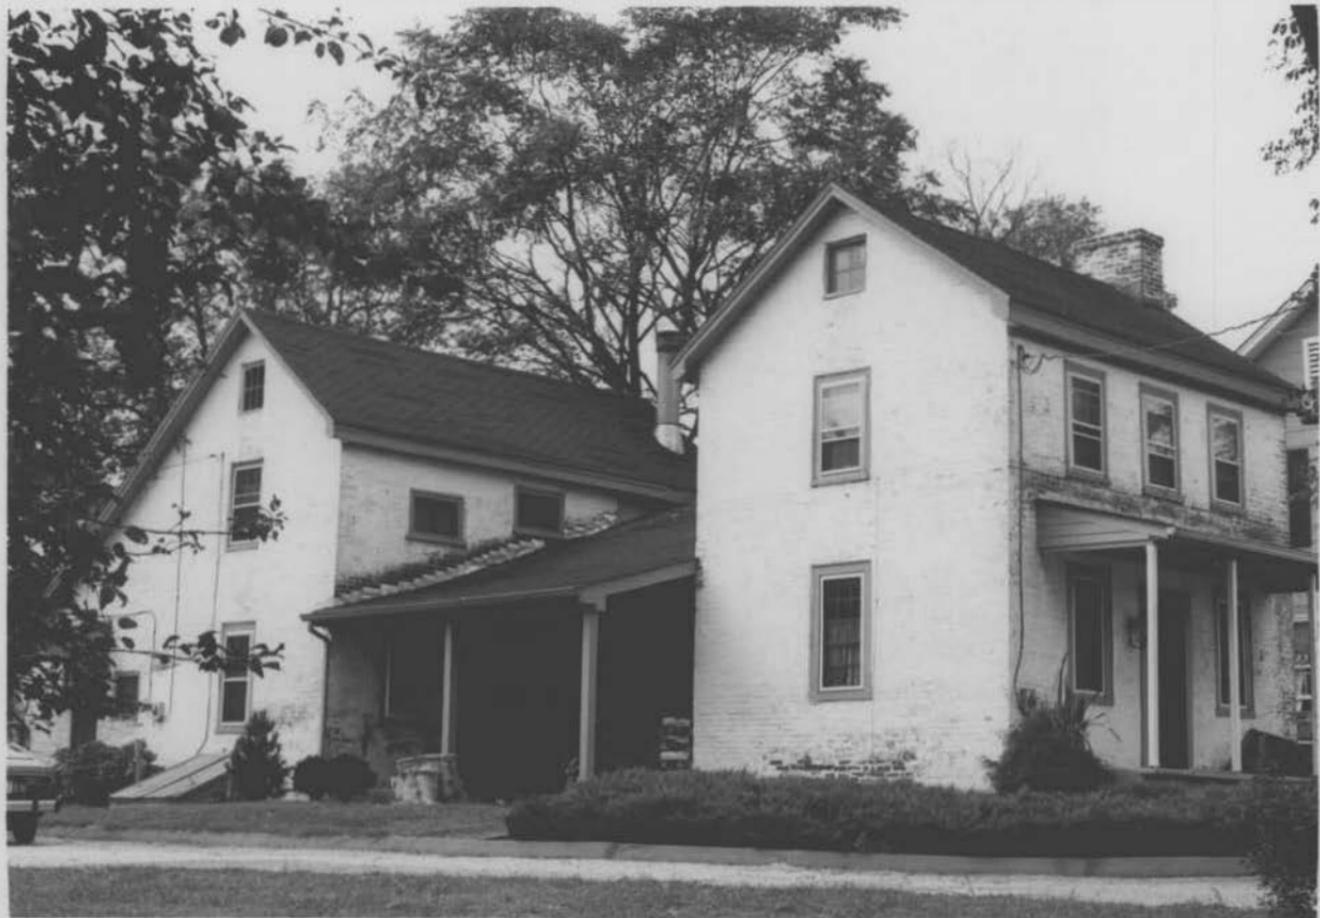
BA 1595#2  
Brooklandvi  
lle Tenant  
House

GSVHD  
Gr. Sp. Vly. Rd  
JTW  
9-13-79  
Md. Hist. Tr.  
from SE
