NOMINATION FORM for the NATIONAL REGISTER OF HISTORIC PLACES, NATIONAL PARKS SERVICE

COMMON: **Belmont**

STREET AND NUMBER: **Belmont Road**

CITY OR TOWN: **Glyndon**

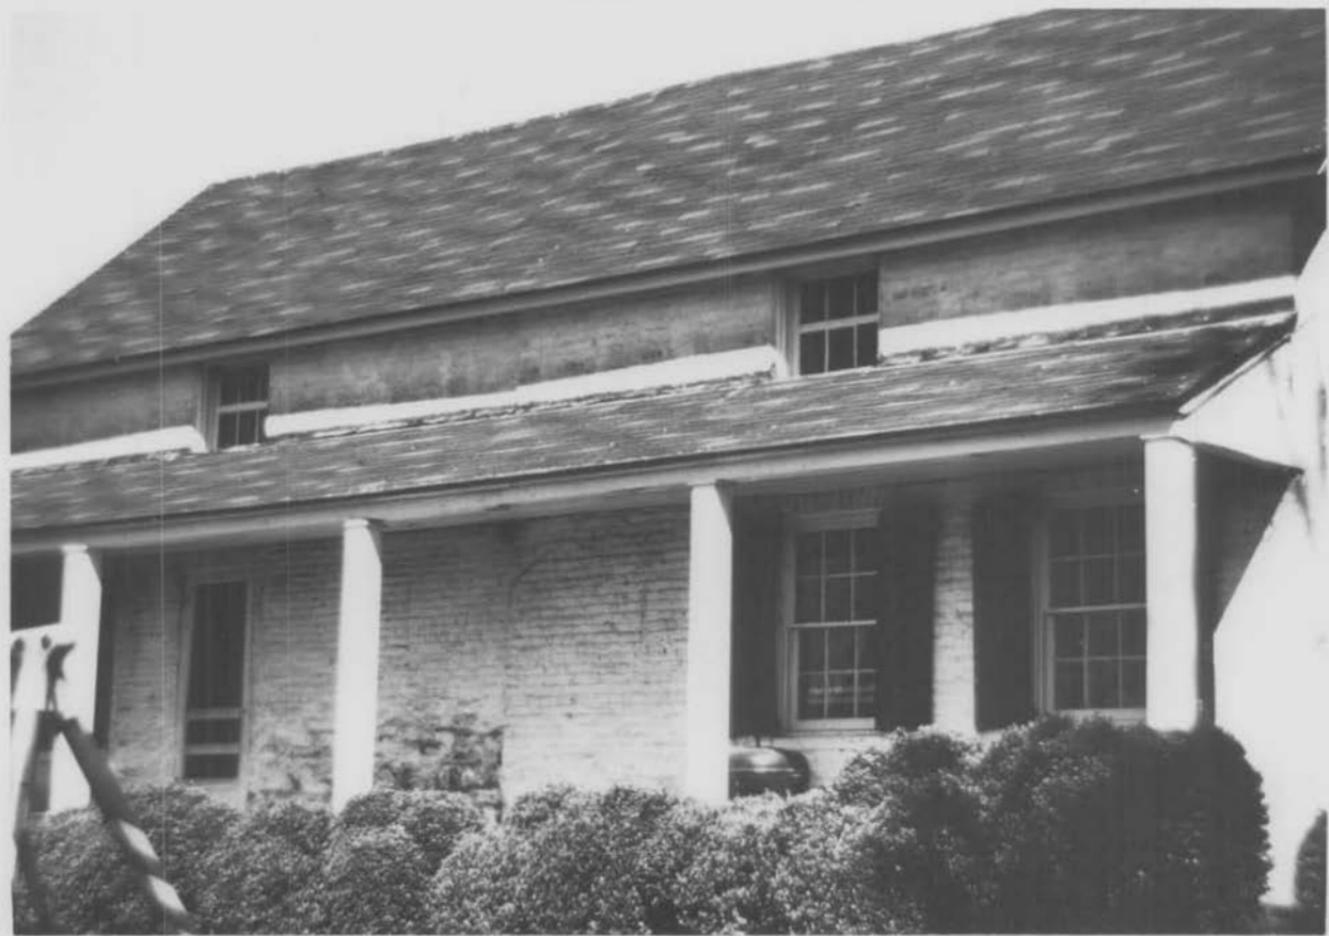
BA-169

Belmont - old quarters
from southeast

The old slave quarters was built in two two-bay sections, each about the same size, with irregular fenestration. It is of brick above a high stone foundation, one and one-half stories in height, the plate being several feet above the second floor. A chimney is not visible externally, but was probably between the two halves.
