CAPSULE
SCARBORO HOUSE

INVENTORY FORM FOR STATE HISTORIC SITES SURVEY

Scarboro House

509 Chesapeake Ave.

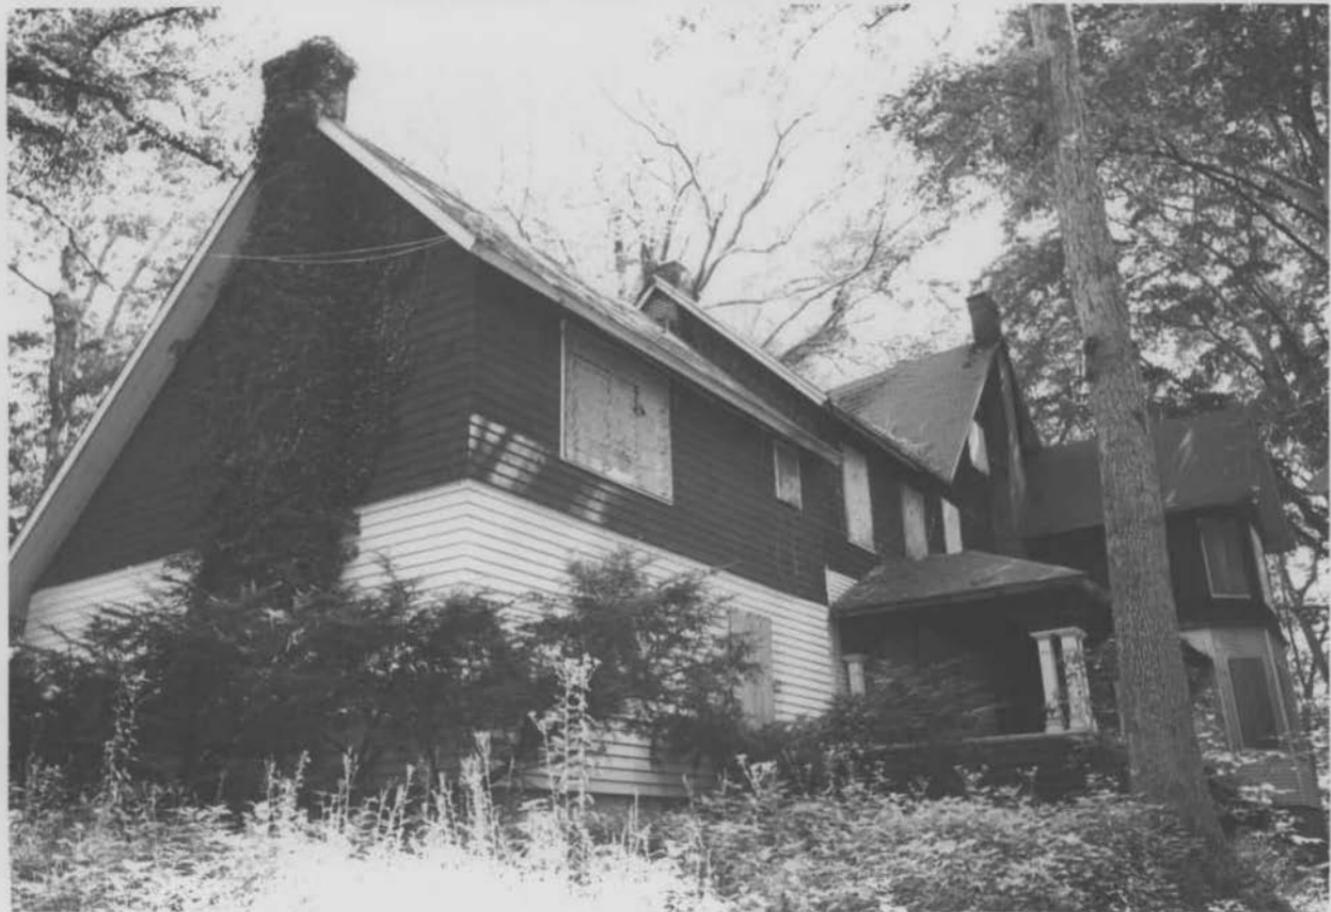
SCARBORO HOUSE
N.E. CORNER

The north facade is the main facade and contains many interesting characteristics. Most prominent is the two story polygonal projection. This projection has a steeply pitched gable end with deep eaves.

The main block itself is three bays wide. This gabled facade is occupied by an exterior chimney located in the corner formed by the projection and the block. The chimney is made of salmon colored brick with yellow decoration at the shoulders. What appears to be an original fireplace is served by this chimney and is located in this southwest corner of the porch. The siding has been cut to fit this fireplace which is made of a deep red brick. There is also a brick hearth in the porch floor.

The porch occupies the ell and is three bays wide. A single story shed roof is supported by short clustered square columns resting on a shingled enclosure measuring 2½ feet high. Lattice work occupies the space between this enclosure and the ground. The distance between the columns is spanned by round arches with shingled spandrels. The tongue and groove ceiling of the porch is trapezoidal.

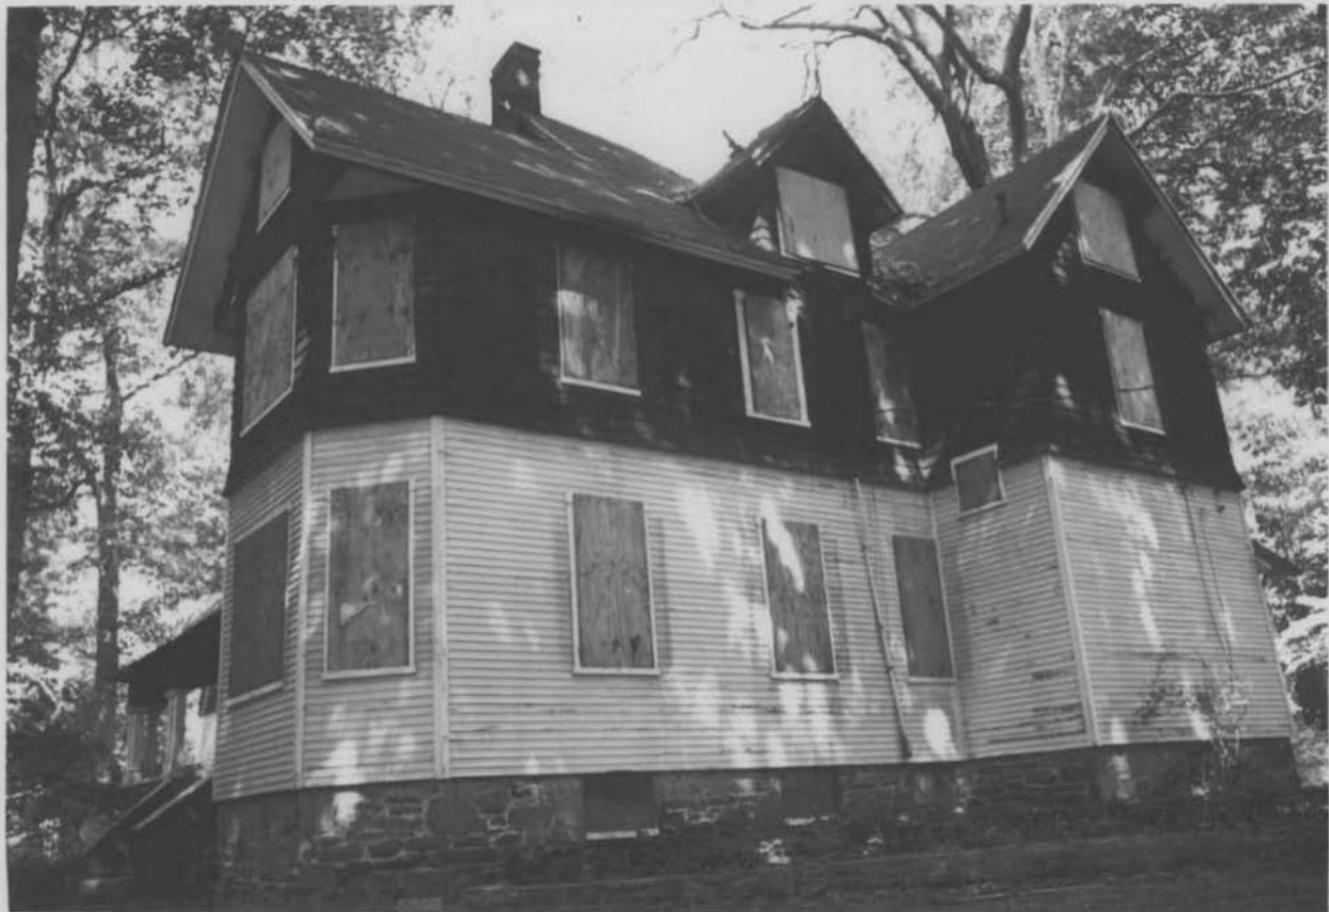
W. FACADE

Three bays of the northern projection have a western exposure. The main block has centrally placed pedimented dormers that suggest a cross-gable.

The symmetry is broken by the fact that the southern one-third of the facade projects 6 feet to the West, is gabled, and windowless on the first level. It is also vented by a single window on the second and attic level.

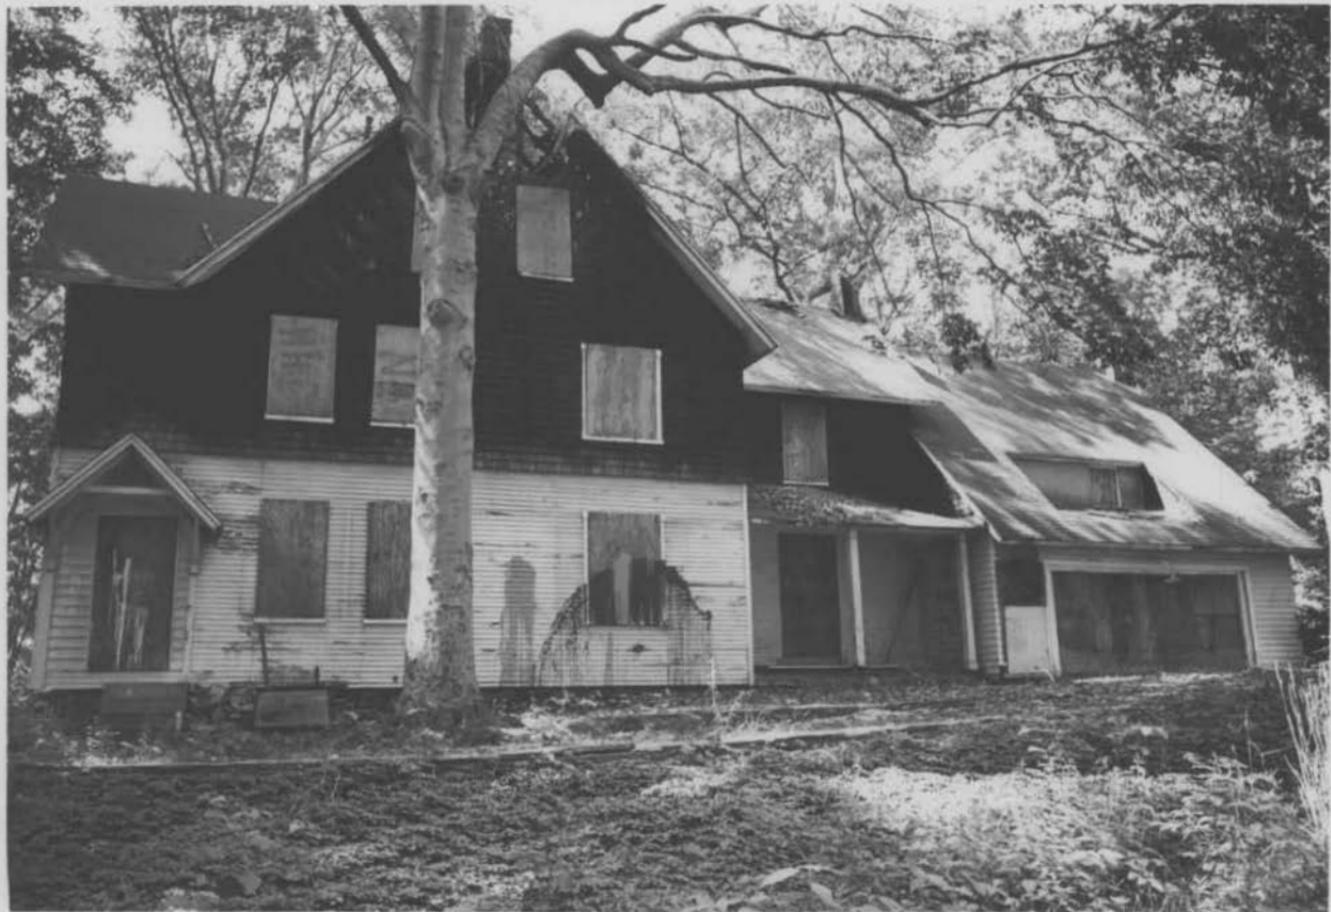
SCARBORO HOUSE
S. FACADE

The south facade is the most regular although there are four unevenly spaced bays. The first level of the westernmost bay was once apparently occupied by a recessed entrance which still has a bracketed hood that constitutes a pediment over a keyed arch. This arch is 5 inches wide, has an opening of 66 inches and measures 99 inches from the top of the key to the bottom of the opening.

A bulk head for a partial cellar below is also on this end of the building.

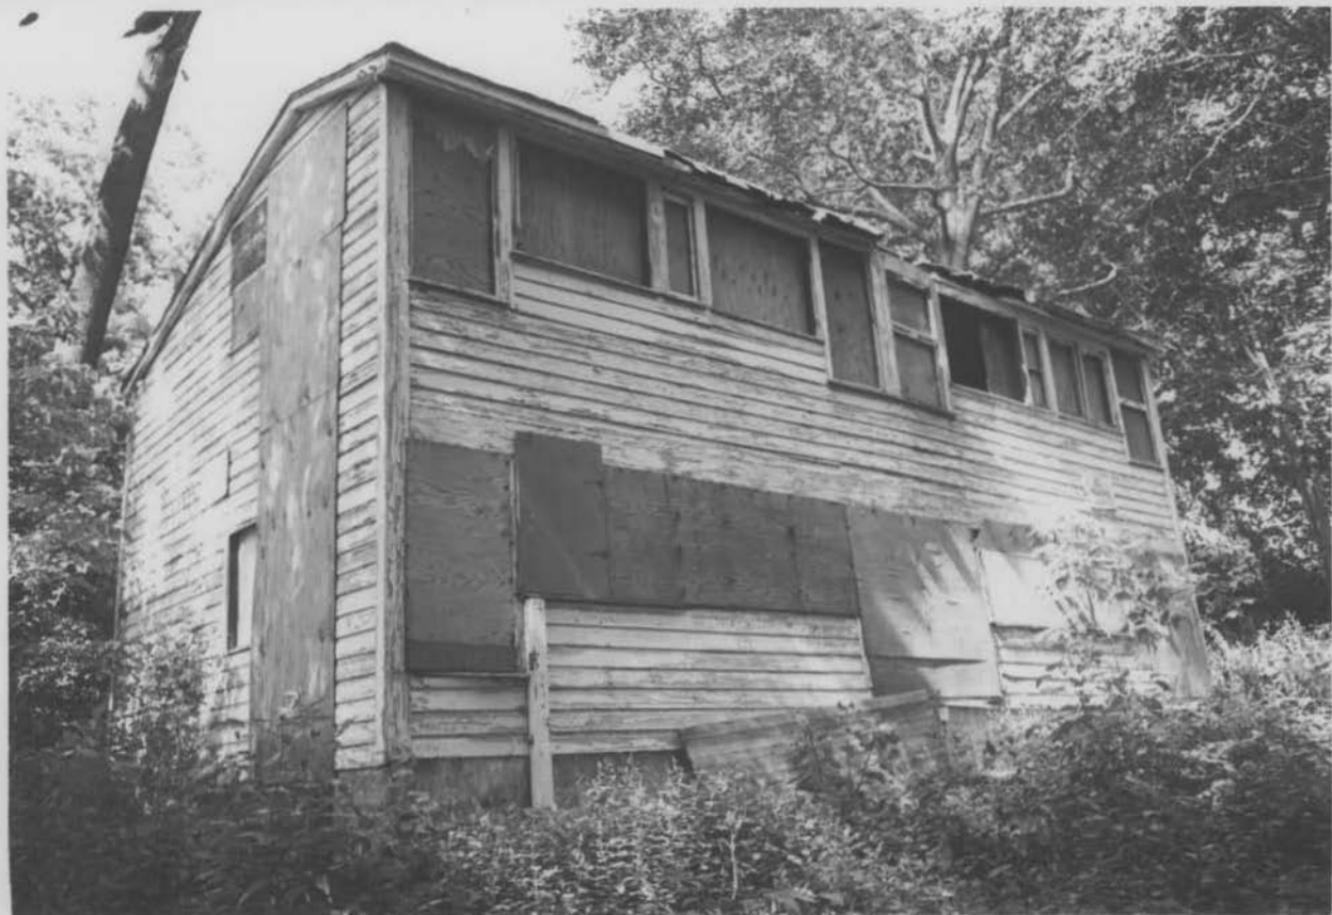
OUTBUILDING -

The second building is a two story frame structure on a concrete foundation which seems to have been designed to house fowl. The building measures 16 feet 3 inches wide by 32 feet long. The siding is german clapboards.

The irregular feature is that the shed roof is higher on the west end than the east. The ridge sets back 3 feet from the south wall and gives a cat slide roof appearance. Between the eaves and the ground the southeast corner measures 11 feet while the southwest corner measures 13½ feet.
