BA 1771

ST. JOHN'S PARSONAGE

INVENTORY FORM FOR STATE HISTORIC SITES SURVEY

**Stone Dwelling:**

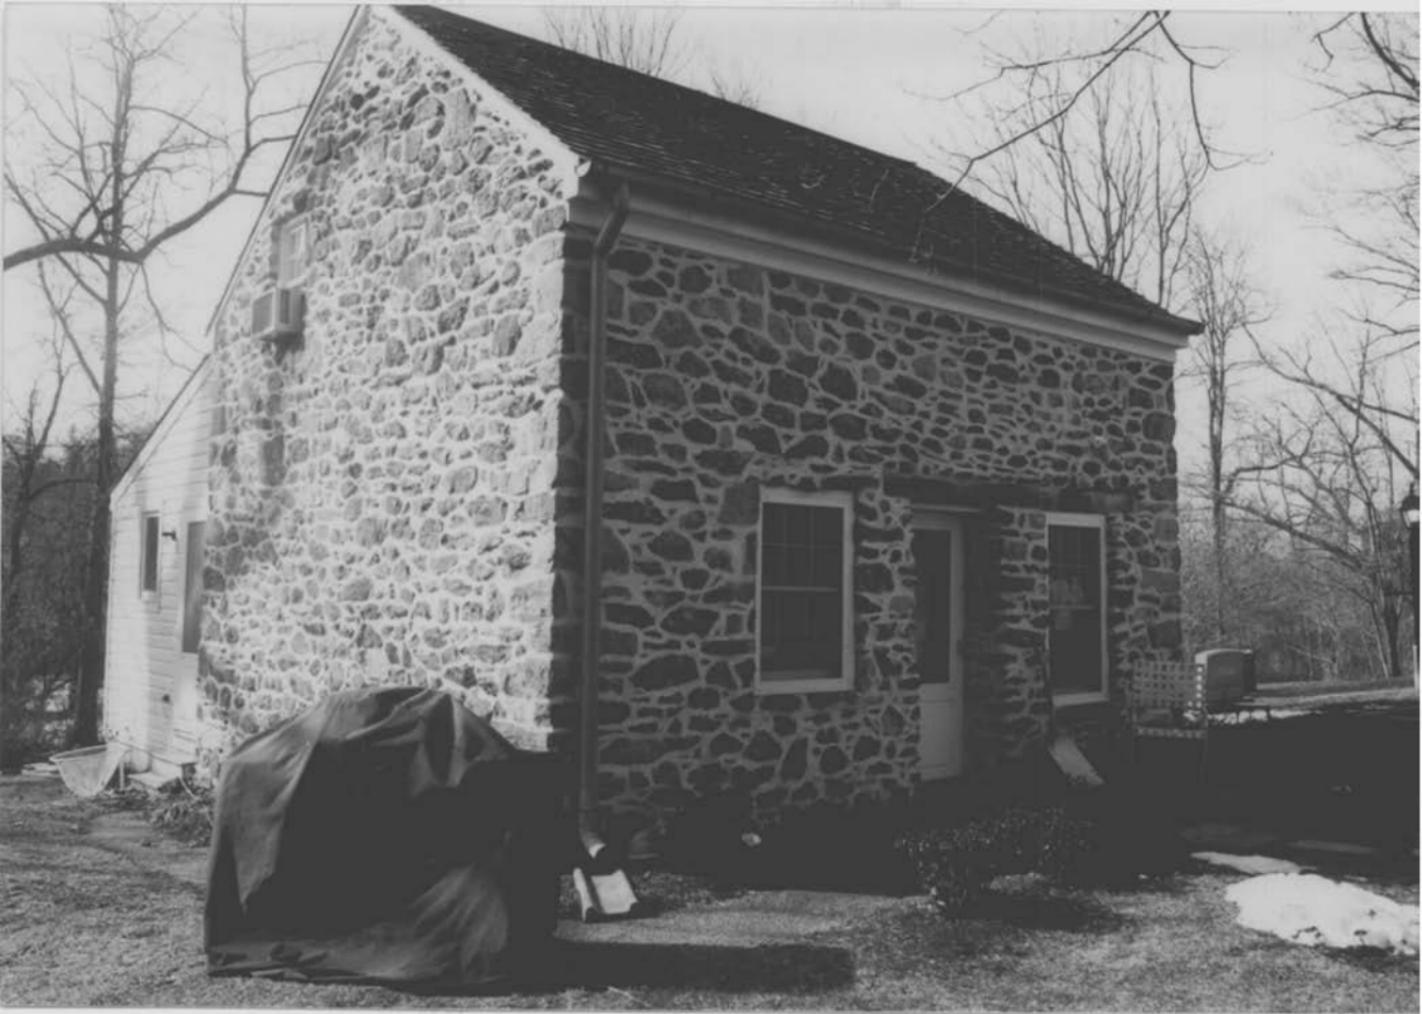
ST JOHN'S CHURCH PARSONAGE

3/4 view of parsonage, view to north west.

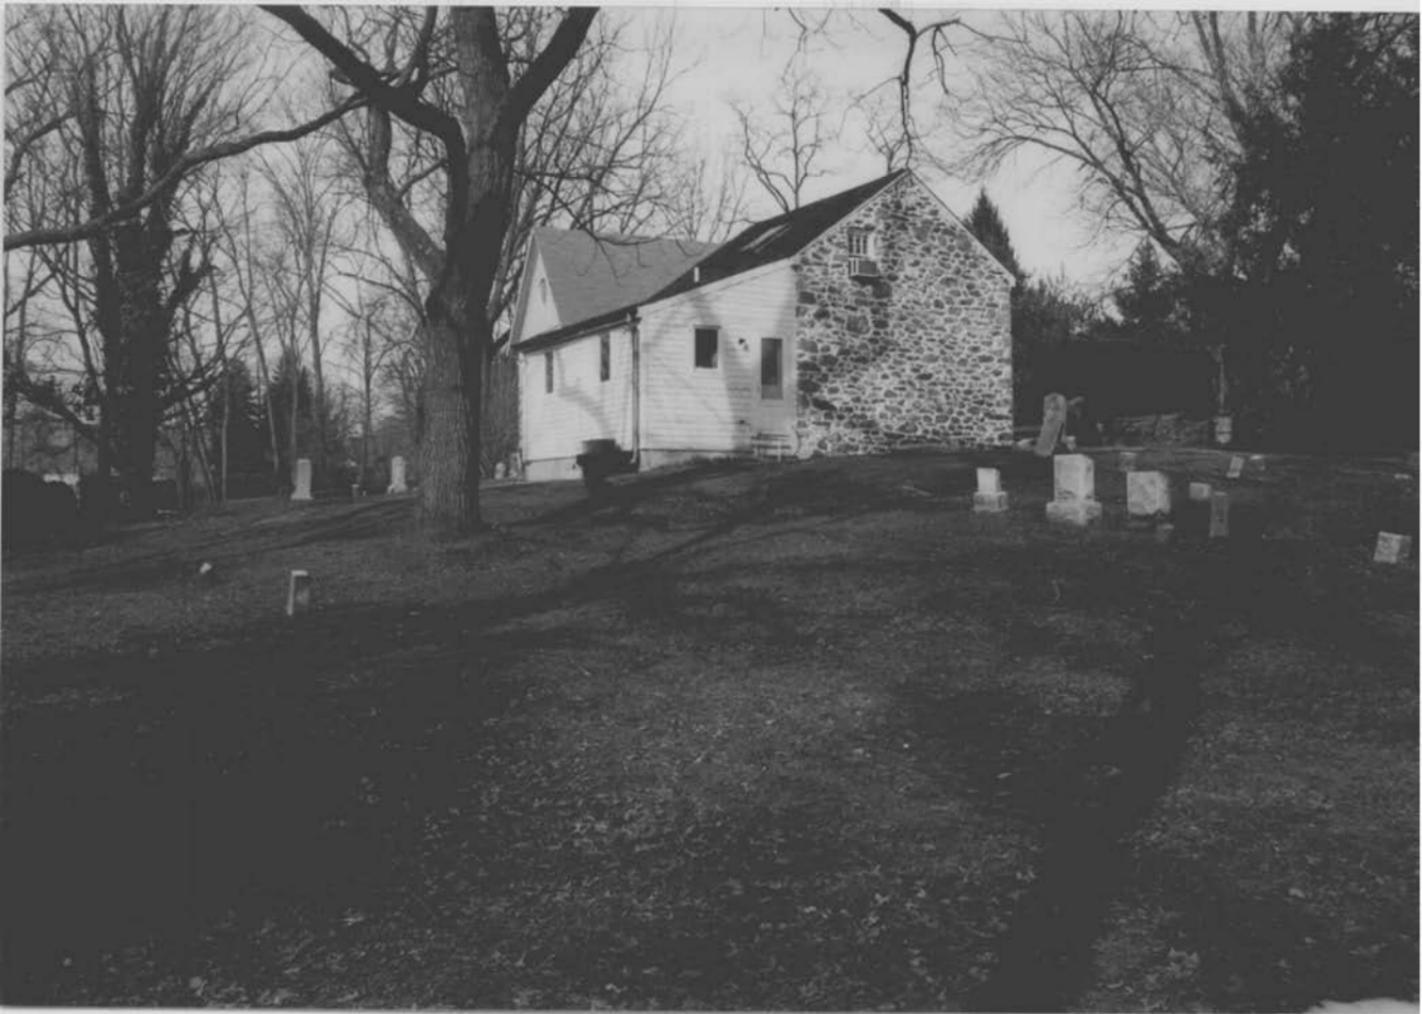
EN. 1771  
St. John's Church parsonage  
Baltimore County, MD

3/4 view from cemetery towards  
rear of parsonage. View to north

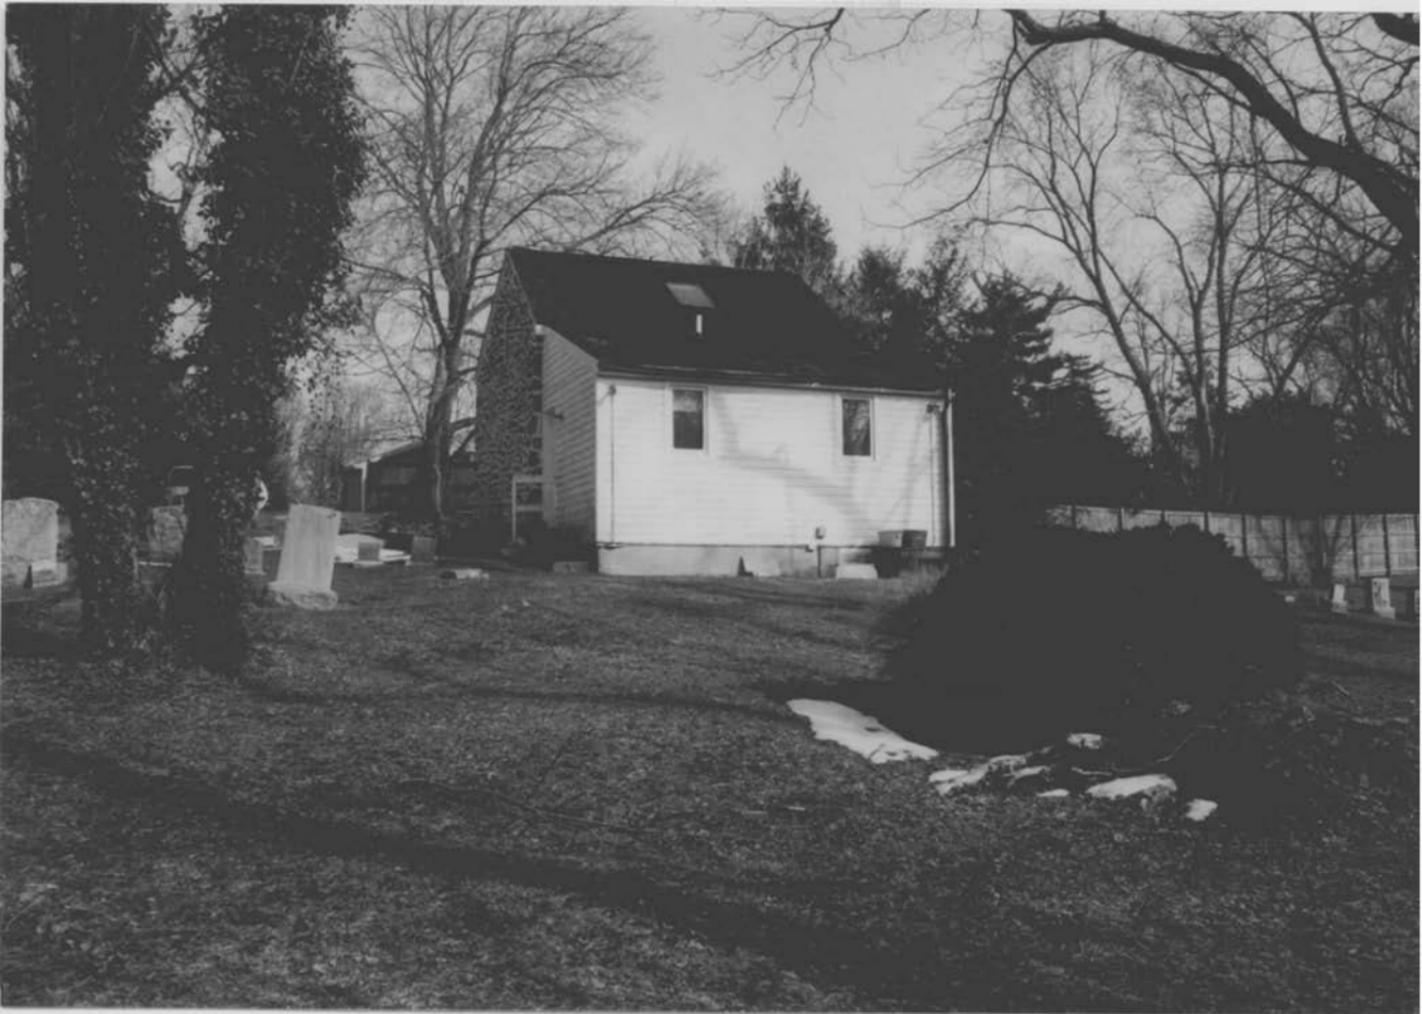
St. John's Church Burial Ground

REAR ELEVATION. VIEW TO EAST.

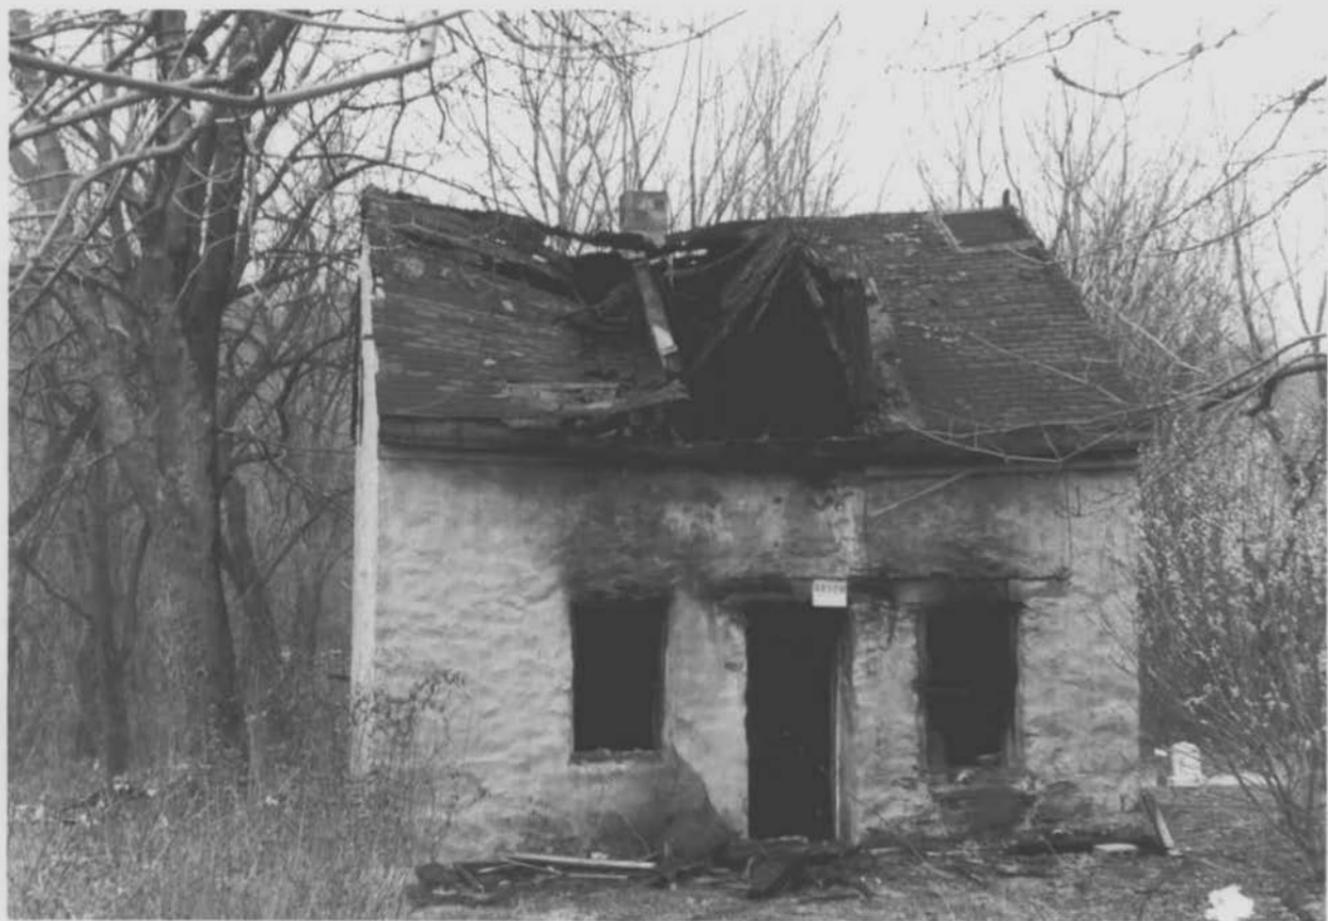
ST. JOHN'S PARSONAGE BA 1771

Main or east facade from east

Each end of the building is windowless except for a small casement window in each gable. That of the north is centralized but the south window is off center to the West. It is interesting to note that these deep casements are presently mounted on the inside of the opening. The main facade faces East like the church. It has three bays to it consisting of a centrally located door flanked by windows. The south window, however, is not as large as the north and it may be an alteration. The door and north window share the same wooden jack arch and the taller north window has a large fieldstone sill.

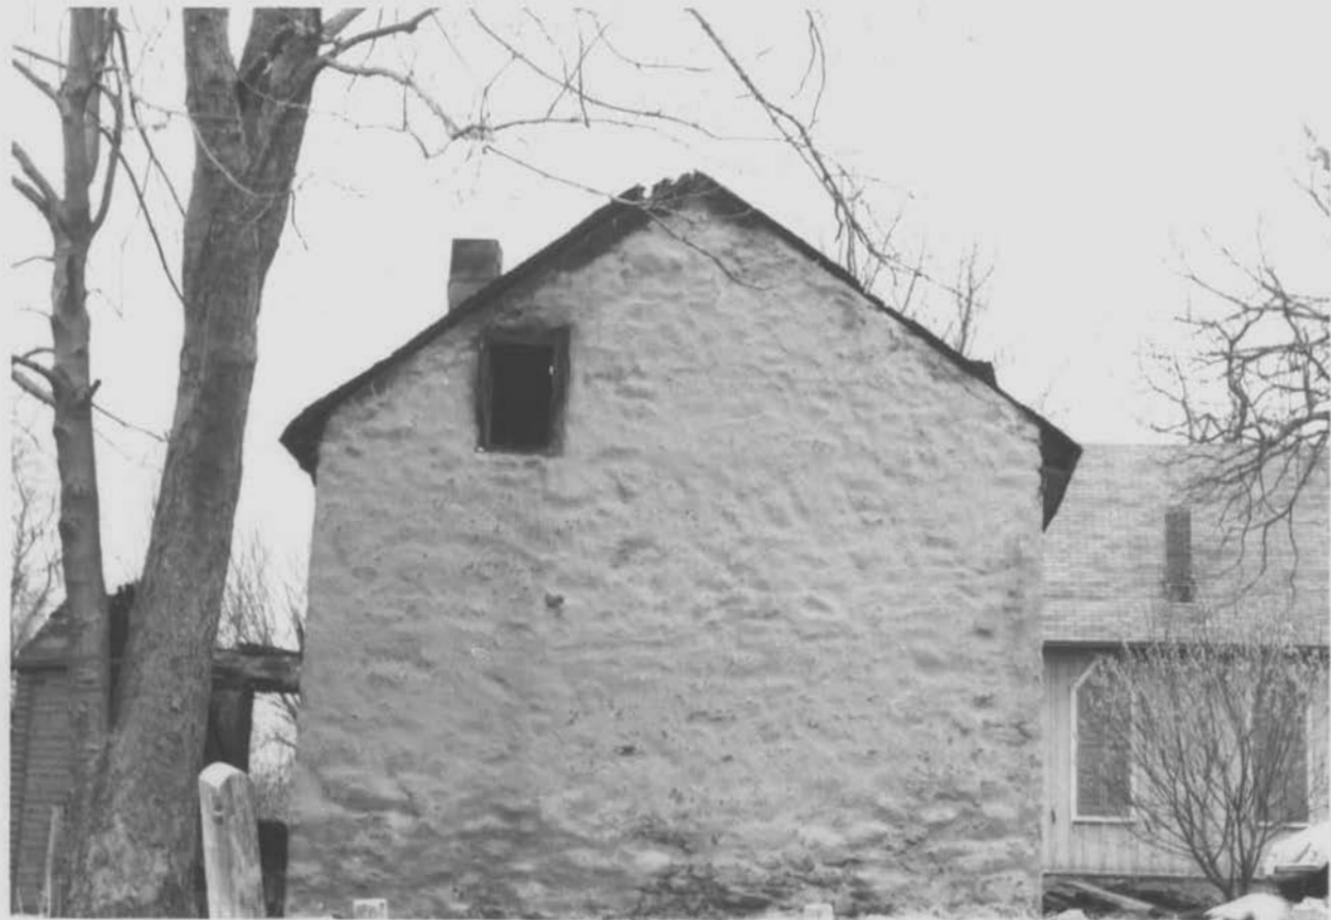
ST. JOHN'S PARSONAGE      BA 1771  
Baltimore County, Maryland  
J. McGrain,      April 1, 1981  
Neg. located at MHT  
South gable end from south  
~~Photo 9 of 12~~

wonders what relationship there is, if any, between this fact and the off center gable window at the top. The placement of that window and the protruding beam on the exterior of the south end could be indicative of a fireplace, however, the south side would be an odd place for one:

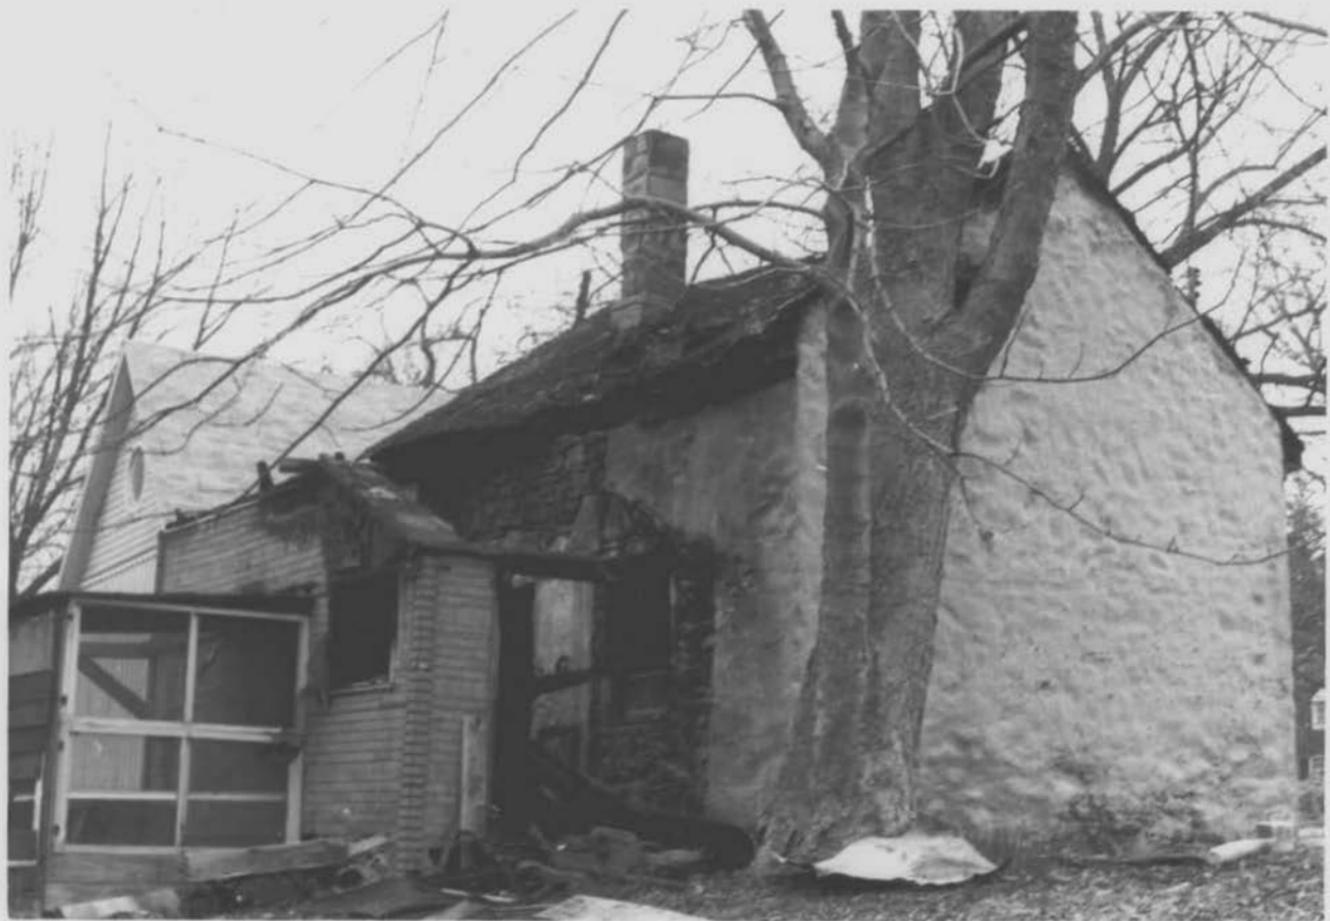
ST. JOHN'S PARSONAGE

South gable end; rear; burned-out  
annex; from SW

The west facade is nearly obliterated by the frame shed roofed addition. Interior examination suggests that it once had a door on the north side and a single window on the south side of it (original appearance of east facade?).

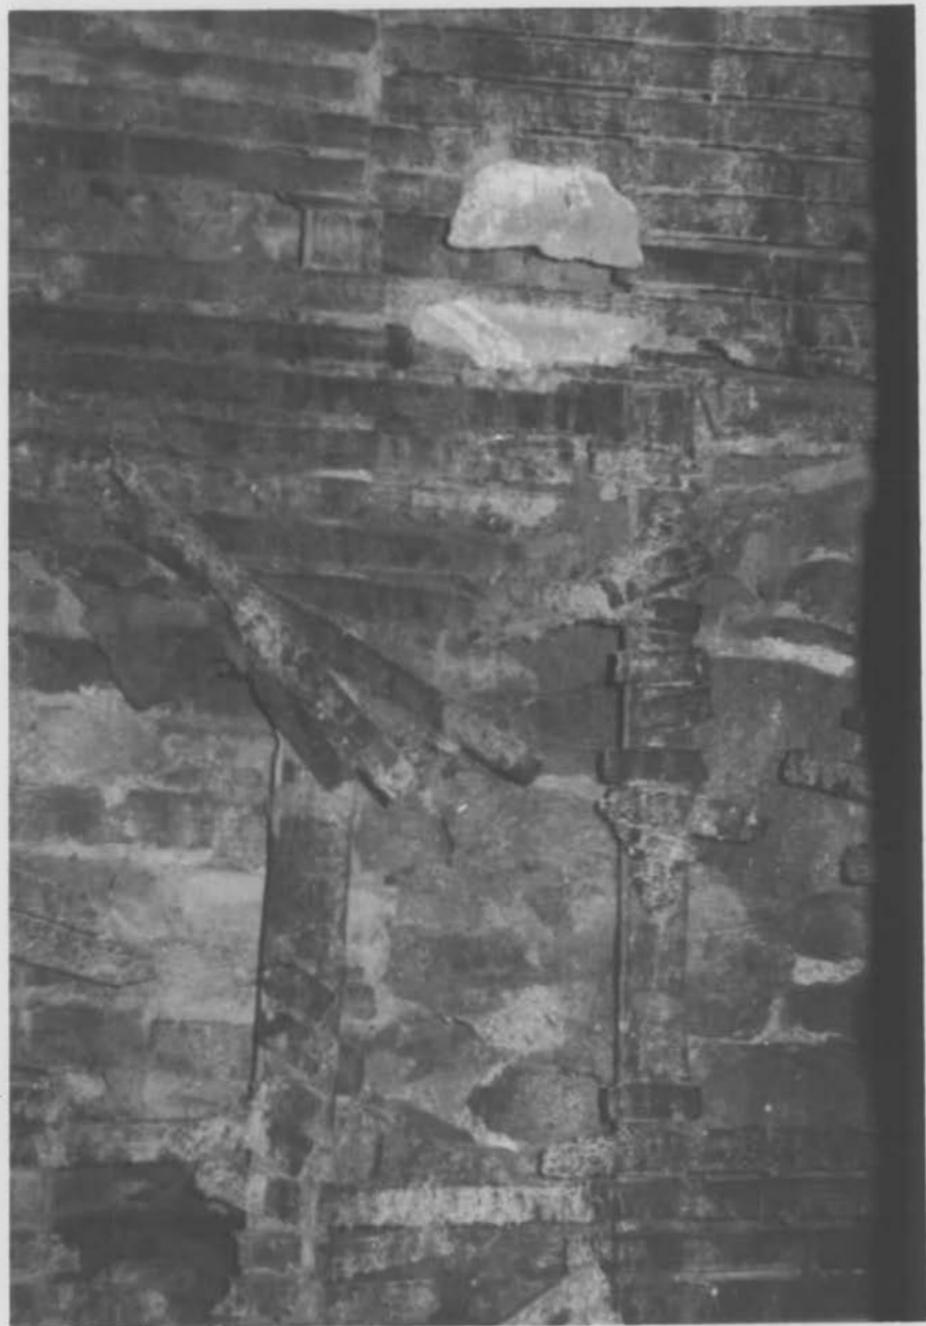
ST. JOHN'S PARSONAGE BA 1771  
Baltimore County, Maryland  
J. McGrain April 1, 1981  
Neg. located at MHT  
Interior; charred laths on south  
wall near stairs  
~~Photo 44 of 12~~

Deterioration in this area allows one to see machine cut laths and parts of the roof construction. The roof consists of vertically sawn timbers cut by machine. Rafters are joined at the top by a ridgeboard and the trusses are nailed to flat false plates in some instances with wire nails. The upper half of each knee wall is frame.

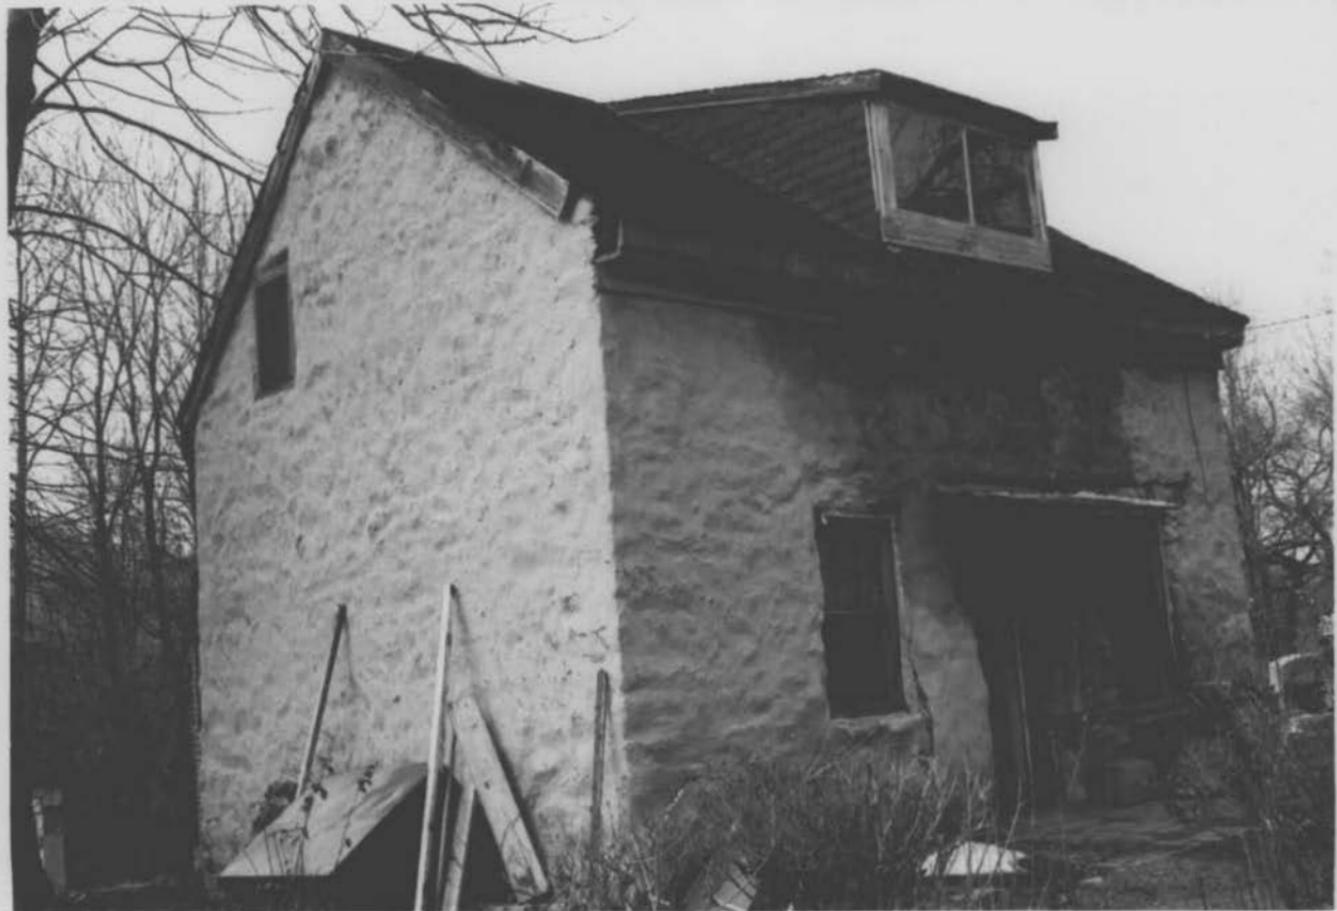
STONE DWELLING -  
NEAR ST. JOHN'S CHURCH.  
S. E. CORNER

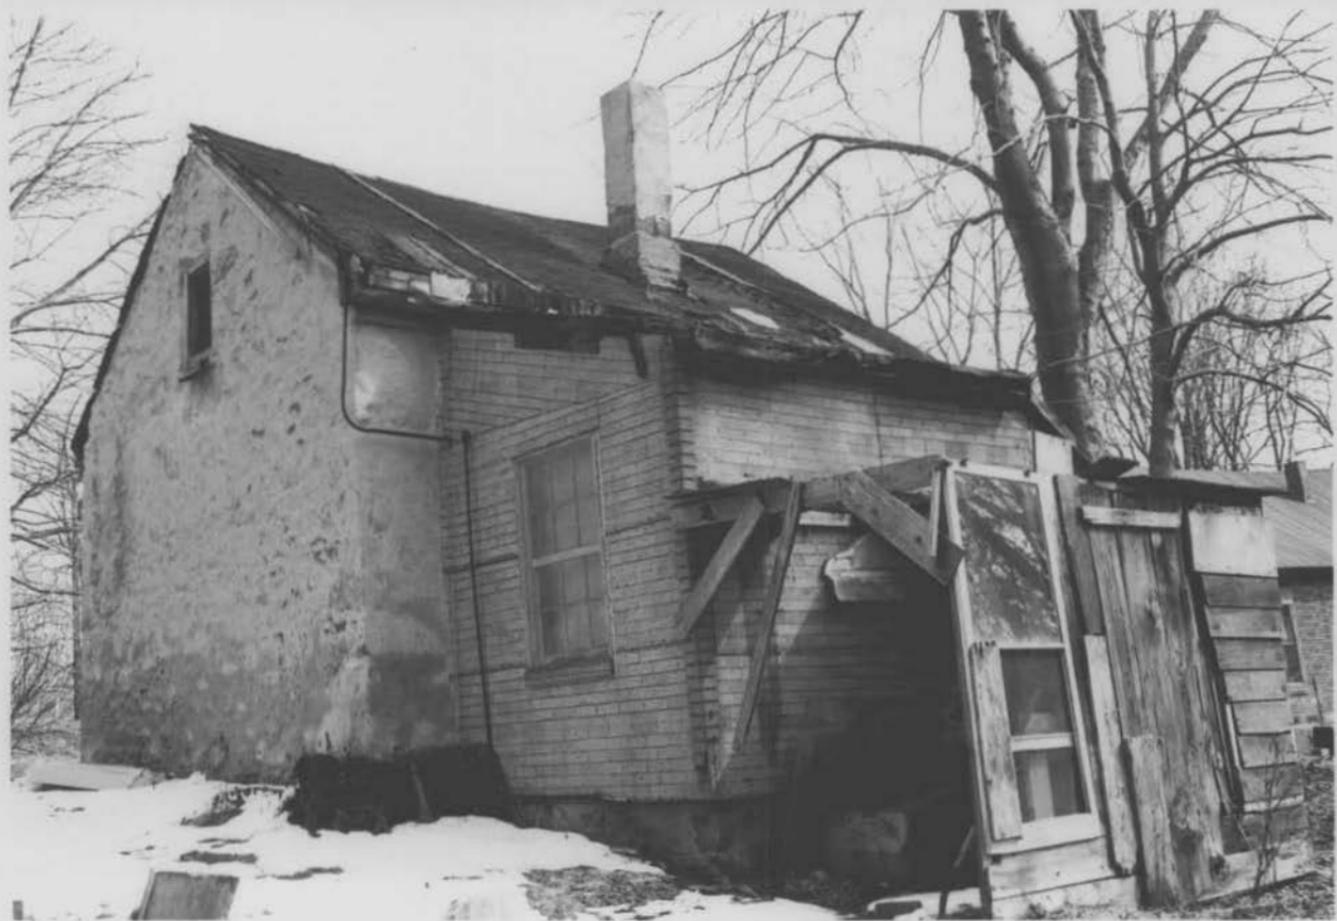
STONE DWELLING  
NEAR ST. JOHN'S CHURCH  
N.W. CORNER

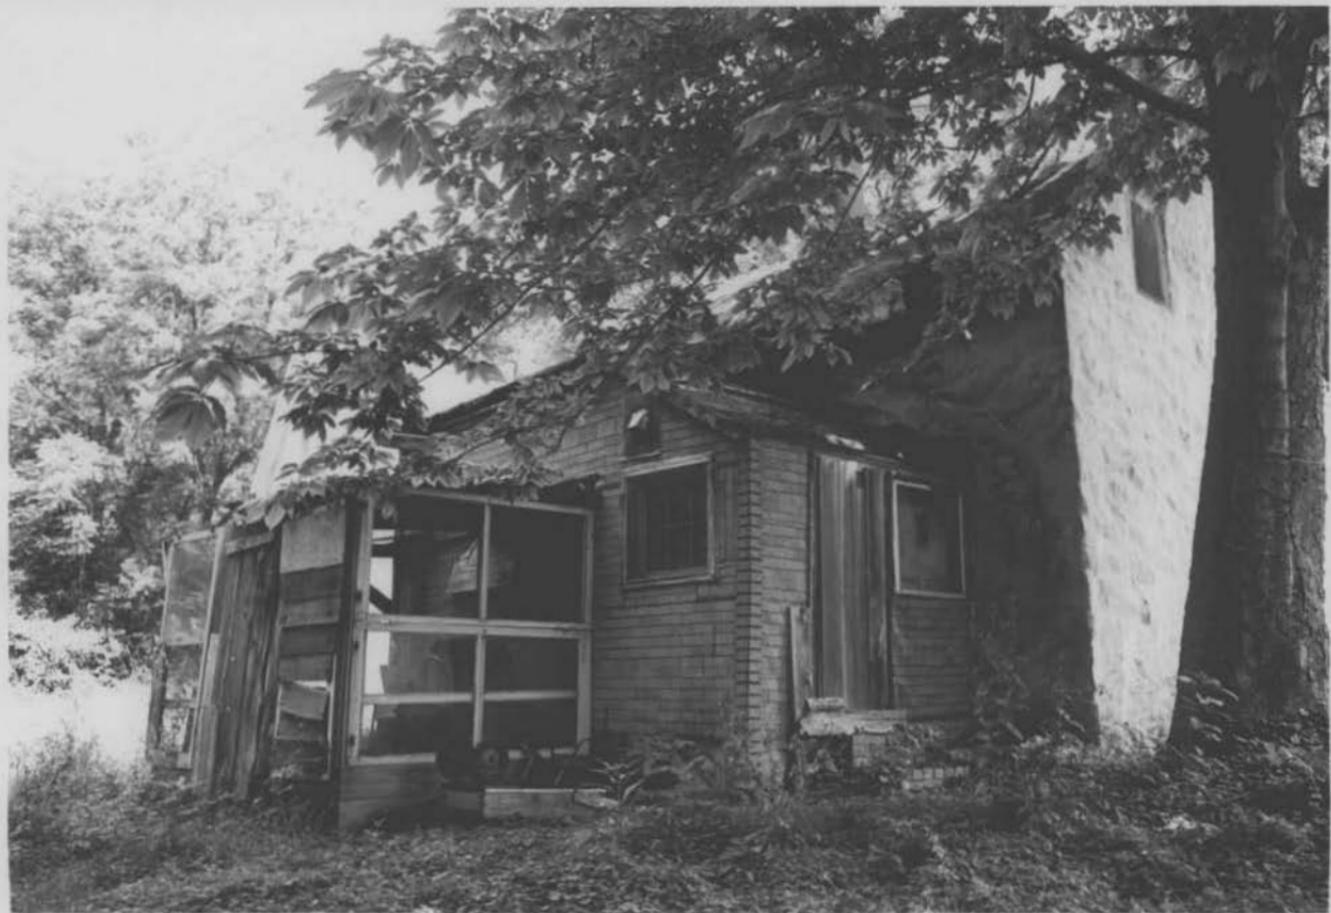
STONE DWELLING  
S.W. CORNER
