1. STATE Maryland
 COUNTY Baltimore
 TOWN Lutherville VICINITY
 STREET NO. 1400 Front Avenue

HISTORIC AMERICAN BUILDINGS SURVEY INVENTORY

2. NAME Creighton C³

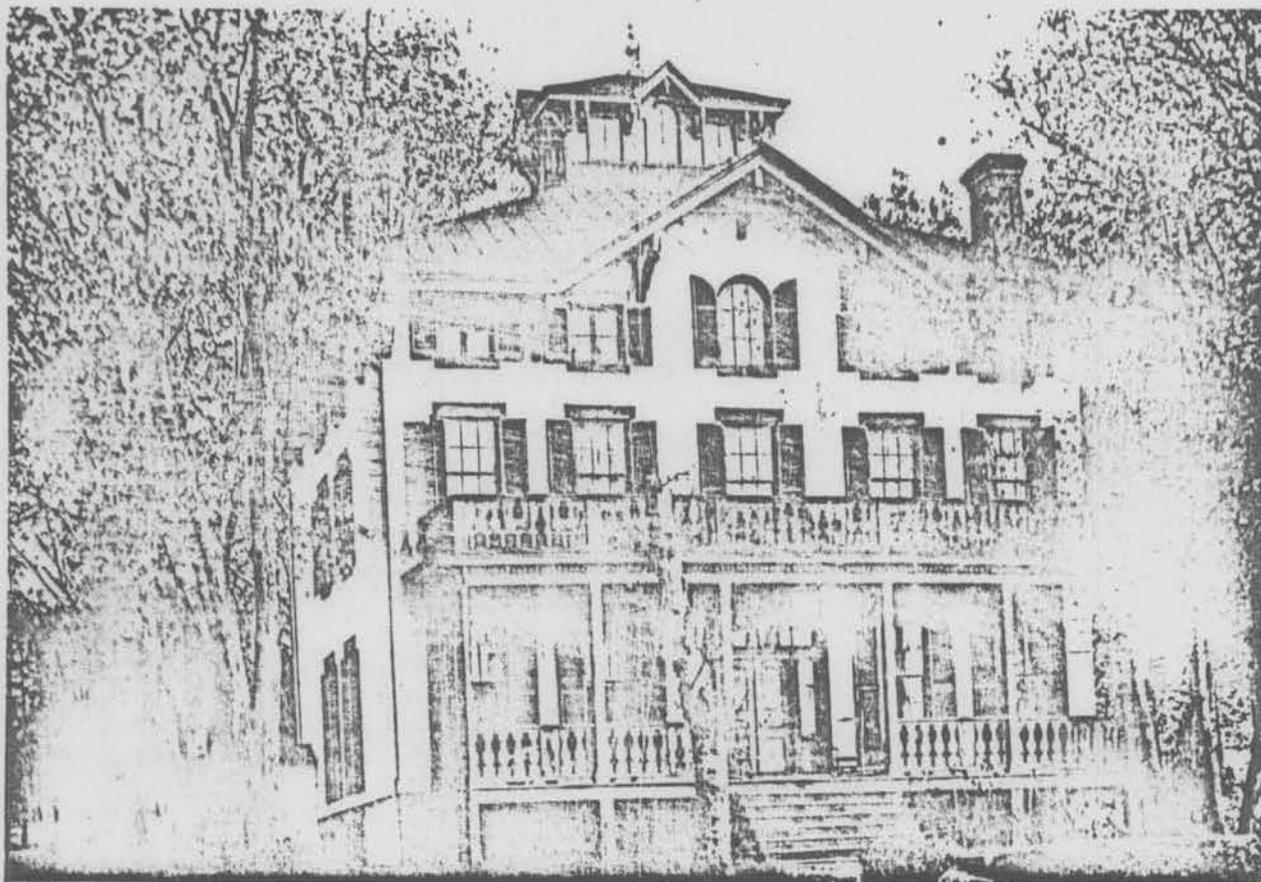
"Creighton," 1400 Front Avenue, Sheet 3

An old view of the house taken c. 1915

The existing appearance of this house, often said to have been built in the 1830's and Lutherville's "oldest house," is the result of extensive alterations which took place in the 1930's by a Mr. Edmundson. By this remodeling a fine Italianate house seen in the old photograph with a third floor, wide overhanging eaves supported on large brackets, a handsome belvedere which had an arched window on each face breaking the eaves and flanked by flat headed windows with brackets supporting its roof and finial, a hipped roof with central open gables over arched third floor windows, and with a front veranda with its jig-saw out slat balustrade, square columns and dentiled cornice was obliterated. The effect rendered a particularly handsome example of mid-nineteenth century Victorian country villa type architecture, designed in the mode of Nathan Starkweather (a Washington-Baltimore architect), a bland example of the so-called "colonial" style with a low hipped roof, four end chimneys, two stories, and five bays which still retain the original wooden lentils set into the brick work. Architecturally, the only ornament visable is a fine set of wrought iron porch rails at the front stoop of the main entrance which still retains the original character of the sidelighted and transomed doorway which retains the original paneled, double doors.

Of additional note, a modern wing extends to the south adding a conservatory to the first floor plan and together with the raise in grade obscures the stone foundation seen in the old photograph. At the garden entrance opposite the front door, both opening into a central hall, there is a modern veranda with brick construction and flag stone paved.
