**MARYLAND HISTORICAL TRUST
NR-ELIGIBILITY REVIEW FORM**

Property Name: Ensor House Inventory Number: BA-2048

Project: Hereford Tower Project Agency: FCC

INVENTORY FORM FOR STATE HISTORIC SITES SURVEY

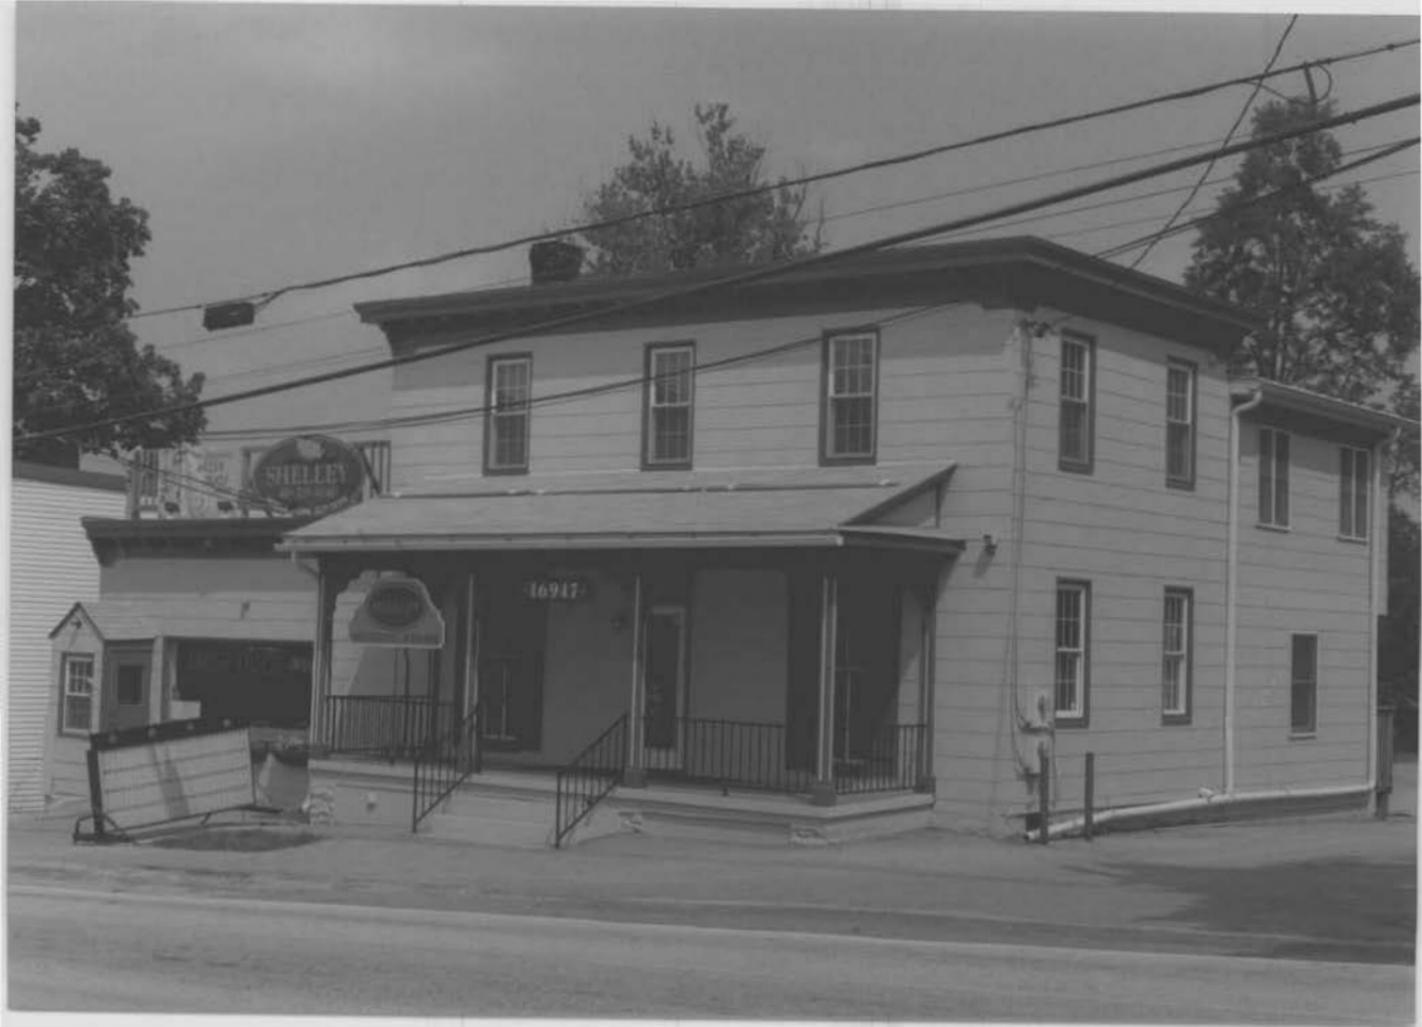
1/2

View of the Ensor House, to the
northeast.

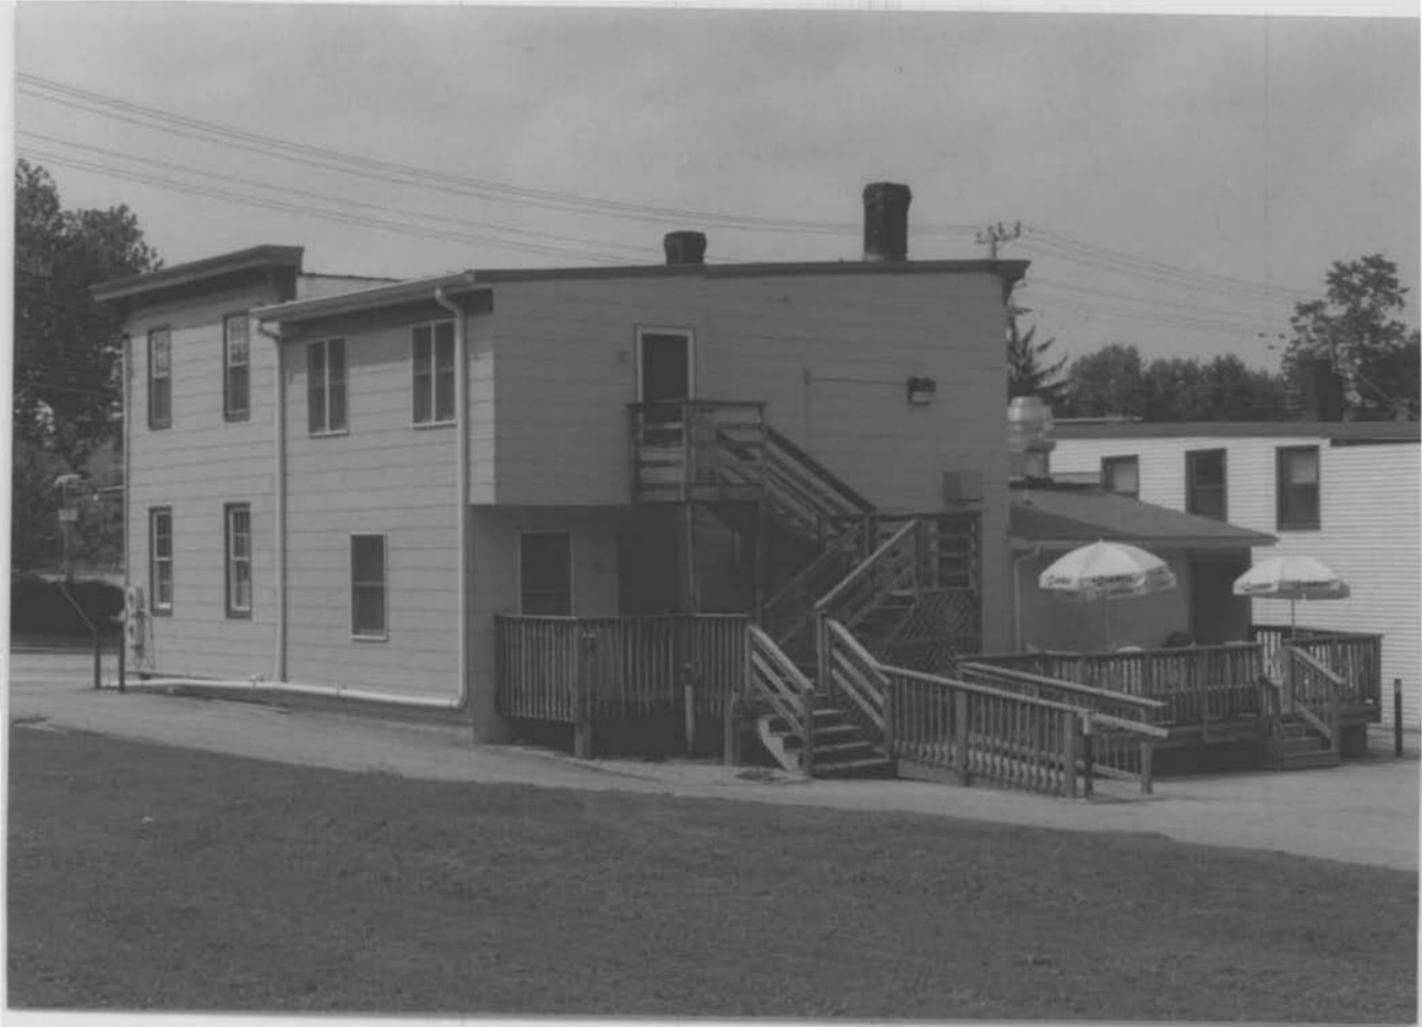
2/2

View of the rear of the Enson House,
to the north west.

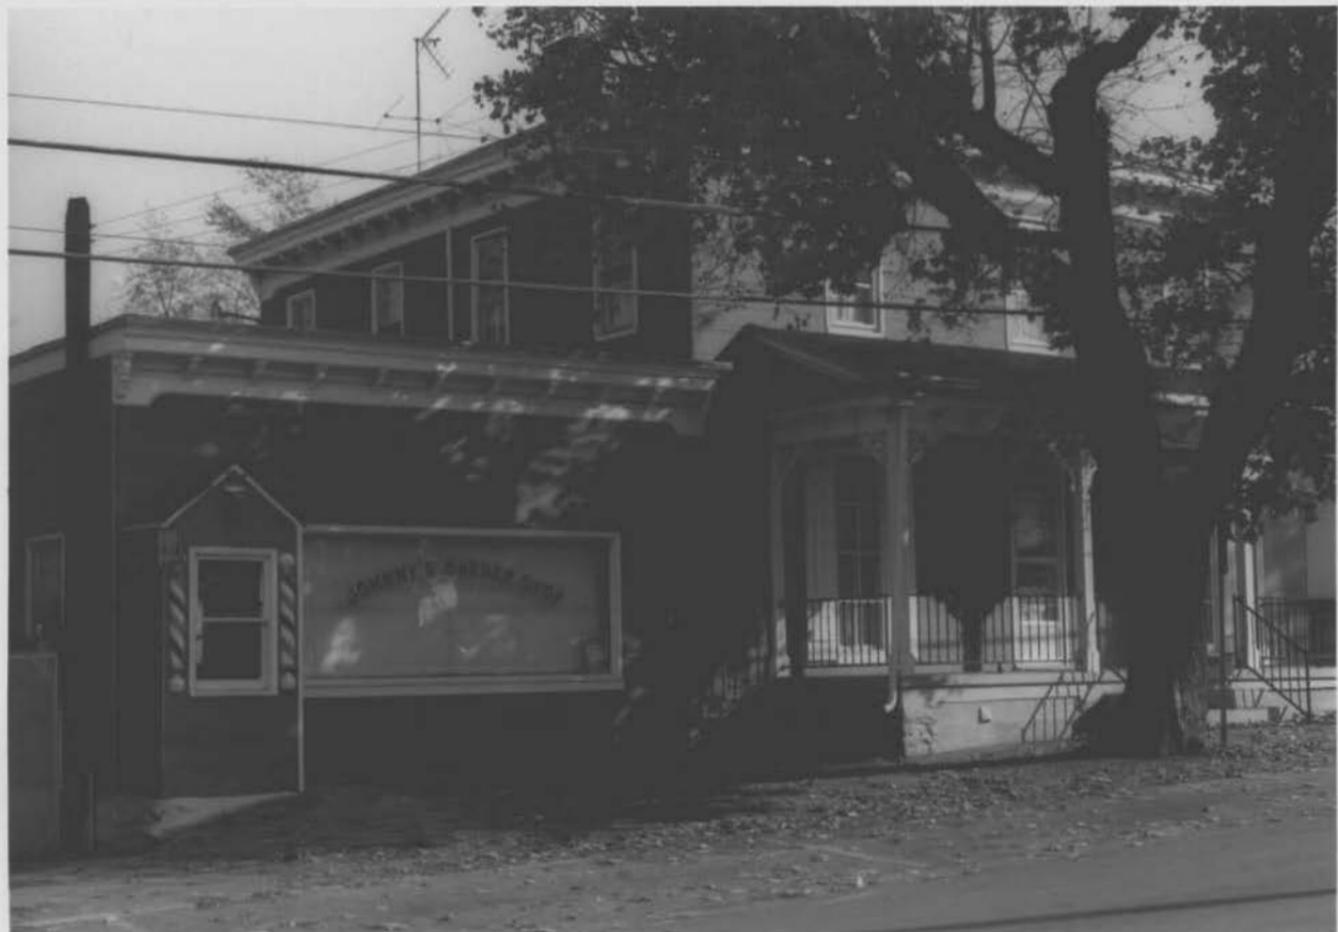
ENSOR HOUSE (COSTA BARBER SHOP)
Balto. Co., Md. BA 2048
J. McGrain, Oct 1979
Neg. located at MHT
Main (west) facade & north wing

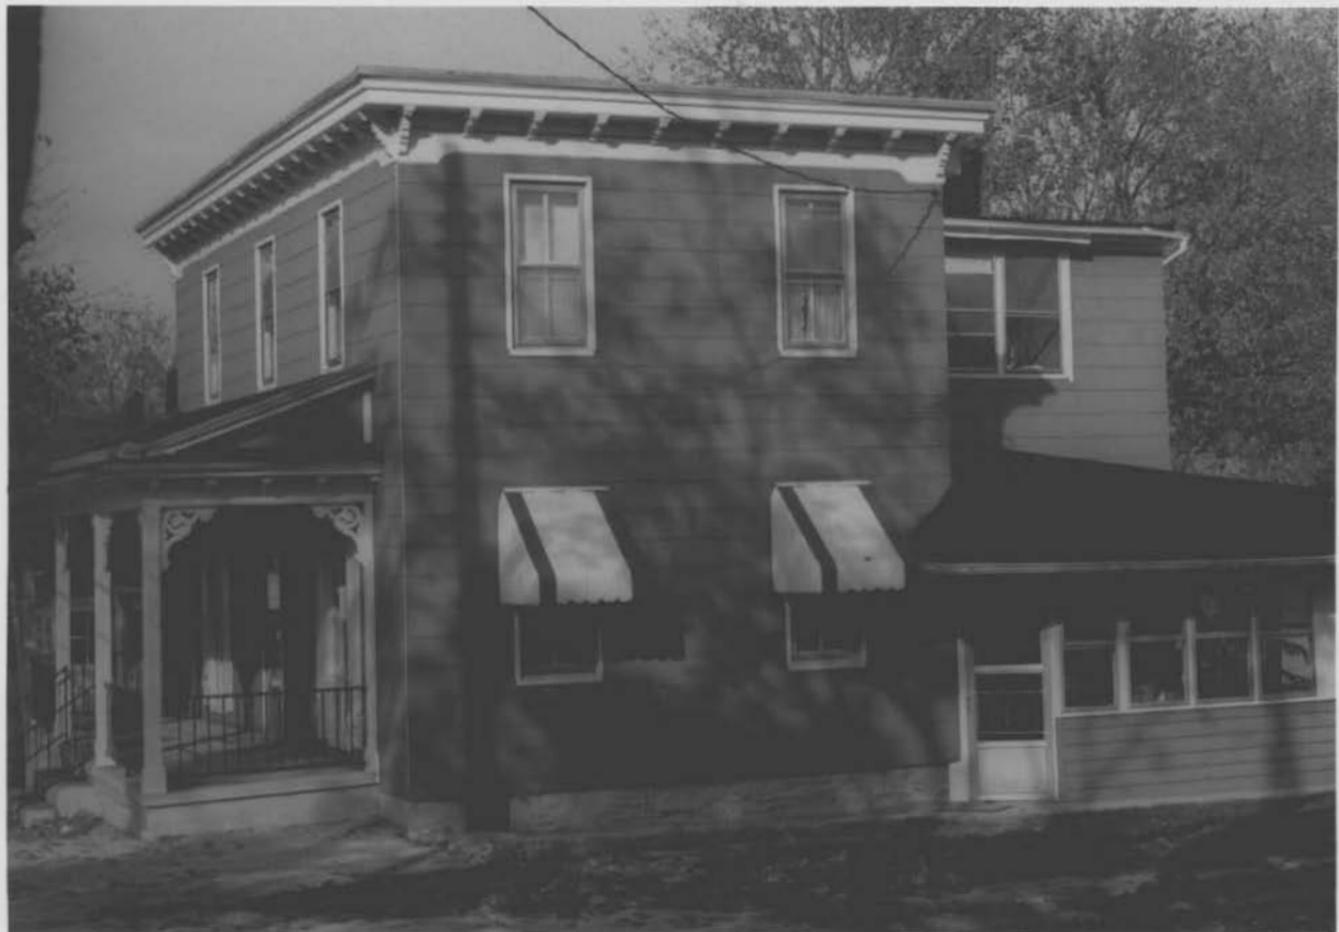
ENSOR HOUSE (COSTA BARBER SHOP)
Balto. Co., Md. BA 2048
J. McGrain, OCT 1979
Neg. located at MHT
South facade & main (W) facade

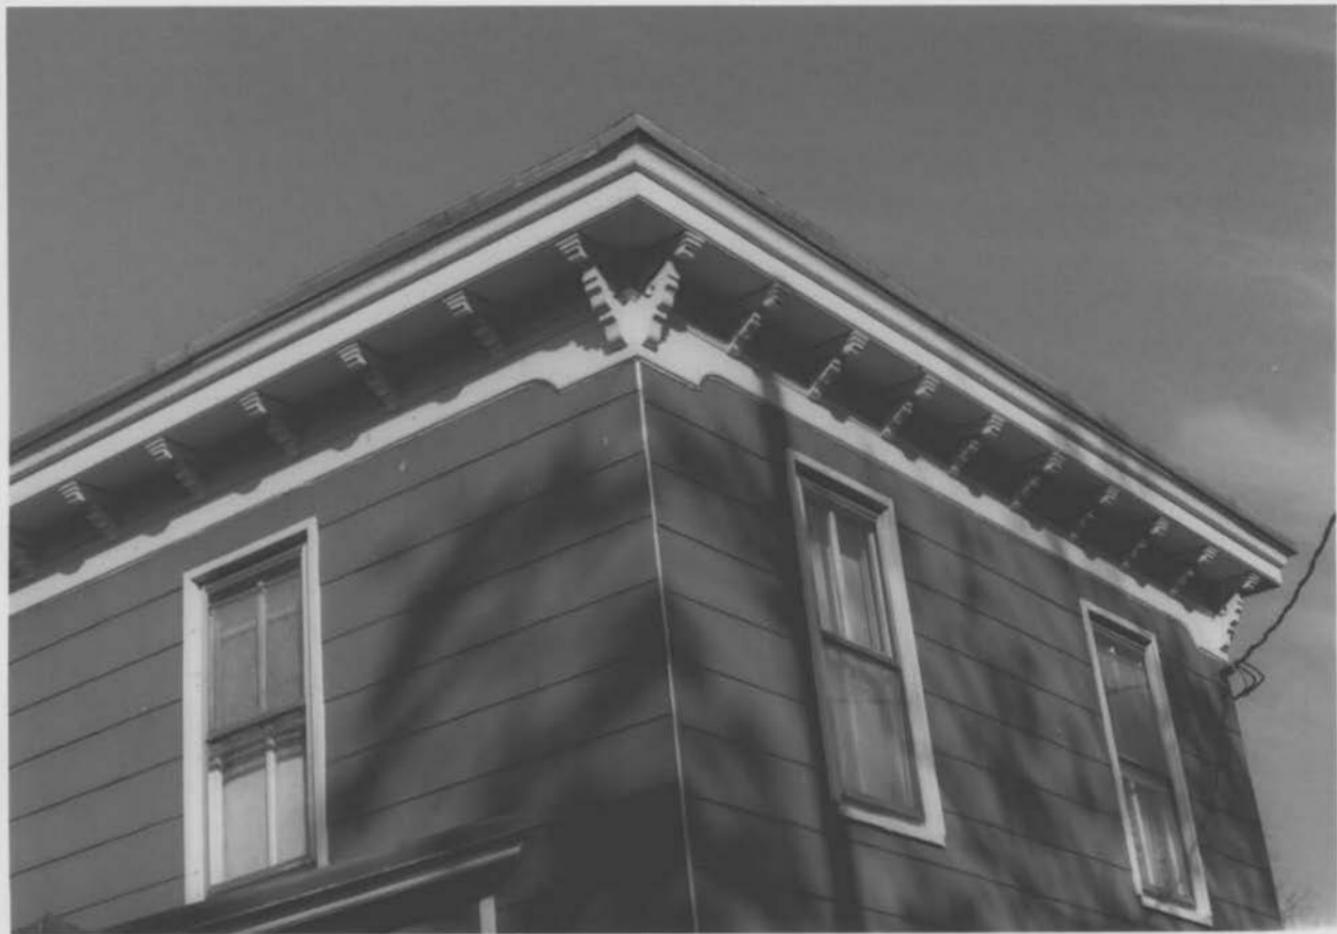
ENSOR HOUSE (COSTA BARBER SHOP)
Balto. Co., Md. BA 2048
J. McGrain, OCT 1979
Neg. located at MHT
Cornice & SW corner of bldg
