MARYLAND HISTORICAL TRUST
DETERMINATION OF ELIGIBILITY FORM

Property Name: Dairy House, Spring Grove Inventory Number: BA-2322
Address: Spring Grove Hospital City: Catonsville Zip Code: _____
County: Baltimore County USGS Topographic Map: Baltimore West
Owner: DHMH Is the property being evaluated a district? yes
Tax Parcel Number: _____ Tax Map Number: _____ Tax Account ID Number: _____
Project: _____ Agency: _____
Site visit by MHT staff: no yes Name: L. Bowlin, 1985 Date: _____
Is the property is located within a historic district? yes no

State Historic Sites Inventory Form

historic Dairy House

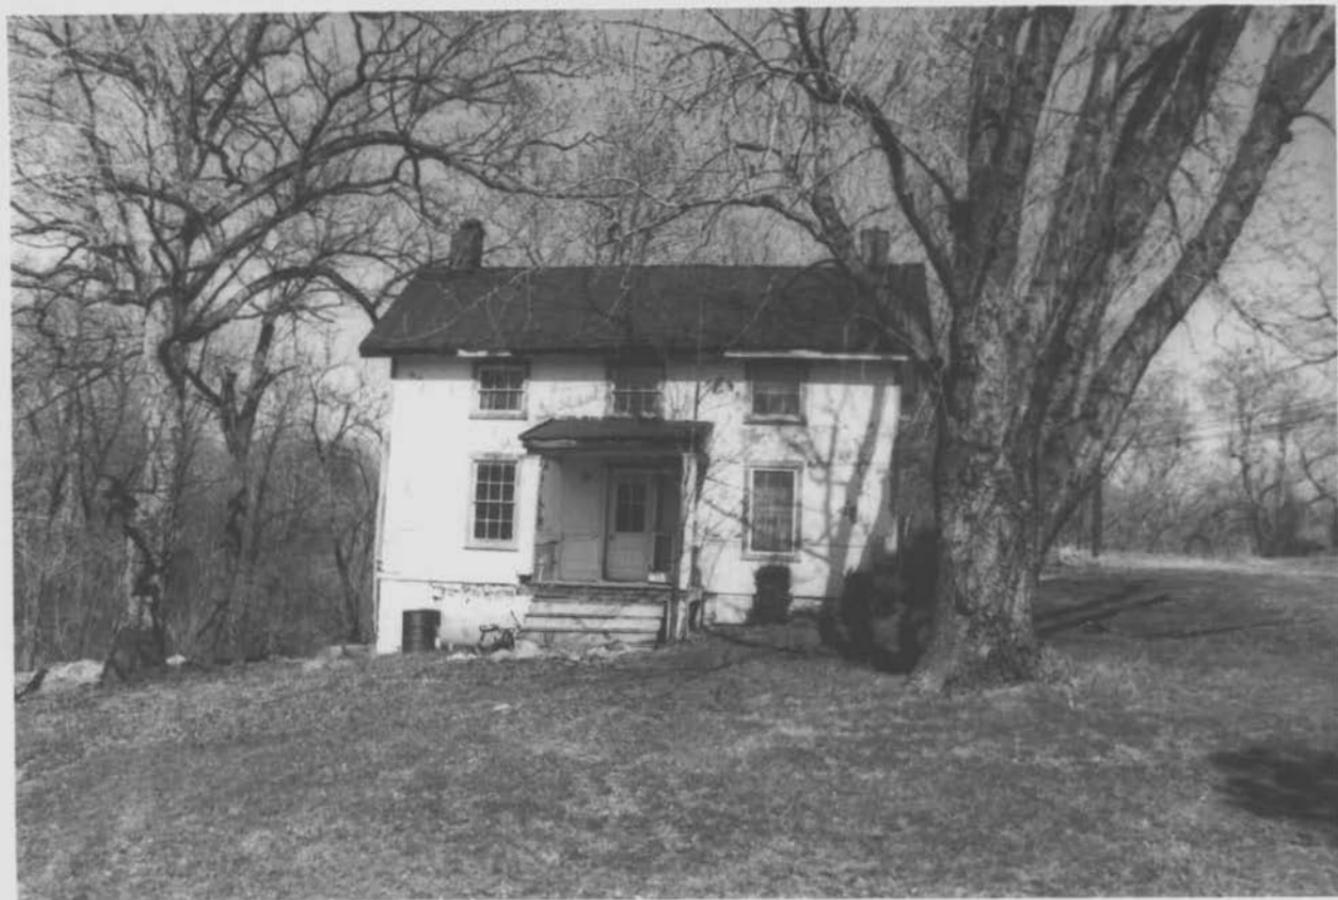
WEST WALL

A simple portico characterizes the western facade. Supported by brick piers, the wooden portico has tongue and groove flooring and square turnposts. The balustrade no longer exists, and in some places has been replaced by a chain-link fence. The portico frames the main door. Though the door is original because of its porcelain doorknob and Victorian hardware, the rest of the door treatment remains undistinguished. Two windows flank the central doorway. Flat pieces of wood form a square surround and lintel around these 6/6 double-hung sash windows. The three second-floor windows show a slight variation: a 3/3 sash and a triangular shaped lintel. The west facade reveals an unusual treatment on the first story. Attached to the stucco, clapboard siding appears from the stone foundation up to the first floor window sills like an exterior wainscoting.

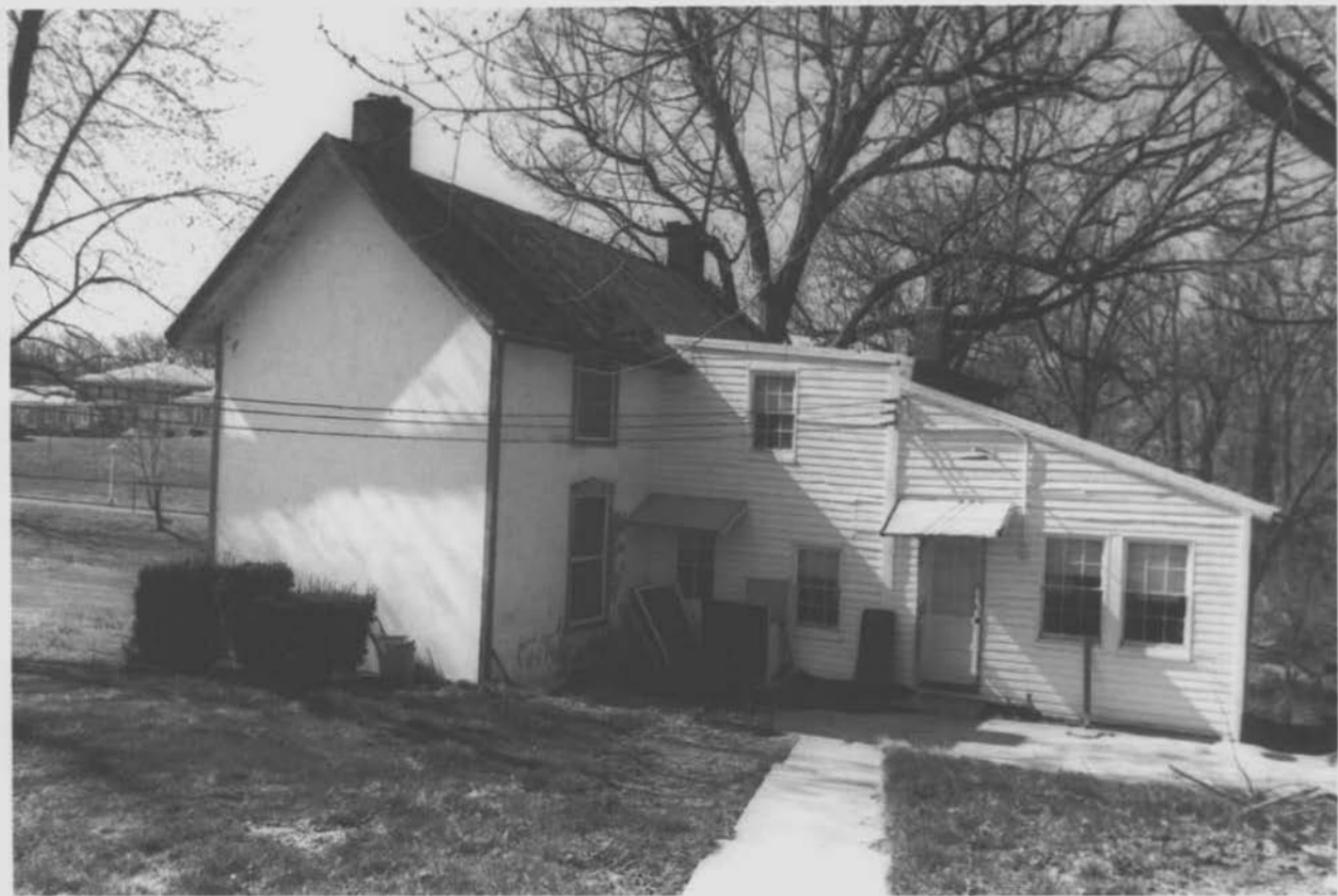
SOUTH WALL

The gabled ends on the north and south are enclosed by wooden framing members. The southern wall is detailed only by the plain, projecting verges. While the northern wall displays the same verges, it also shows a first and second floor window. Though deeply recessed, the windows demonstrate the same lintel treatment of a flat, wooden triangular pediment. These casement windows appear on the eastern portion of the northern wall, close to the clapboard addition. The triangular lintel is repeated on the eastern wall as the windows match the treatment of the western facade: first floor-6/6 sash, second floor-3/3 sash.
