**MARYLAND HISTORICAL TRUST  
DETERMINATION OF ELIGIBILITY FORM**

Wade Avenue Gatehouse, Spring Grove

historic Wade Avenue Gatehouse

Survey No. BA-2325

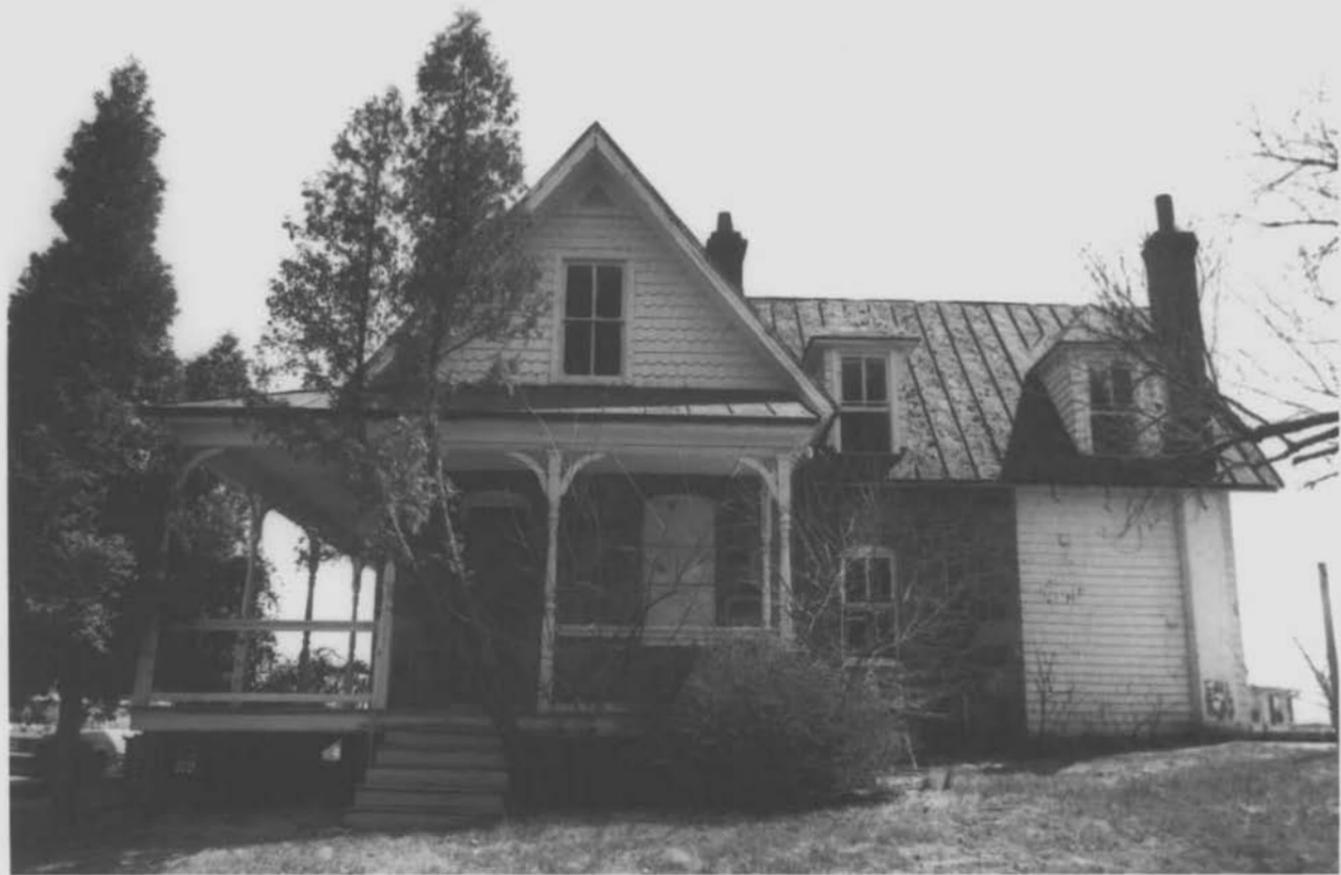
WADE AVENUE GATEHOUSE  
SPRING GROVE HOSPITAL CENTER  
CATONSVILLE, MARYLAND  
NORTH WALL  
DON JEWELL, 4/86  
NEGATIVES AT MHT

The residence is built on a "T" plan with a two-story clapboard addition on the west end. The original portion of the building is three bays wide and one bay deep. The building rests on a stone foundation. In contrast, the two-sided porch gains support from brick piers. Existing on the northern and eastern faces, the wooden porch incorporates a simple geometric design in its balustrade. Scrollwork decorates the turnposts. The wooden flooring was assembled by the tongue and groove technique. The roof of the porch is also covered by tin. Shadowed somewhat by the porch, granite quoins accent the rubblestone corners.

Both the eastern and northern faces display doors. The ornamental details mirror those decorative elements of the windows. The long, narrow doors retain the brick Gibbs surround, carved transom detail and the segmented arch lintel. In addition, the doors have a two pane glass transom.

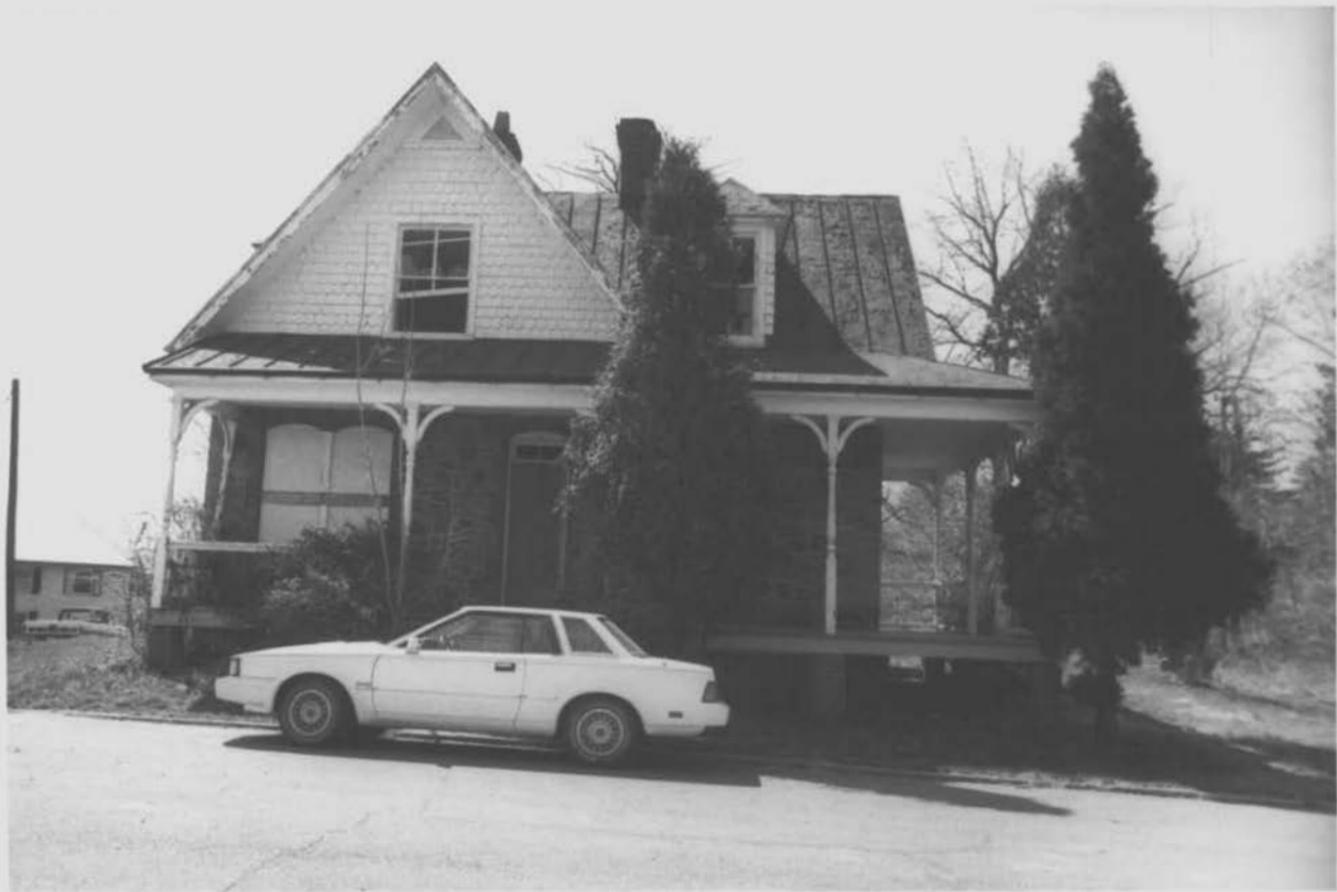
EAST WALL

The window treatment repeats the same design elements throughout the rubblestone fenestration. On the first floor, red bricks form a Gibbs surround and the radiating voussoirs of the segmented arch lintels. A wooden transom with a delicate carving caps the 2/2 double-hung windows. The eastern face of the building shows a pair of windows on the southern side of the front door. The paired windows have connecting lintels and share a brick surround. The ground level windows have less ornamentation. The brick lintel becomes flat and the wooden sill has been left unpainted.
