**MARYLAND HISTORICAL TRUST
DETERMINATION OF ELIGIBILITY FORM**

Property Name: Lloyd Schwartz Museum, Spring Grove Inventory Number: BA-2326

Maryland Historical Trust State Historic Sites Inventory Form

historic Firehouse

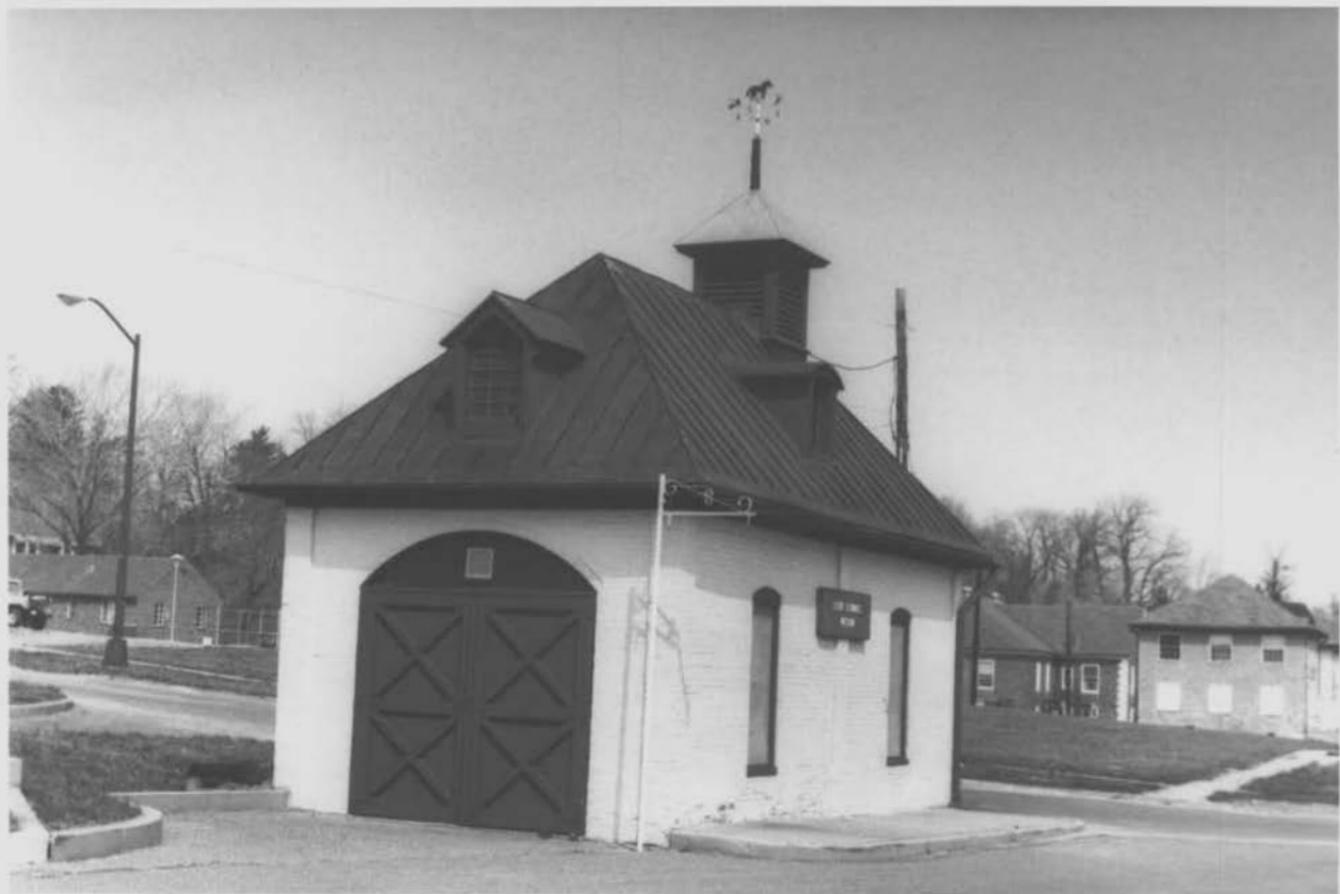
BA-2326
SCHWARTZ MUSEUM
SPRING GROVE HOSPITAL CENTER
CATONSVILLE, MARYLAND
SOUTH AND EAST WALL
DON JEWELL, 4/86
NEGATIVES AT MHT

Six brick piers support the significant weight of the building. The piers extend outward from the wall approximately the width of a header brick at each corner of the building and in the center of the east and west facades. Flanking the central piers on the east and west walls are long, rectangular, structural openings with jack arches, carved wooden transoms and wooden sills. Three of these four openings are windows with a single sash of four panes. The fourth opening is a door. Though plywood covers much of the door, the Victorian hardware is still visible.

The north and south facades have large stable doors which conform to the shape of the brick, elliptical arch lintels. The doors differ in several ways. The northern door has a multipaned glass transom with a few original due to the alteration to its transom which has been enclosed by wooden laths and a modern, metal air vent. In addition, the southern door has a different structural pattern of framing members than the northern double door. Both lintels are constructed of two rows of header bond bricks to form the elliptical arches.

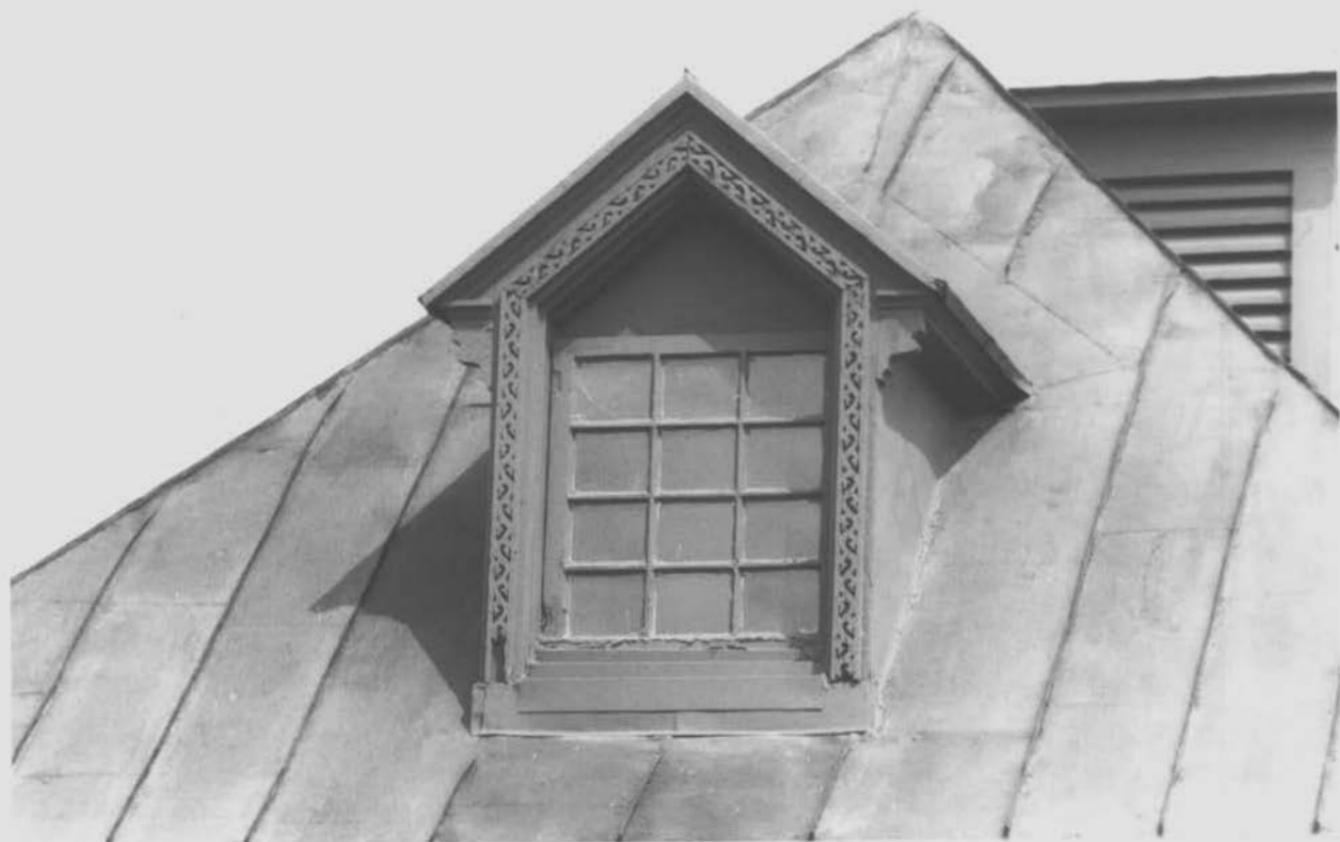
BA-2326

SCHWARTZ MUSEUM
SPRING GROVE HOSPITAL CENTER
CATONSVILLE, MARYLAND
DORMER DETAIL
DON JEWELL, 4/86
NEGATIVES AT MHT

Three dormers interrupt the roof as well. Two have segmental arches and the third displays a simple gable. All three of the dormers demonstrate decorative scrollwork on the surrounds. In addition, the dormers are characterized by ornamental impost blocks, painted tin sides, and metal flashing. The two segmented arch dormers display a 2/2 single sash while the gabled dormer exhibits a 4/3 arrangement.

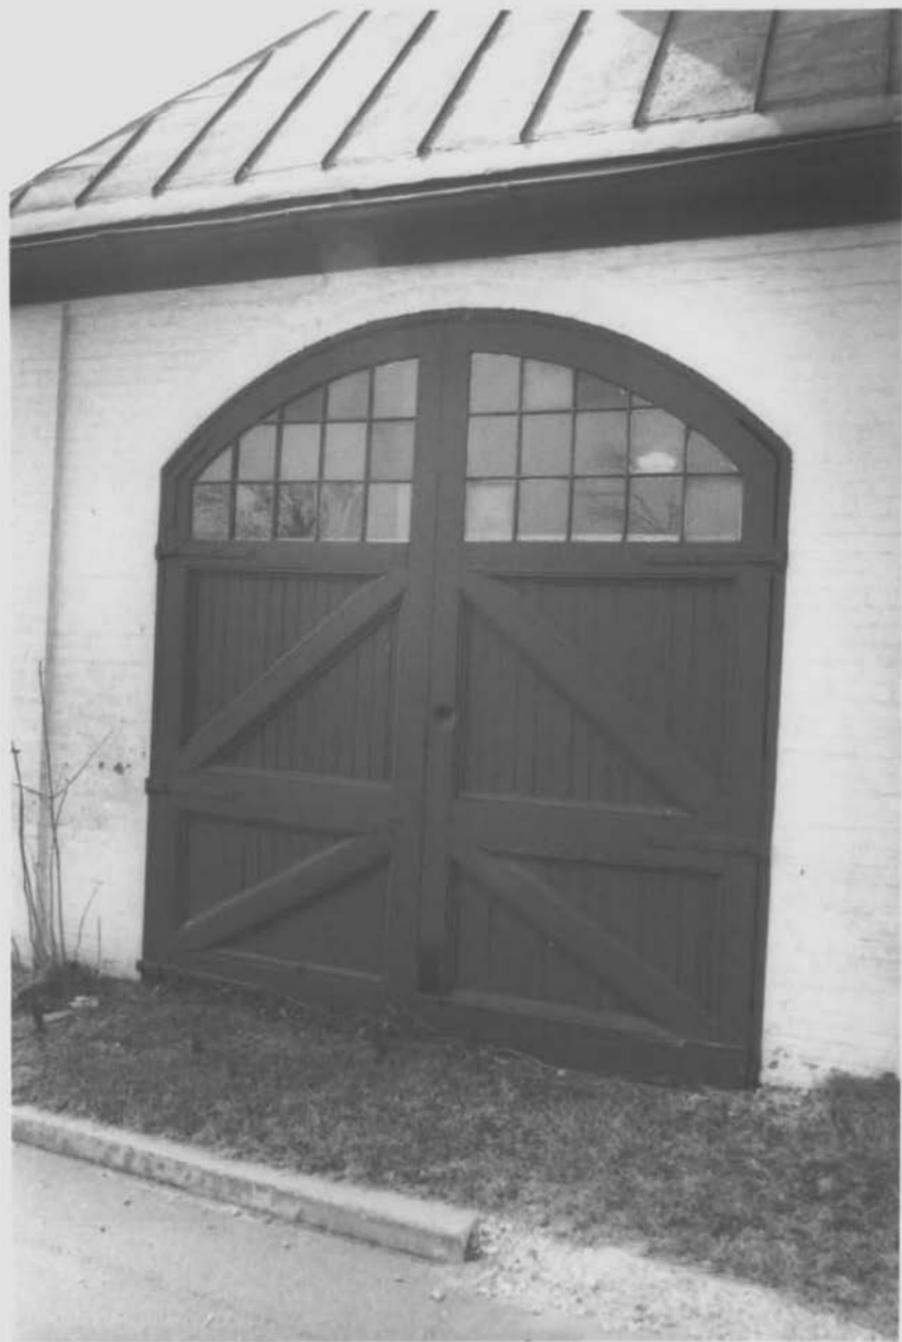
BA - 2326

NORTH WALL
