BA-264
"Perry Hall"
3930 Perry Hall Road
Perry Hall vic.
Public
1840-44, c. 1925

Maryland Inventory of Historic Properties Form

Inventory No. BA-264

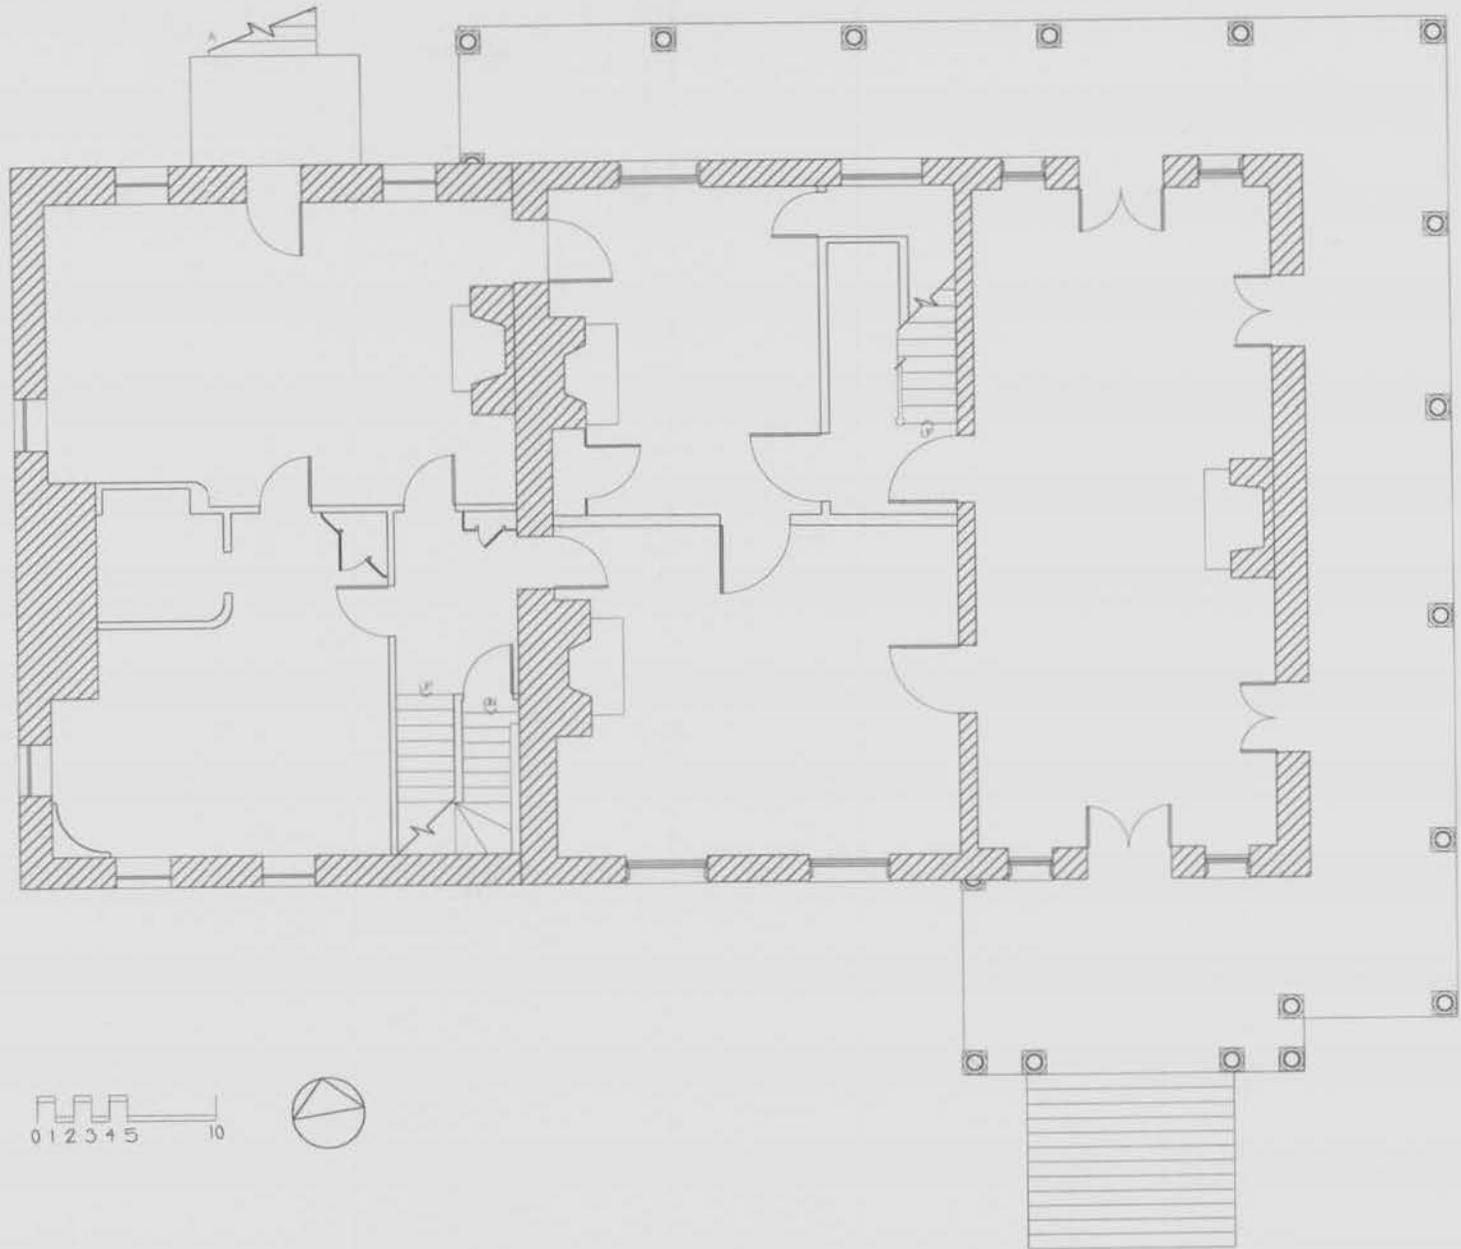
FIRST FLOOR PLAN MEASURED BY TOM RINEHART, MARCIA MILLER, KEN SHORT, HEATHER BARRETT, & KAY SMITH DRAWN BY KEN SHORT JULY 2002

The first story has a side-passage, double-pile plan with a stair hall between the passage and the north room. The wing contains two rooms and a service stair, with a bathroom created inside the south room of the wing. The passage has random-width pine between 4 ¼ inches and 6 ½ inches that runs north-south. The baseboard has a broken field and a quirked Greek ogee and fillet at the top. There is symmetrical architrave with bull's-eye corner blocks. The architrave has a pyramidal moulding in the center flanked by quirked Greek ogees on either side, and has a beaded interior edge. There is chair rail with a small ogee at the bottom, an ogee under the shelf, and a quarter round on top of the shelf. There are wood panel moulds applied to the plaster walls above and below the chair rail. They have a cavetto on the outer edge and a cavetto and fillet on the inner edge. There is a run plaster cornice with a Greek ovolo at the top and a fillet with an undercut cove, a Greek ovolo bed mould, and a plain frieze. Beneath the frieze is an architrave with a Greek ovolo and bead and a moulding at the bottom that flares out. The north and south windows have 12-inch by 14-inch lights in lancet-profile muntins, and have parting beads. There are both spring latches and pivoting catches on the top of the bottom sash. The exterior sills have wrought strap spring catches for the shutters. The window openings are recessed, with one panel below the sill that has a sunk field and a quirked Greek ogee panel mould. There is one panel on each jamb and on the soffit. They are very narrow, and have the same mouldings and panels as the panel beneath the sill. The jamb panels extend all the way down to the floor. The south doorway has a pair of four-panel doors, and the panels match those under the windowsills. The architrave matches the windows and interior doors, but has no corner blocks. The door has slide bolts at the top and bottom of the east door and slide bolts across the center of both doors. The center slide bolts are all brass. The top and bottom slide bolts are set in mortises in the door. The doors are hung on three hinges each, and they have five knuckles and fast joints. The doors are fastened shut, prohibiting further examination of the hardware. There is a pressed-glass knob and an escutcheon that appears to be bronze. Above the doors is a fanlight. The north door is identical to the south doors, but the slide bolts are on the west door, and there is a blind fanlight that is plastered.

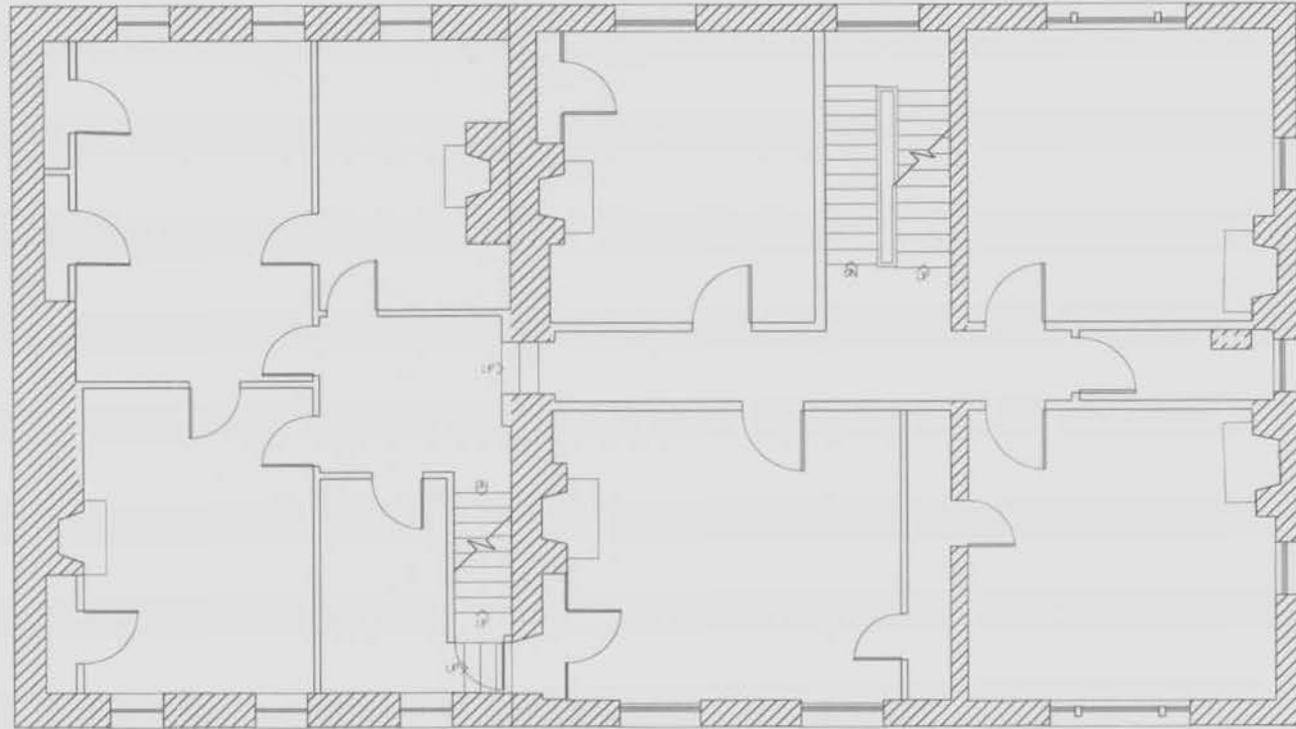
SECOND FLOOR PLAN MEASURED BY KEN SHORT, KAY SMITH, HEATHER BARRETT, NICOLE DIELMAN & TOM RINEHART DRAWN BY KEN SHORT JULY 2002

The second story has a center transverse passage that runs east-west, with two rooms to the south and two rooms and the stair hall to the north. The passage connects to the wing on the west. The wing consists of a center vestibule at the top of the service stairs with a room to the north, two rooms to the west, and a room to the south just west of the service stair. The passage flooring is 4 ¼-inch to 4 ¾-inch pine that runs north-south. The baseboard has a broken field, and there is a short section on the north, west of the stairs that also has the ogee carried around from the stairway. The stairway has a complete baseboard, but the fillet is dropped off. The architrave has a sunk field with ogee moulds on either side and a beaded interior edge. There are bulls-eye corner blocks that align with the symmetrical part of the architrave only, and do not cover the bead. The two south doors and the east door each have three-light transoms. The east door is a typical eight-panel door with cast iron butt hinges labeled "W. H. CARR PATENT PHILADELPHIA," and it had a rim lock on the east side, but only the knob and escutcheon survive. The south door, to the east, is a typical eight-panel door with "CARR" hinges and a Carpenter lock that appears to be original. The south door, to the west is a typical eight-panel door with "CARR" hinges, but the rim lock is missing and it has a 20th-century mortise lock. The west door has six typical panels, "CARR" hinges, and an original Carpenter lock. The north door, to the west, is a typical eight-panel door

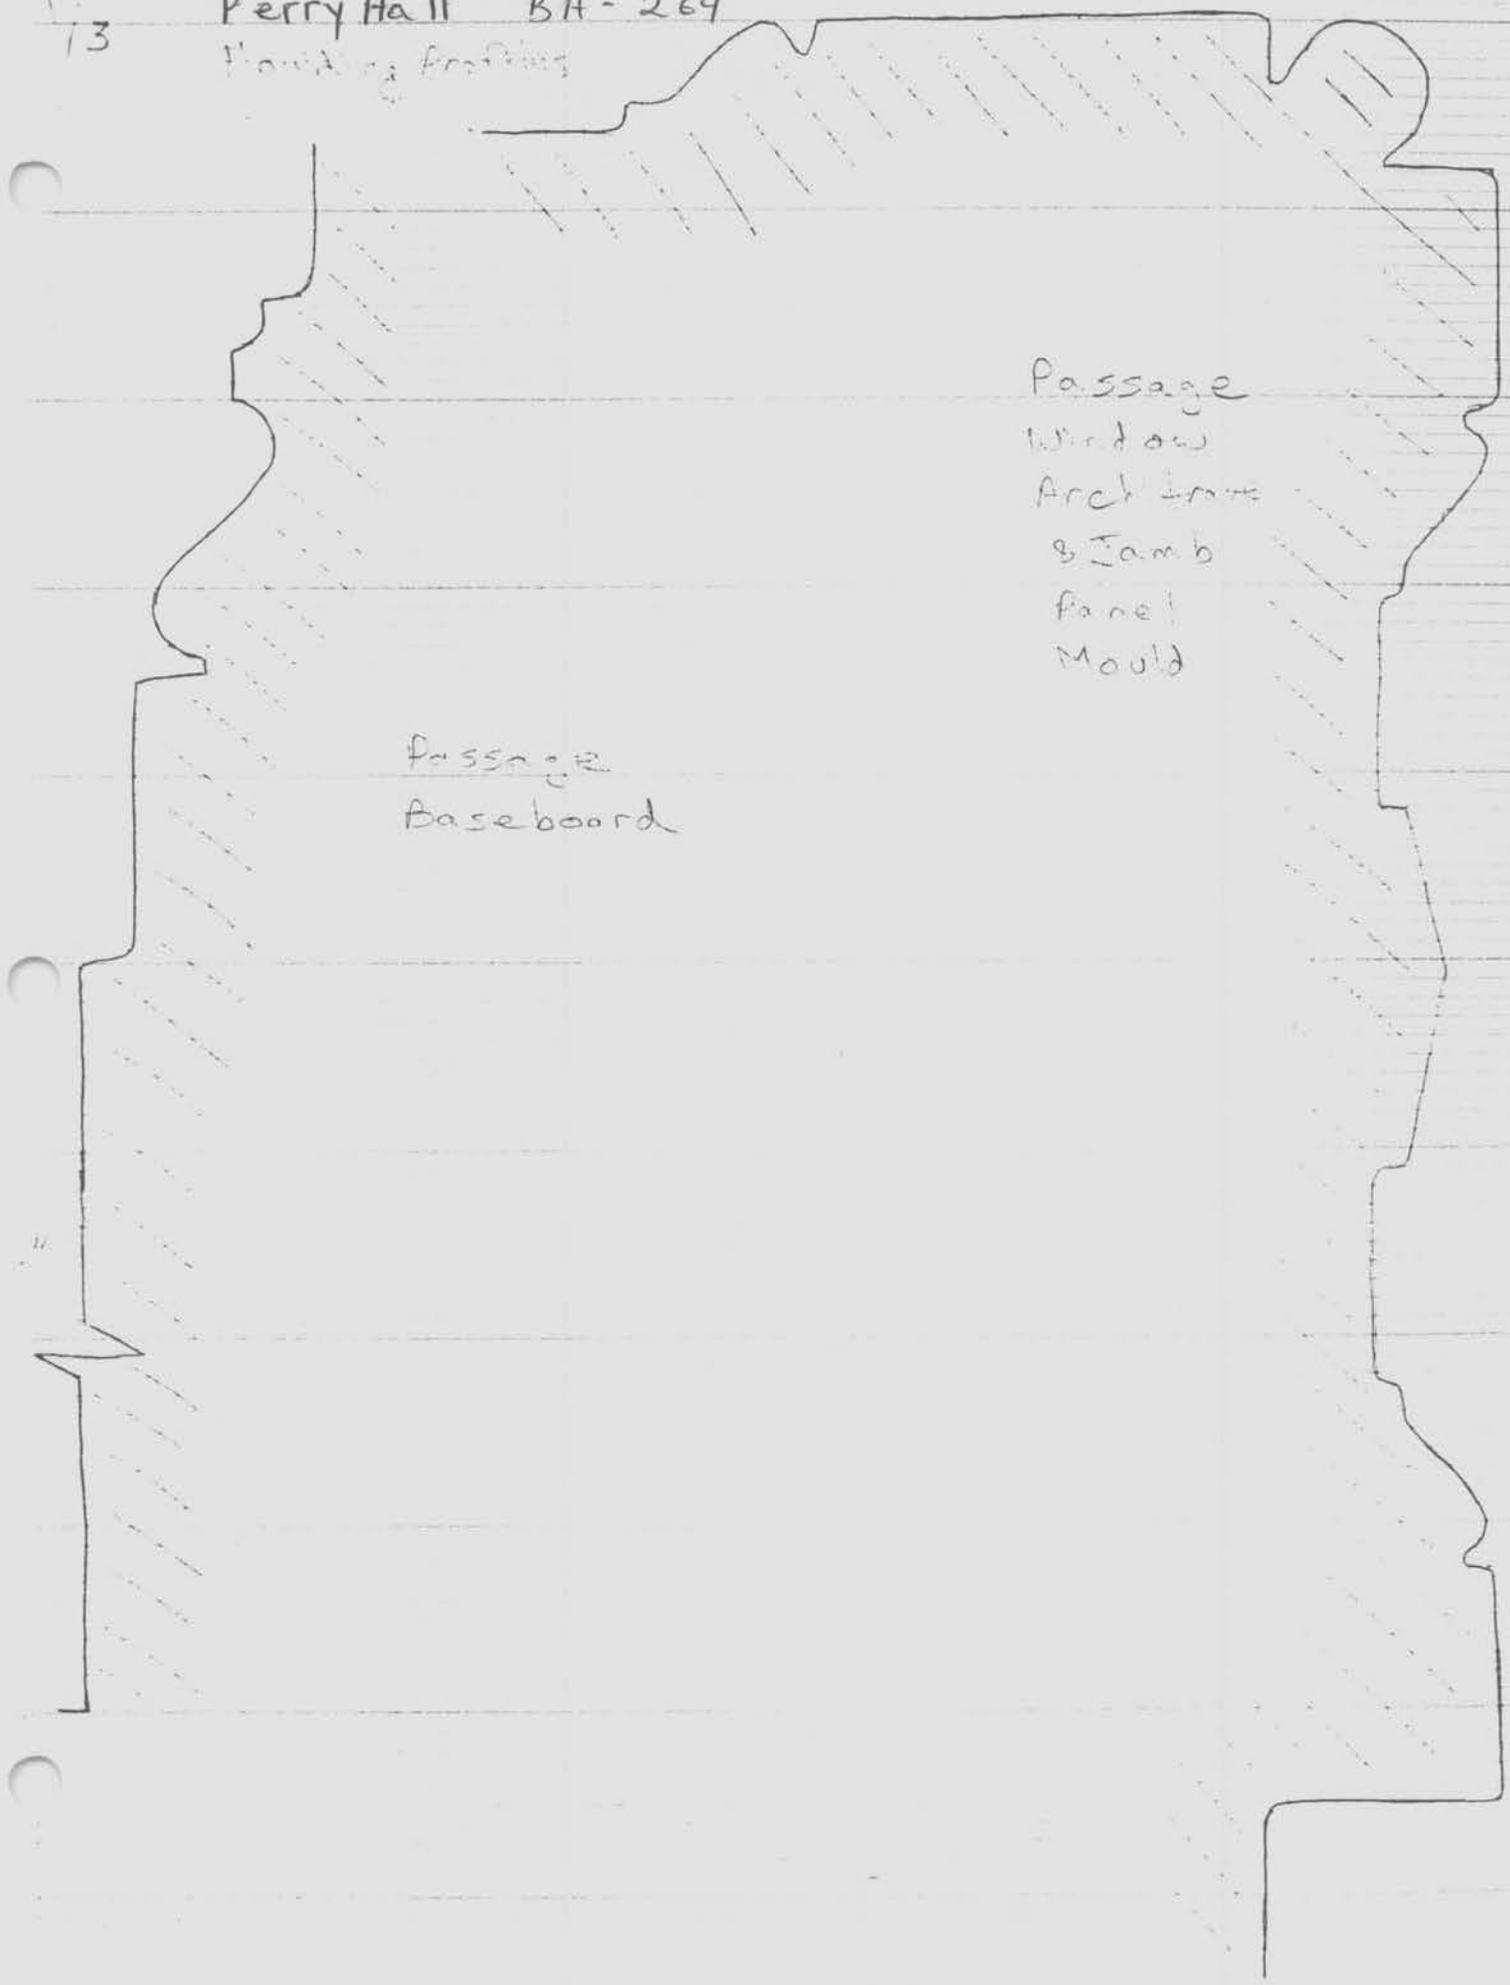
Passage
Window
Architrave
& Jamb
Panel
Mould

Passage
Baseboard

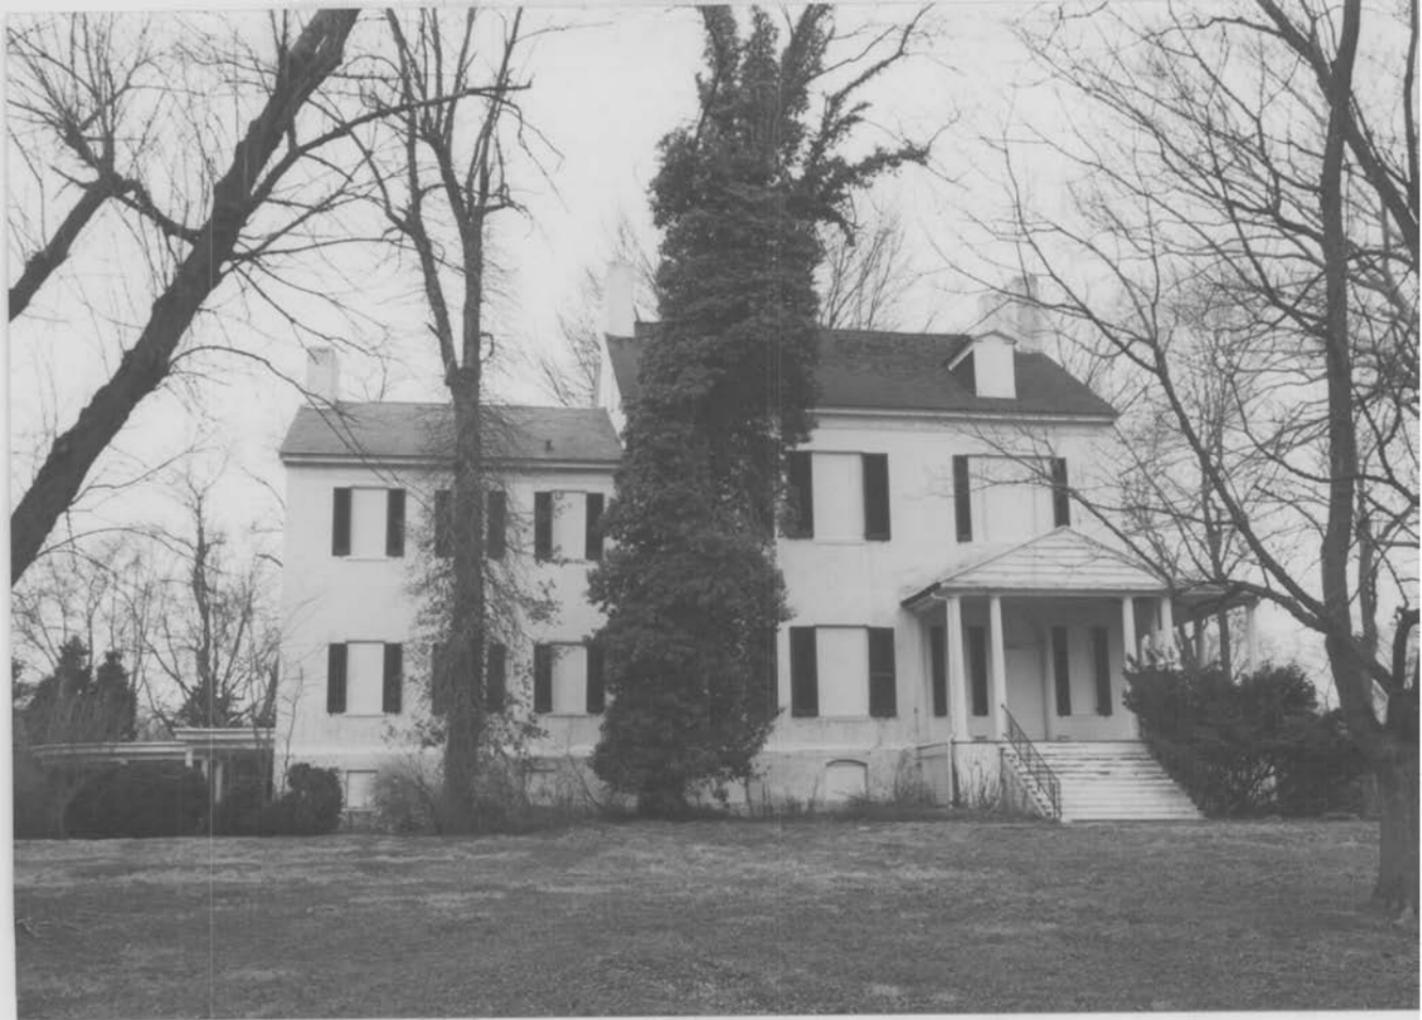
BA-264
Perry Hall
3930 Perry Hall Rd
Balto. Co., MD
Ken Short
Feb 2002
MD SHPO
South elev.
1/11

The south elevation of the main block has segmentally-arched openings in the west and center bays of the basement and a porch in the east bay. There is a water table that is covered in stucco. The first story has two window openings that have stone lug sills with washes, bull nose frames, and blinds hung on strap hinges with T-plates screwed to the frames. The east bay has a doorway with a fanlight. There is a limestone slip sill with wash. There is one panel on each jamb, and one on the soffit. The panels have sunken fields and quirked Greek ovolo panel moulds. The transom bar also has a quirked Greek ovolo, and has a broken field below it. The doors had blinds, and one T-plate for the hinge survives, as well as three mortises for other hinges. There is a roll moulding on the outer corner edge of the doorframe. The door is flanked on each side by a window with typical sill, frame, and blinds. The porch has a rotting wood deck and stairs, beaded-edge-and-center board soffit, and four Greek Doric wood columns. The porch has a gable roof with a north-south ridge, corrugated metal, and weatherboards in the tympanum. The second story has window openings with typical sills, frames, and blinds in the west and center bays. The east bay has a tripartite window with a typical sill, frame, and blinds. The wood box cornice has a Greek ovolo and cavetto bed mould and a plain frieze. There are dormers over the east and west bays. They are gabled, with a north-south ridge. There is an interior brick chimney on both the east and west gable ends; the east chimney has an extra chimney flue in the center of the west side, making it a “T” in plan.

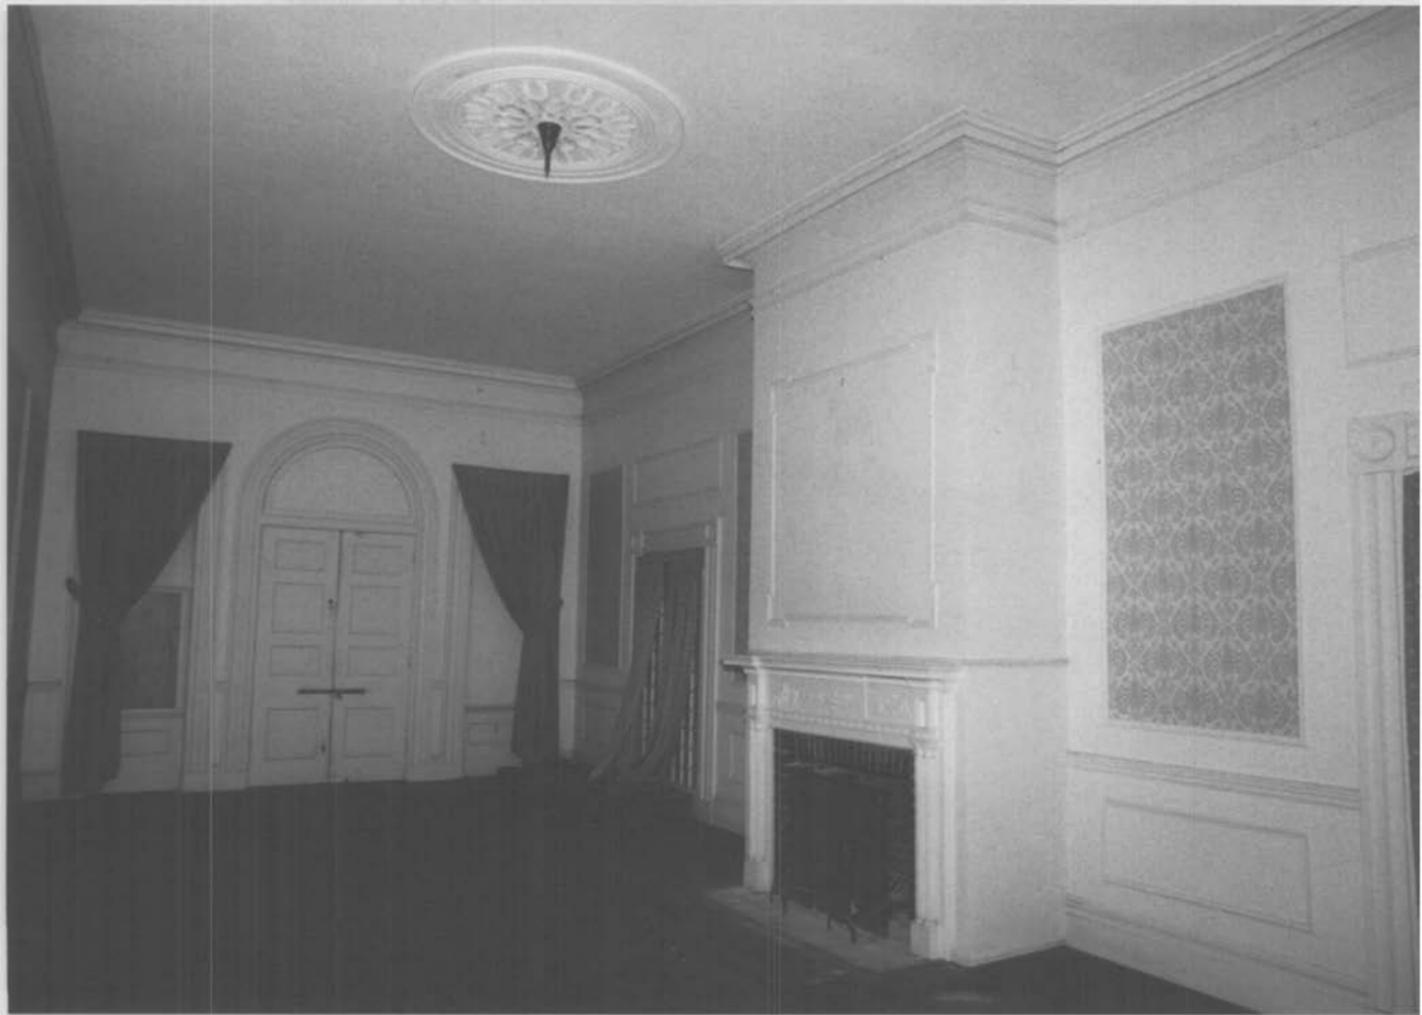
5/11

Passage - vw. northeast

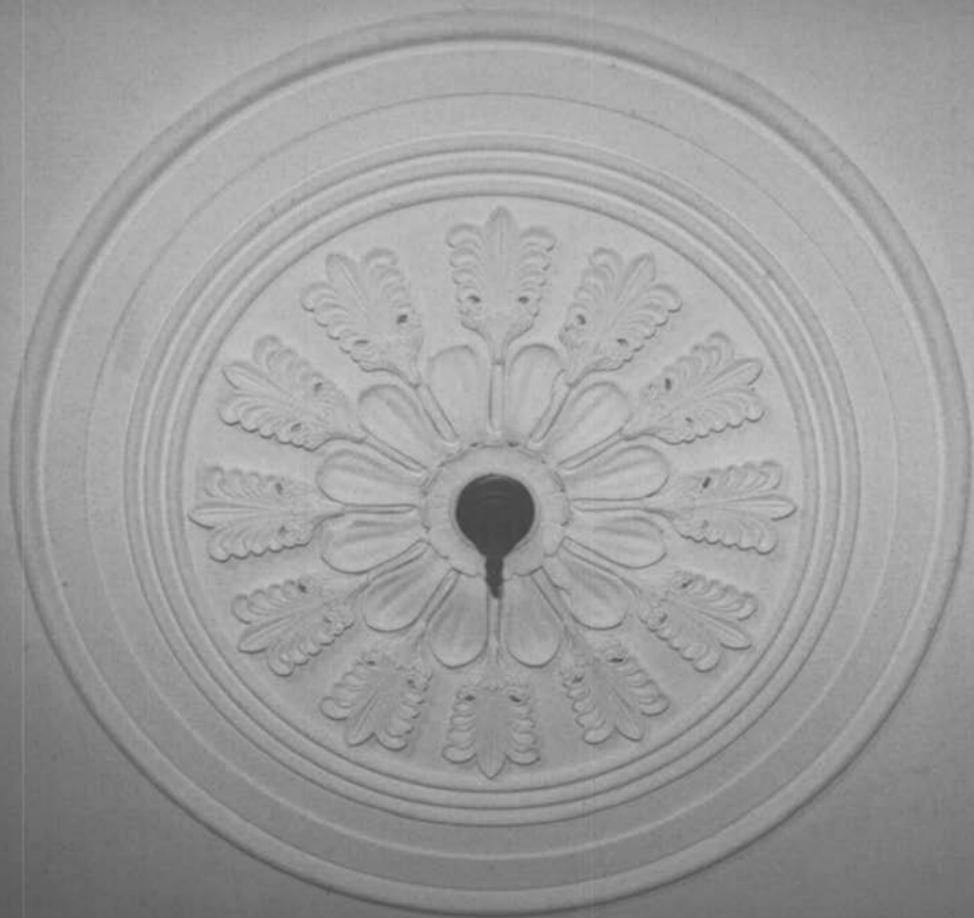
6/11

Passage Ceiling medallion

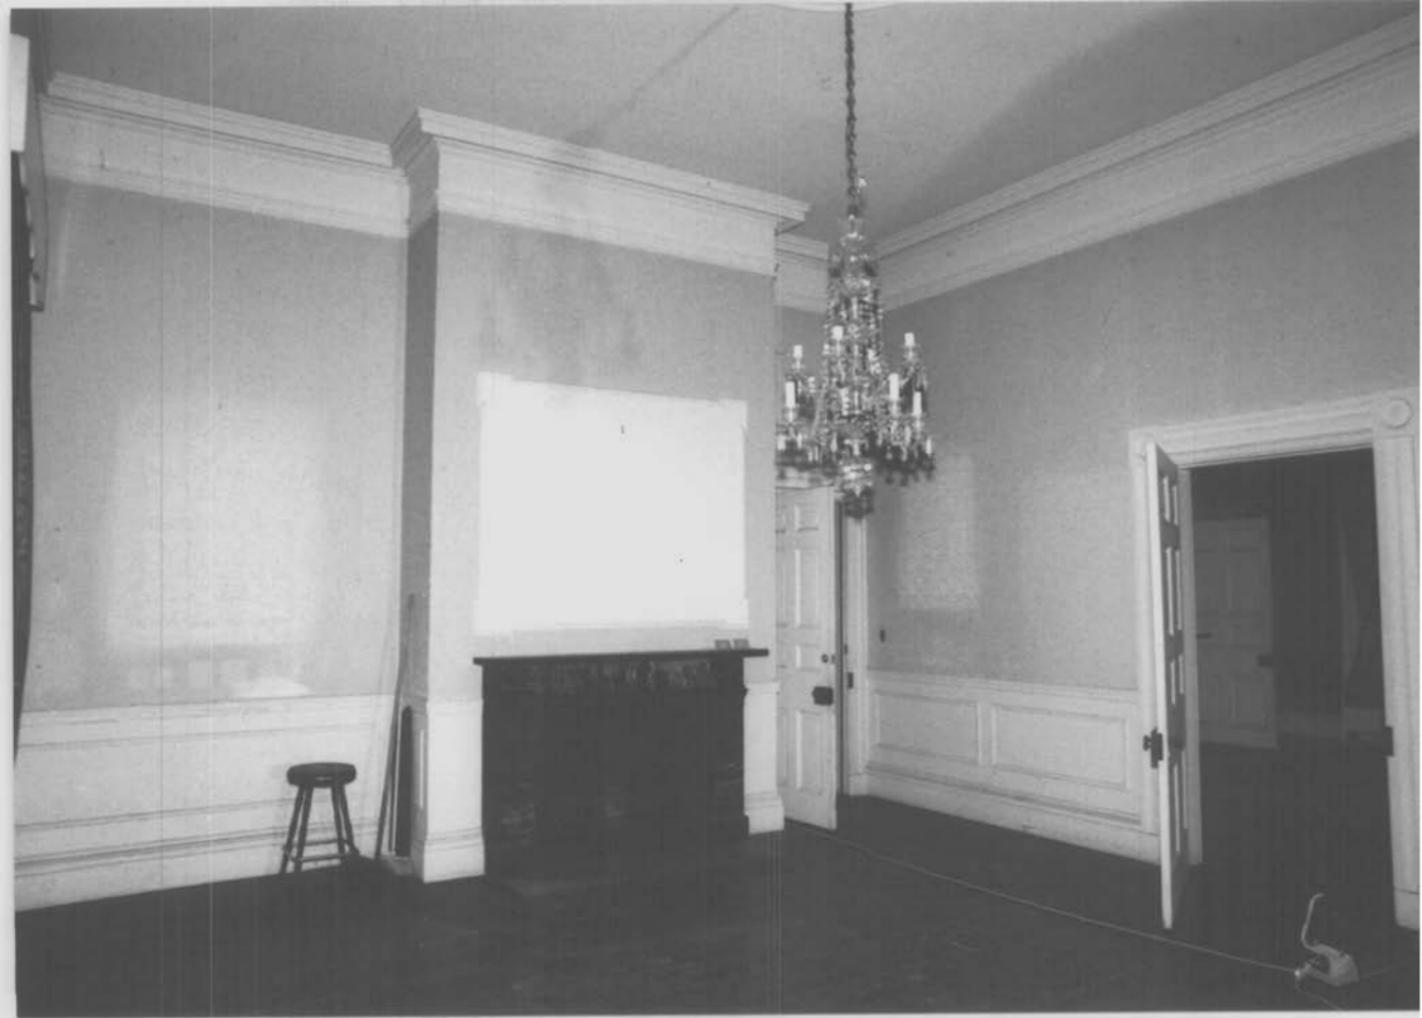
7/11

South rm, vw. northwest

The south room floor, baseboard, architrave, chair rail, and cornice are identical to that in the passage. The wall panel moulds are also the same but are found only below the chair rail. The windows are twelve-over-twelve double hung sash with 12-inch by 14-inch lights. The sash are mortised-and-tenoned-and-pegged, have lancet-profile muntins, parting beads, and pulleys for sash weights. They have plain soffits and jambs. The windows are recessed, with one typical panel below the sill. There is a plaster ceiling medallion with acanthus leaves in the center, three beads, a broken field, and a torus at the outer edge. On the west elevation is a fireplace with a marble hearth and splayed jambs of soapstone. Behind the soapstone linings are splayed brick jambs constructed of a pressed brick with narrow joints. The firebox appears to have been wider than the mantel. The mantel is a dark gray marble with light gray and tan veining, and has plain pilaster strips with Greek ogee capitals and a plain frieze. To the north of the fireplace is a doorway that leads to the service stairs. It is a typical eight-panel door with a Carpenter lock that replaces a mortise lock, and "CLARK" hinges. On the north elevation is a door to the north room that also is a typical eight-panel door with a Carpenter lock replacing a mortise lock, and it has "CLARK" hinges.

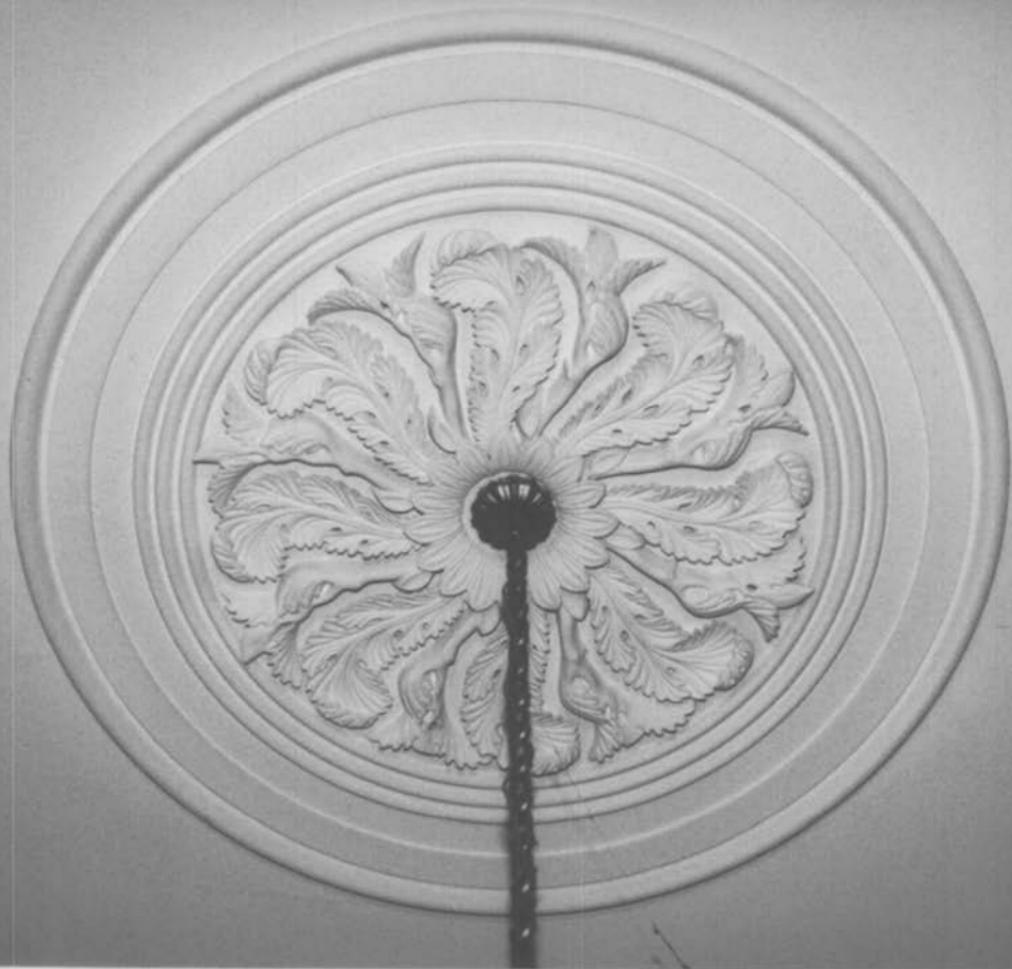
9/11

South rm ceiling medallion

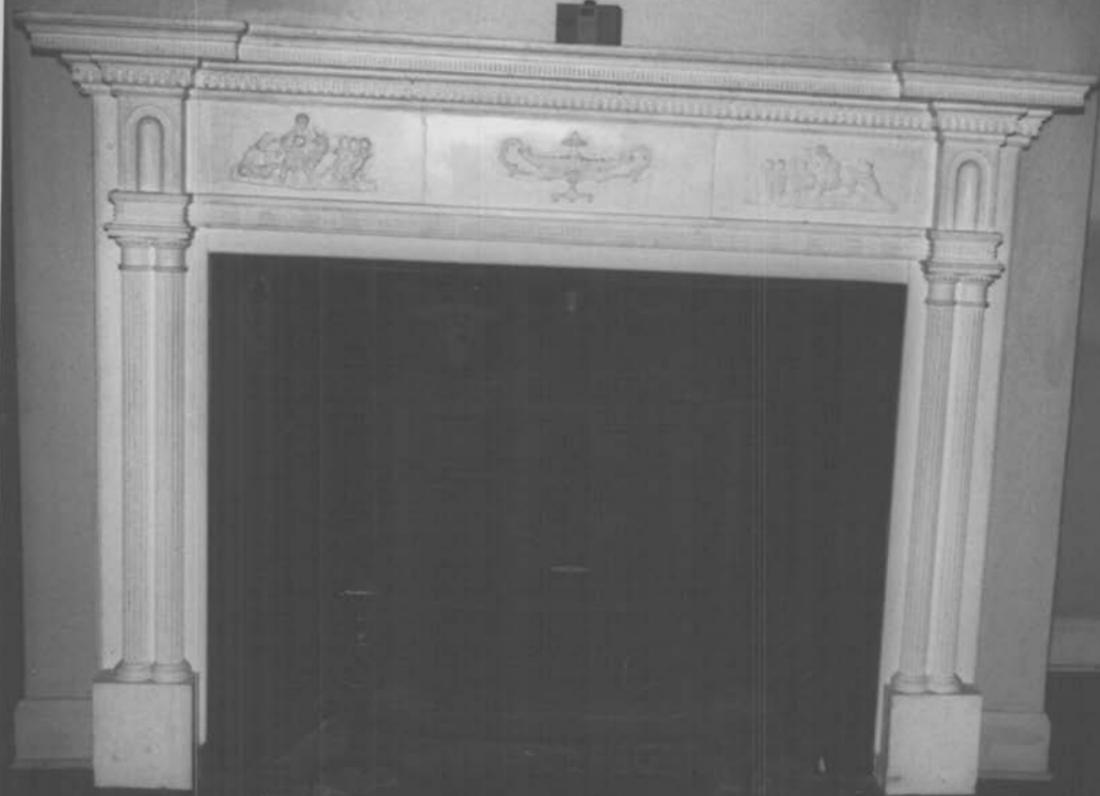
10/11

Wing north room mantel

The north wing room floor is raised slightly above the level of the main block, and is 3 ½-inch-wide pine that runs north-south. The baseboard has a broken field. The window architrave has a beaded interior edge and is side cut. The windows are six-over-six double-hung sash that are not mortised-and-tenoned-and-pegged and are hung on metal tube springs. The muntins have an ovolo profile and are narrow. The sash appears to be 20th century replacements. The door architrave varies, having all had crossettes added, with a quirked ogee back band and a beaded interior edge. The east door architrave is mitered and the soffit and each jamb have one typical panel. The north door has nine lights over a cross buck design, and the architrave has a broken field. The architrave is side cut. The south door, to the east, has six panels that are identical to the eight-panel doors. There is a large iron plate rim lock that is not original, as there is a ghost of a larger rim lock. The door is hung on three stamped plate butt hinges with loose joints. To the west of this door is another door like it, with six panels, and it has thin plywood added to one side of the door. The hinges are the same as the door to the east of it, and the Carpenter lock could be original. There is a fireplace on the east elevation with a wood mantel that is identical to that in the passage. It is nailed to the wall with wire nails. The mantel is much wider than the hearth, and the hearth appears to be laid mortar. The firebox has splayed brick jambs of irregular pressed brick with narrow joints. The ceiling has one wide beam in the center that runs north-south, and two smaller beams that run east-west. Above these beams are wood boards with "V" grooves at the edges, and these boards also run east-west.
