Maryland Inventory of Historic Properties number: BA-2703

Name: 3069/ Rt. 128 over Mc Gill Run

MARYLAND INVENTORY OF HISTORIC BRIDGES  
HISTORIC BRIDGE INVENTORY  
MARYLAND STATE HIGHWAY ADMINISTRATION/  
MARYLAND HISTORICAL TRUST

SHA Bridge No. 3069 Bridge name Route 128 over McGill Run

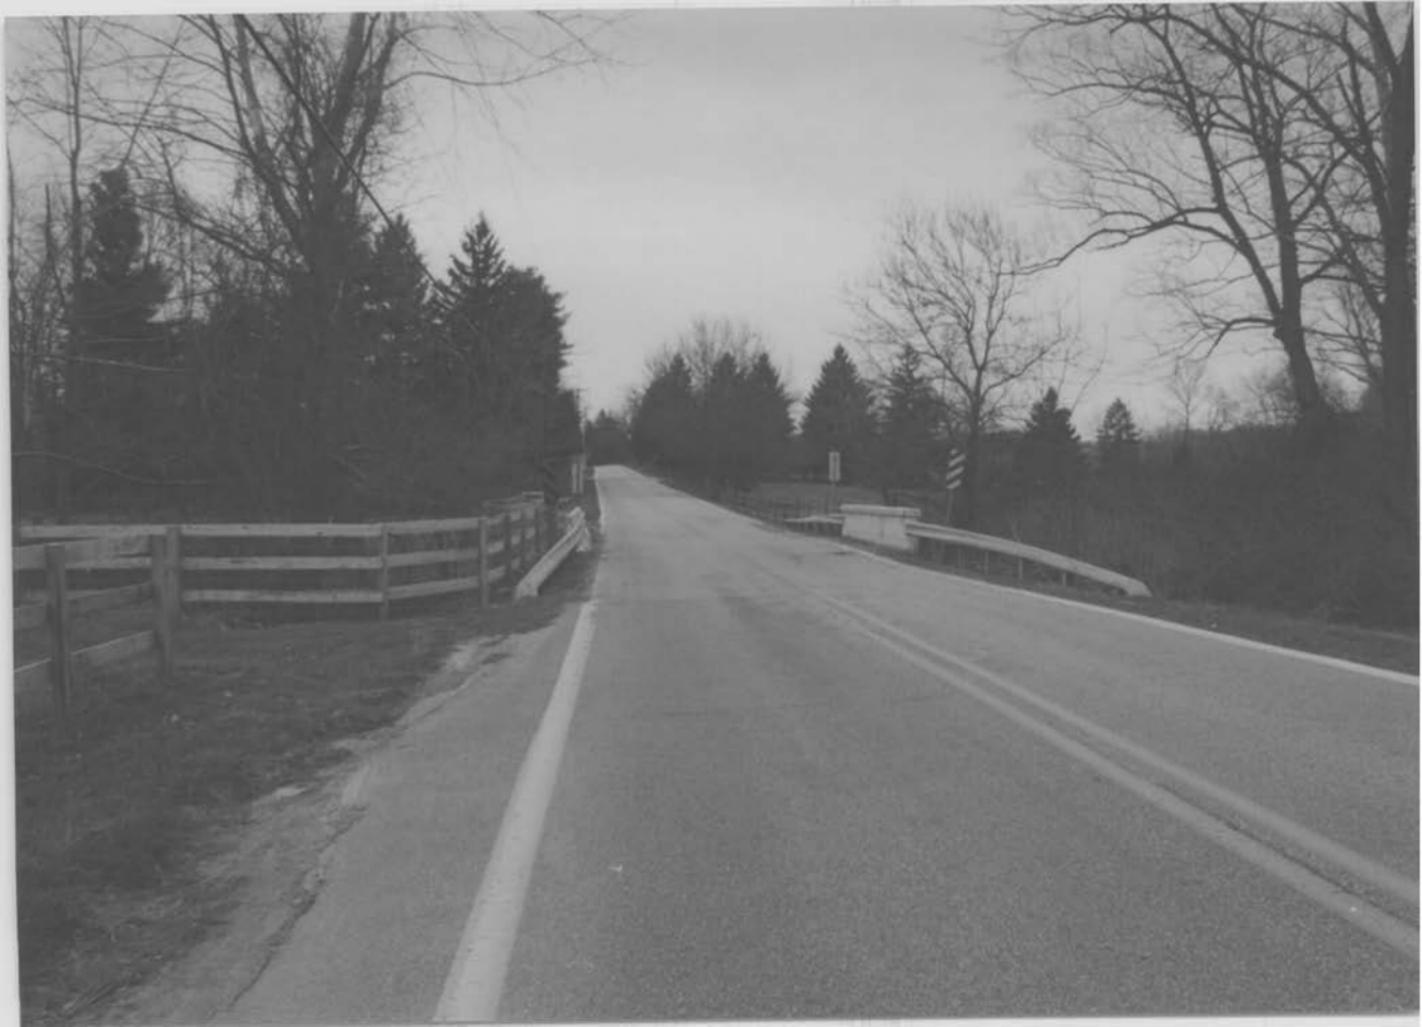
Number

Description SOUTH APPROACH LOOKING  
NORTHEAST

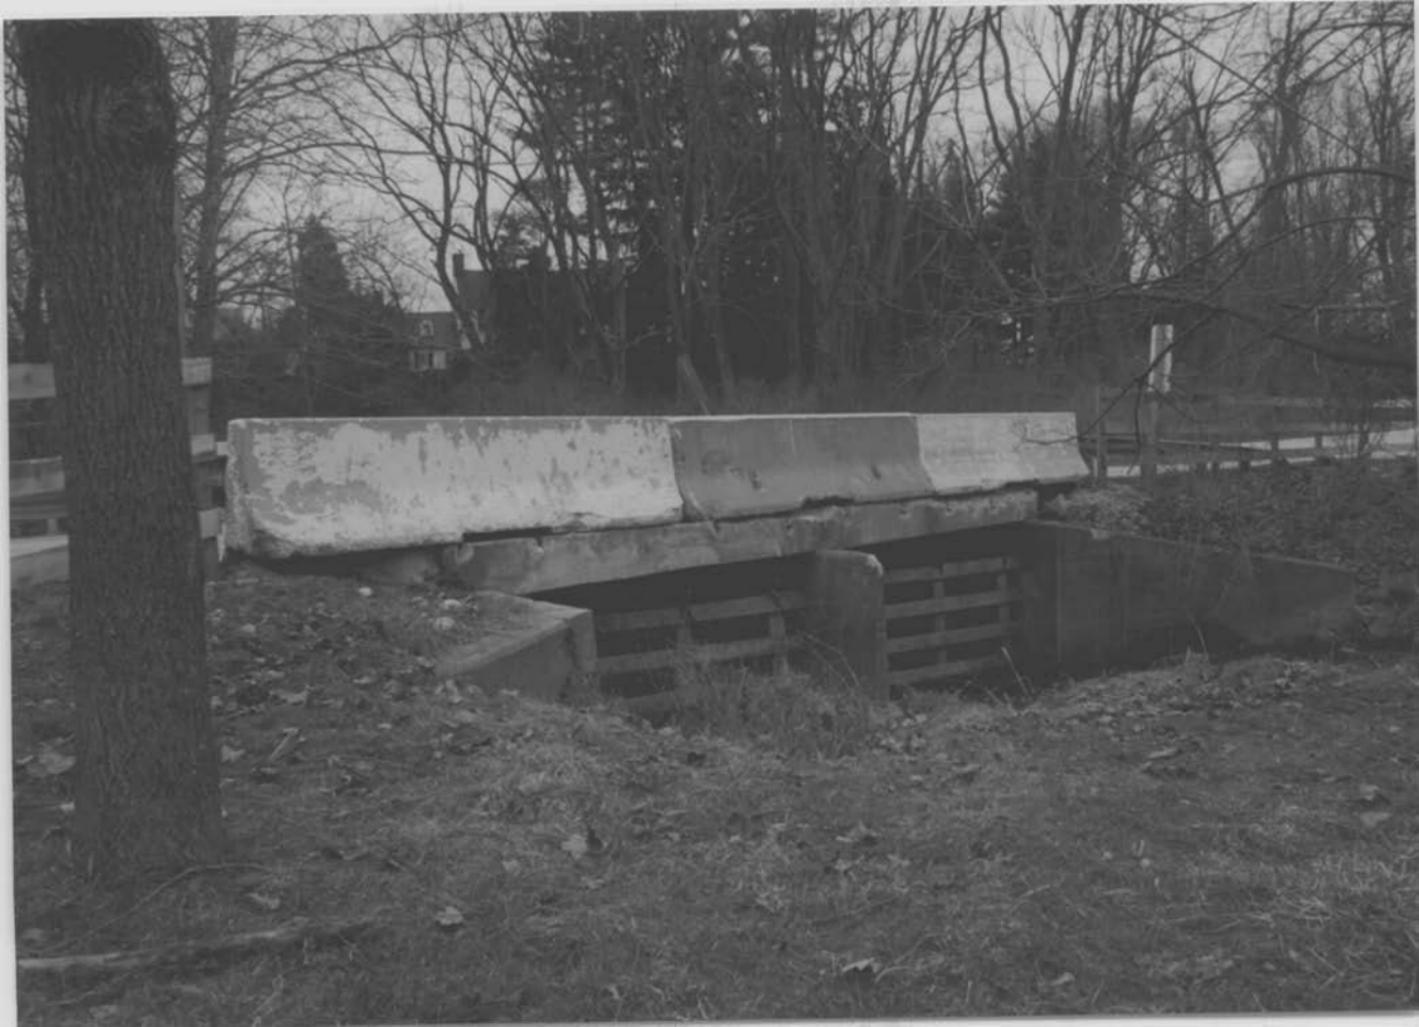
Number 25 of 34

The west parapet has been replaced with a jersey barrier.

Description WEST ELEVATION LOOKING  
SOUTH EAST

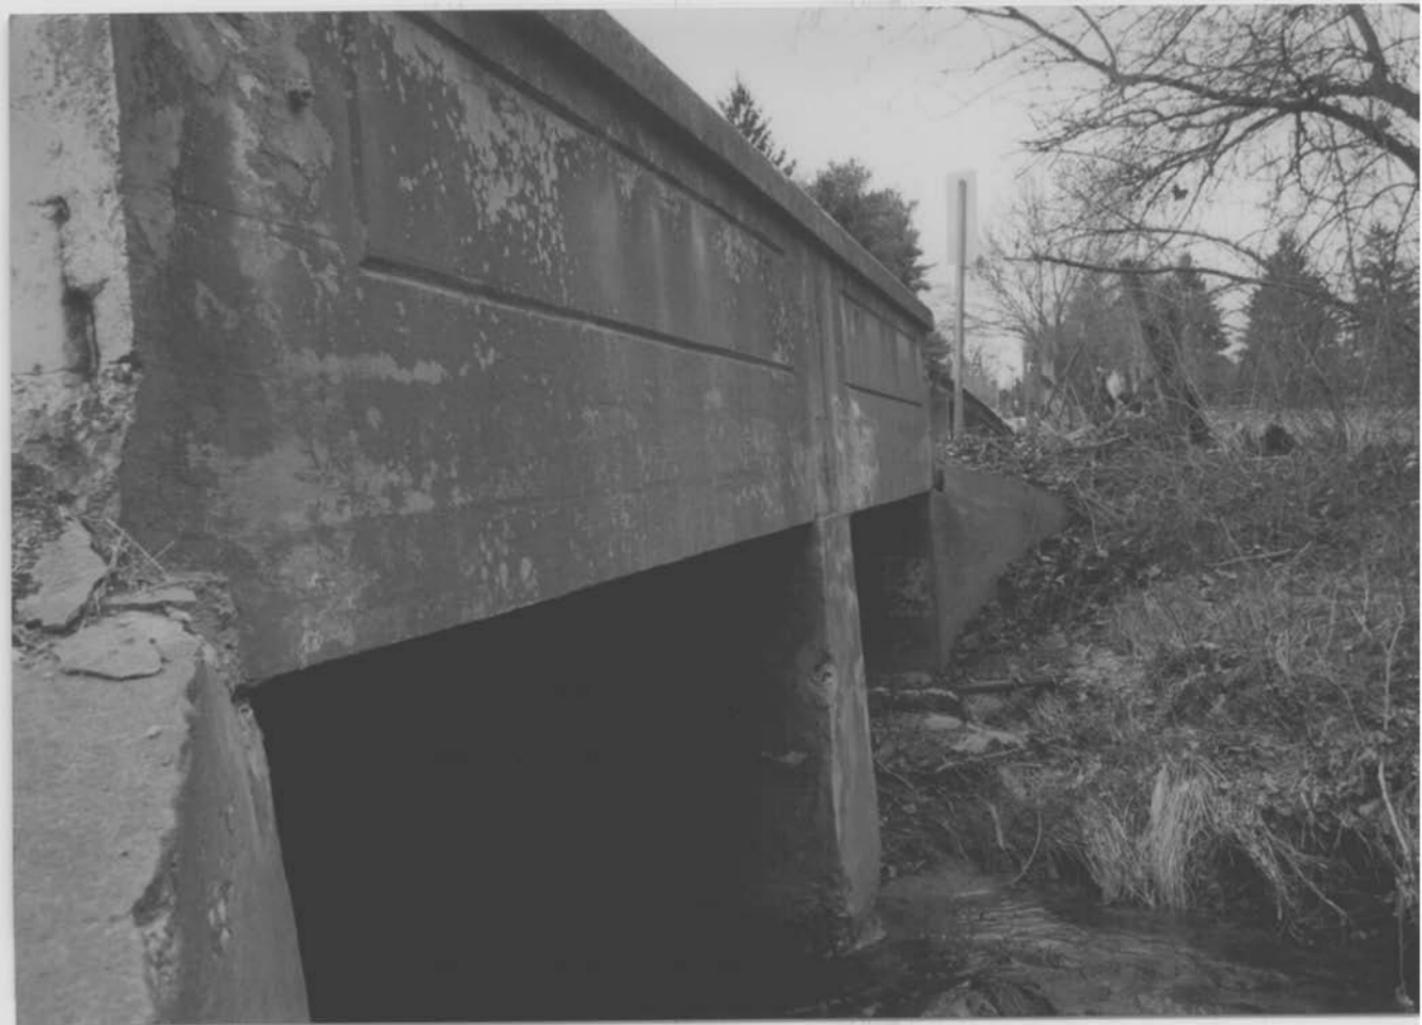
Number 3 26 of 32 4

Bridge 3069 is a two span concrete slab on concrete abutments, with a solid shaft concrete pier. It was built in 1929. Each span measures 12 feet and the bridge measures 26.0 feet in total length. The bridge has solid parapets integral to the deck, although the west has been replaced by a jersey barrier. The concrete wingwalls flare back approximately 45 degrees. The bridge has a clear roadway width of 24 feet and the crossing has a 71 degrees skew. The roadway supports two lanes of traffic with a 1985 ADT of 1300 vehicles per day. The design is similar to the state standard design of 1924.

Description EAST ELEVATION LOOKING  
NORTH

In 1990 repairs were made to the center pier to correct severe spalling and undermining. The pier was under pinned at this time.

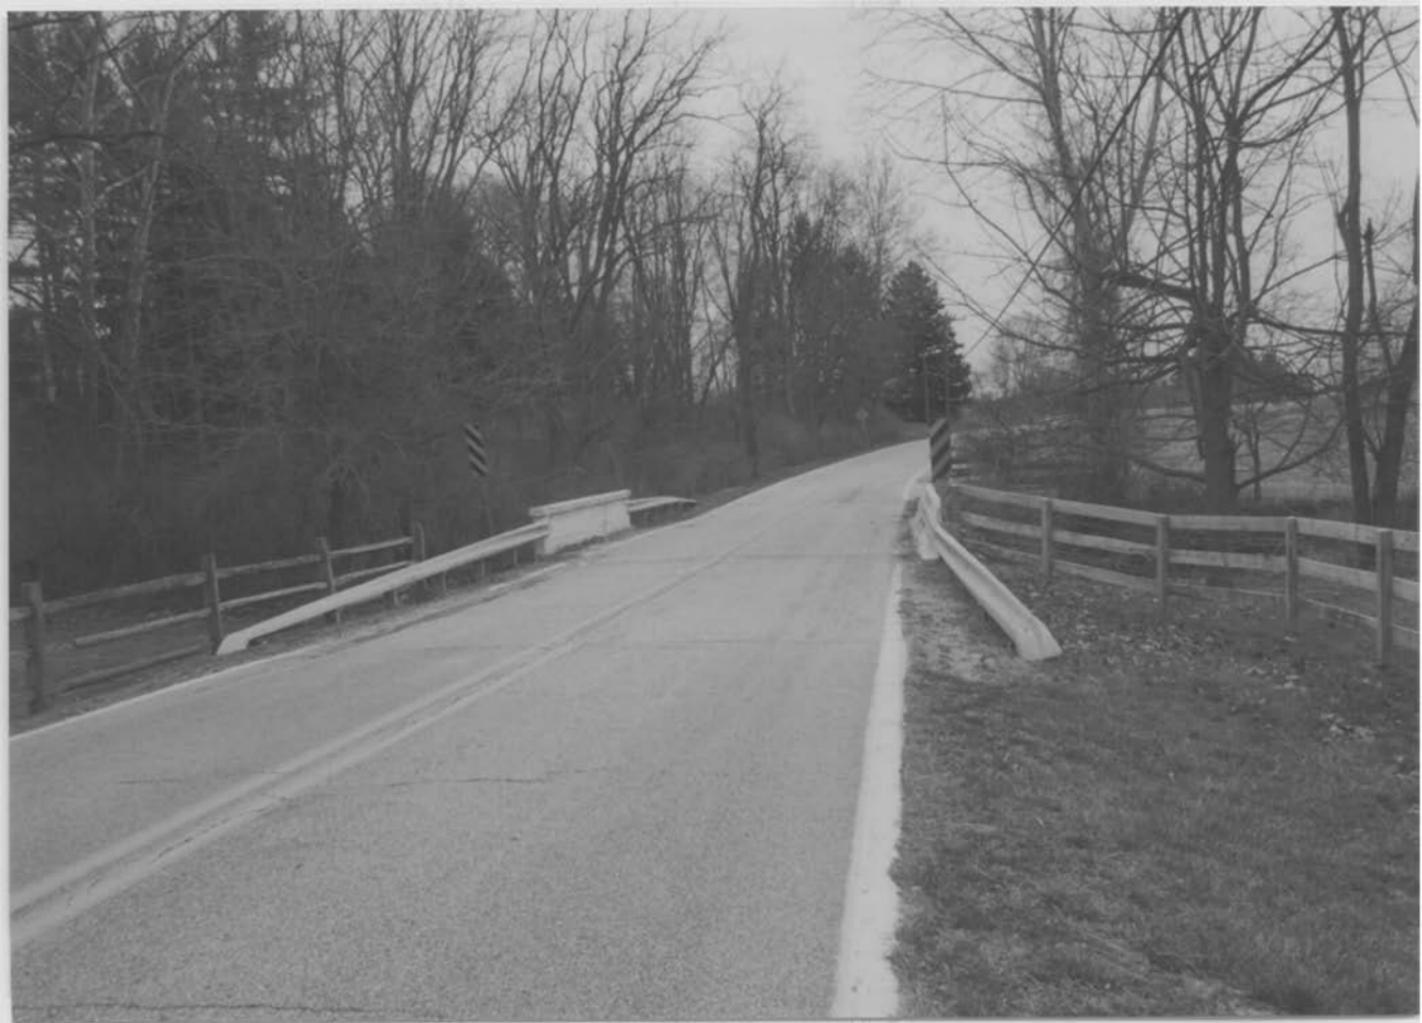
Number 4 of 32 4

Description NORTH APPROACH LOOKING  
SOUTHWEST
