BA-2807
McCormick-Holt Park
McCormick Avenue
Overlea
Private
c. 1895-1910, c. 1930s

Maryland Inventory of Historic Properties Form

historic McCormick-Holt Farm
 other McCormick-Holt Park

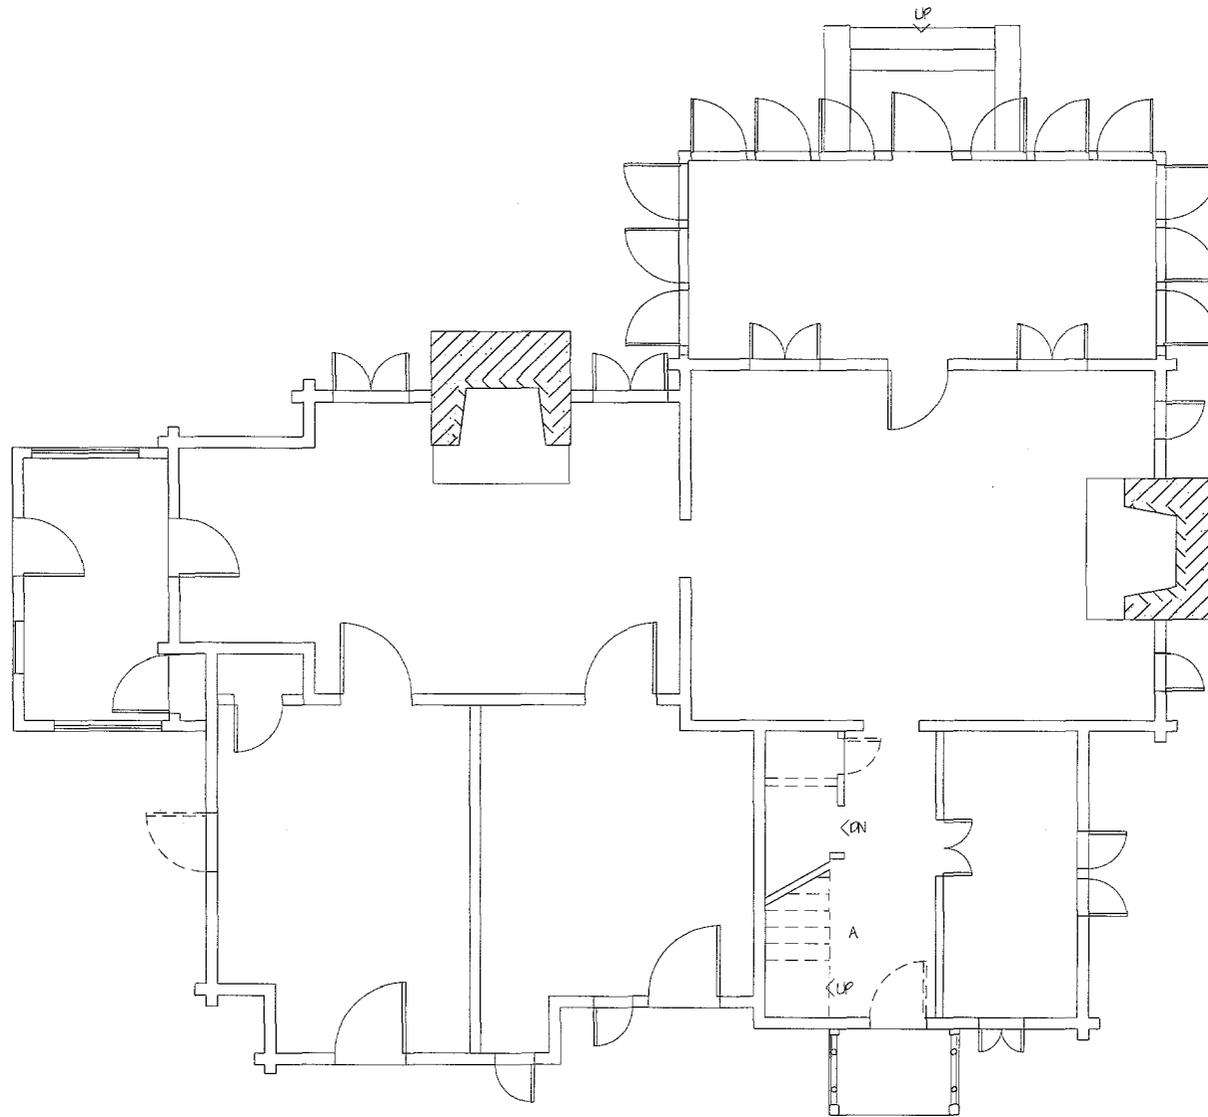
BA-2807 MCCORMICK-HOLT PARK MARCHLOTTE HOUSE 104 MCCORMICK AVENUE

NOTES
 A DOTTED IN ELEMENTS ARE RECONSTRUCTED FROM FIRE DAMAGED MATERIAL AND ARE APPROXIMATE. CELLAR STAIRS NOT ACCESSIBLE.

FIRST FLOOR PLAN MEASURED AND DRAWN BY KEN SHORT JANUARY 2001

The cabin at 104 McCormick Avenue, also known as "Marcharlotte House" faces north and is burned on the north side. It is a one and one-half story structure with an irregular plan. It is constructed of hewn logs that are exposed and have v-notched corners with projecting ends, and the corners are toe nailed with wire nails. The logs are set on a concrete foundation. On the north elevation, the western section projects forward, and has a boarded-up window to the west and a boarded-up door to the east. Covering the door is a one-story, gabled roof portico of Adirondack style with round stick work and a bench on each side of the porch, under the roof. The upper story here has a gable with three openings, and has heavy fire damage. The center section of the north elevation is slightly recessed, is one story tall with a shed roof, and has a new door to the west and a boarded-up window to the east. The eastern section projects to the north and also has a shed roof. There is a boarded-up window to the west and a boarded-up door to the east in this section. Behind the center and east sections are gable roofs with two dormers.

On the west elevation, the north section has a boarded-up window in the first story and vinyl siding and two dormers on the second story. One of the dormers retains its four-light sash. The ridge on the gable roof here runs north-south. The center section has an exterior rubble stone chimney in the center with a boarded-up window to each side of the first story. The upper story has a gable end with vinyl siding and a window on each side of the chimney. One of these windows retains a four-light casement. The south section is an enclosed porch with vinyl siding and three two-light casements. The western section of the south elevation is an enclosed porch with a center doorway reached by three concrete steps set between stone cheek walls. There are three two-light casements on each side of the doorway. This section has a gable roof with an east-west ridge and two windows. On the east section, is an exterior rubble stone chimney in the center, with a cellar bulkhead to the west and a three-light cellar sash to the east. The first story has a boarded-up window to each side of the chimney. There is a gable roof with an east-west ridge, and two dormers, one of which has a four-light casement. The east elevation has an enclosed porch with a stone foundation under most of it, and a brick foundation on the north end where the porch was extended. There are two fixed, two-light sash on the north and south elevations of the porch. The north bay of the east elevation has a four-light sash and the south bay has a door with four lights above three lying panels. Above the porch is a gable-in-gable with a window opening. The north section of the east elevation has

a shed roof which slopes down to the north, and there is an altered casement window in the east end of the roof.

The southeast room walls are exposed log and the floor is random-width boards that run east-west. The second story joists are exposed, and are dimensional 2 by 6's. On the south elevation is a brick fireplace with a firebox of firebrick, a quarry tile hearth, and a brick mantel with a wood shelf. On either side of the fireplace are paired eight-light casements. The north elevation has two doors leading to a large public rest room addition. On the east elevation is a door with six lights over two panels that leads to an enclosed porch addition on the east end.

The southwest room has the same walls and flooring as found in the southeast room, but the joists above are $\frac{3}{4}$ -round logs. The west elevation has a fireplace with a rubble stone mantel, shelf and hearth, and a firebox of firebrick. Some of the stones used in the fireplace have small brass tags identifying the Maryland County from which they came. The fireplace is flanked by a six-light casement on each side. The south elevation has a central doorway that has nine lights beneath a fanlight with Gothic muntins, and has a single panel beneath the glazing. The door is flanked by a pair of eight-light casements on each side. The north elevation has a doorway into the stair hall, but this has been burned out. The stairway has been completely destroyed by the fire, as has most of the second story, rendering it inaccessible.

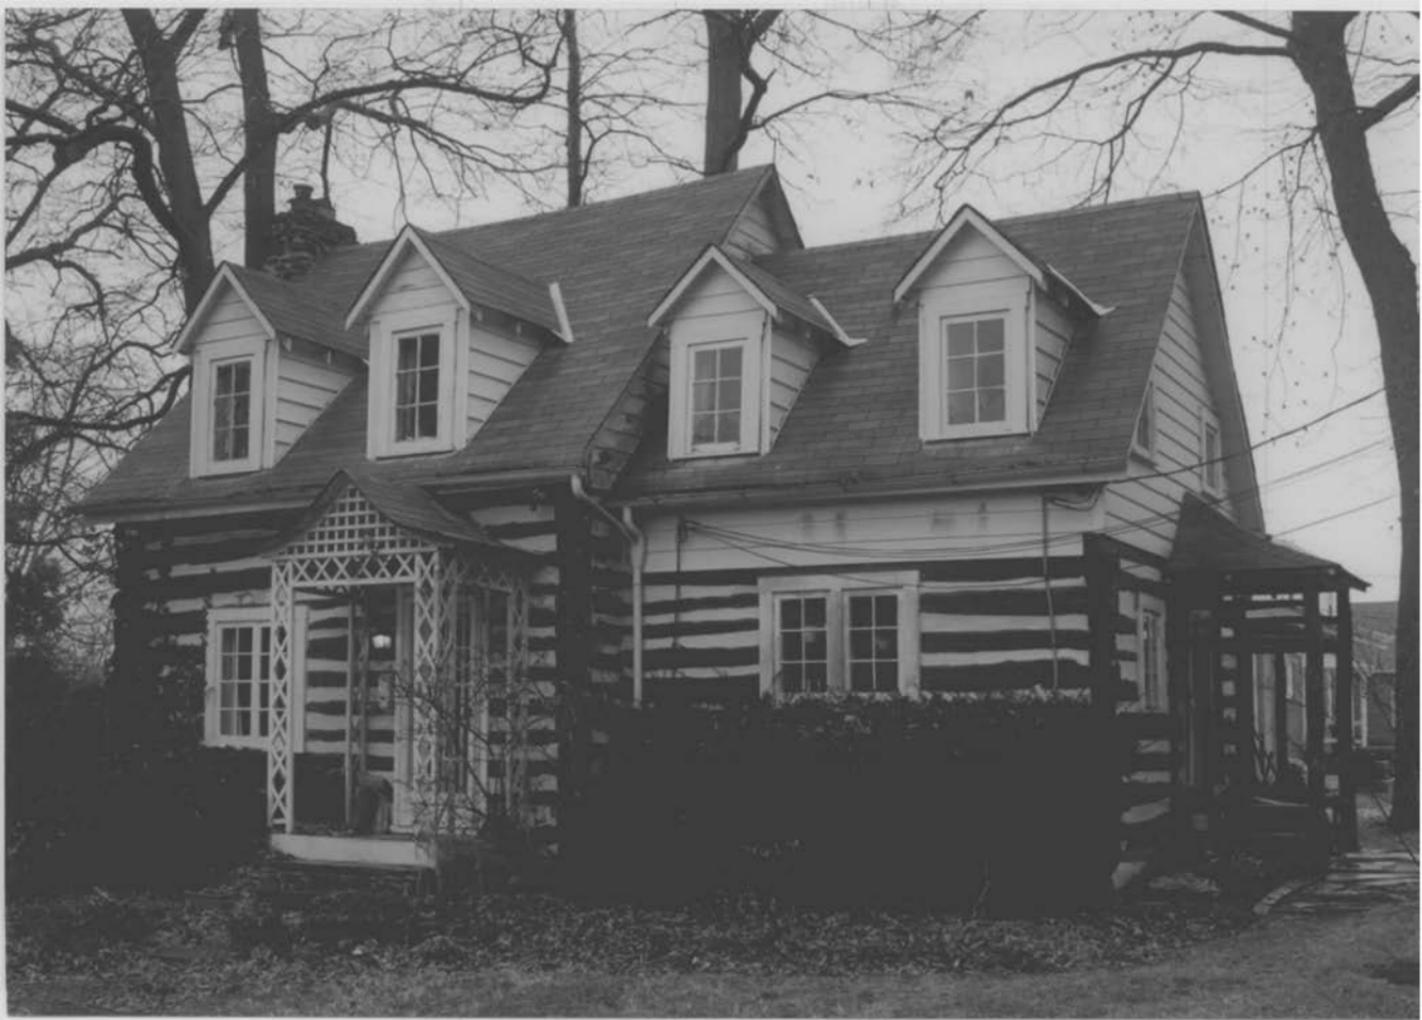
1/18

100 McCormick, southeast & northeast elevs

The building at 100 McCormick Avenue is a one and one half story cabin with a concrete foundation, exposed log walls with V-notch corners, and a gable roof of asphalt shingles with a northeast-southwest ridge. The main block of the house faces southeast and is two bays wide. The first story of the southeast elevation has a pair of eight-light casements to the south and a door with 15 lights to the east. The door has a porch with a pagoda roof and a trellis. The upper story has two gable roof dormers with six-light casements. There is a recessed wing on the northeast elevation that has a lower ridge. The southeast elevation of this wing has a pair of six-light casements on the first story and two gable roof dormers with six-light casements on the upper story. The northeast elevation of the wing is two bays. The first story has a pair of three-light casements to the east end a door with four lights over three panels to the north. This door has a porch with round log posts and railings and a hipped pagoda roof. The gable end has two four-light casements windows.

The southwest elevation has an exterior rubble stone chimney in the center with a 10-light sash to each side and a concave shed roof above each window. The northwest elevation has a pair of six-light casements in the center of the first story and two dormers that match those on the southeast elevation. The wing has no openings or dormers on this elevation. The interior of this building was not accessible.

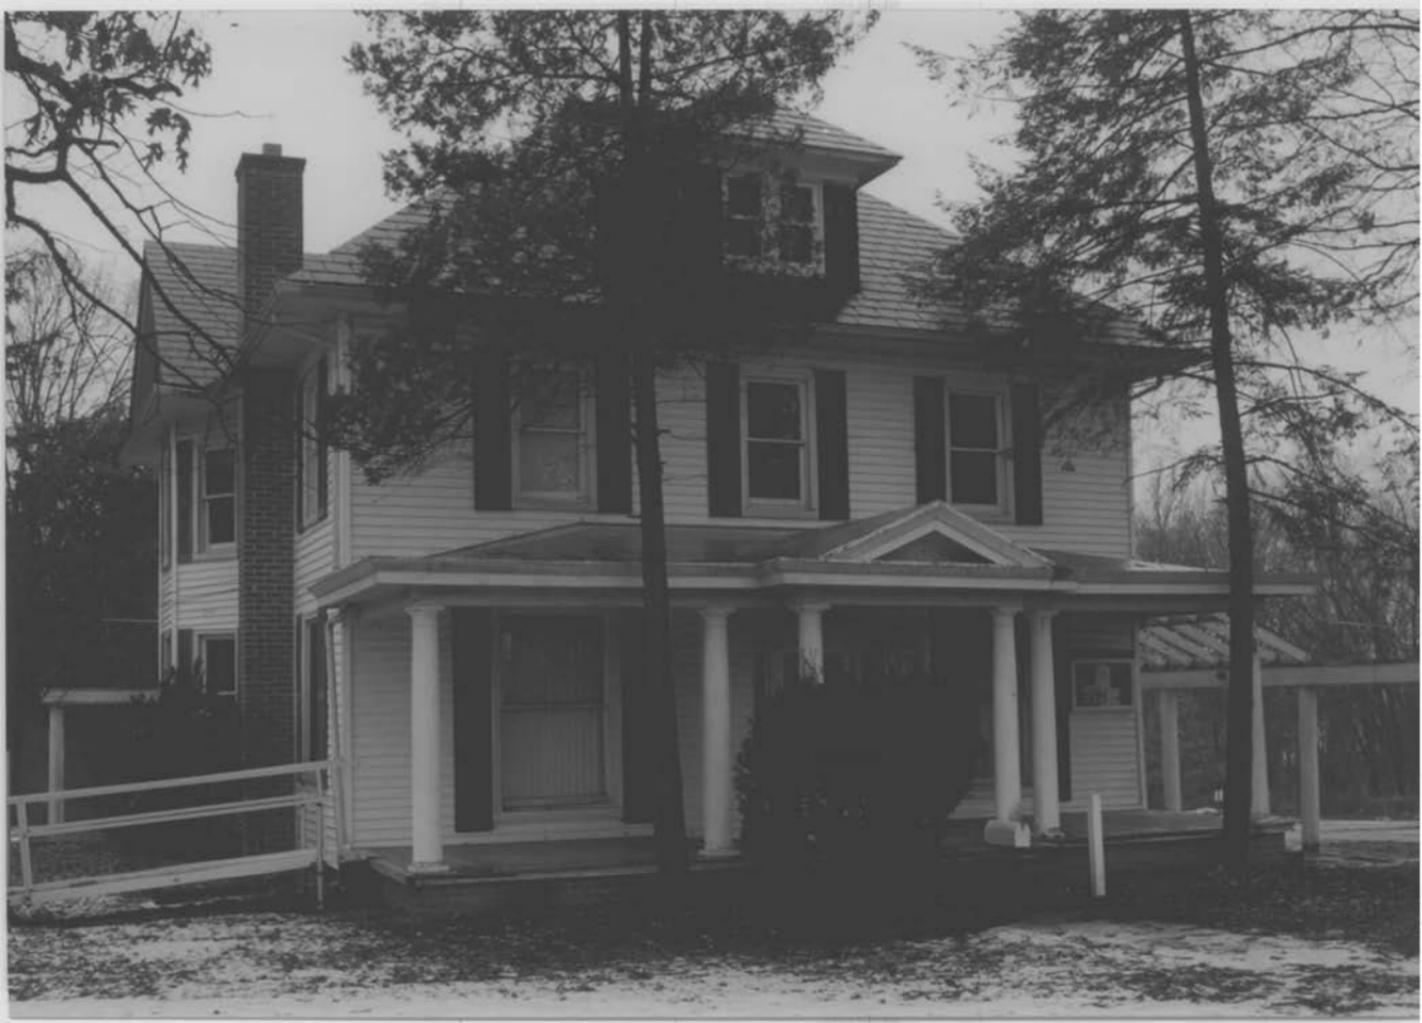
2/18

102 McCormick, North elev.

The building at 102 McCormick Avenue, commonly known as the "White House," faces north, and is a 2 ½-story, three-bay by three-bay square house with a parged foundation, aluminum siding, and a hip roof that is flat in the center and is covered with slate. On the north elevation, the first story has a projecting center bay that contains a door with one light of beveled glass and a dentil moulding below the light. The sidelights also have one light of beveled glass with a dentil moulding below it, and there are pilaster strips between the sidelights and door that have three flutes each. The transom has one beveled light and there are dentils on the transom bar. There is a large one-over-one sash on each side of the doorway. There is a one-story, three-bay hip roof porch with a brick foundation, a wood deck that projects in the center, and six wood Doric columns. The porch has new aluminum soffit and the center bay is pedimented. The second story has three one-over-one sash and the room has a hip roof dormer with slate on the sides and a pair of one-over-one sash.

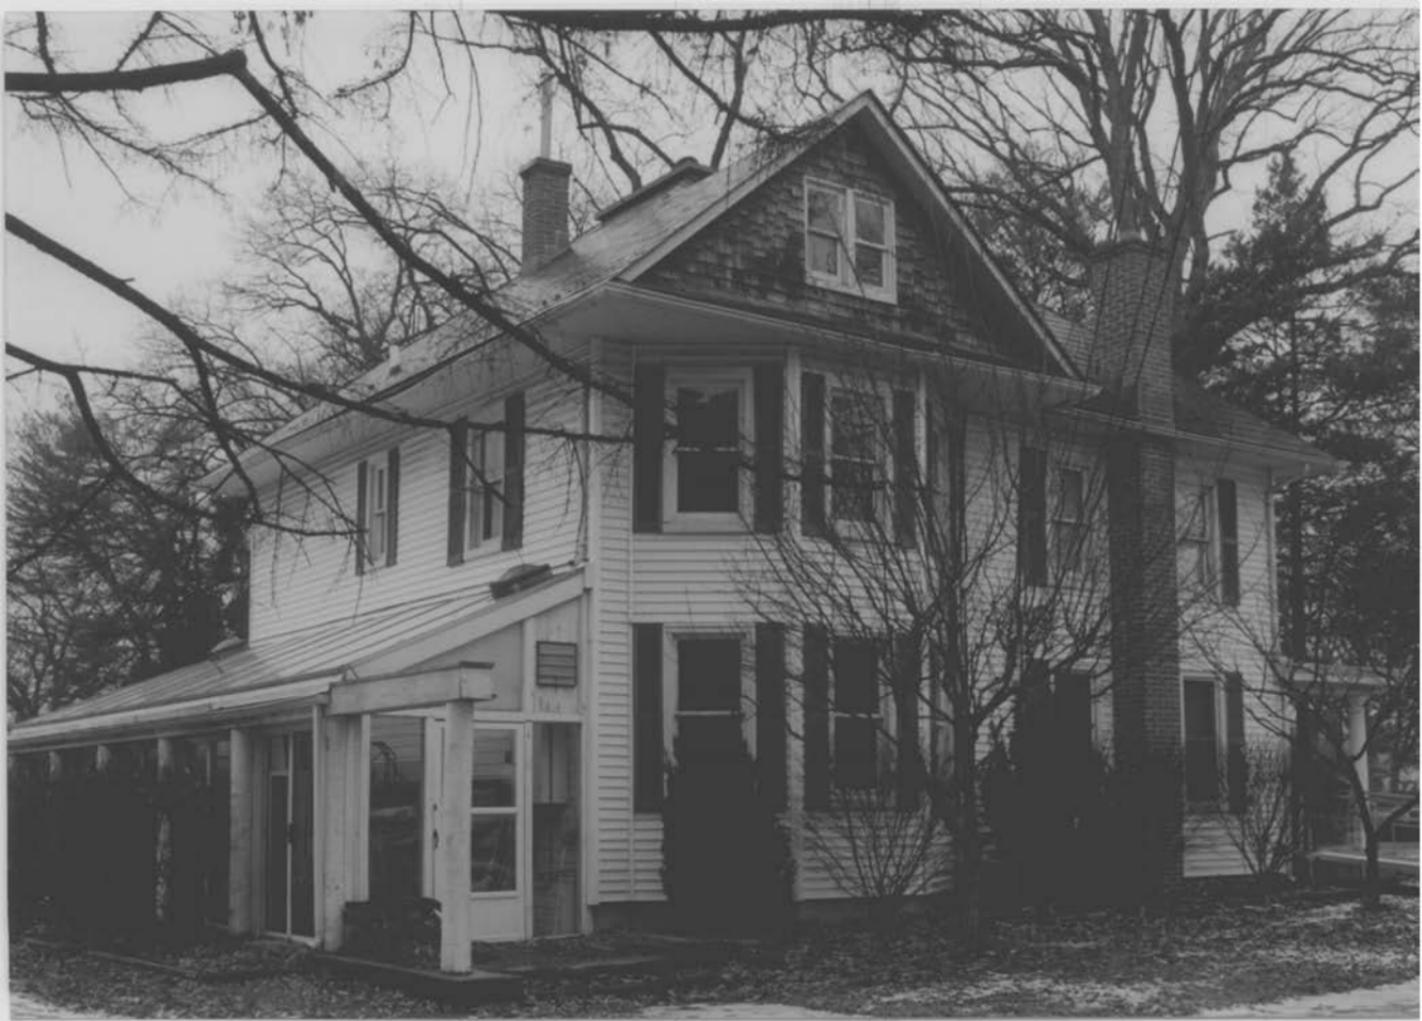
3/18

102 McCormick, south & east elevs

The west elevation has had a pergola added to the first story. Both the first and second stories have four one-over-one sash and the room has a dormer like that on the north elevation. The south elevation has had a greenhouse added to the first story. The west bay of the first story has a door with six lights over two panels, while the center and east bays each have a one-over-one sash. The west bay of the second story has no opening, while the center and east bays each have a one-over-one sash. There is an interior brick chimney near the center. On the east elevation, the south bay has a two-story, three-sided bay with a one-over-one sash on each side of both stories of the bay. It is topped by a gable with a ridge that runs east-west and has staggered butt wood shingles and two one-over-one sash. The center and north bays each have a one-over-one sash on the first and second stories, with an exterior brick chimney between them.

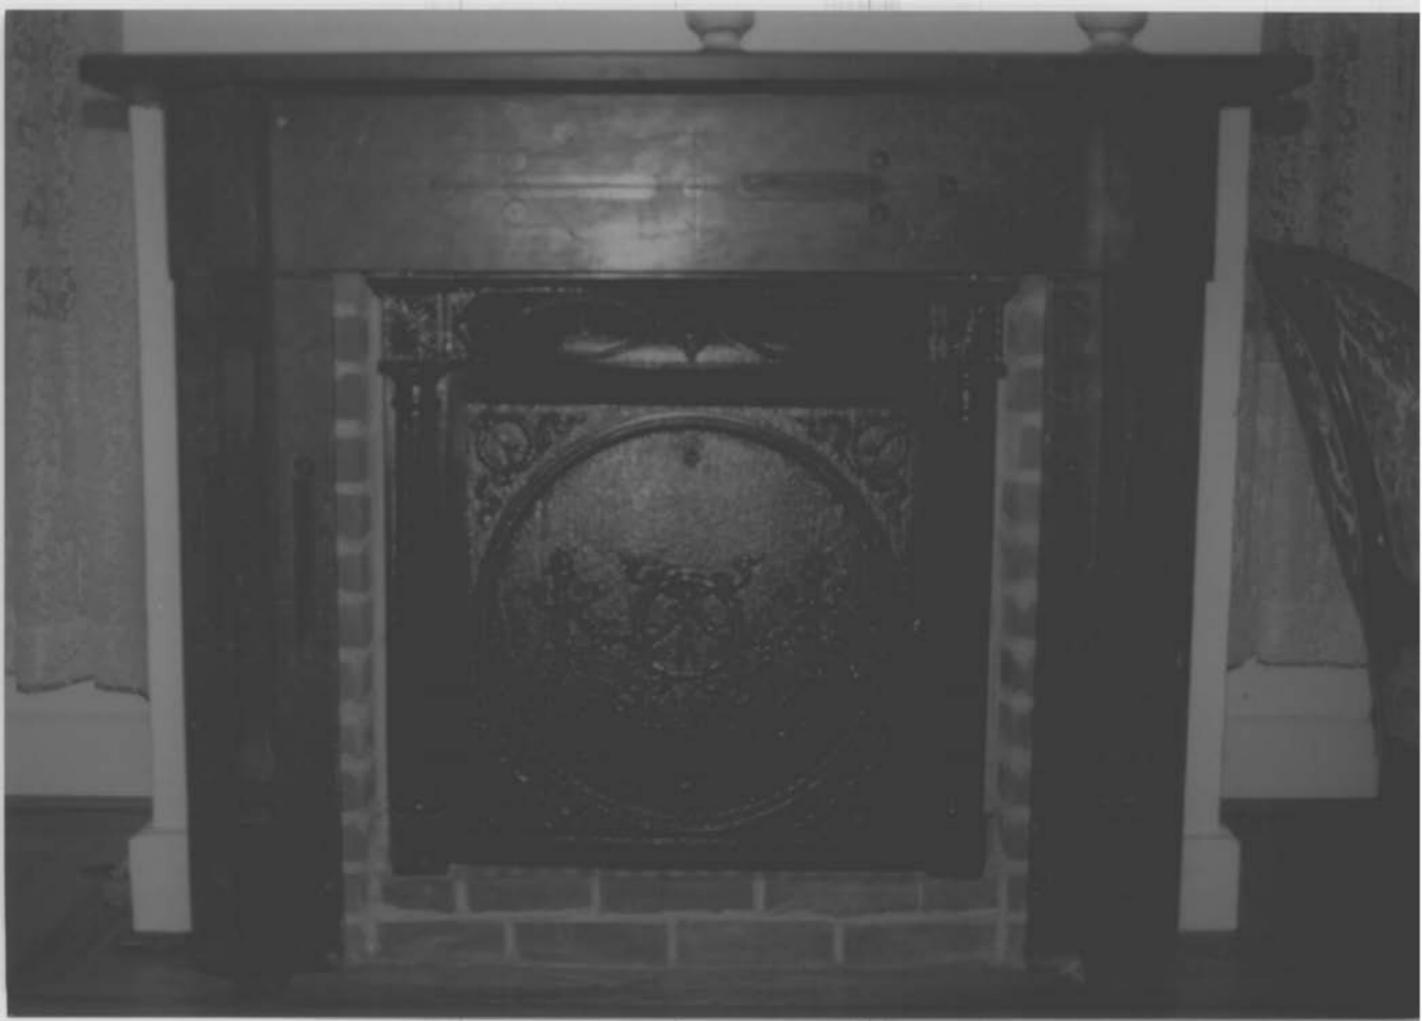
4/18

102 McCormick, Northwest rm, mantel on west

On the interior of the house, there is a vestibule with a center stairway that is open on the west to the northwest room. The flooring throughout is two-inch wide oak with two bands of walnut inlay. The stairs have a square, paneled newel post, closed stringer, and turned balusters. There is a pair of French doors on the east side of the vestibule, set at an angle, with a fanlight above them. The floor inlay follows the stairway and the angle of the French doors. The northwest room has a marbleized slate mantel on the west elevation, with two large brackets supporting the mantelshelf. The faux painting imitates red marble, with incised geometric designs that are painted black. There is modern brick around the inside of the opening, and a cast iron plate that covers the opening. This plate has fluted columns on each side. The window and door architrave is pulvinated in the center, with two beads on each side. The south end of the room has an extra band of inlay, and it appears that there were short sections of wall set about three feet north of the present wall, possibly creating a passage that ran east-west. The center of the room has a square of inlay in it.

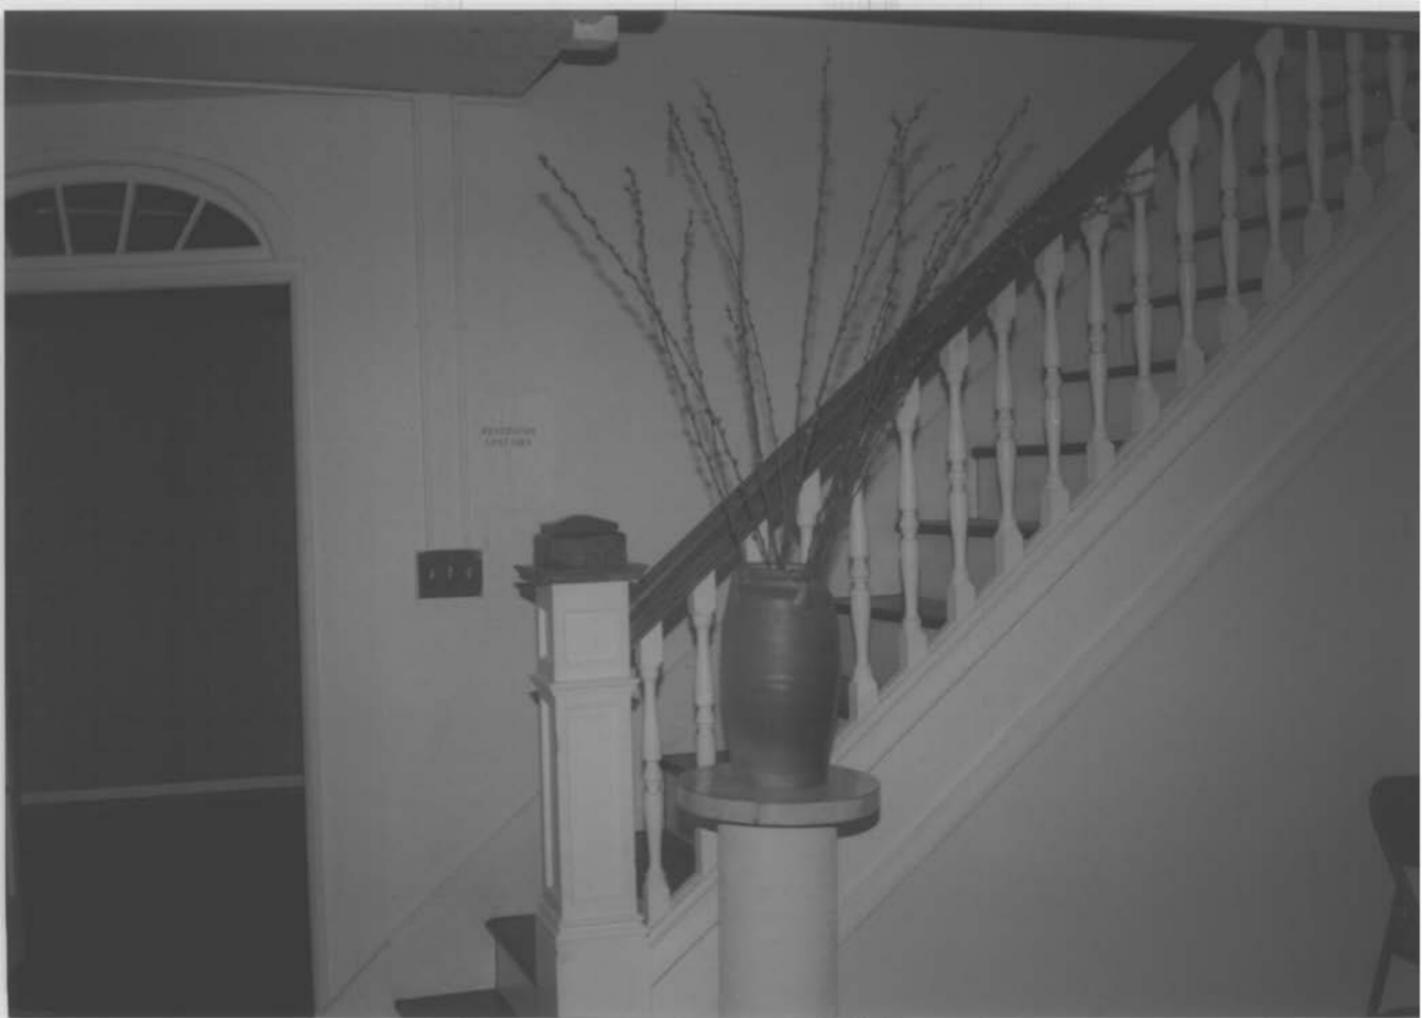
5/18

102 McCormick, Northwest rm, stairs on East

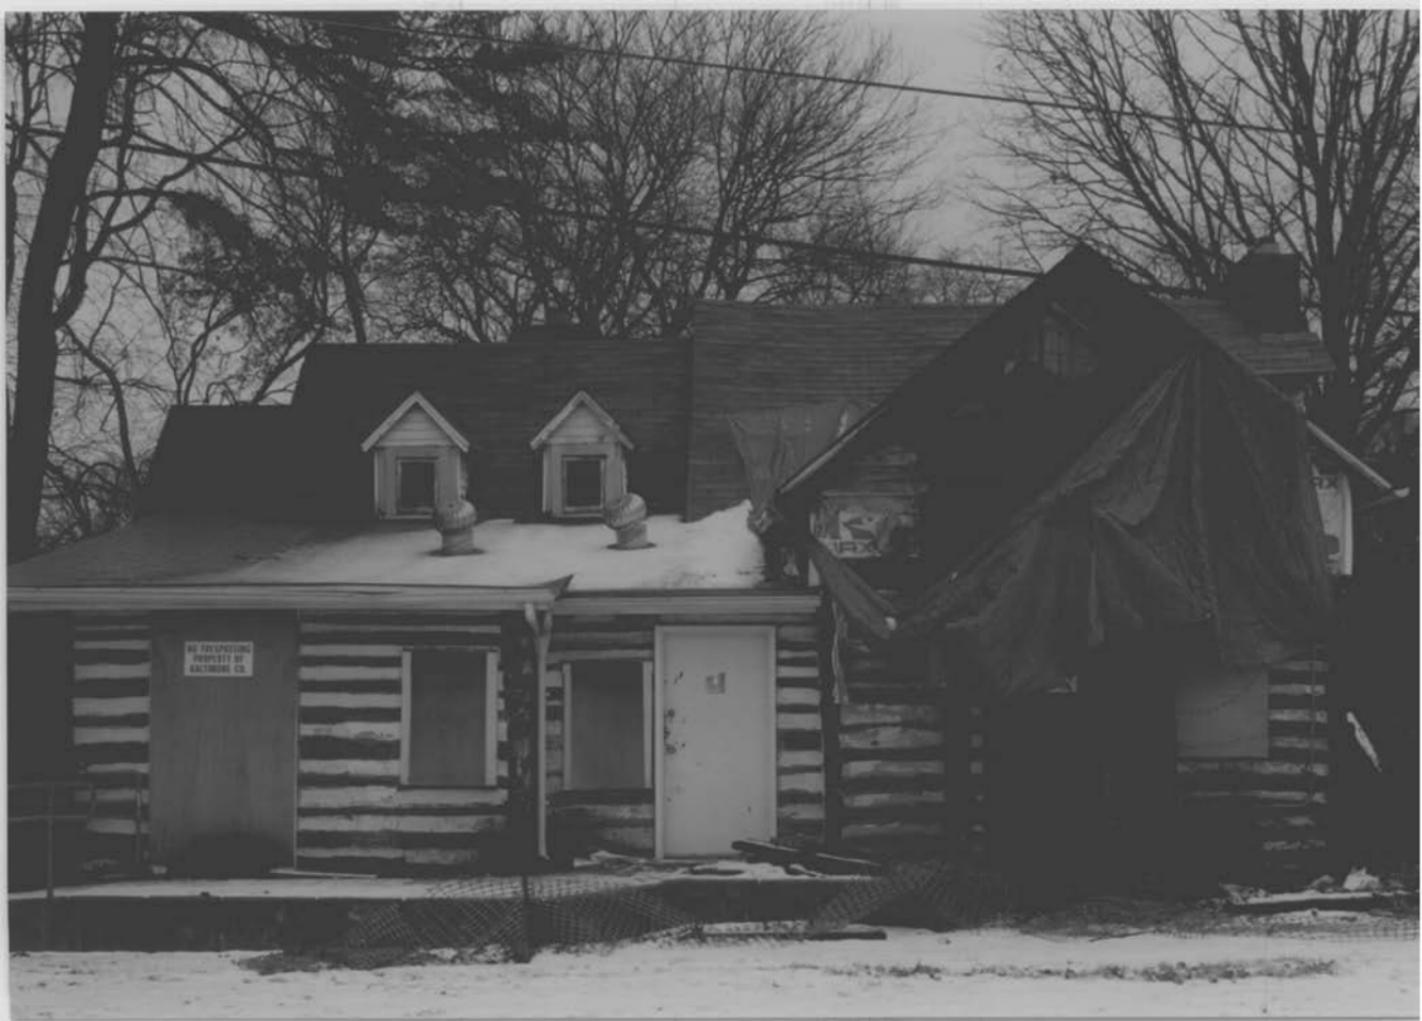
6/18

104 McCormick, Northeleu.

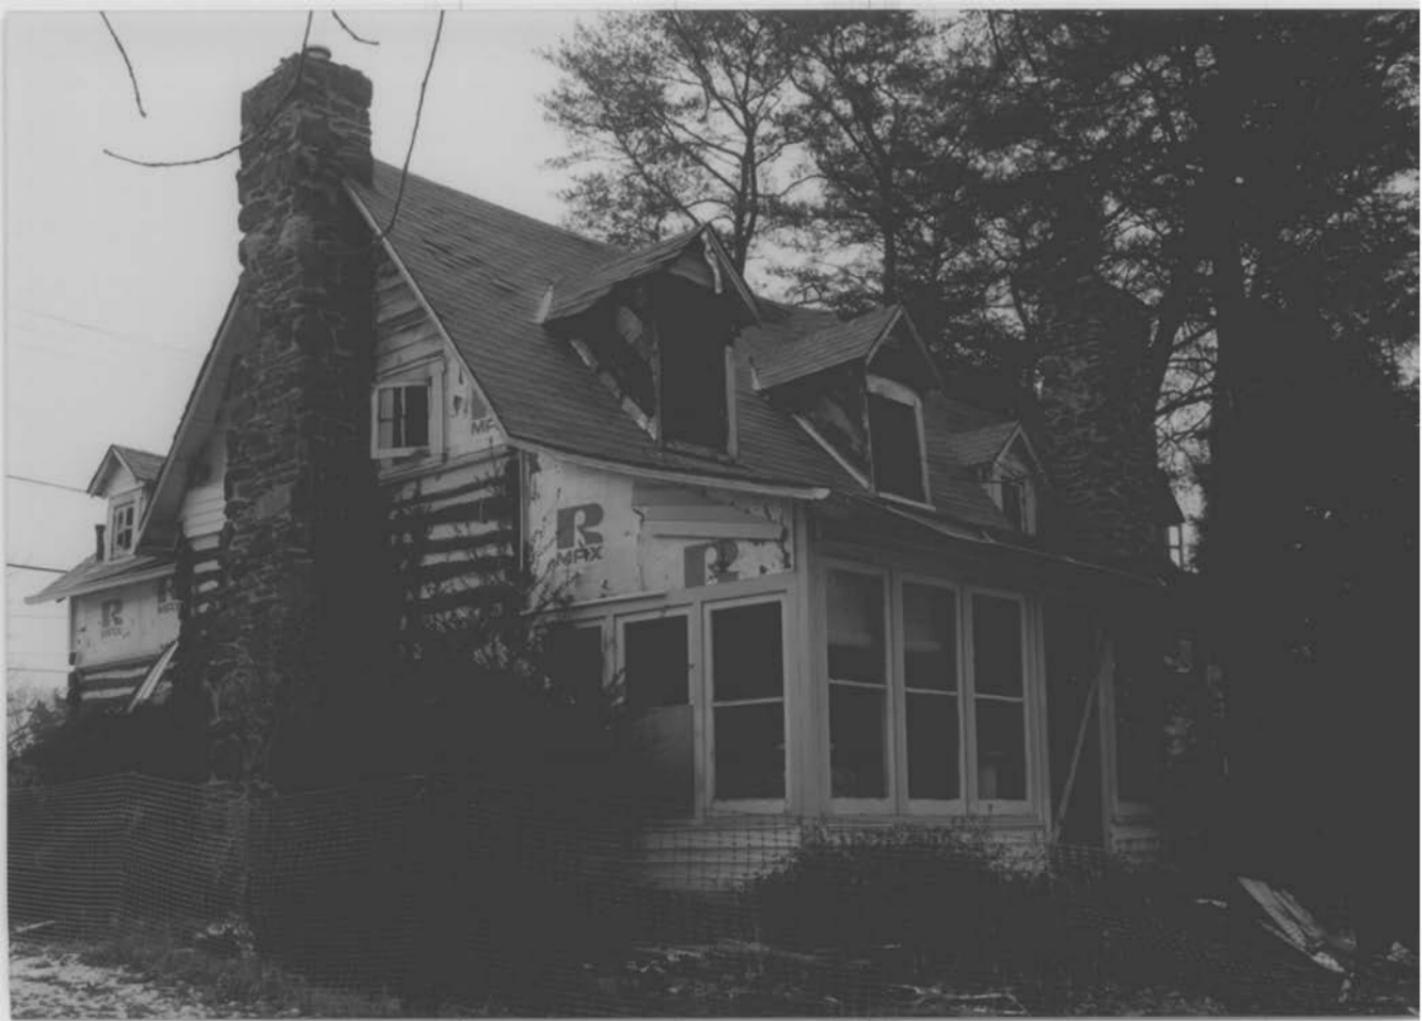
7/18

104 McCormick, West & South elevs

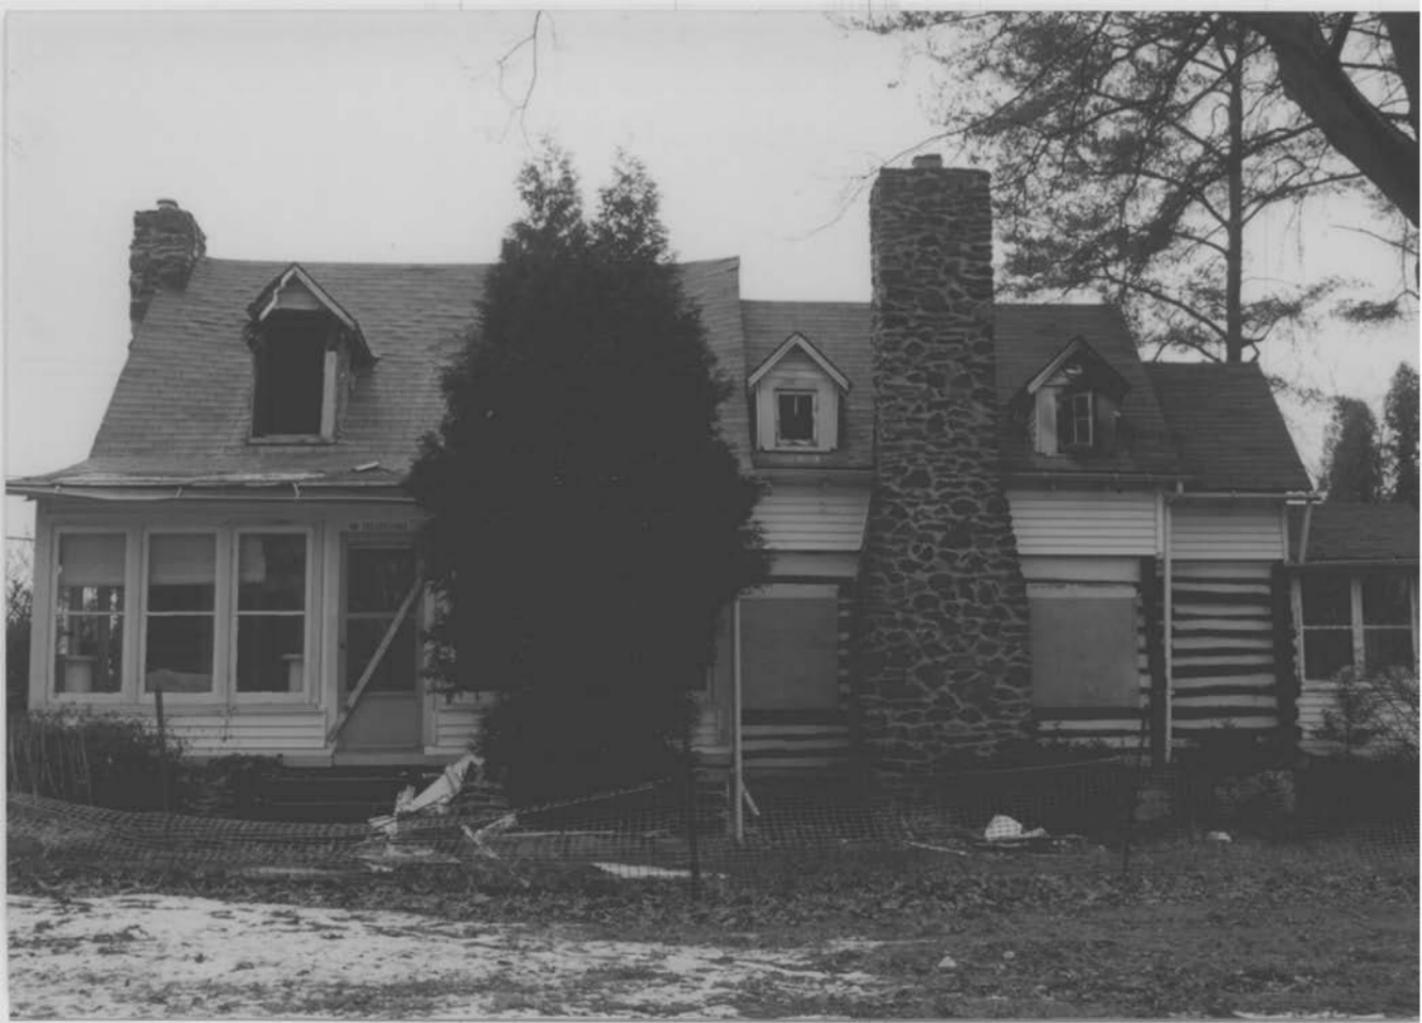
8/18

104 McCormick, Southellor.

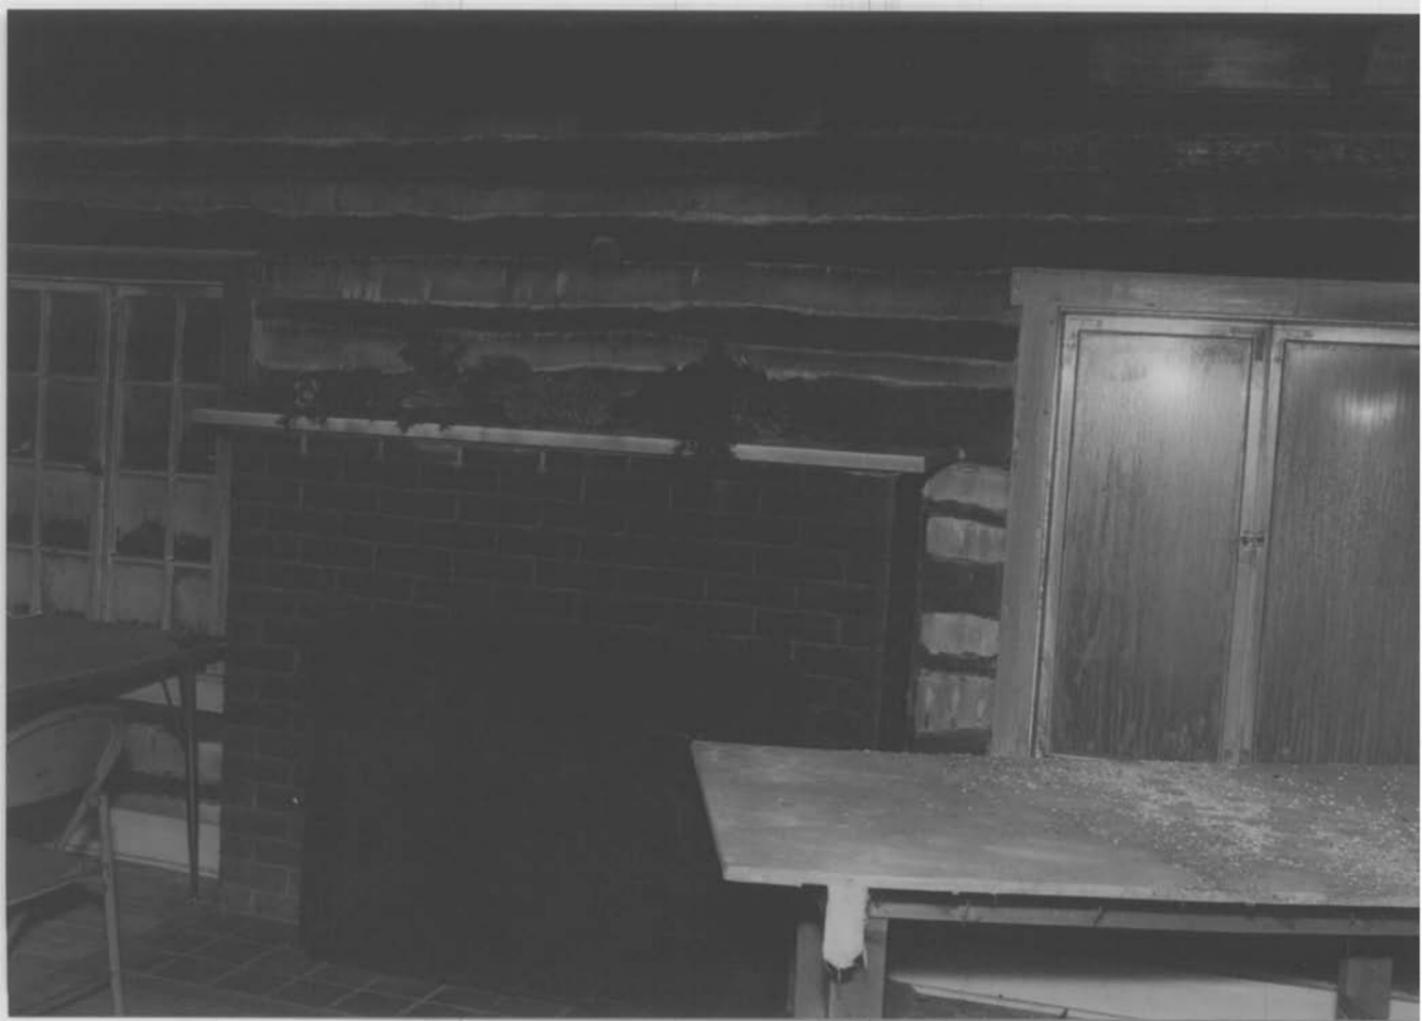
9/18

104 McCormick, Southeast rm, VW. South

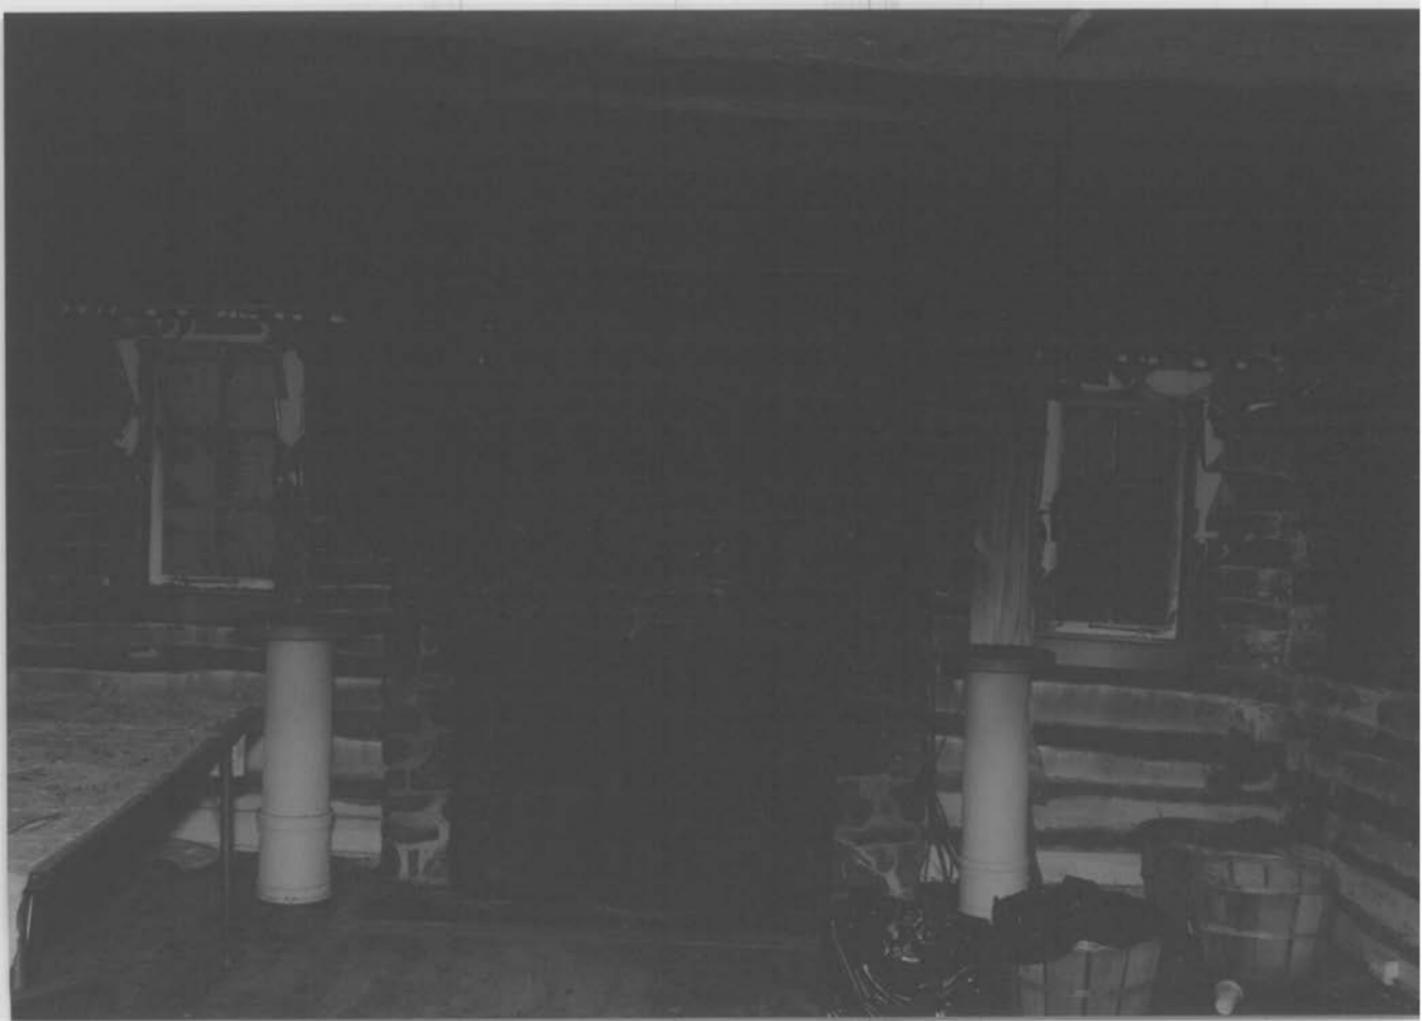
10/18

104 McCormick, southwest room, VW West.

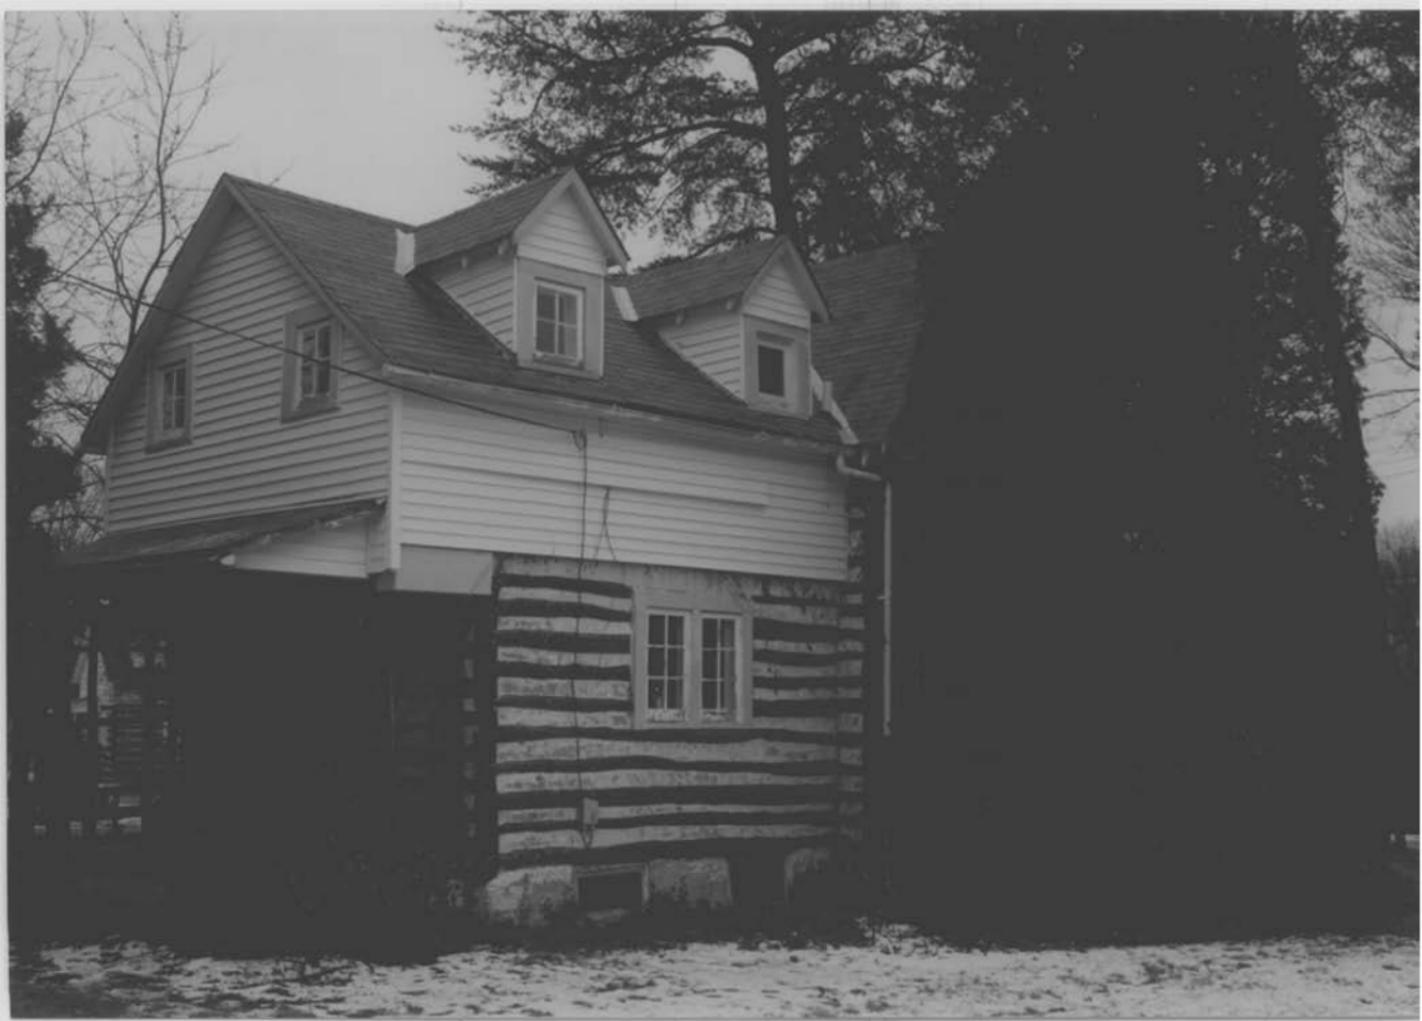
12/18

106 McCormick, North & West elevs

The cabin at 106 McCormick Avenue faces north, and is a 1 $\frac{1}{2}$ -story structure with an "L" plan. It has a concrete foundation, exposed log walls on the first story that have v-notched corners, aluminum siding on the second story, and an asphalt shingle roof. The north elevation is two bays. The first story has a door with nine lights over two panels to the east and a six-light casement to the west. There is a two-bay shed roof porch with round log posts and railings. The second story has a gable end that is cantilevered to the north approximately two feet, and it has two four-light casements. On the west elevation, the north half has two three-light sash in the foundation. There are paired six-light casements in the first story and no openings in the second story. There are two gable-roofed dormers, the north one with a four-light casement and the south one with a new one-light sash. The south bay of the west elevation projects about one foot and has an exterior rubble stone chimney in the center with a six-light casement to each side. The second story has a gable end with a four-light casement to each side of the chimney. The south elevation is three bays. The first story has a center door with nine lights over two panels, and a pair of six-light casement windows to each side. There is a three-bay shed roof porch with a wood deck, four chamfered square posts, and exposed rafters. The upper story has two gable-roofed dormers, each with a six-light casement. There is a small, one-story bay on the east side that has a gable roof with an east-west ridge. The south elevation of this bay has a tall eight-light sash. The east elevation of this bay has a three-light sash in the foundation, a pair of six-light casements on the first story, and a three-light casement in the gable end. Above this bay is the gable end of the south end of the east elevation, and it has a four-light casement to each side of a room. The east elevation of the north half has no openings on the first story and has a four-light casement on the second story.

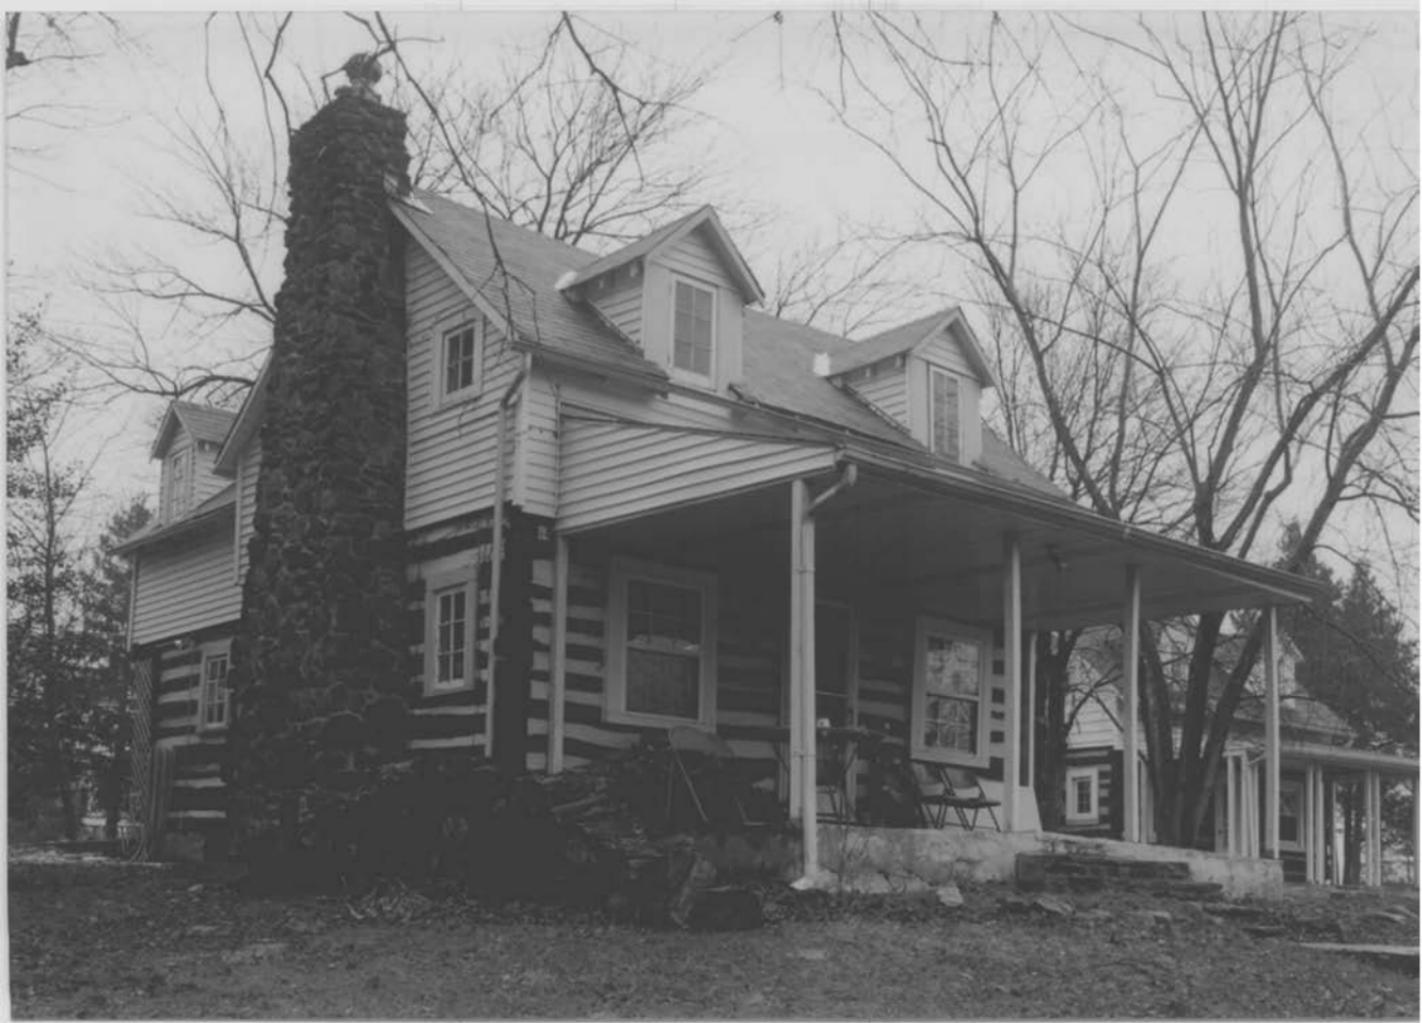
13/18

108 McCormick, West & Southeast

The cabin at 108 McCormick Avenue faces north, and is a 1-½ story structure with an "L" plan and faces south. It has a concrete foundation, exposed log walls on the first story that have v-notched corners, aluminum siding on the second story, and an asphalt shingle roof. The south elevation is three bays. The first story has a center door with nine lights over two panels, and there is a pair of new six-over-six casement windows to each side. There is a three-bay, shed roof porch with a wood deck, four square wood posts, and aluminum soffit. The upper story has two gable-roofed dormers, each with a six-light casement. On the east elevation, the south half projects about two feet and has two three-light metal sash in the foundation. The first story has a large fifteen light door and the second story has two four-light casements. The north half has a door with nine lights above one lying panel above two panels on the first story. There is a four-light casement on the second story.
