BA-2807
McCormick-Holt Park
McCormick Avenue
Overlea
Private
c. 1895-1910, c. 1930s

Maryland Inventory of Historic Properties Form

historic McCormick-Holt Farm
 other McCormick-Holt Park

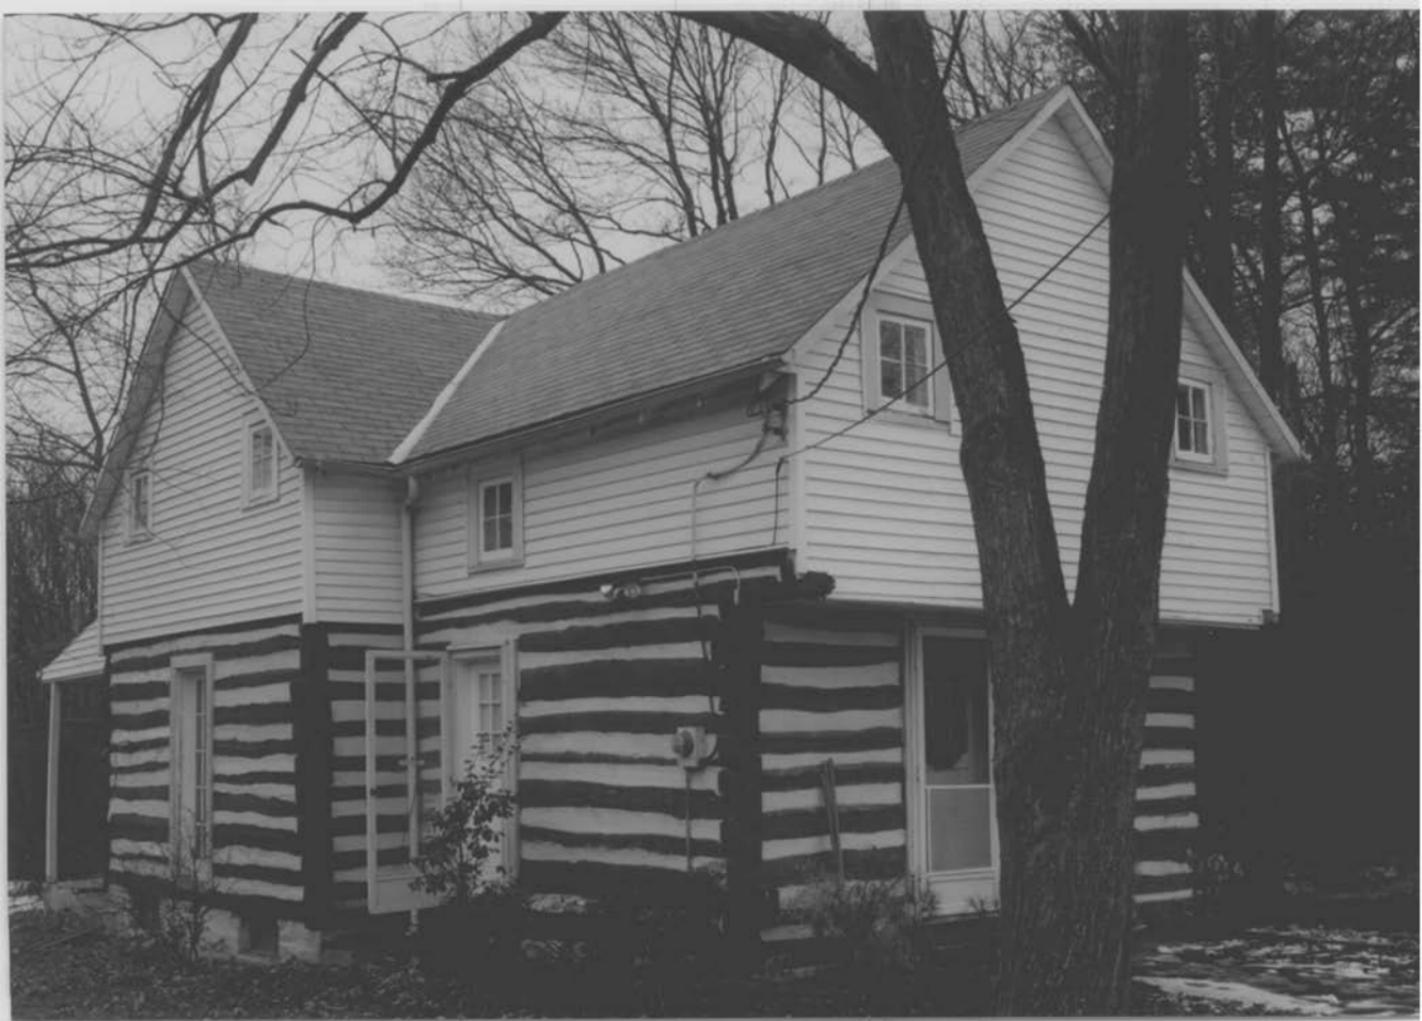
14/18

108 McCormick, E & N. elevs

The north elevation is two bays. The first story has a door with nine lights over two panels to the east, with two three-light casements to the west. There is a two-bay shed roof porch with round log posts and railings. The second story has a gable end that is cantilevered to the north approximately two feet, and it has two four-light casements. On the west elevation, the north half has a three-light sash in the foundation. There are paired six-light casements in the first story and no openings in the second story. There are two gable-roofed dormers, the north one with a six-light casement and the south one with a new one-over-one sash. The south half of the west elevation projects about two feet and has an exterior rubble stone chimney in the center with a three-light sash to each side in the foundation, and a six-light casement to each side in the first story. The second story has a gable end with a four-light casement to the south and an air conditioner in a similar opening to the north of the chimney.

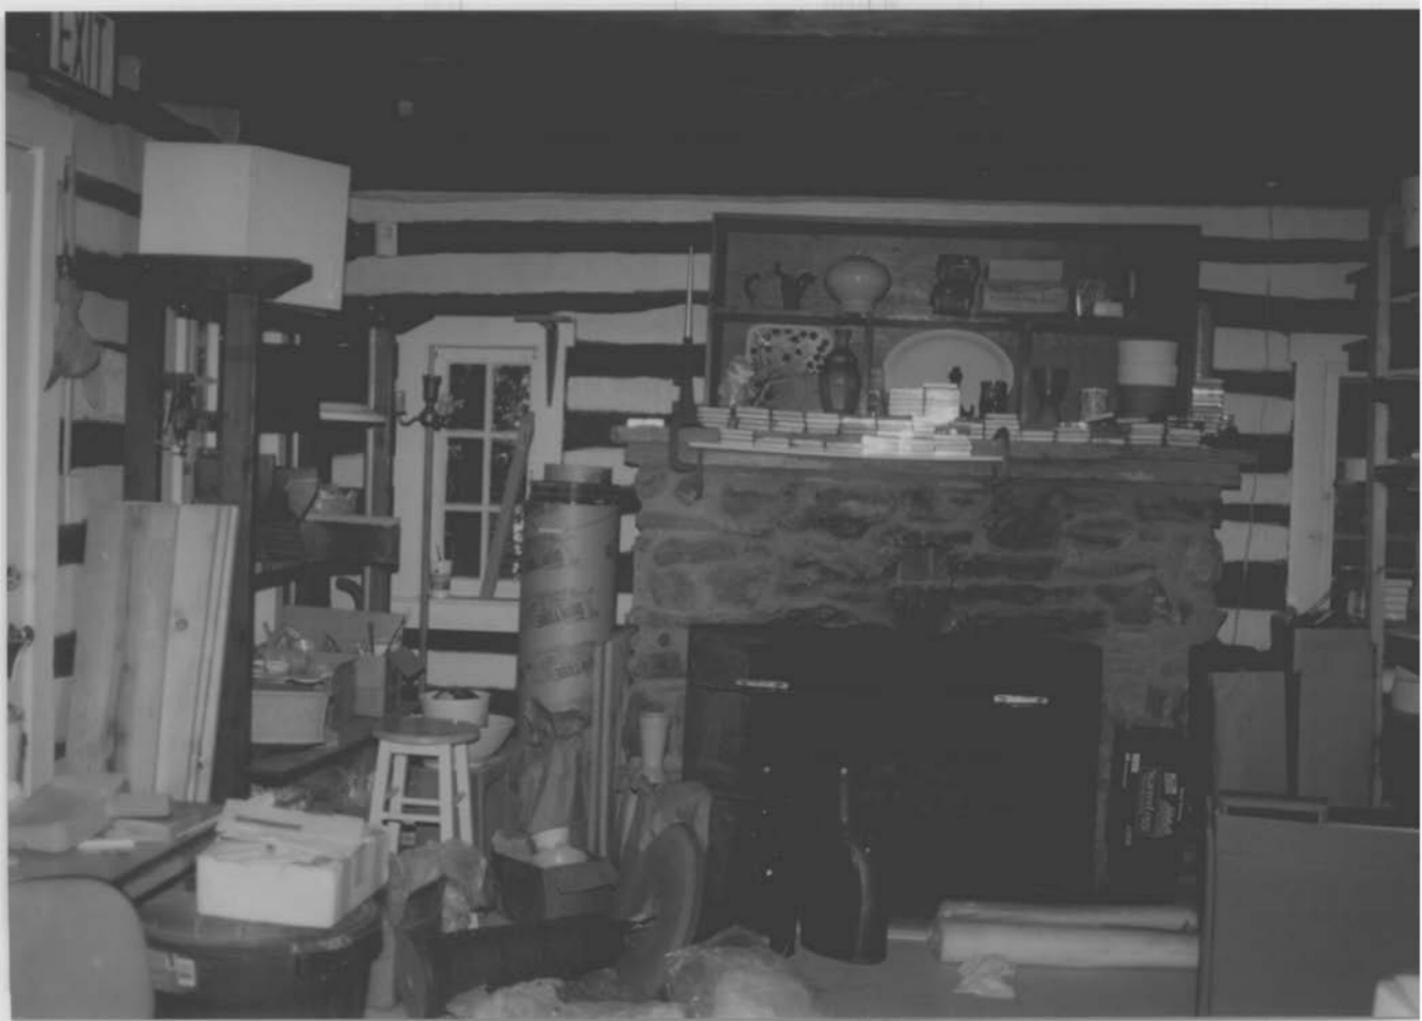
15/18

108 McCormick, southwest rm, vw. west

The passage has a three-run dogleg stair on the east with a cellar stairway beneath it. There is three inch wide flooring, exposed log walls, and textured plaster on the west elevation and beneath the stairway. There is head cut trim throughout the building. The ceiling has exposed log joists that are hewn on top and bottom and run north-south. The east elevation has built-in shelves with five shelves above two two-panel doors. The small northwest room has a modern kitchen with sheetrock on the ceiling. The south room has random-width flooring, exposed log walls with plaster chinking, and exposed second story joists that are mostly ¾-round logs. The west elevation has a fireplace with a rubble stone mantel, shelf, and hearth, and a firebox of firebrick. The fireplace is flanked by a six-light casement window one each side. The south elevation has a center door that has nine lights above one lying panel, with two panels at the bottom. There is a new six-over-six sash to each side of the door. The east elevation has a large fifteen-light sash in the center.

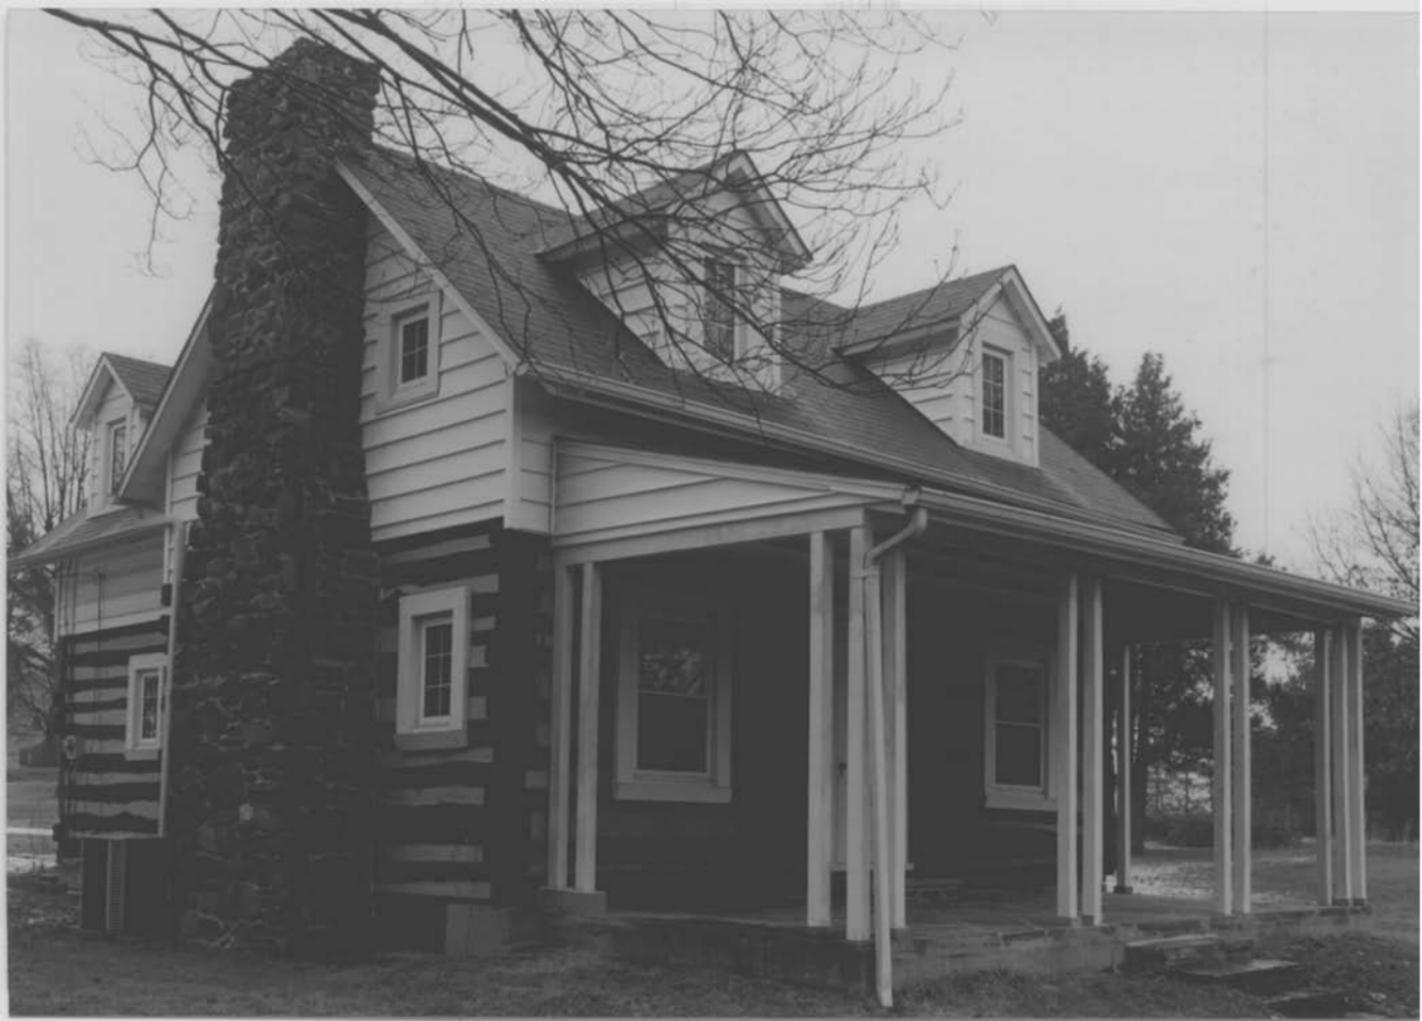
16/18

110 McCormick, West & South elevs

The building at 110 McCormick Avenue is a one and one half story cabin with a concrete foundation, exposed logs that have v-notched corners on the first story, aluminum siding on the second story, and a gable roof with an east-west ridge and asphalt shingles. There is an ell on the north that has a gable roof with a north-south ridge. The south elevation is three bays. The first story has a center door with six lights above two square panels, with two panels at the bottom. There is a new six-over-six sash to each side of the door. There is a one-story, shed roof porch that has triple posts at the south corners and double posts at the north

and on either side of center on the south. The posts are square wood and the rafters are exposed. The second story has two gable roof dormers, each with a six-light casement. The east elevation has two three-light sash in the foundation and a pair of new six-light aluminum casement windows on the first story. The second story has two new aluminum four-light casements. The north ell is recessed approximately three feet from the east elevation of the building, and has a door with six lights over two panels on the first story and a four-light casement on the second. On the north elevation, the first story west bay has a door with six lights above two square panels, with two rectangular panels at the bottom, while the east bay has a new six-light casement. There is a shed roof porch at the west bay that has triple posts at the north corners and single posts at the south, with benches on the east and west sides. The second story has two new four-light casements. The west elevation of the ell has two three-light metal sash in the foundation, a pair of new six-light casements on the first story, and two gable roof dormers with six-light casements on the second story. The west elevation of the main block projects about three feet beyond the west plane of the ell. The foundation has two three-light metal sash, with an exterior rubble stone chimney in the center. The first story has a new six-light casement on either side of the chimney and the second story has a new four-light casement on each side. The interior of this building was not accessible.

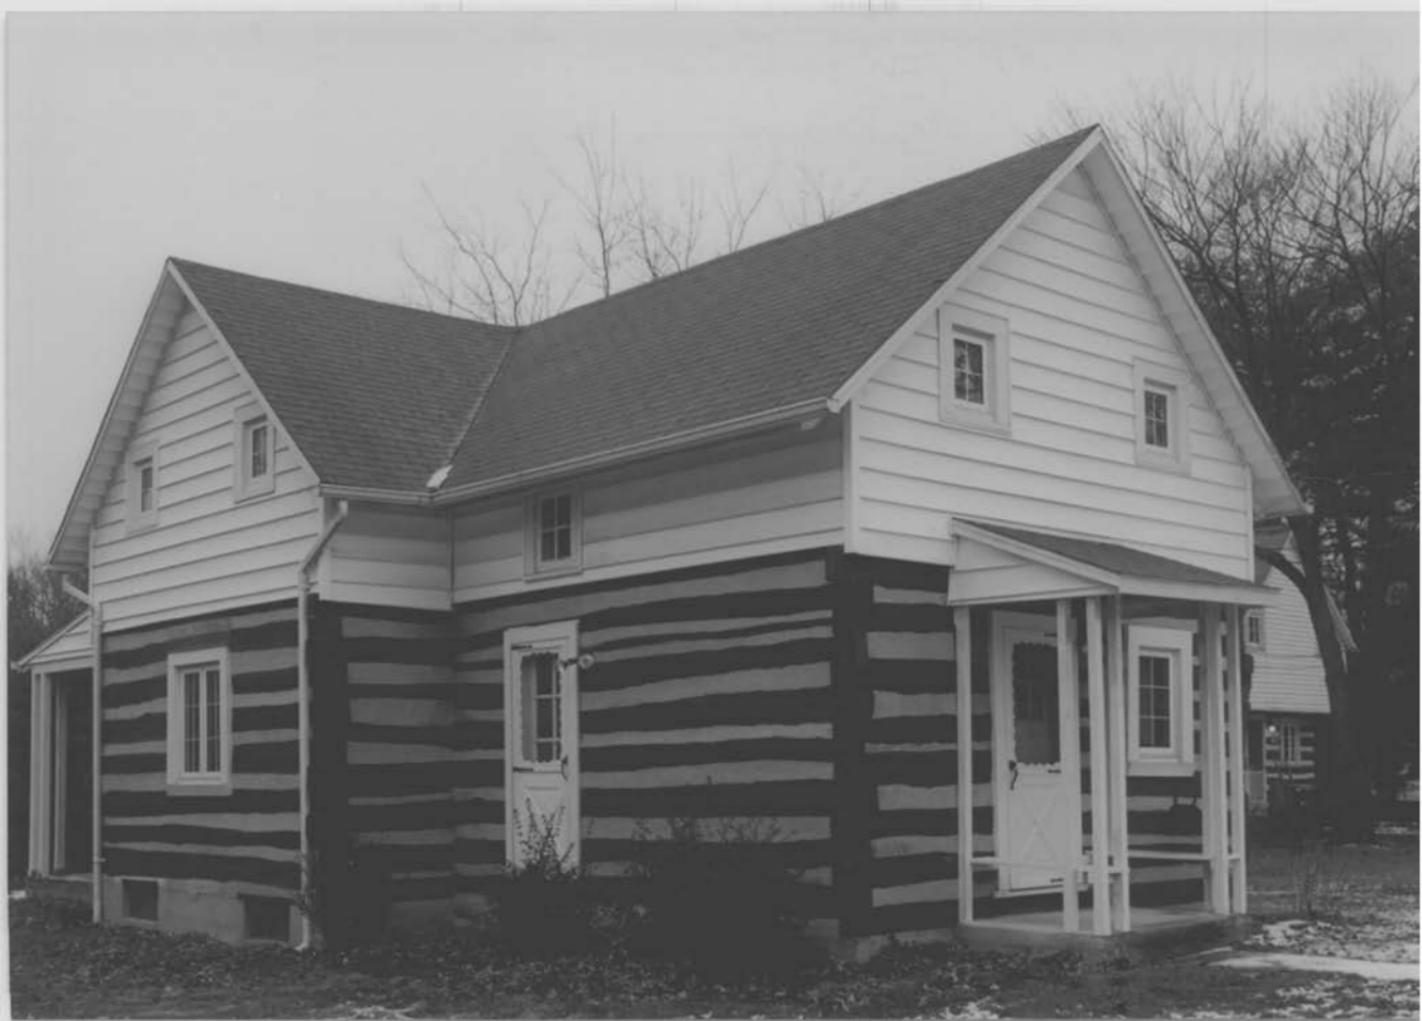
17/18

110 McCormick - East & North elevs
