**MARYLAND HISTORICAL TRUST  
NR-ELIGIBILITY REVIEW FORM**

Property Name: Tollhouse Historic District Inventory Number: BA-2951

Project: York Road at Broadmead Retirement Community Entrance Agency: State Highway Administration (SHA)

TOLL HOUSE HISTORIC DISTRICT

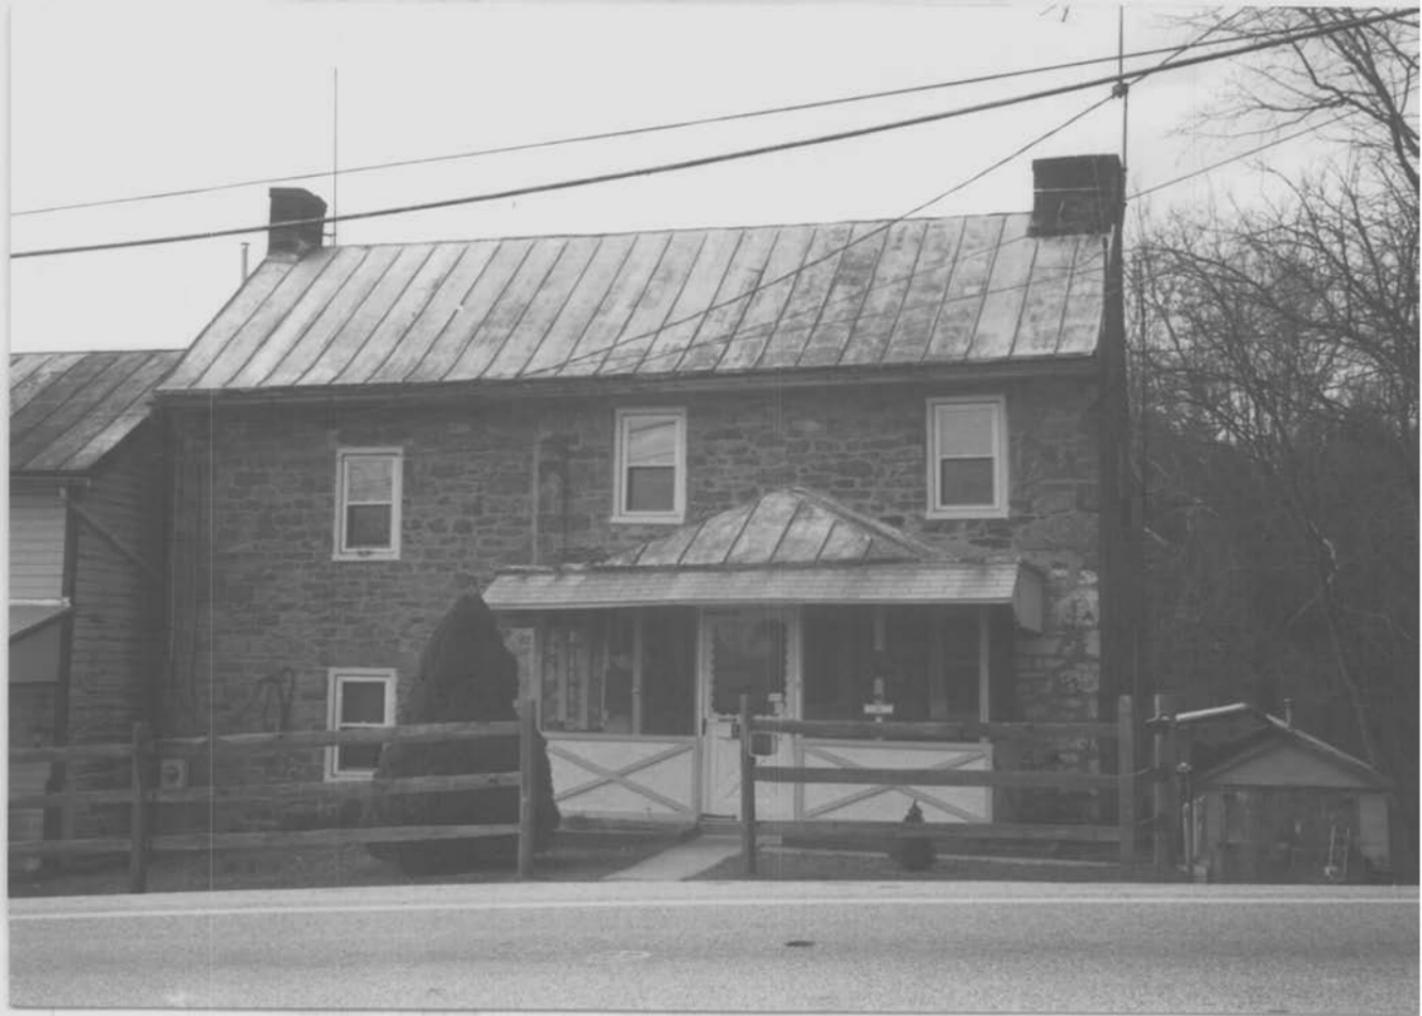
1 of 6

13820 YORK ROAD

View to West

13820 York Road - This resource consists of a single stone house, two stories tall, three bays wide, and one room deep. The house is oriented with a side gable roof paralleling the road. The roof is clad in standing seam metal, and there are end internal brick chimneys rising through the ridge at the end facades. There is a stone rear addition on the building, two stories high. The main façade of the dwelling has a hipped entry porch across a portion of the façade, altered from its historic appearance. The entry is off center, sheltered by this altered porch. Windows flanking this entry, on the first and second stories, are all one over one, double hung. This building appears to have been erected in two stages, with the earlier stage on the north and a later addition to the south. The stonework on the building is roughly laid, with corner quoins illustrating the breaks in construction between the two sections. There is a small grass lawn in the front of the building, enclosed by a modern split rail fence. Although tax records indicate that the house was built in 1854, the building may date from an earlier period.

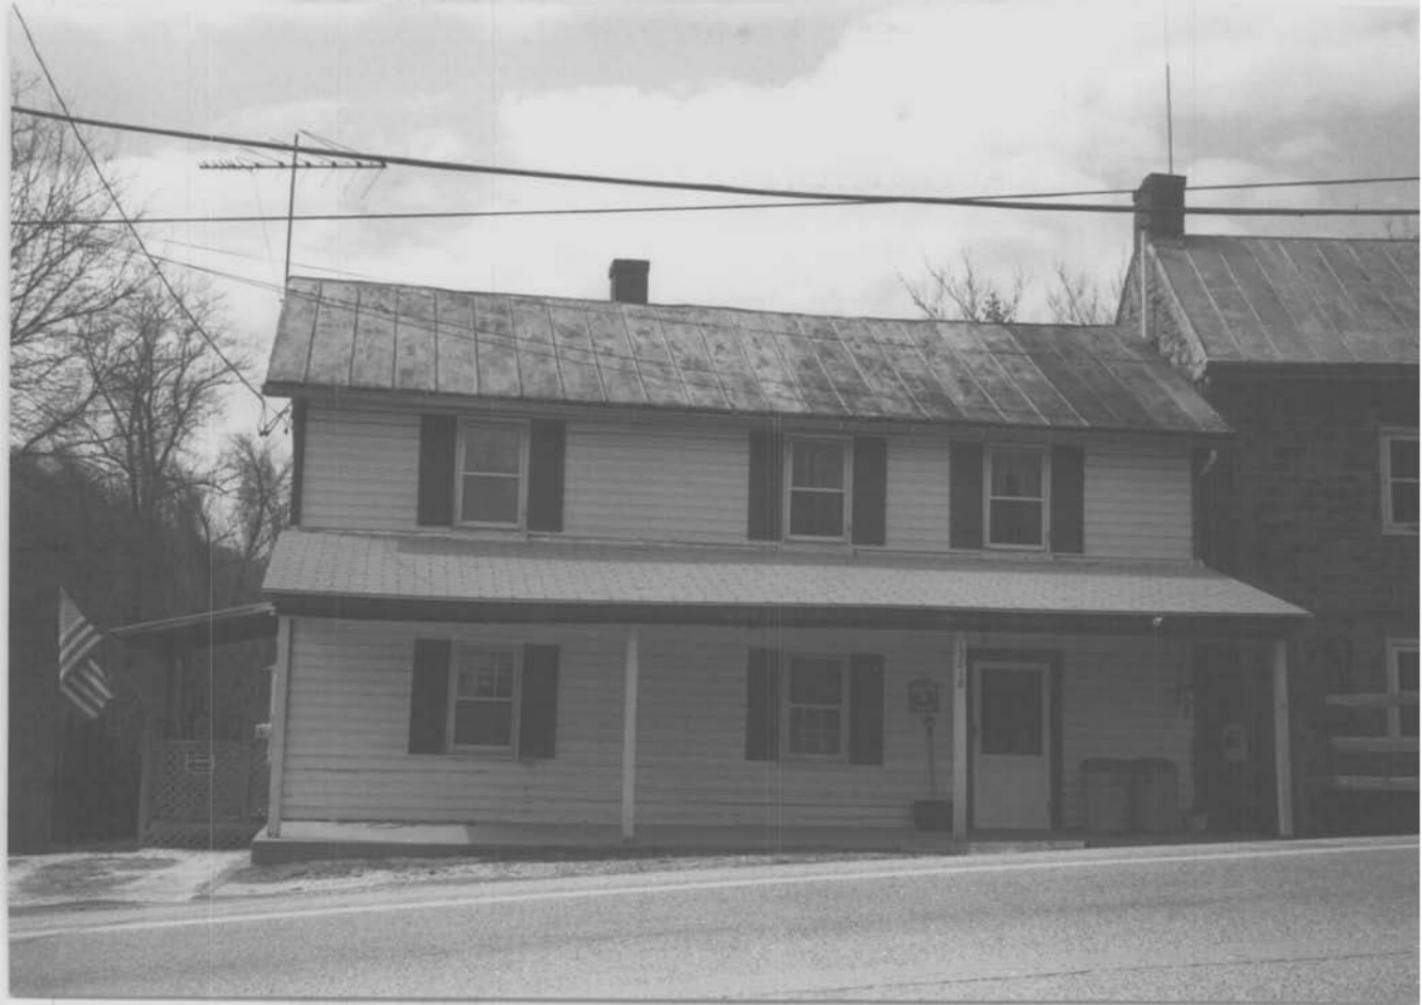
2 of 6

13818 YORK ROAD

VIEW TO WEST

13818 York Road - This resource consists of a single frame house, three bays wide, two bays deep, and two stories tall. The building has a rectangular plan with a side gable roof paralleling the street. The main façade has a shed roof porch across the entire façade, supported by wooden posts. The front entry to the house is in the northernmost bay. The windows are the one over one, double hung sash type, with modern storm windows and shutters. The second story, main façade, also has three single windows, each one over one, double hung, with modern shutters. The building is clad in narrow wood siding with corner boards. The side gable roof is clad in standing seam metal. Tax records indicate that it dates from 1852.

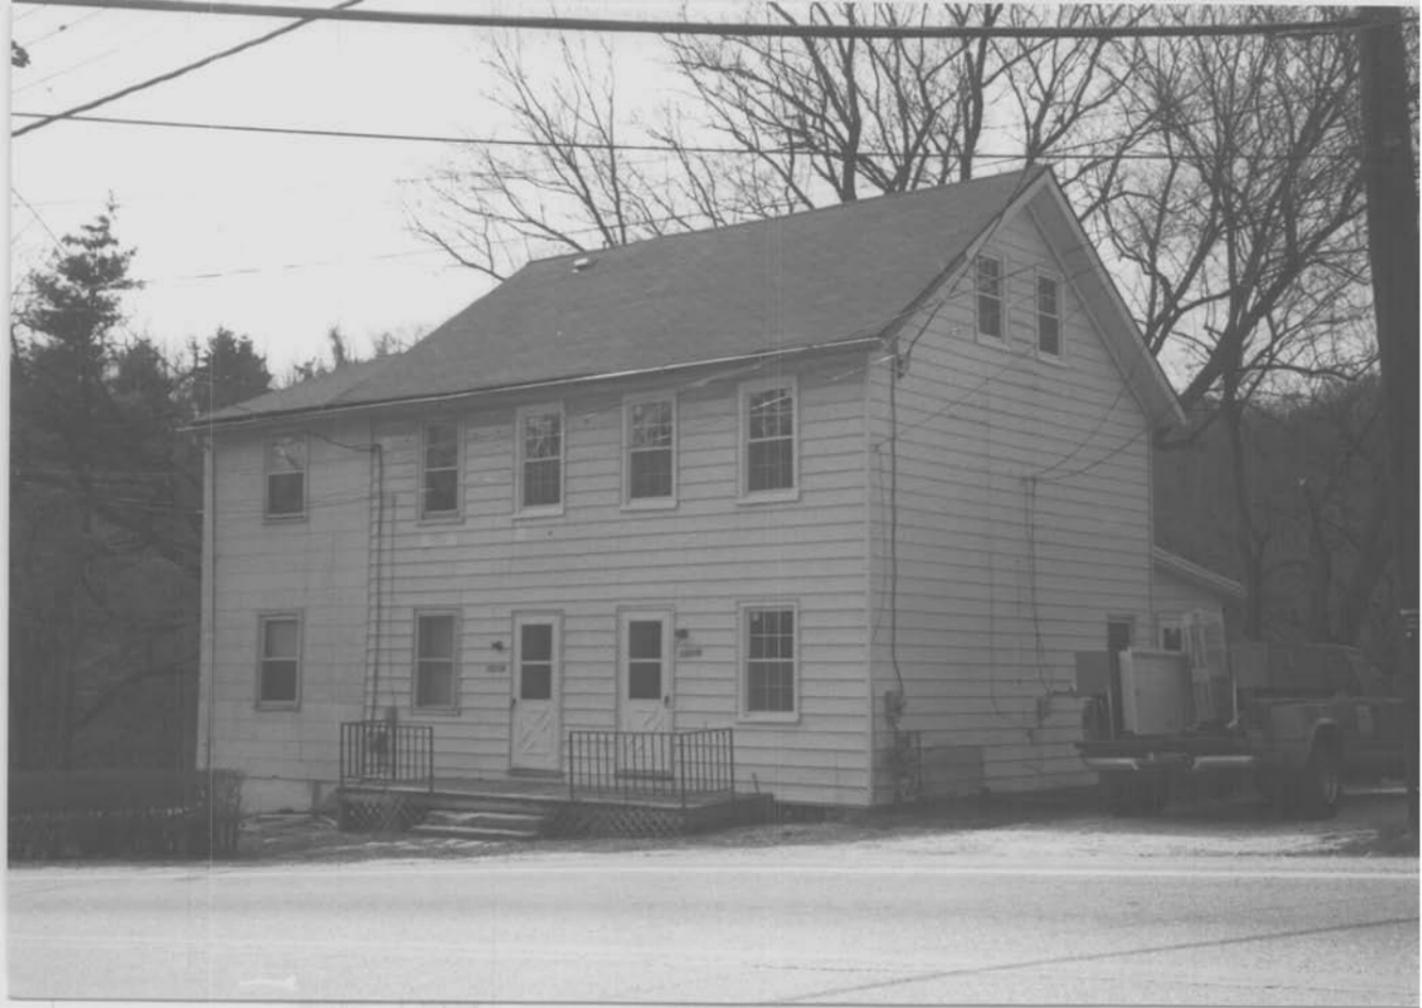
3-76

13814 YORK ROAD

VIEW TO SOUTHWEST

13814 York Road - This resource consists of a frame house, four bays wide, two bays deep, and two and one half stories tall. The house is clad in a modern vinyl siding to resemble wood siding. The building has a rectangular plan, with a rear and side addition. The house has a side gable roof, clad in asphalt shingles, parallel to the street. The main façade, original portion, has four bays with two centrally placed doors. The second story has four windows. All of the windows on the façade appear to be six over six, double hung. There is a two story, shallow pitched gable roofed section on the side façade, which is one room wide and two rooms deep. This addition has a single window on the first and second stories. There is a modern wooden entry porch across the front façade, with a wood deck and plain balustrade. There are two small attic windows on the side façade, both six over six, double hung. There is a modern shed roofed addition across the rear of the house. The windows and doors on the house are modern replacement. Although tax records state that this house was built in 1892, historic research suggests that it was built prior to that time. The tax record date may refer to the later side addition.

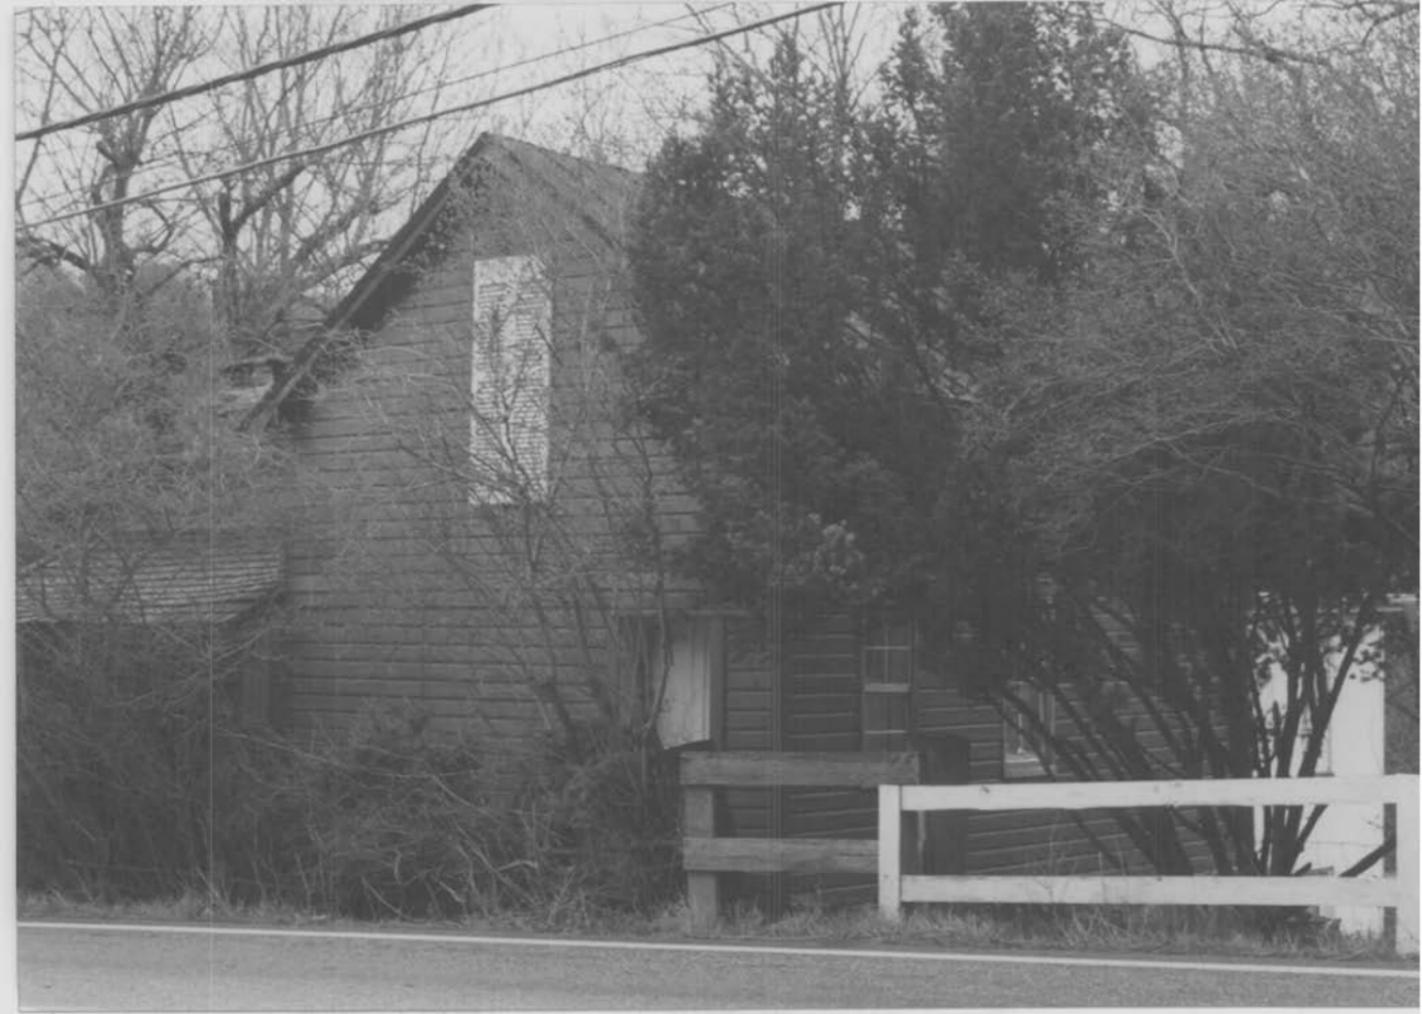
5 of 6

13822 YAC - ROAD

view to southwest showing detail  
of front of house 1 1/2 mi. S. of YAC - ROAD

13822 York Road – This resource consists of a single house with a T-plan. The main portion of the house is a rectangular block, one and one half stories high, and two bays wide, with a side gable roof. It is constructed of frame and clad in board siding. There is a brick end chimney along the end façade. The roof of this portion of the house and the main rectangular block is clad in standing seam metal. There is a later, one-story kitchen wing attached to the rear of the house, forming the bottom of the T plan. This kitchen wing appears to be a single room, with a flat roof. There is a shed roof porch across the

street façade, supported by wooden posts. The kitchen wing appears to be constructed of stone, and there is a large stone chimney along the end façade. The stonework is uncrushed, roughly laid. Mature trees and shrubs surround the house, with a modern wooden fence along portions of the property. Tax records indicate that the house was built in 1953, but this probably refers to the kitchen wing addition. According to Hollifield (1978) and supported by historic maps, this appears to be the tollgate house built circa 1810.

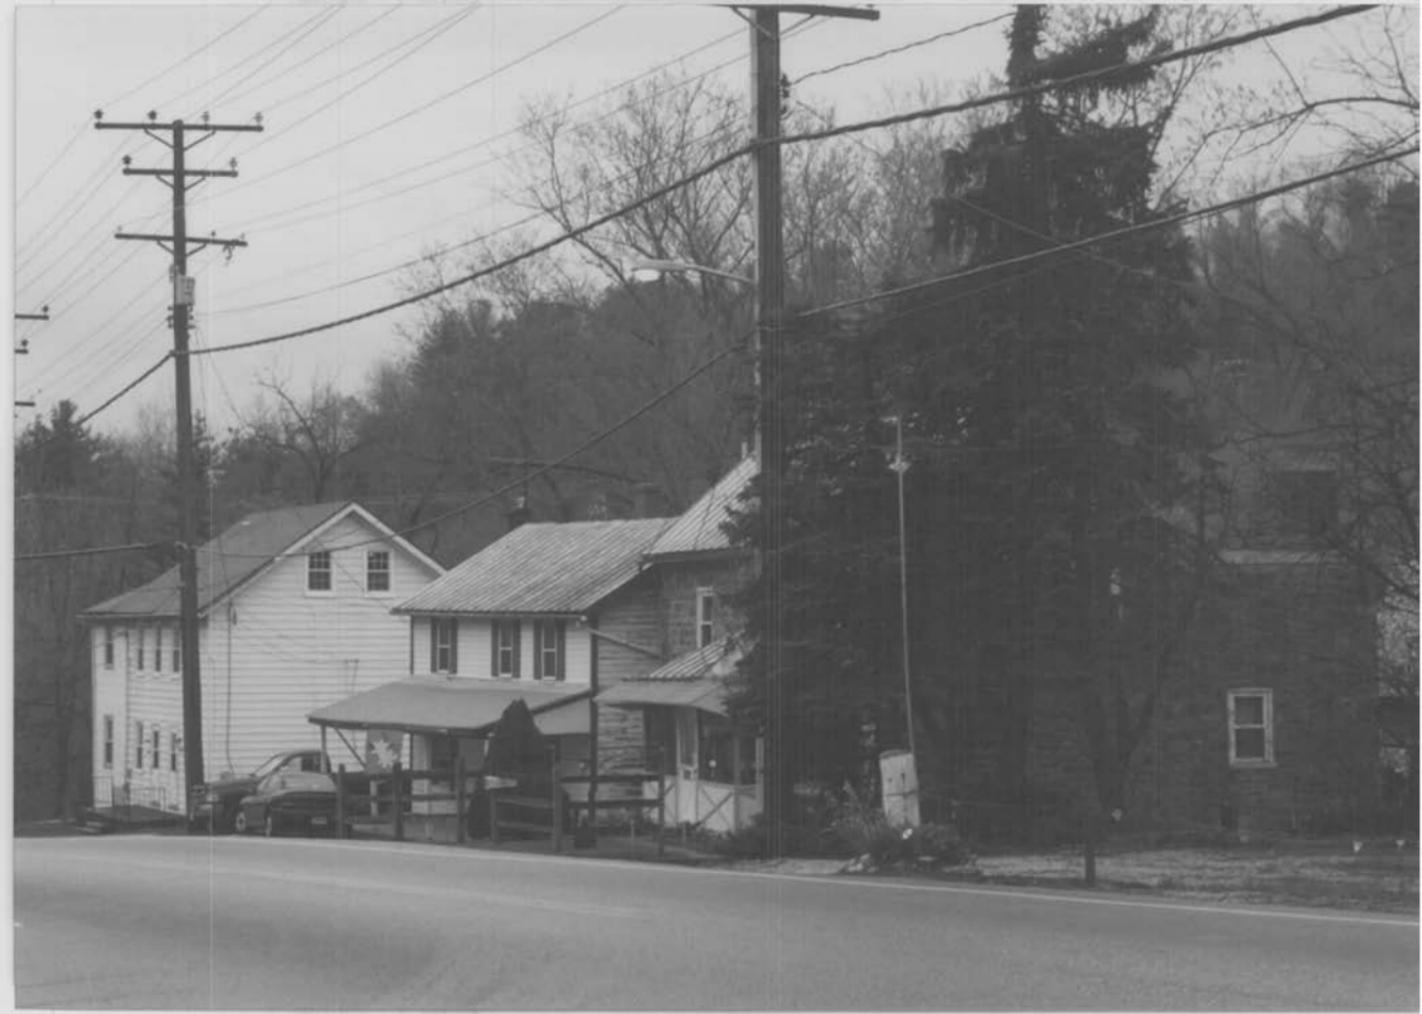
6d6

YORK ROAD near TOLLHOUSE

Shewing from left to right: 13814 13818

and 13820 York Rd. View to S. West.

The "TOLLHOUSE" at 13822 York Rd. -> to RIGHT
