BA-3078

10517 Liberty Road
Randallstown vic.
Private
c. 1875-1910

Maryland Inventory of Historic Properties Form

other A. H. Callow House

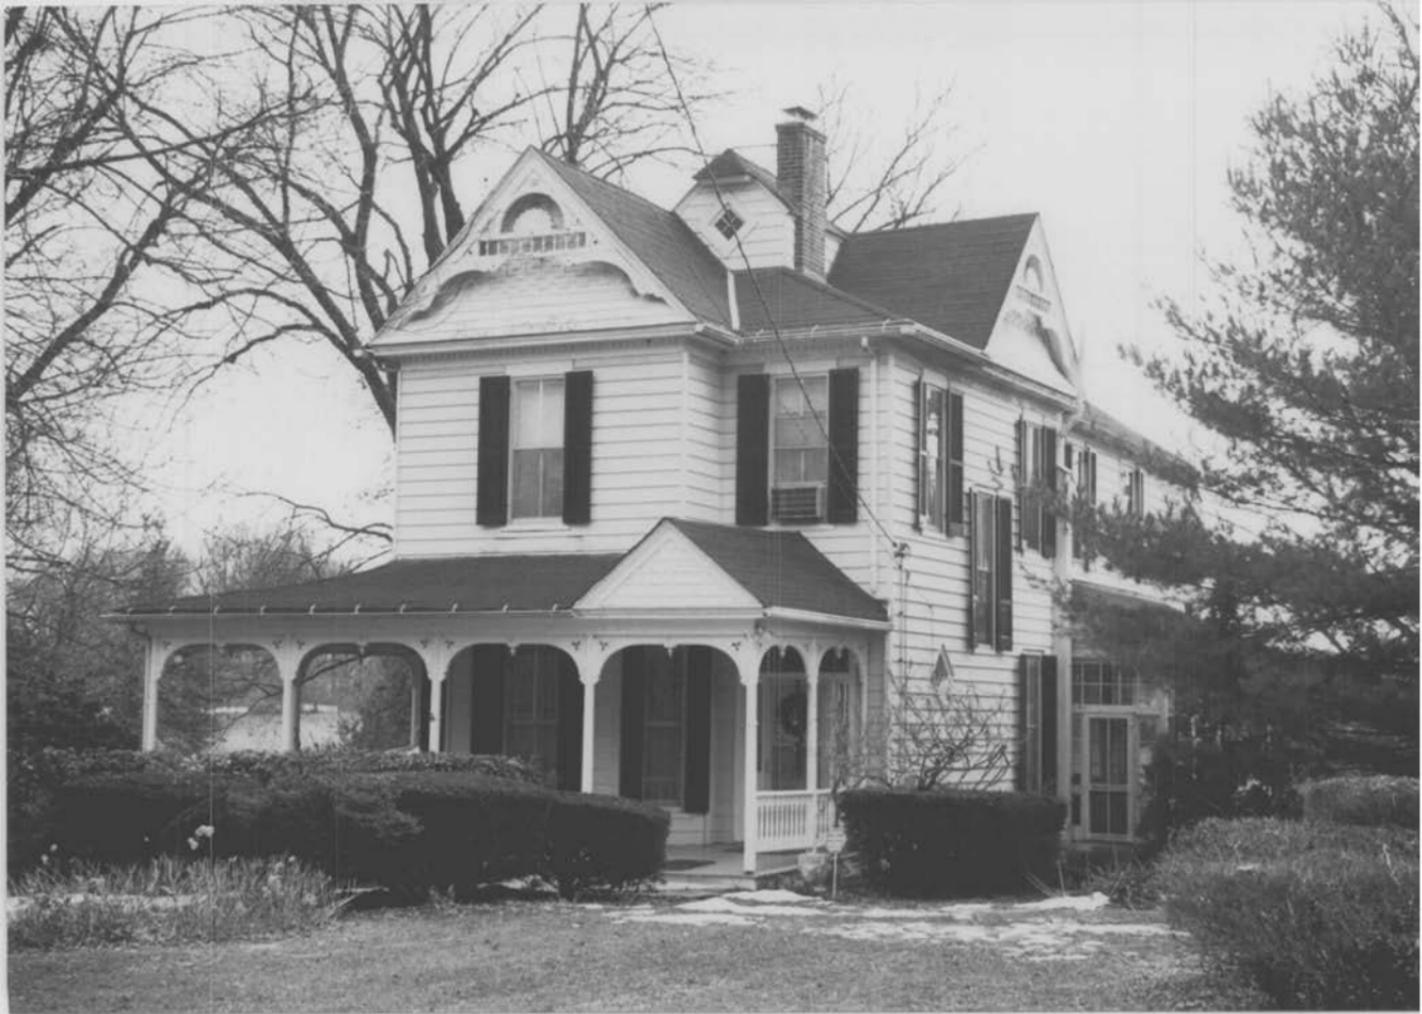
1/2

The first story of the west elevation has a diamond Queen Anne sash in the north bay, a one-over-one sash in the north-center bay, and a new enclosed porch covering the two south bays. There is a door in the center of the east two bays in the house. The second story has four one-over-one sash, and there is a similar sash set between the north and north-center bays, between the first and second stories. Above the north-center bay is a gable that is identical to the gable on the north elevation.

N. & W. eLeus

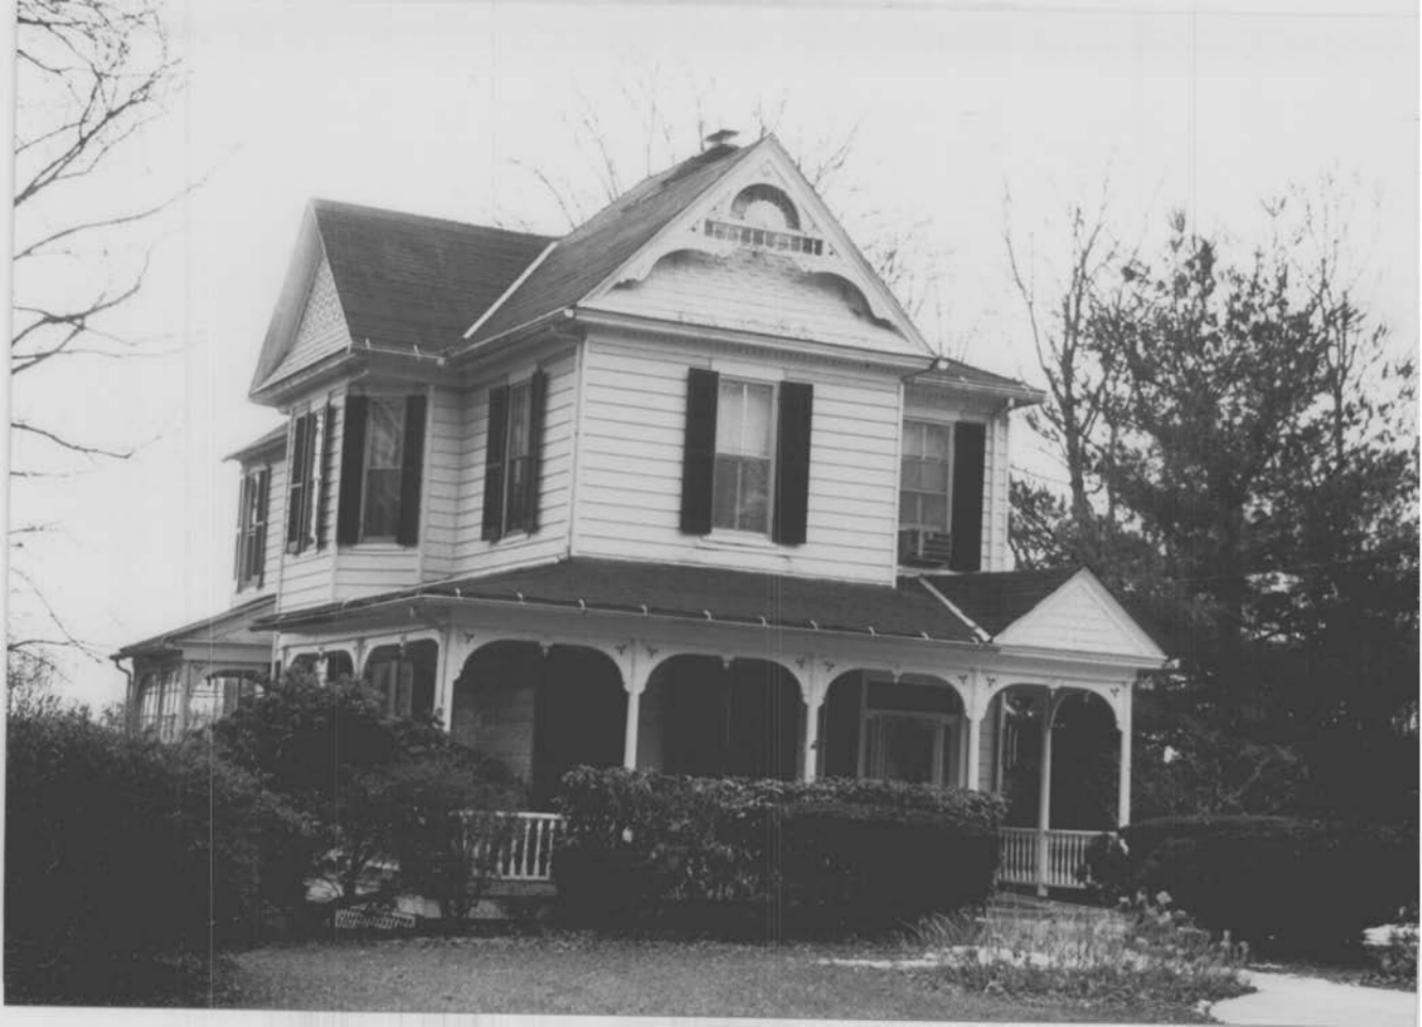
2/2

On the east elevation, the north-center bay is a three-sided, two-story projecting bay window with a one-over-one sash in each side of both stories. Above it is a gable end with the same shingles as the north gable. The bargeboard is missing, as it came down in a storm according to the owner. The north bay has no opening on the first story and a one-over-one sash on the second story. The south bay has a one-over-one sash on both the first and second stories. The south-center bay has a door on the first story and a one-story, one-bay porch with a shed roof and the same details as the north porch. This porch is now enclosed with windows.

E. & N. eleus
