1. STATE **Maryland**
 COUNTY **Baltimore**
 TOWN **Lutherville** VICINITY
 STREET NO.
1507 Bellona Avenue
 ORIGINAL OWNER
 ORIGINAL USE **residence**
 PRESENT OWNER **Frank Hasbrouck**
 PRESENT USE **residence**
 WALL CONSTRUCTION **frame**
 NO. OF STORIES **2 1/2**

HISTORIC AMERICAN BUILDINGS SURVEY
INVENTORY

2. NAME
 DATE OR PERIOD **ca. 1885**
 STYLE **Downing-Vaux Cottage**
 ARCHITECT
 BUILDER

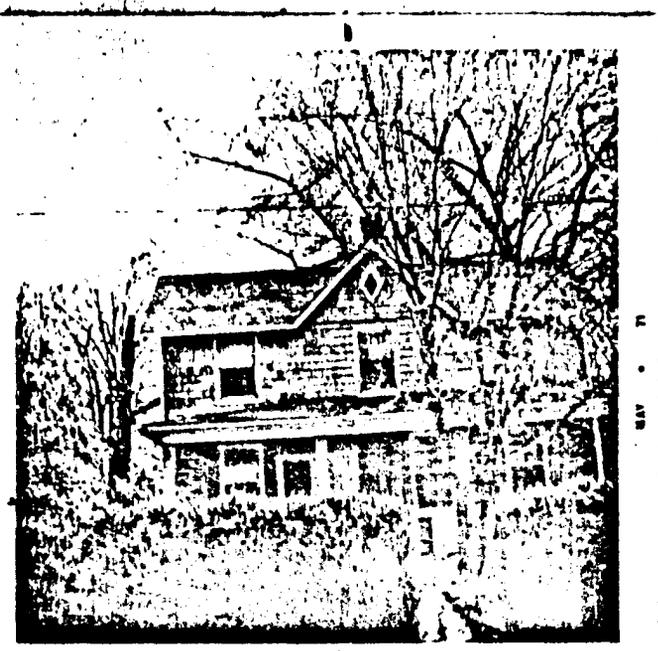
Produced from the typical Lutherville mould, this shingled house with its front, central attic gable at a right angle to the main roof ridge has three bays at the second floor level and an unusual four bays at the first floor level behind the one story porch. The porch is supported on shingled columns set on a shingled balustrade and has a moulded cornice at the eaves of the half hipped roof. Opening onto the porch is the paneled front door with one window bay to the north and two window bays to the south. The second floor windows are set directly over the end first floor windows with the central window under a diamond shaped window in the attic gable which has shingling projecting slightly beyond the lower wall surface.

The sash is typically six over six lights set in narrow trim similar in character to the unmoulded eaves and rakes.
