1. STATE Maryland  
 COUNTY Baltimore  
 TOWN Lutherville VICINITY  
 STREET NO. 1505 Front Avenue  
 ORIGINAL OWNER Rev. Benjamin Stadler  
 ORIGINAL USE residence  
 PRESENT OWNER Mrs. Nancy Armstrong  
 PRESENT USE apartments  
 WALL CONSTRUCTION frame  
 NO. OF STORIES 2

HISTORIC AMERICAN BUILDINGS SURVEY INVENTORY

1505 Front Avenue, Sheet 2

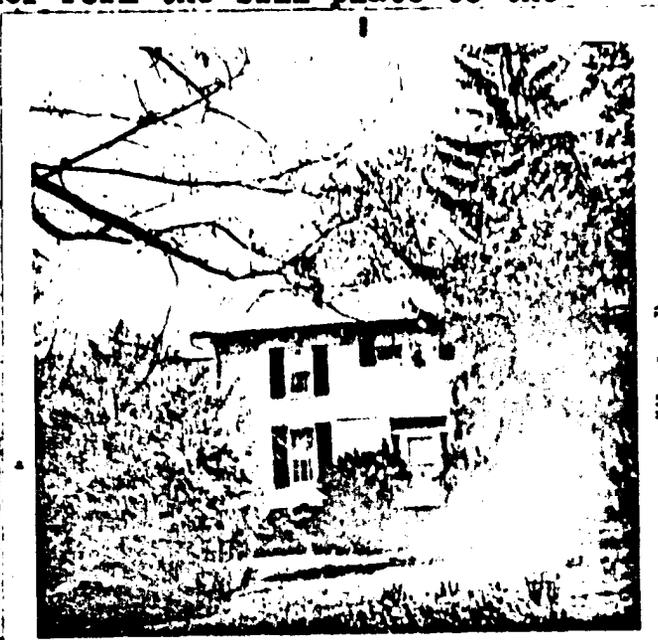
A simple house of low symmetrical proportions, it sits at the rear of a very deep, narrow lot facing Front Avenue and has a two story side wing set back from the main facade. Unornamented except for the small sparsely spaced brackets supporting the eaves of the low pitched, gabled roof, the house presents a three bay facade with a central sidelighted and transomed front door flanked by windows with six over six sash. Similar windows directly above at the second floor are slightly smaller scaled. Over the front door an awkward pair of low double windows interrupt the cornice frieze board.

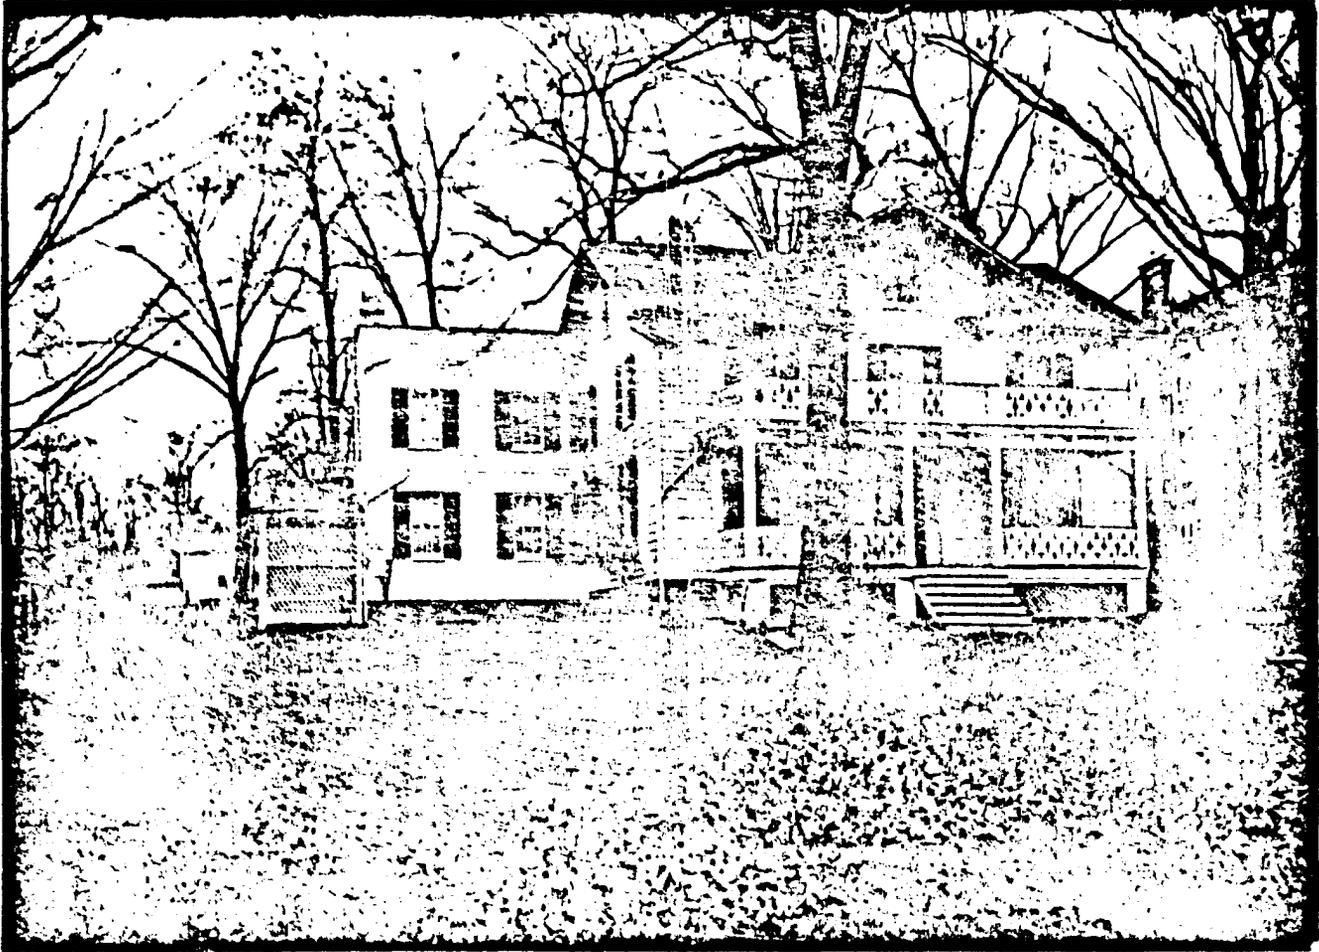
This existing house is the product of a 1940's remodeling which removed, as seen in the accompanying old photograph, an interesting central gabled motif in which the front wall of second floor extended through the eaves and appeared as a short tower form with a gabled roof, its ridge at the ridge of the main roof. This vestidule tower had large brackets at its verges and a semi-circular arched window which lighted the attic. Below this window there was a six over six window which was replaced with the double windows. The original porch was also removed with its square columns supporting a bracketed cornice and a balcony balustrade. Like the balustrade at the main level of the porch, it had unusual jig-saw cut slat balusters in an 'X' pattern. Still existing, though, and seen clearly in the old photo is the particularly interesting use of clapboard siding nailed in a diminishing exposure to the weather from the sill plate to the eaves. Also the original windows still retain their louvered

An early view of the house circa 1915
