BA-4
Old Salem Lutheran Church
701 Ingleside Avenue
Catonsville
Private
1849, 1869

Maryland Inventory of Historic Properties Form

Old Salem Evangelical Lutheran Church
701 Ingleside Avenue
Catonsville

**NATIONAL REGISTER OF HISTORIC PLACES
INVENTORY -- NOMINATION FORM**

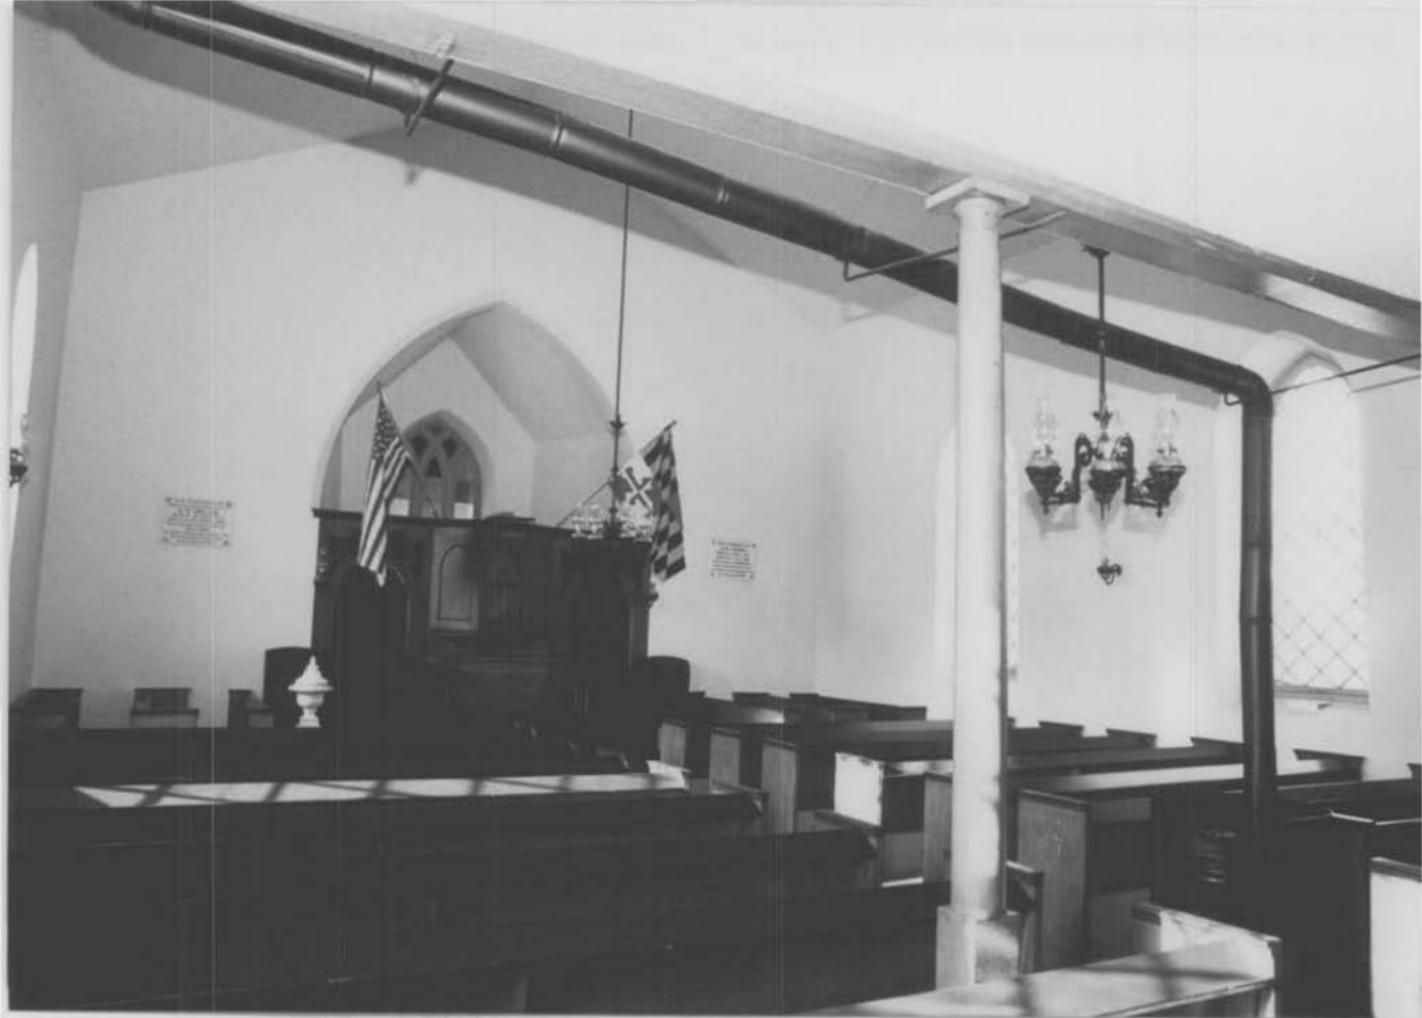
2/4

At the west end is a raised platform with a second platform for the altar in the center, under the pulpit. On the north and south sides of the altar platform are railings with turned balusters and newel posts. The newel posts are mortised and tenoned and pegged to the bottom rail, and the top rail is ovoid. The altar has one panel on each side that is sunk and flat and has no panel moulds. The east side of the altar is canted outward toward the nave of the church, and the whole altar is grained. There is a wall that closes off the sacristy from the nave, with a door in it on each side of the pulpit. The doors are lancet-shaped and have vertical boards with fillets that stop short of the top and bottom of the door. They are hung on cast iron butt hinges that appear to be plain, and have five knuckles and fast joints. They each have a plate latch with a brass knob. The east doors are tongue and grooved, but have no battens. The back side of the doors also has fillets, but they extend from the bottom to the top. The architrave also has a fillet. In the spandrels flanking each door are carved wood acanthus leaves that are applied. The pulpit projects out into the nave over the altar and is three-sided, with an ogee and bevel moulding at the bottom and a cavetto and large bead on the top rail. There is one panel on each side of the pulpit that is sunk and flat, and the rails and stiles have beveled edges. There are two pews on both the north and south sides of the platform, and they face in toward the altar. There is a marble baptismal font consisting of an urn on a pedestal, with a wood top.

Interior - vw. NW

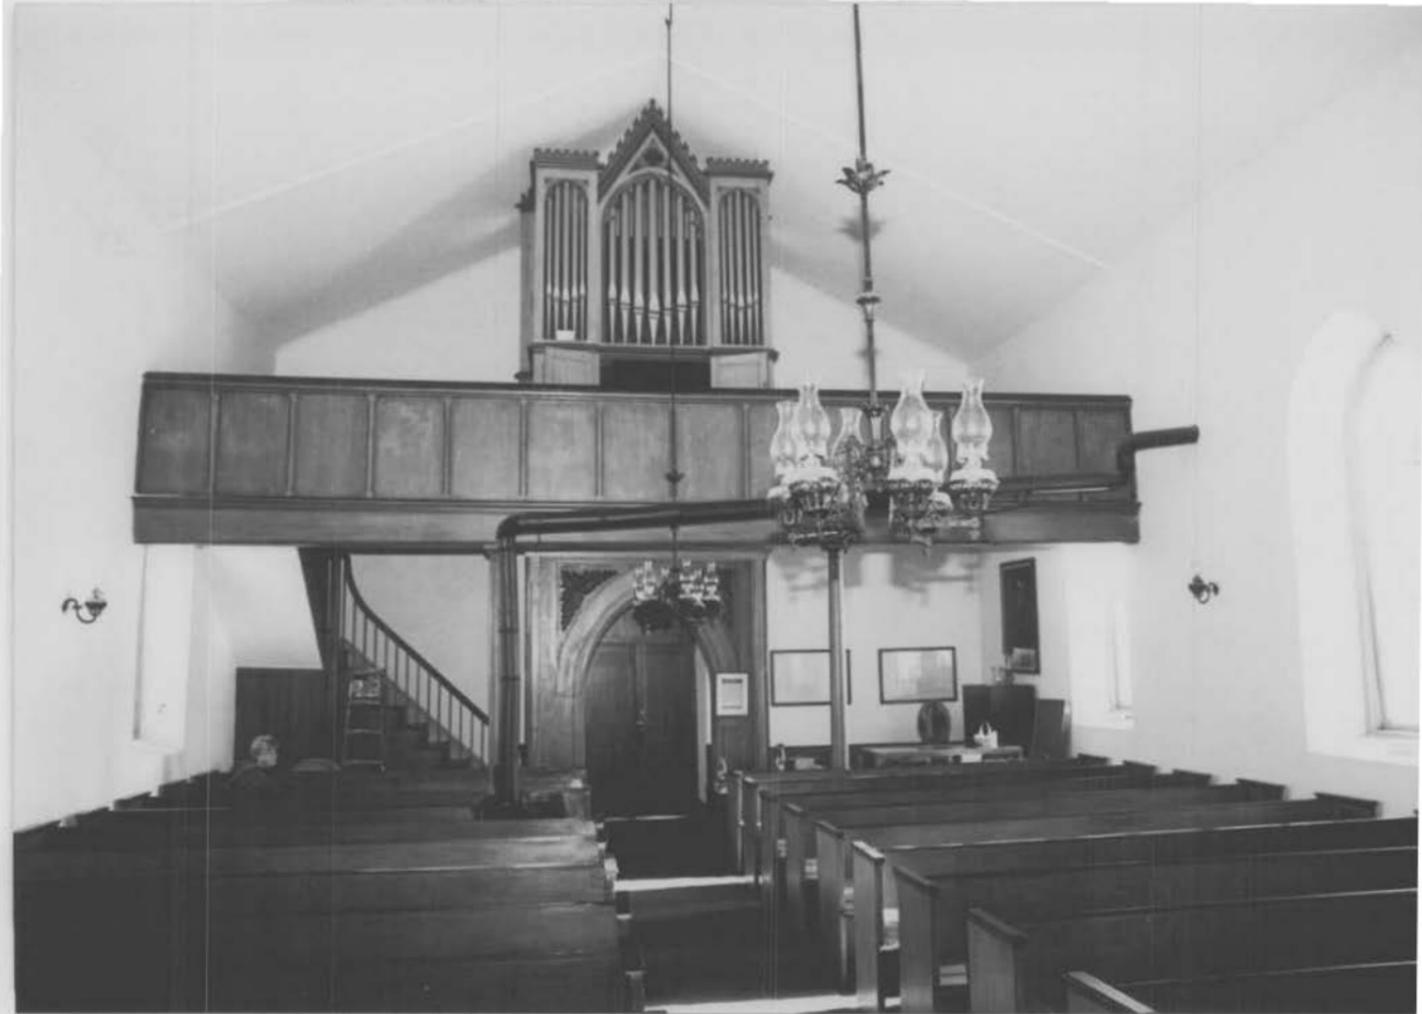
3/4

The gallery and organ loft has four tiers that step up to the east. It is constructed of random-width pine flooring that runs north-south. The balustrade at the west end has wide, hand-planed tongue and groove vertical boards on the east side and, on the west side has chamfered battens that cover the joints in these boards. The west side is grained. On top of the rail is a canted board with a stop that matches those on the backs of the pews, to hold a hymnal. In the center of the loft is the organ, which is still hand pumped by a wood lever on the north side of the case. The north and south sides, and the bottom of the west side are paneled with sunk, flat panels that have beveled edges to the rails and stiles. In the center of the case is a horizontal moulding with a deep cove and a bead at the bottom. The top of the case on the west is divided into three parts and has a pediment in the center with a quatrefoil in it and square towers on each side. Each part has a round-arched opening with cusps in the top of the arch. At the top is a cornice moulding consisting of the same cove and bead used around the middle of the case. Above the cornice are battlements. The case has graining. The organ has 17 pipes and ten stops, and was restored in 1987 by the Columbia Organ Works in Columbia, Pennsylvania. The bench here also appears to be original. On each side of the organ, behind it, are lancet-arched openings to the area under the belfry. On the east wall in this area is a rose window with new sash and glass added in 1990 to replace the deteriorated original.

Interior - view East

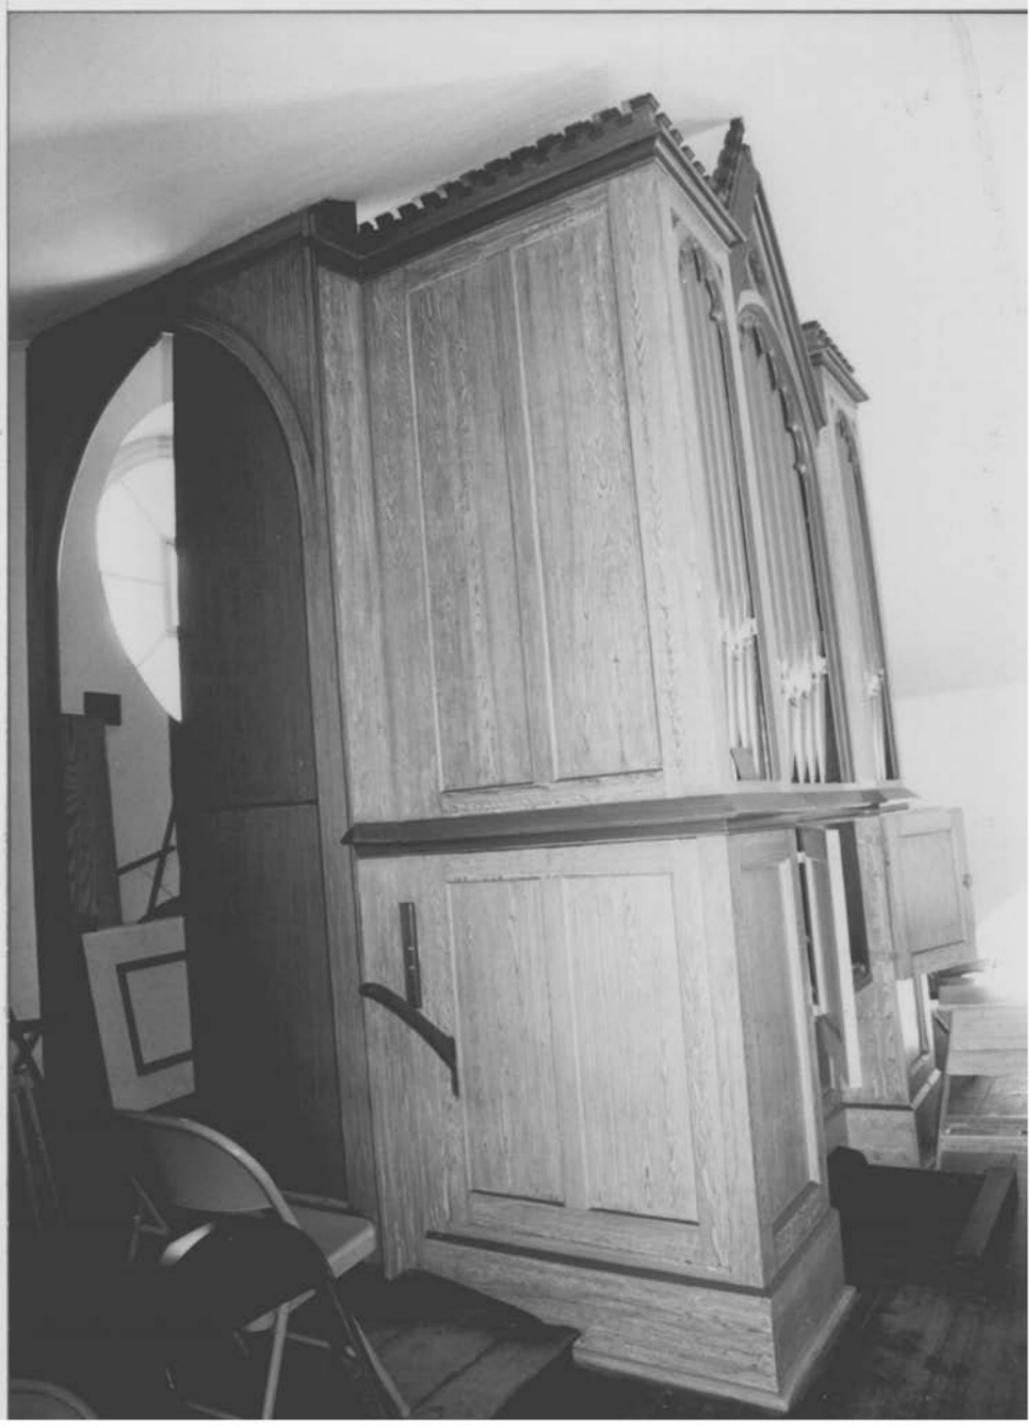
4/4

Organ

In the balcony of the church building is a fine example of a direct-tracker playing action pipe organ, built in the mid-nineteenth century. It is cased in wood, but the upper sides are open. It is still in operable condition, and is played at the fall service the congregation holds there each year. A lever action pump provides air for its pipes.
