MARYLAND HISTORICAL TRUST WORKSHEET

1. NAME				
COMMON: Melinda				
AND/OR HISTORIC:				
2. LOCATION				
STREET AND NUMBER: Worthington Avenue				
CITY OR TOWN: Glyndon				
STATE Maryland		COUNTY: Baltimore

BA-60

Melinda

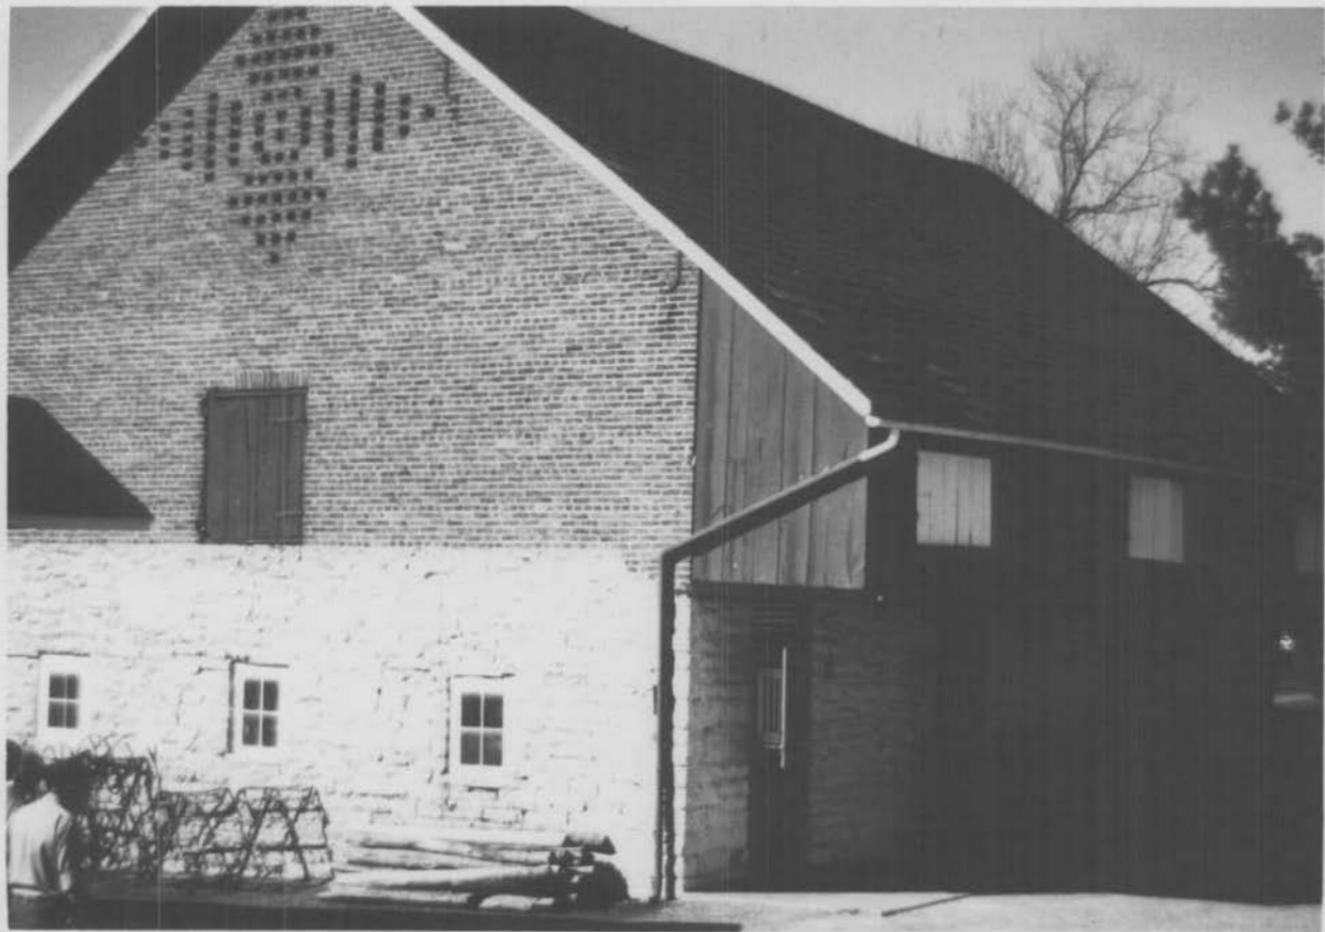
barn from southwest

An early two storey masonry barn is of interest, its first storey is of stone, containing box stalls; the second storey is of brick with decorative ventilators formed by omitted bricks. The hewn timber framing, open to the roof, is nearly complete. A wide cantilevered frame section of the second storey shelters the principal doors along one long side.
