1. STATE Maryland  
 COUNTY Baltimore  
 TOWN Lutherville VICINITY  
 STREET NO. 1613 Kurtz Avenue

HISTORIC AMERICAN BUILDINGS SURVEY INVENTORY

2. NAME Graystone 0300655504

DATE OR PERIOD 1857 and c. 1890  
 STYLE Downing-Vaux Cottage  
 ARCHITECT  
 BUILDER William Cockey

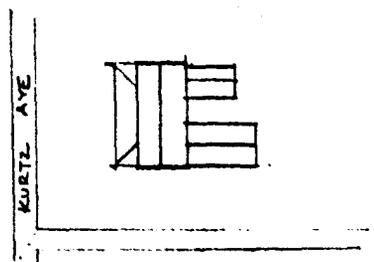
Graystone as it stands is the product of a late nineteenth century remodeling. Old photographs reveal that it was a typical two story, three bay Lutherville house, though in stone, with a front attic gable similar to the Shipley House at Lincoln and Clark Avenues. Graystone's gables were probably ornamented with similar verge boards decoratively jig-saw cut in an inverted crocket design like the gables of the dormer and the two rear wings, each a story and a half high and constructed of stone, set at right angles to the main house forming an 'U' plan.

The attic was raised to a full story and sheathed in horizontal siding before the turn of the century, seemingly in an effort to achieve a Georgian Revival character. Probably this also resulted in the addition of a Chinese Chippendale porch balustrade. This remodeling barely glossed over the earlier work showing through at the front porch with the open Gothic Revival trifoliate corner brackets at the porch columns and the bracket cornice which suggests modillions. The front door with sidelights and transom is flanked by pairs of elongated windows with large four over four sash. Like the second floor, two bay side elevations, and the wings the windows are filled with traditional six over six sash, matching the third floor addition, and have wooden lintels set over the masonry openings. See sheet 2

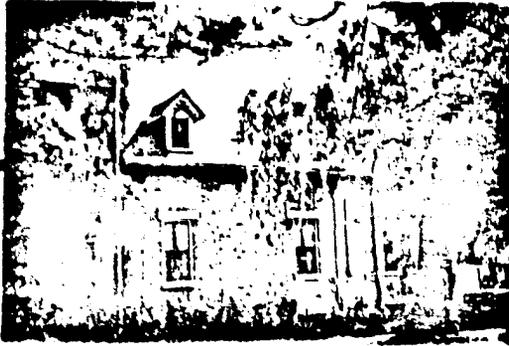
The photo graph below shows the dormer windows of one of the rear wings. The jig-saw cut ornament of the verge boards show how the front gables of "Graystone" must have been decorated prior to the remodeling when the attic was raised to a full story.
