**CAPSULE SUMMARY**  
**BA-924**  
**2315 Meredith Road**  
**White Hall, Baltimore County**  
**Circa 1875**  
**Private**

# Maryland Historical Trust Maryland Inventory of Historic Properties Form

Inventory No. BA-924

Name 2315 Meredith Road, White Hall, Baltimore County  
**Continuation Sheet**

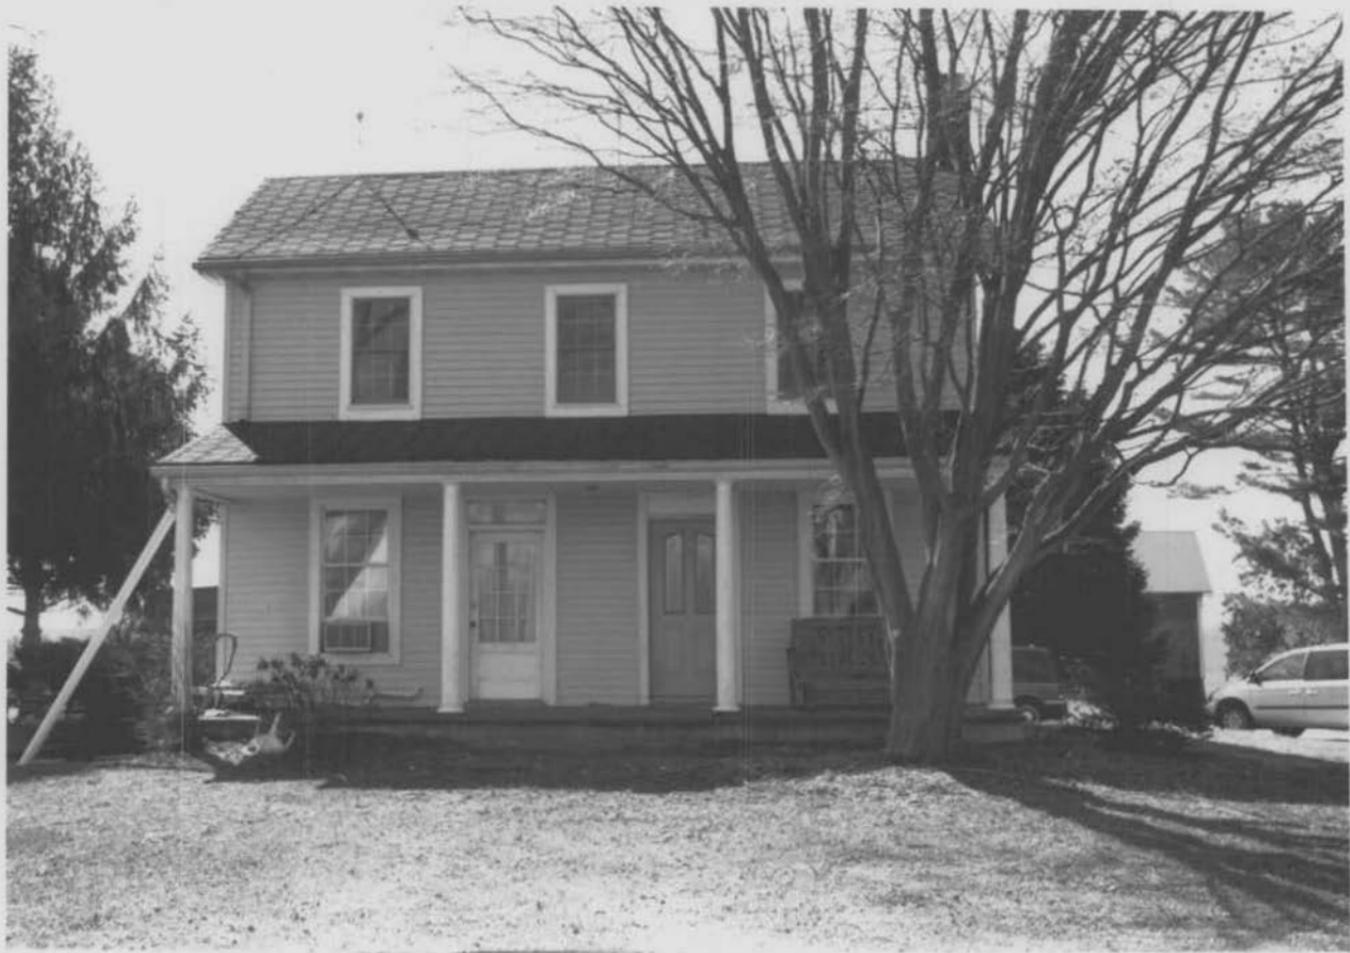
1 OF 7

MAIN HOUSE, NORTHEAST ELEVATION

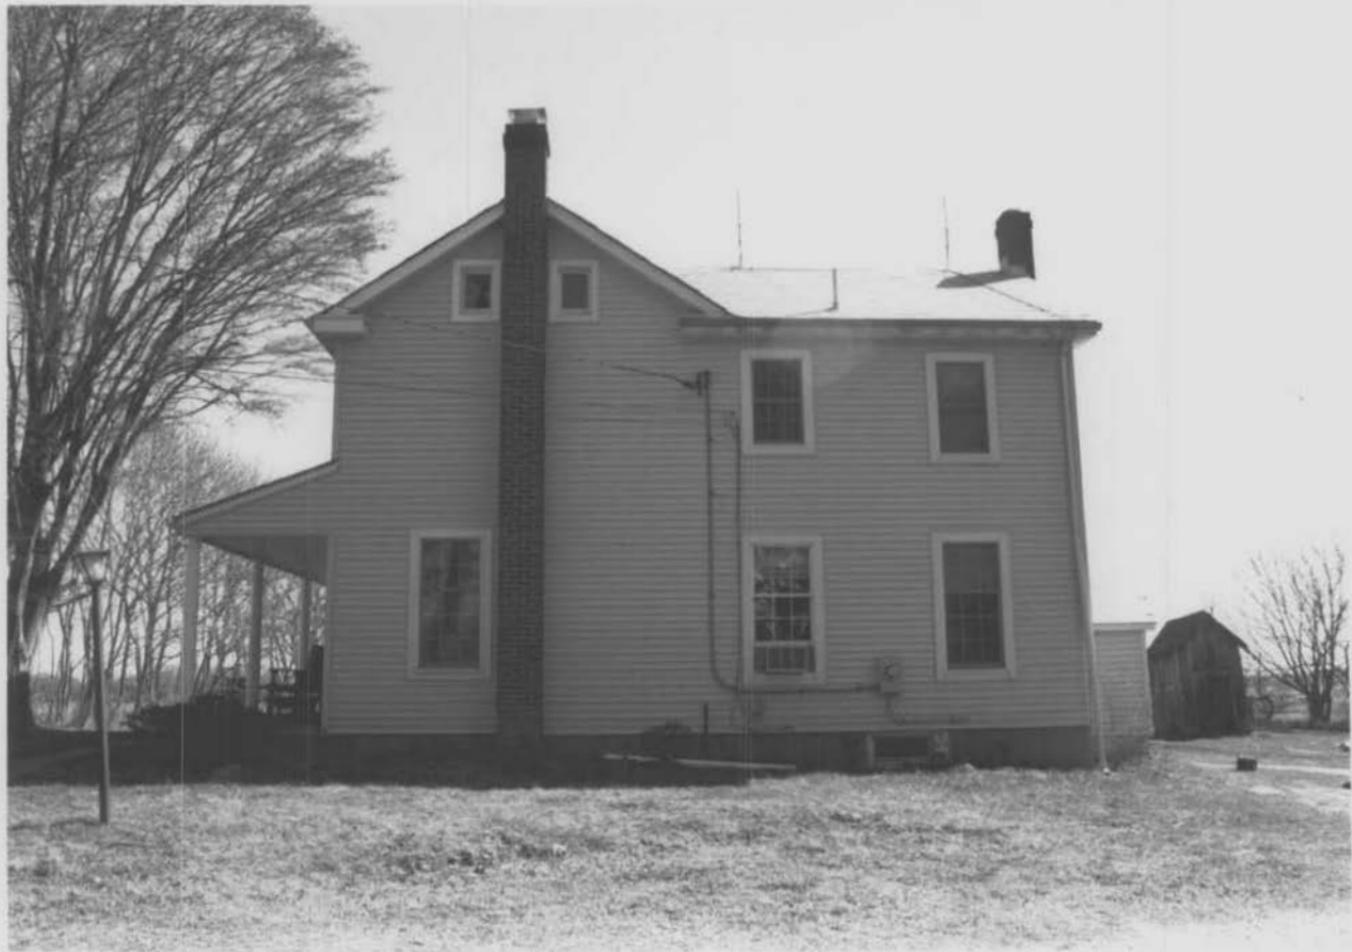
2 of 7

MAIN HOUSE, NORTHWEST ELEVATION

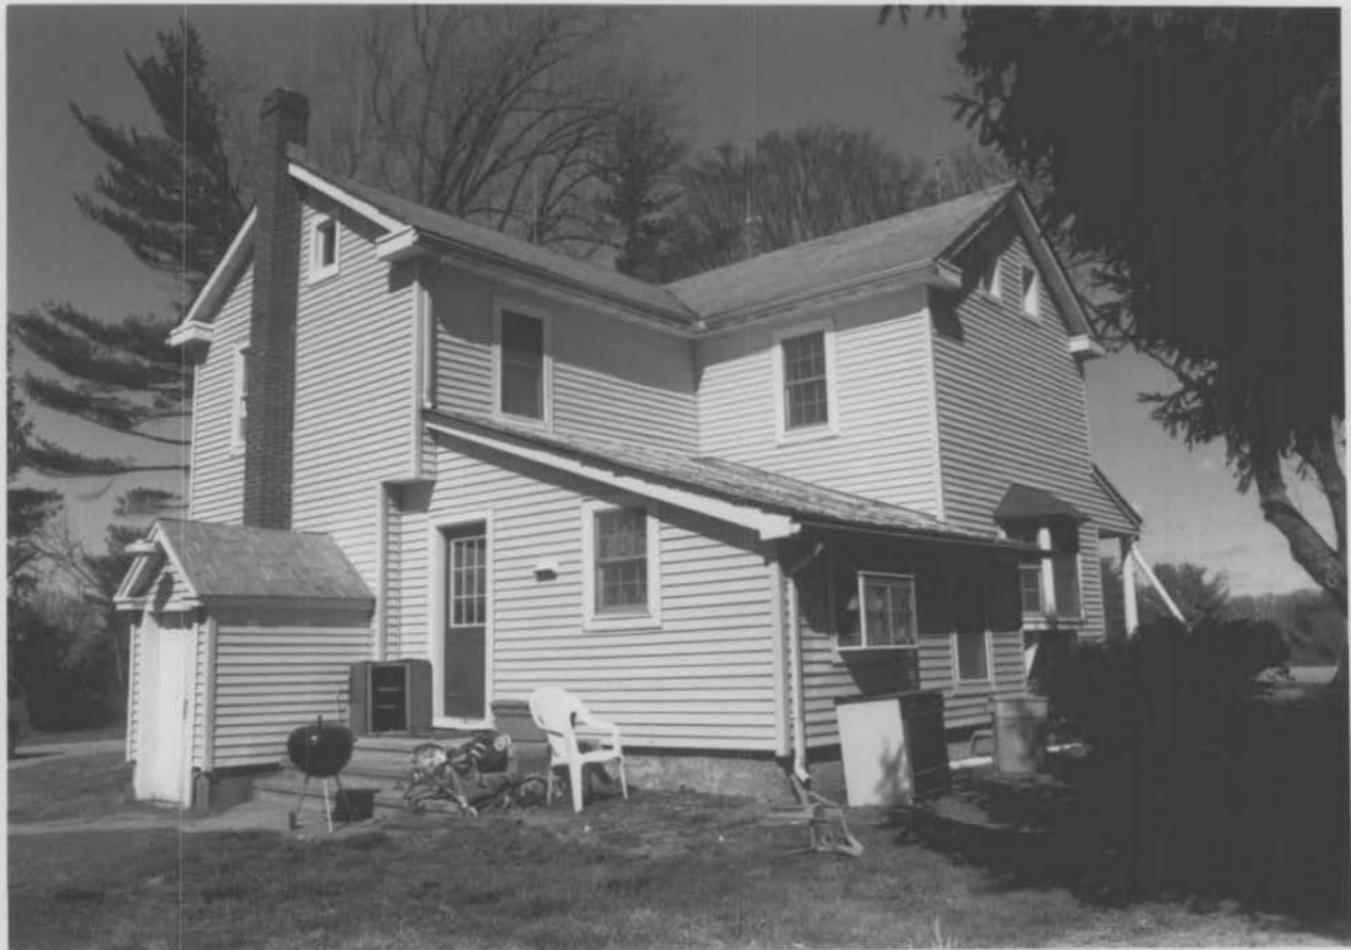
3 OF 7

MAIN HOUSE, SOUTH CORNER

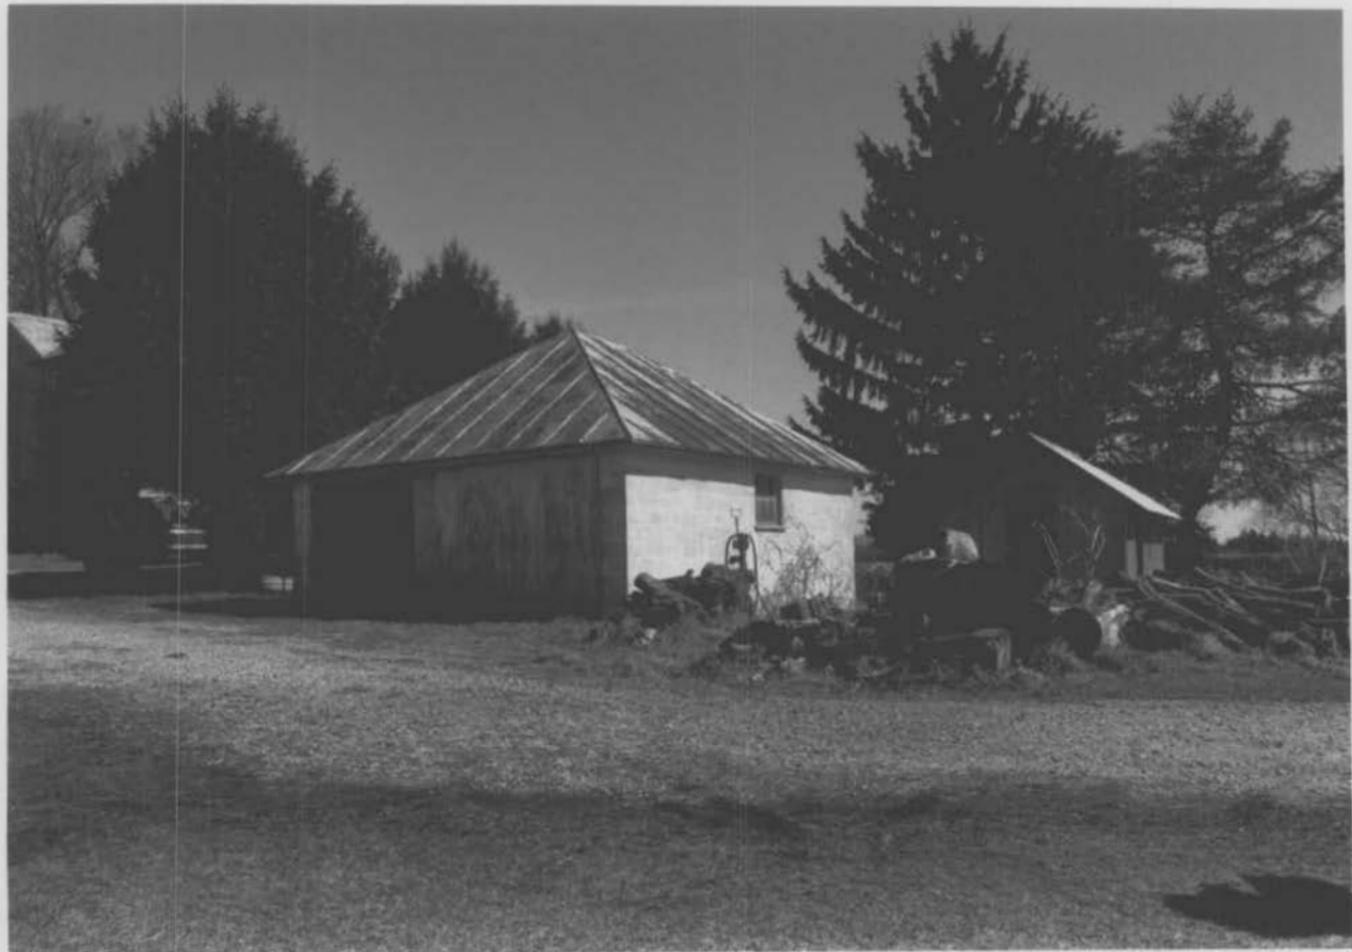
4 OF 7

A circa 1940s paneled concrete block garage is located to the rear of the house. The façade is pierced with a two-leaf vertical board sliding door. It is capped with a hipped roof clad with standing-seam metal.

Next to the garage is a one-story high one bay wide circa 1950 wood frame shed. The walls and front gable roof are clad with corrugated sheet metal. The one-leaf door on the front is missing.

GARAGE AND SHED, VIEW LOOKING NORTHEAST

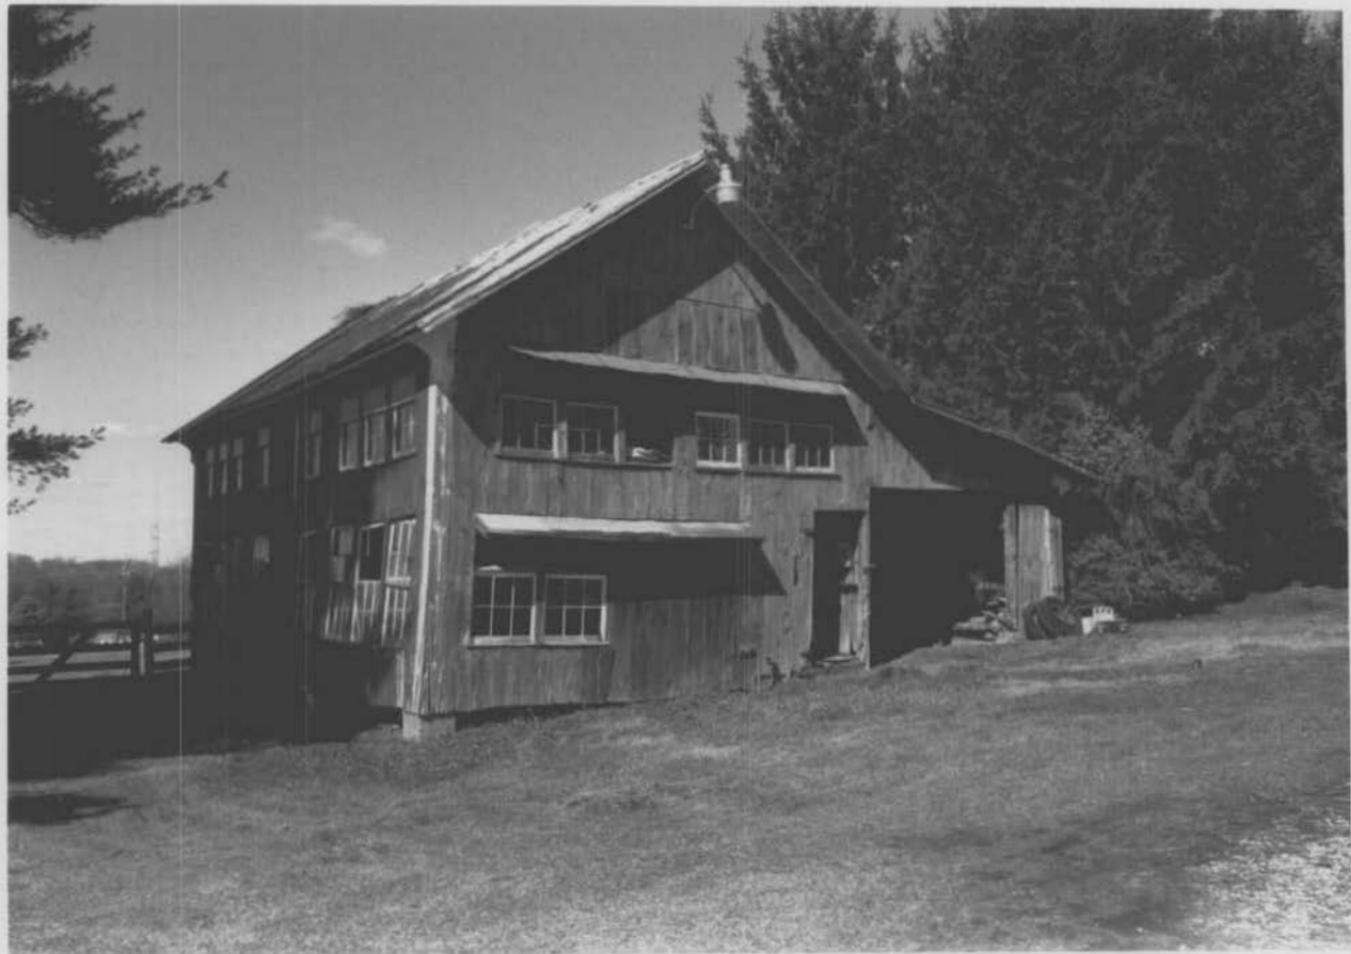
5 OF 7

A circa 1930 dairy bank-barn standing one-and-a-half stories high sits on a solid parged foundation and is clad with vertical boards. The façade has several open bays at the ground level and a two-leaf sliding vertical board door on the upper story. It is capped with a gambrel roof covered with corrugated sheet metal. A concrete-stave silo is attached to the barn.

BANK BARN, EAST ELEVATION

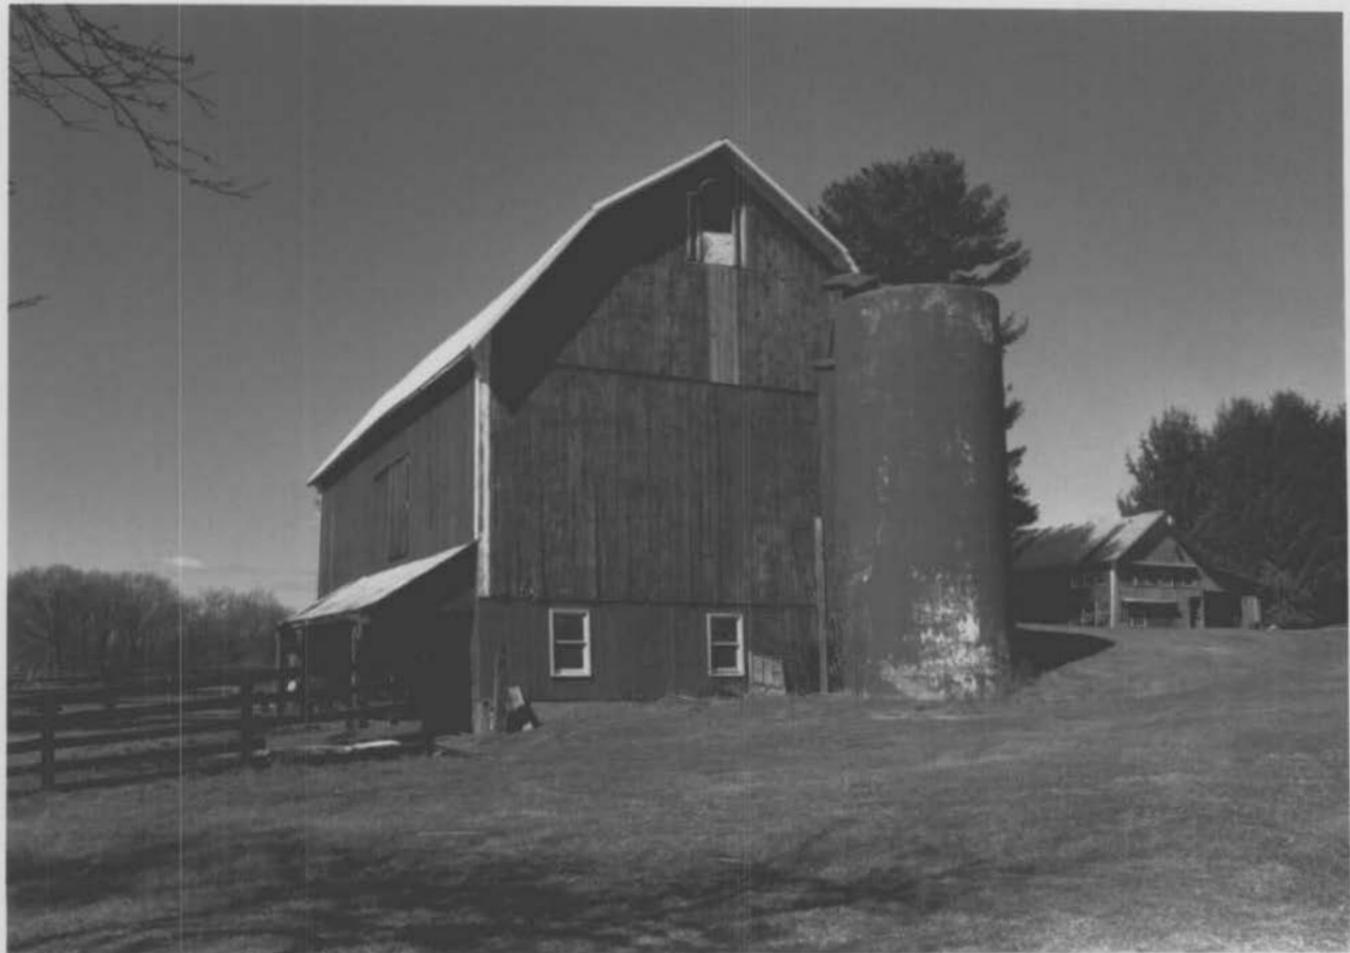
6 OF 7

To the southwest of the main house is a circa 1900 two-story wood frame barn, possibly a dairy barn suggested by the numerous windows on the front and side elevations. It stands on a concrete-block pier replacement foundation and is clad with vertical boards. The southeast elevation shows 8 6/6 double-hung wood sash windows and the side elevation shows 16 6/6 double-hung wood sash windows. The southeast elevation has a single-leaf door opening which is missing the door. The building is capped by a front gable roof with overhanging eaves and clad with corrugated sheet metal. The northeast elevation has a one-story shed roof addition with a large open bay.

BARN AND BANK BARN, EAST CORNER

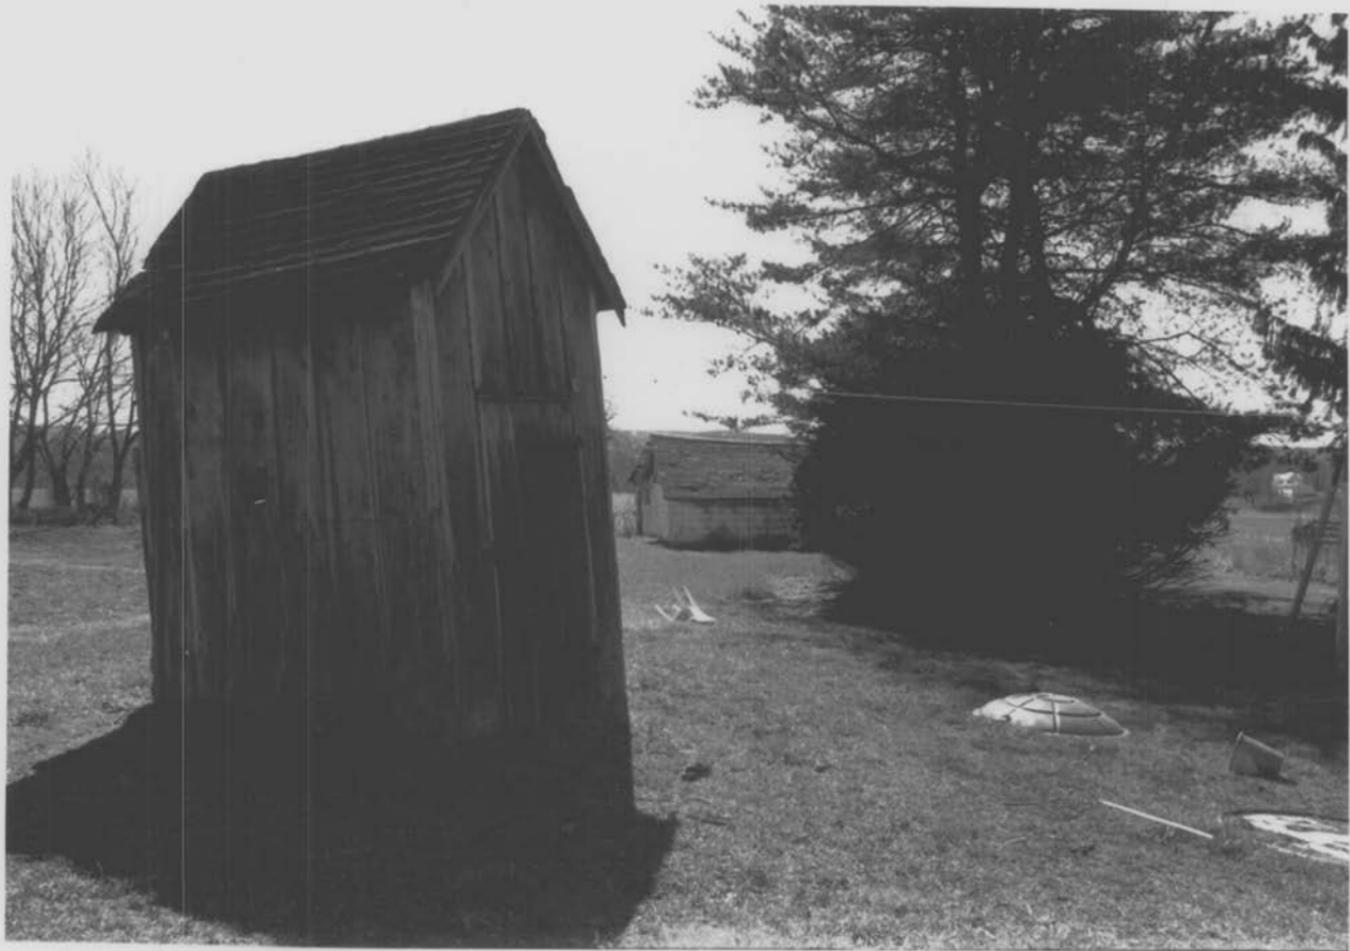
7 OF 7

There are six historic outbuildings associated with this property. A circa 1920 smokehouse is one bay wide and one story high and is wood frame covered with board-and-batten siding. No foundation is visible, and the single-leaf door is of vertical boards. The asphalt shingle covered front-gable roof is steeply pitched and features exposed roof rafters.

Finally, furthest away from the main house to the rear is a circa 1920 chicken coop constructed of concrete blocks. It has a front gable roof covered both with asphalt shingles and corrugated sheet metal. It is pierced

with two 6-light wood awning windows and a single-leaf vertical board door. The overhanging eaves of the roof feature exposed roof rafters.

SMOKEHOUSE AND CHICKEN COOP, VIEW LOOKING SOUTHWEST
