BA-99
"Dumbarton"
300 Dumbarton Road
Towson
c. 1853, 1923
Private

Maryland Inventory of Historic Properties Form

Inventory No. BA-99

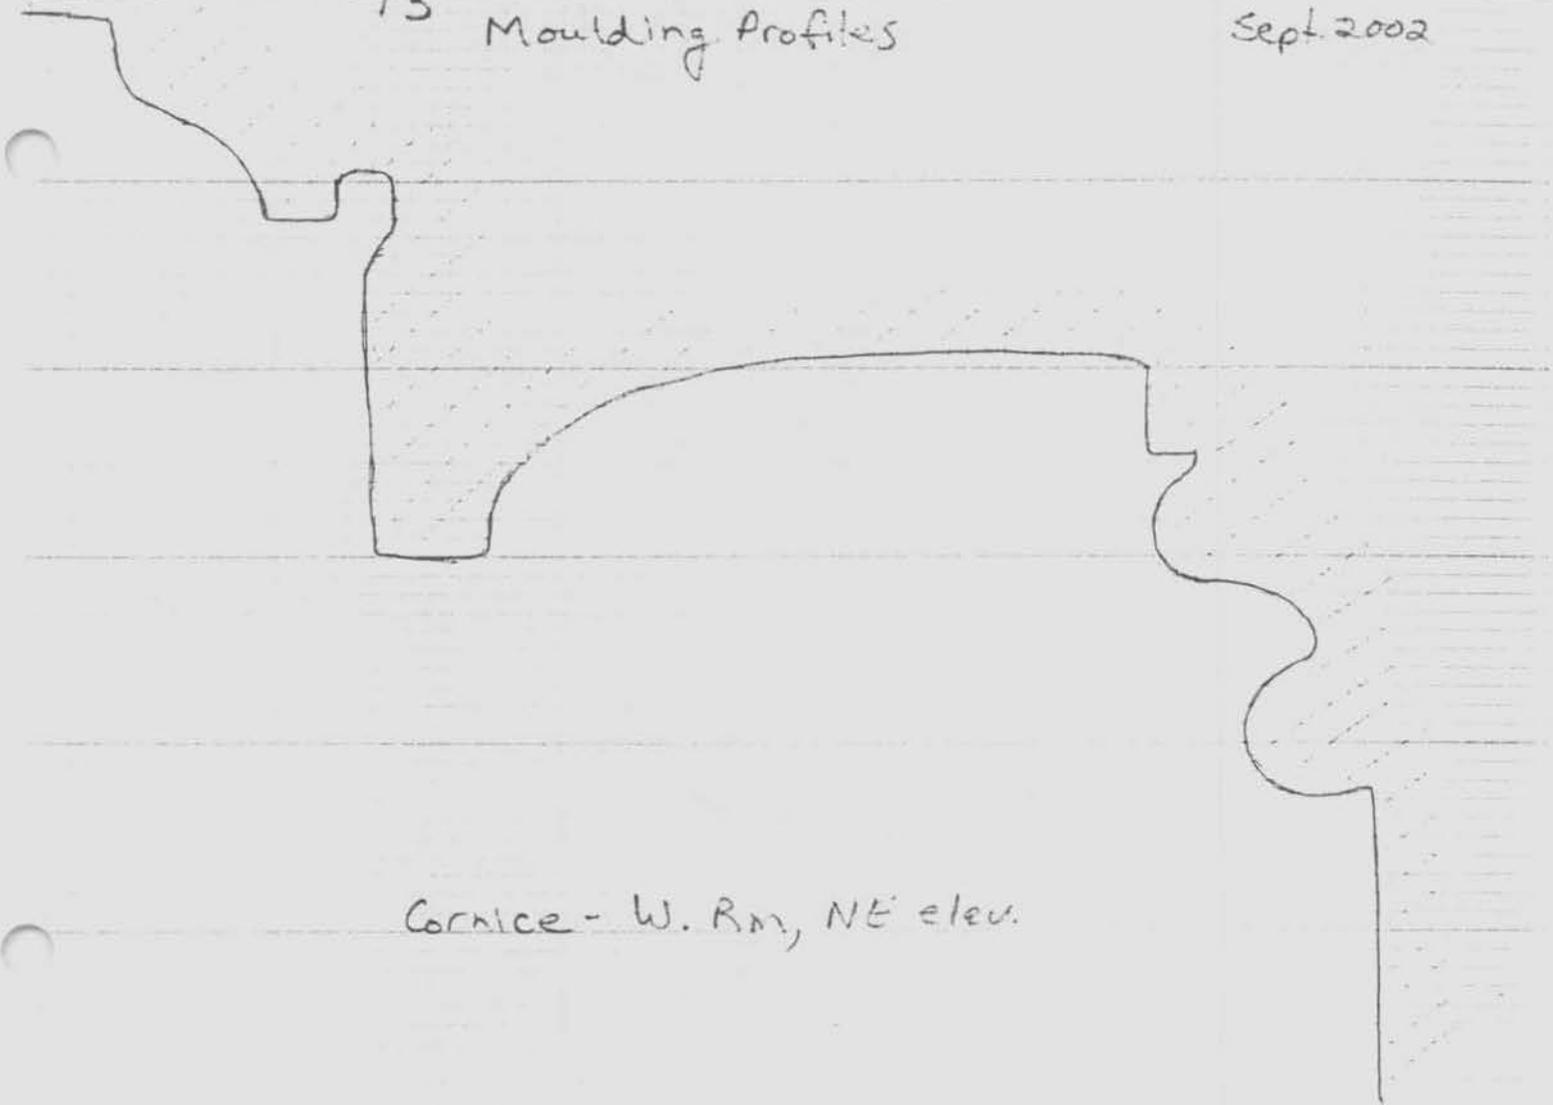
3/3 Dumbarton BA-99
Moulding Profiles

Cornice - W. Rm, NE elev.

Window Architrave - W. Rm.

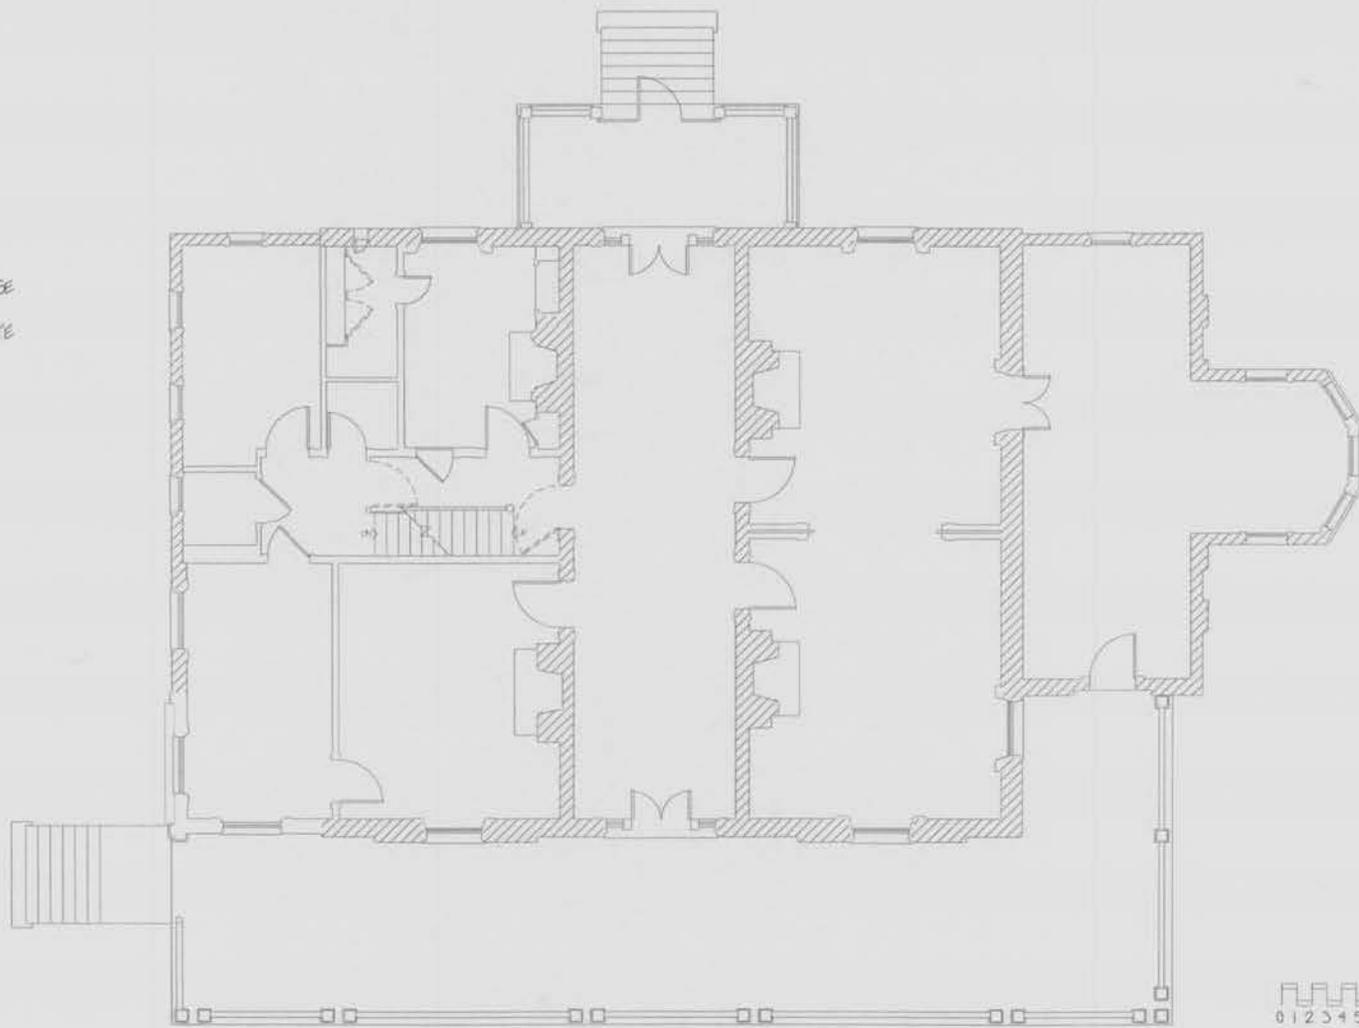
FIRST FLOOR PLAN MEASURED BY KEN SHORT, HEATHER BARRETT, MARCIA MILLER & TOM RINEHART DRAWN BY KEN SHORT SEPTEMBER 2002

RECENT CLOSET AND BOOKCASE
ADDITIONS NOT SHOWN
RETAINING WALL AND CONCRETE
CELLAR STEPS NOT SHOWN

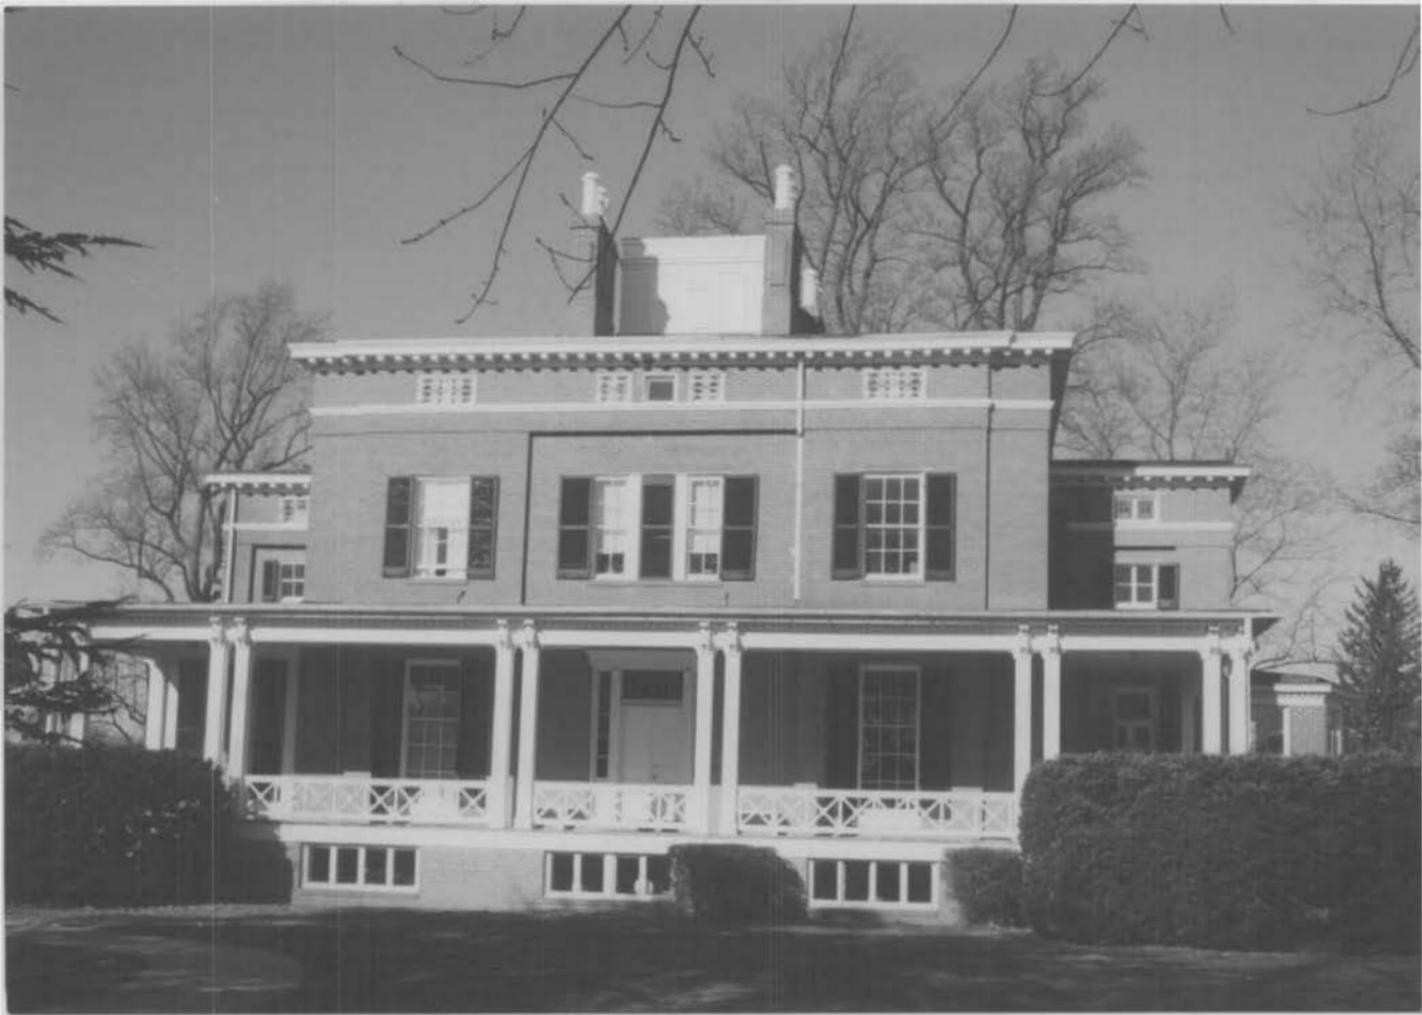
1/13

southeast elev.

The southeast elevation of the center block has brick infill beneath the porch, with four one-light casements in each bay. This foundation is divided into five bays, as the porch wraps both sides of the center block. On the first story, the center bay has a painted stone sill with no wash and a pair of three-panel doors with sunk, flat panels and quirked ogee and bevel panel moulds. There is a four-light transom with iron bars set in front of it in the pattern of a rectangle with an oval inside of it and a diamond inside of the oval, all crossed by two diagonals, one from each corner. There are paneled pilasters with scroll brackets at the top that have Greek anthemion. The brackets are also carved on each side. The sidelights have five lights each above one panel that is sunk and flat and has a quirked ogee and bevel. The door cornice has a Greek ovolo bed mould and a plain frieze, all in wood. The transom bar has an ovolo and the doorframe has a bull-nose moulding that is more similar to a Greek ogee. The end bays each have a six-over-nine sash in a bull nose-moulded frame with a painted stone sill and an iron lintel. There are exterior blinds with original hardware of three cast iron butt hinges on each blind and a slide bolt. Both of the end bays project about 4 inches. There is a one-story porch that wraps around both sides of the center block. It has six pairs of square posts with scroll brackets on the face and smaller brackets on each side beneath the frieze. The porch has a dentil cornice and a railing with cross braces between vertical balusters, with roundels at the crossing of the diagonal braces. The center section of porch railing is constructed differently than the remaining sections. The second story center bay has paired four-over-four sash with a brownstone sill, an iron lintel, and three blinds, one being in the center between the two sash. The end bays have a six-over-six sash with a brownstone sill, an iron lintel, and blinds. The end bays also project on the second story, making the corners and center appear to be recessed. On the upper story, all three bays project. This story has an ogee architrave, a plain brick frieze containing windows, and a cornice with uncut blocks. The center bay has three windows, the two end windows having cast iron grilles with anthemion. The end bays each have paired windows with double cast iron grilles of the same pattern. There are four sets of paneled, interior brick chimneys with terra cotta chimney pots, and each set has three flues and pots. Between the chimneys is a lantern with a shed roof that slope down to the northwest, and three closed-off window openings on each side.

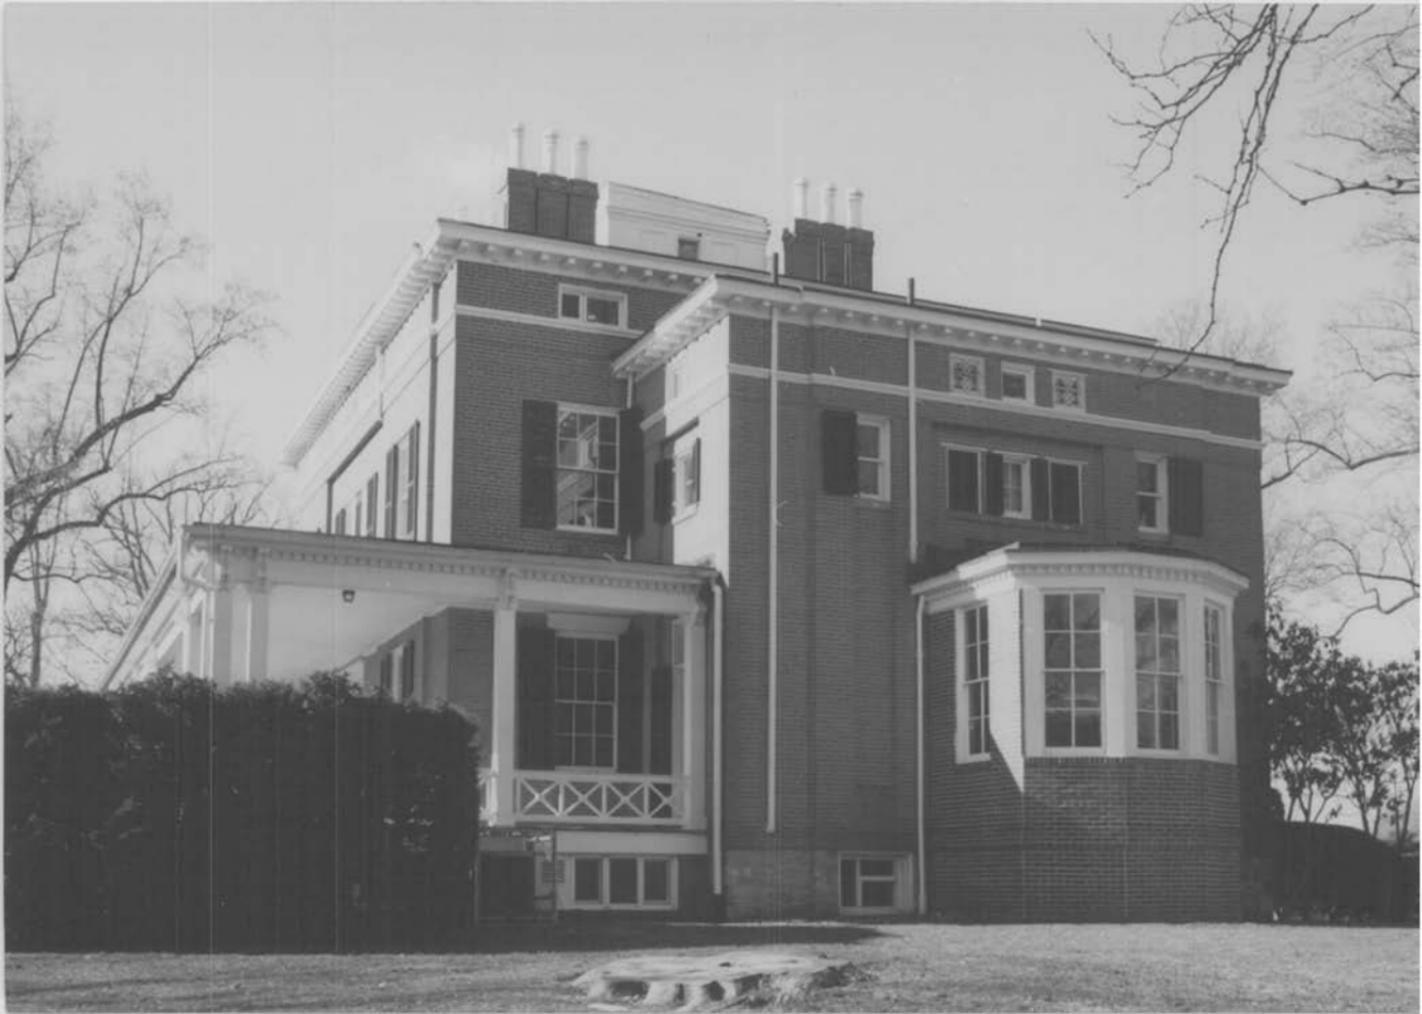
2/13

Northeast elev

On the northeast elevation, the east bay of the center block has typical brick infill and four casements in the foundation below the porch, and typical details on the porch. The first story has a six-over-six sash with a painted sill and a wood cornice that matches that over the center door of the southeast elevation. The second story has a typical six-over-six sash that is shorter than the first story, and has a brownstone sill, iron lintel, and blinds. The frieze is typical and has two one-light casements of different sizes. The northeast wing covers the other three bays. The northeast elevation center block frieze has windows in the center and north bays, but they cannot be carefully observed.

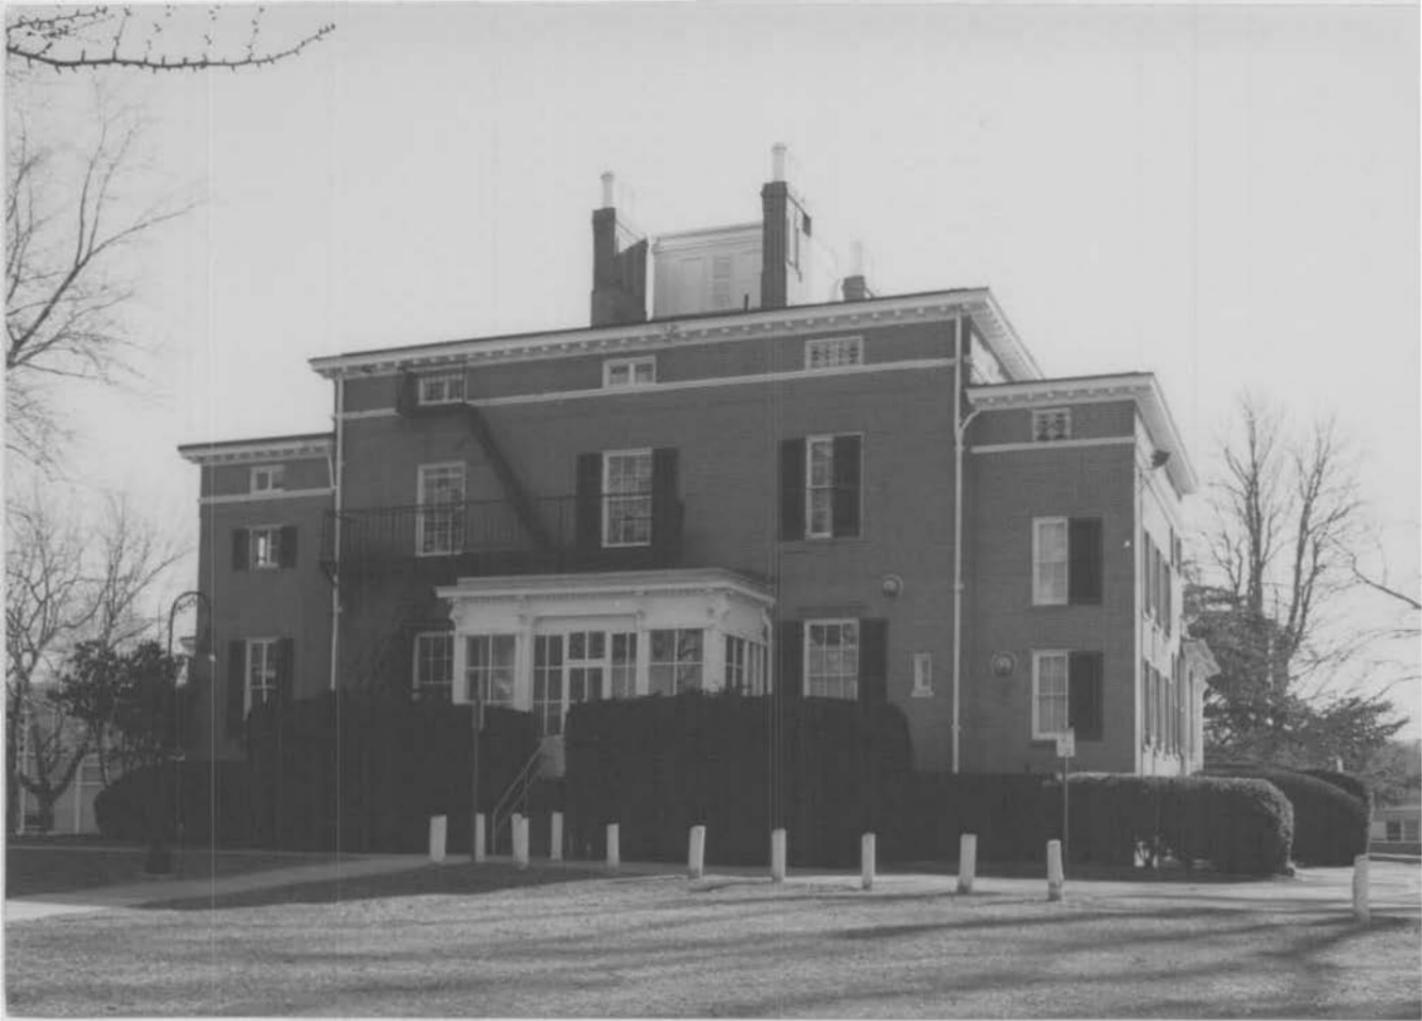
3/13

Northwest elev.

On the northwest elevation the center block has a porch on brick piers in the center, with concrete block infill between the piers at the foundation level. The north bay foundation has paired six-over-six sash with a brownstone sill that has a wash, a brownstone lintel, a bull nose frame, and iron bars. The sills are in two pieces but the lintel is one piece. There is a wide wood post between the bull noses. The west bay is the same as the north bay. There is a water table like that on the northeast. Around the north side of the block and wing, as well as the northeast corner, the ground is excavated about 2 feet deep, about 2 feet from the foundation wall, with a rubble stone wall that has large ashlar coping stones on top. This wall is carried around the west side and west end, as well. Two of the coping stones on the west are reused from another location. Each has a rectangular and a round hole cut into the top, next to each other, near the center. One of these stones has a half-round depression at one end that could have been a gutter. The first-story center bay has a one-story porch with four square posts and the same cornice as the southeast porch. The porch is enclosed with sections that have six lights over three panels between each pair of posts, and they are set in front of railings that match those on the southeast porch. The panels have sunk fields and ovolo moulds. There are two sets of six lights over three panels on each end of the porch and one set on each side. In the center of the porch is a two-light transom above a door with four lights over a covered panel. To each side of the door is a narrow section with six lights over two panels. The rails and stiles are mortised-and-tenoned, with wedges on the ends of the joints, not pegs. There are metal bars on each side of the top of these six-light-over-three-panel sections, and these bars hold a horizontal 2 by 4 that crosses in front of the top rail and holds each section in place. The north bay of the first story has a typical six-over-six sash with a brownstone lintel that has a quirked Greek ovolo mould across the top. There is a fire escape here that extends up to the frieze. The west bay has the same window and lintel as the north bay. To the west of it is a narrow, two-light sash with a limestone sill and iron lintel. The opening appears to have been cut into the wall later. There is a clear break in the brickwork between the first and second stories here. The first story brick is much lighter, and this pattern continues on the southwest wing. The line in the brickwork between the first and second stories continues on the north side of the porch, but is difficult to see because of staining from the fire escape. The second story has three typical six-over-six sash with brownstone sills and iron lintels. The west and center bays still have blinds. There is a typical frieze and cornice that projects slightly, and three frieze windows. There are paired one-light sash, and the west bay retains a typical grille.

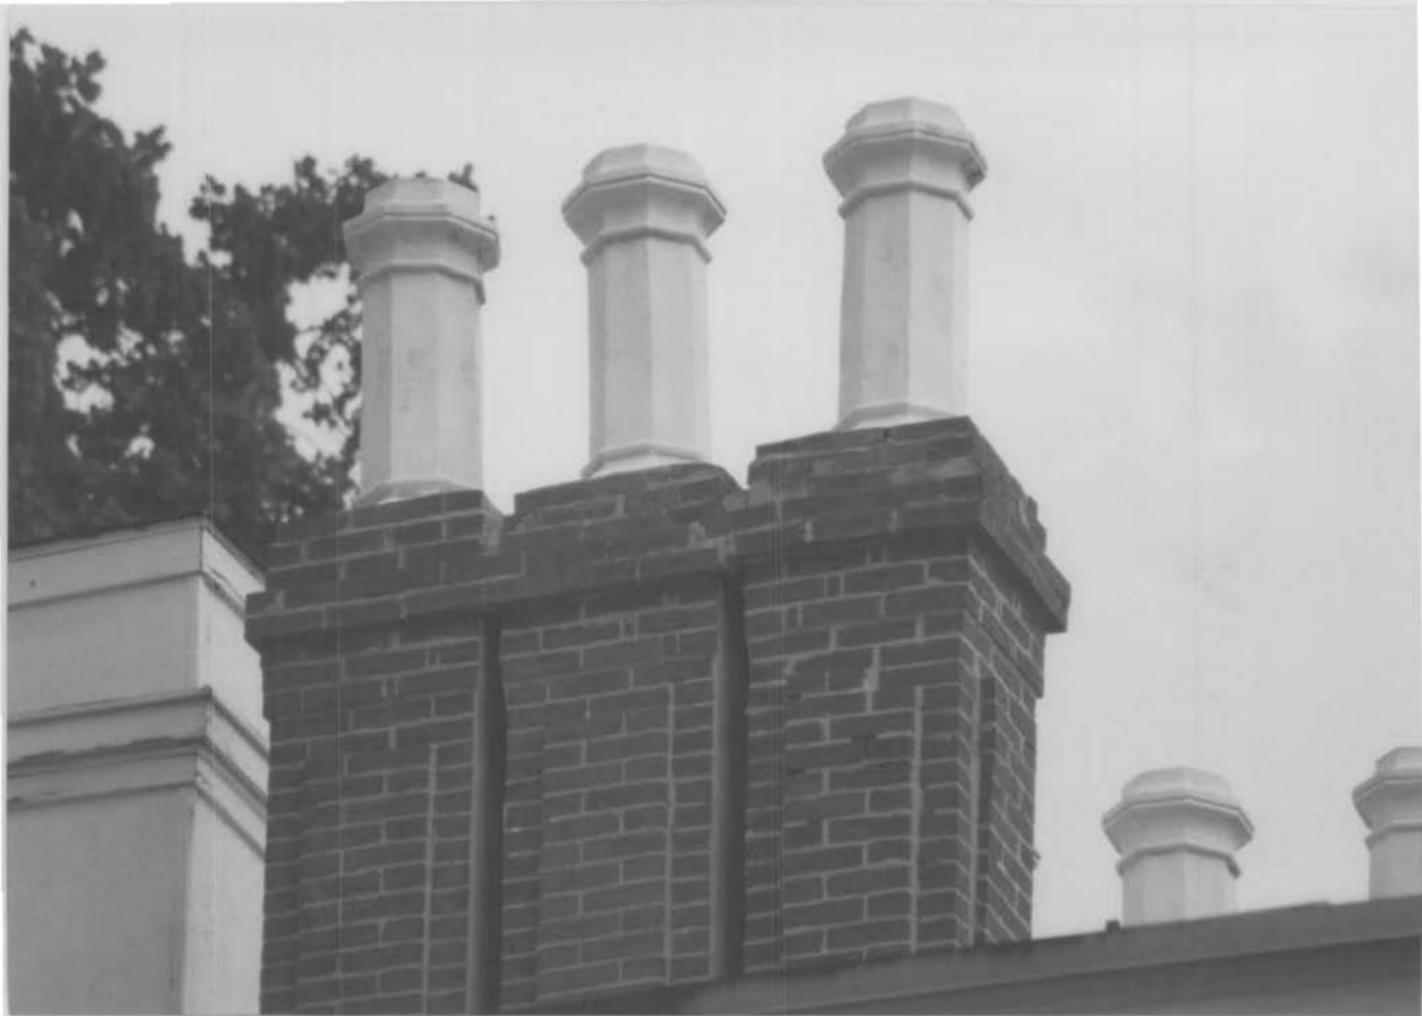
5/13

South chimneys

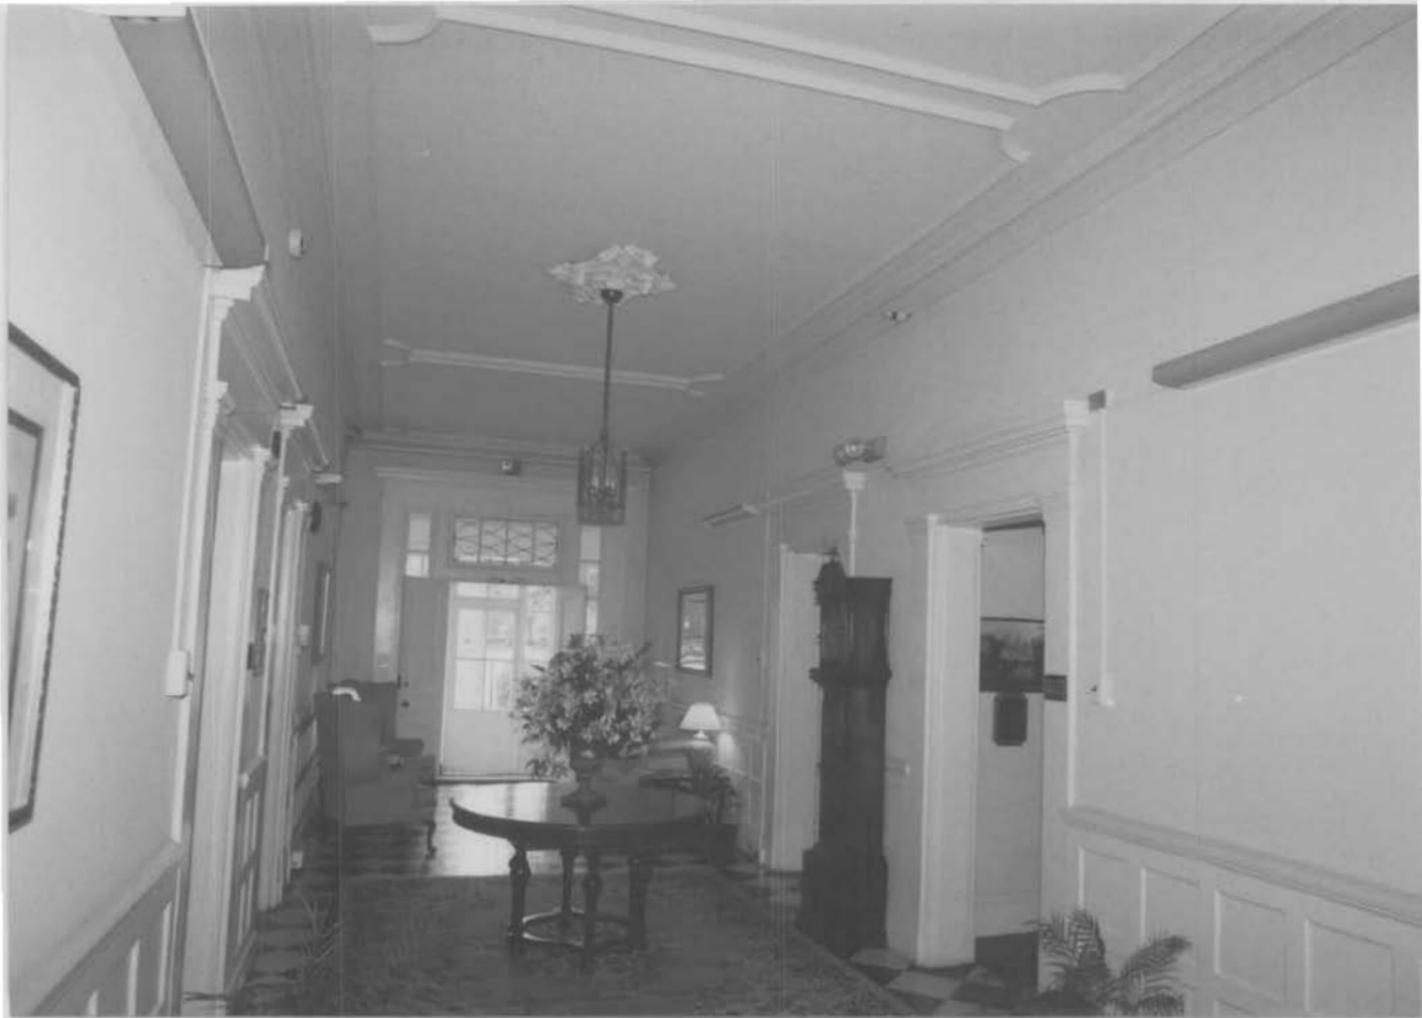
6/13

Passage - vw north west

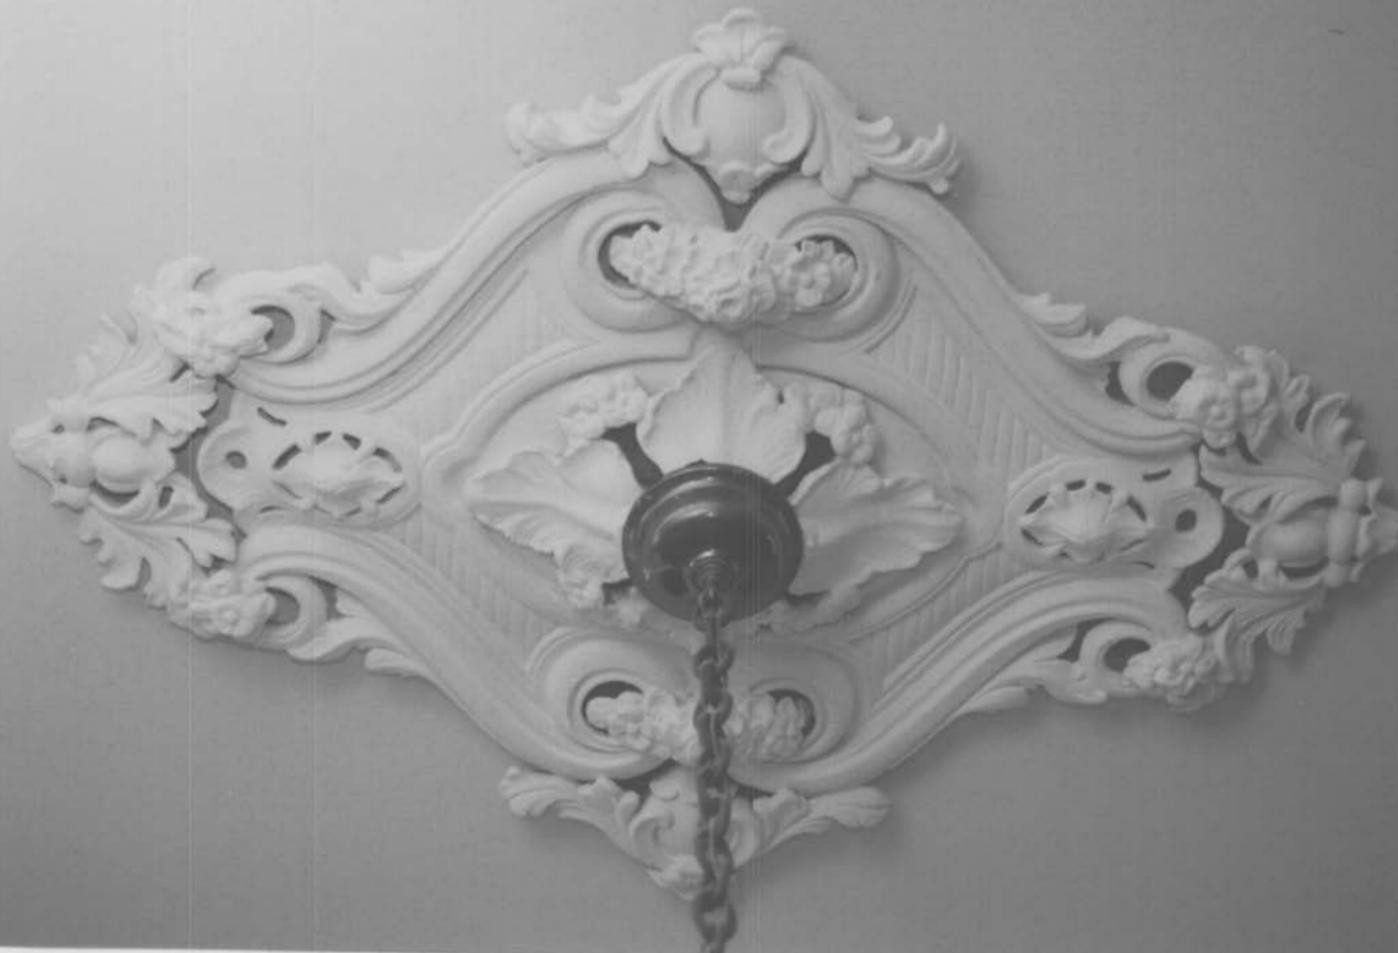
7/13

Passage ceiling medallion

porcelain knobs, flat, rectangular key hole covers and escutcheons that appear to be silver plate. The door to the stair hall is missing. There is a run plaster cornice consisting of a cove with two beads, and the ceiling has ribs that create three panels. The ribs consist of a Torus with a cavetto to each side. In the center of the ceiling is an Italianate plaster medallion with leaves in the center and scrolls on the outer edges that are connected on each side by floral bands. At two ends, the scrolls are separated by bosses. The northwest door is identical to the southeast door.

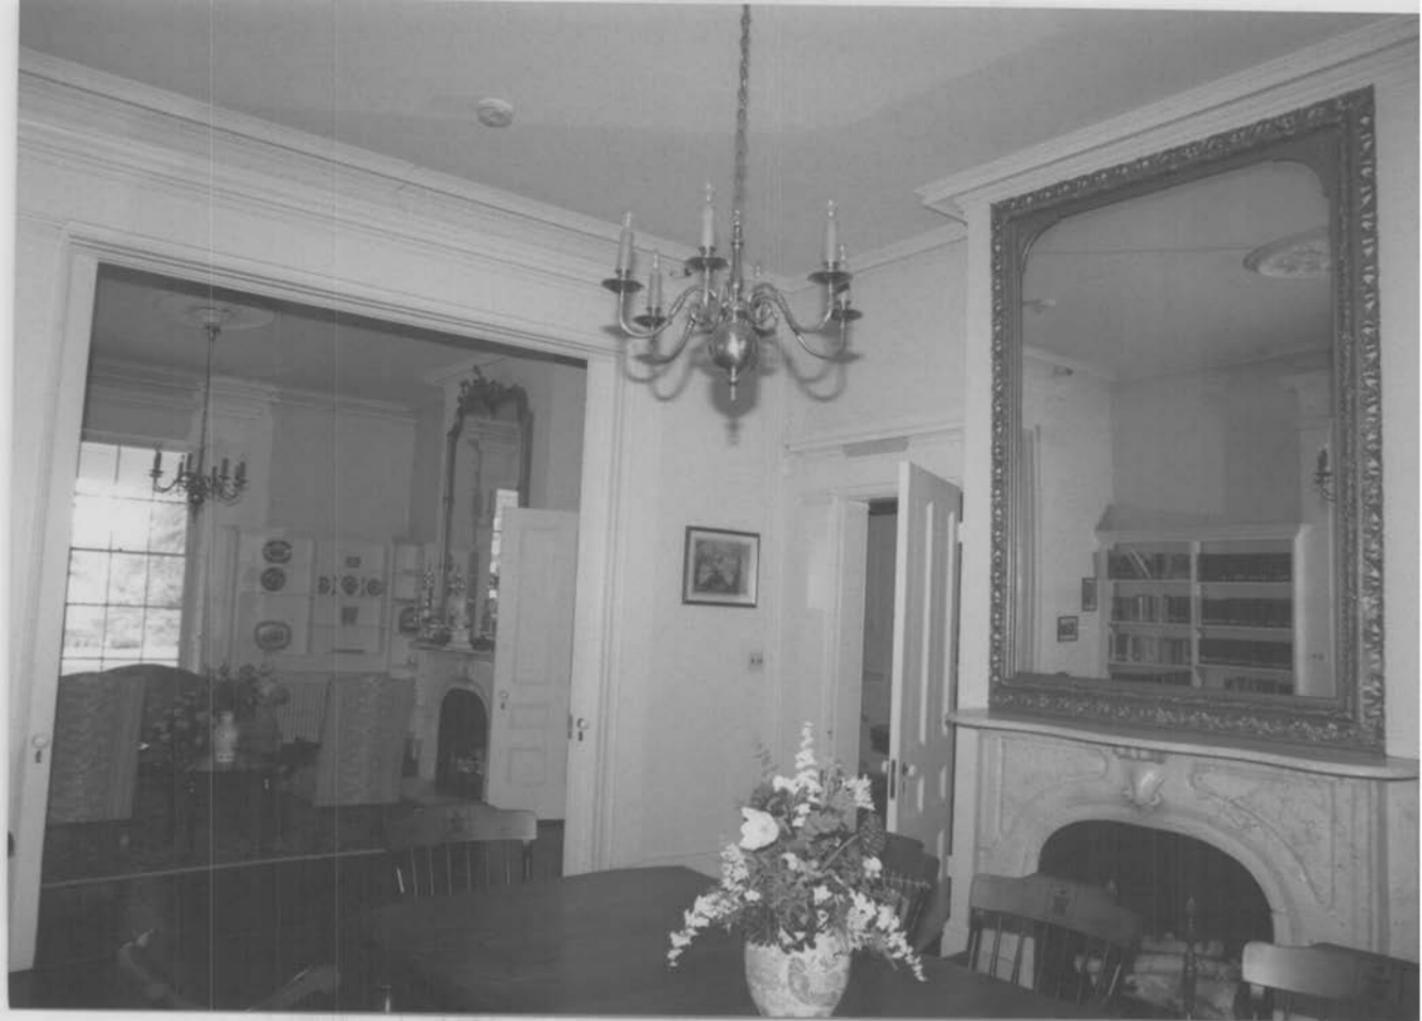
8/13

North & east rooms, view south.

The east room has random-width, pine floor that runs northwest-southeast and is 3 7/8 inches to 4 7/8 inches wide. The baseboard has a broken field and a quirked ogee and bevel. The door architrave and cornice match that of the passage. There is a fireplace centered on the southwest elevation. It has a white marble hearth, and a brick firebox with splayed jambs that is built with regular brickwork and fairly small joints, and is painted. There is a white marble mantel with gray veining. The mantel has a semi-circular arch with grooves in the spandrels, a scroll bracket in the center, and a scalloped shelf. The northwest jamb has a heating grate with adjustable fins on the back side of it. There is a square opening in the brickwork behind the vent, with a round metal duct through the west corner into the wall between the passage and this room. This duct connects to an opening in the brickwork behind the heating grate in the passage. There is a small, square hole in the bottom of the brick wall in the passage. There are double pocket doors on the northwest with a panel arrangement that matches the other doors, and similar locks, but with no labeling visible. There is an oval plaster ceiling medallion in the center that alternates between anthemion and a trumpet-shaped flower with something coming from the center of the flower. This pattern is repeated in a smaller scale in the center, and a boss flanks this centerpiece on either side. The southeast window is a six-over-nine sash that extends down to the baseboard, while the northeast window is a six-over-six sash that has two panels below it and one panel on each splayed jamb. The wall below the windowsill is recessed and the panels here are sunk and flat, with quirked Greek ogee mouldings. The sash are mortised-and-tenoned-and-pegged, have lancet-profile muntins, and have 13 inch x 20 inch lights. The sash have parting beads but no check rail, are hung on chains, and have been retro-fitted with a draft block. There are paneled interior blinds that are screwed open. Above the southeast window is a pocket for the sash to open up into. The northeast pilasters project further from the wall than the southeast ones. The north room is a mirror image of the east room, creating a double parlor divided by pocket doors. There are several minor differences in the north room. There is no heat vent on the southeast jamb of the fireplace, and no evidence there ever was one. The northwest jamb is not accessible because it is hidden by a built-in bookshelf. The northwest window is a six-over-six sash with panels below the sill, and a cast iron foliate radiator in front of the panels. The name on the radiator is heavily painted and thus illegible. The northeast elevation has a door with splayed jambs with panels that are identical to the window jamb arrangement. There is a two-light transom, but the transom bar does not align with the rails in the jamb panels. There are two doors with three lights each and lancet-profile muntins. The bottom of each door has one panel that is sunk and flat and has a quirked ogee and bevel panel mould. There are large beads where the jamb panels meet the flush jambs of the door. The windows do not have this detail because it would interfere with the shutters. The doors have cast iron butt hinges with five knuckles and fast joints. They have an iron plate rim lock with no label on the brass bolt.

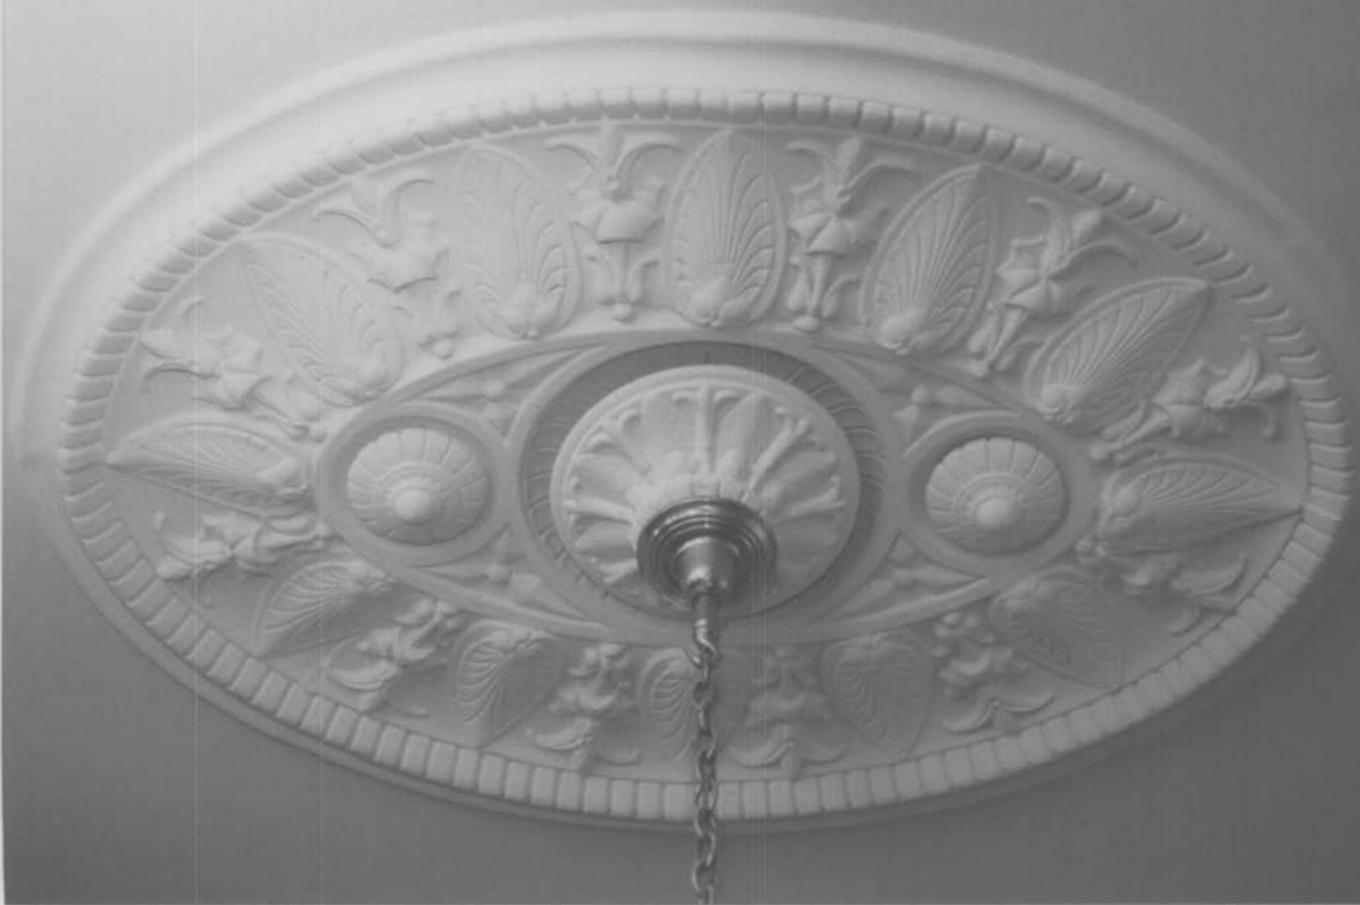
9/13

North room ceiling medallion

The northeast wing room has built-in bookshelves on most of the walls. The floor and cornice match the north and east rooms, and the ceiling has a single rib panel. The ceiling medallion is oval and is the center of the medallion in the east room, with a bead and reel around the edge and a bead moulding on the outer edge. The baseboard has a large bead on the top. The northwest window is a four-over-four double-hung sash with lancet muntins and a wide vertical mullion in the center with a bead down the center of the mullion. The architrave has a broken field with a beaded-interior edge and a quirked ogee and fillet back band. There is a cast iron foliate radiator below the window. The southeast door has six lights over one panel with ovolo muntins and the panel has a sunk field with an ogee and bevel that differs from the other panel moulds with an ogee and bevel. The architrave is the same as the northwest window. The hinges have ball finials and there is a one-light transom that has been altered. On the northeast is a projecting five-sided bay that contains two cast iron foliate radiators and chair rail with an ogee and fillet below. The architrave on the windows in the bay have a wide back band, an ogee and fillet, a small broken field, and a stop. It is mitered at the corners. The four-over-four sash is hung on cords, is not mortised-and-tenoned-and-pegged, and has ovolo muntins, with the center vertical

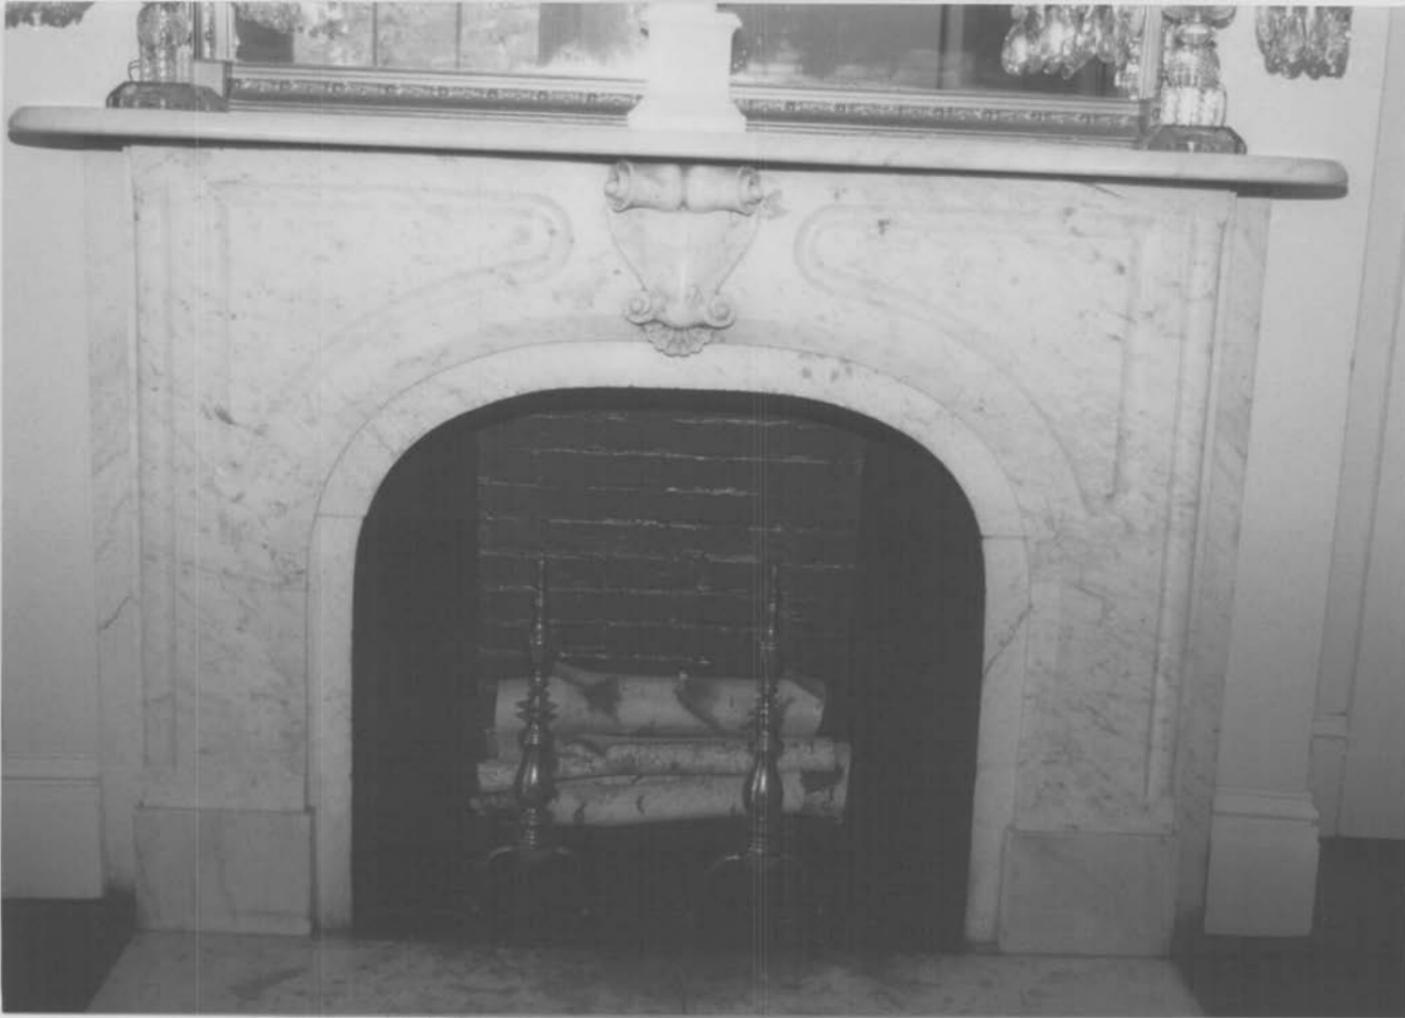
10/13

East room mantel

floor, and in February 1924 additional work was specified for this fireplace, including "brick lining and underfire, damper and throat, marble facing and outside hearth. The final accounts note that Belgian black marble was used for the facing. Perhaps, in the process of making all these changes the mantel was damaged and replaced, but no mention is made of the mantel. (10)

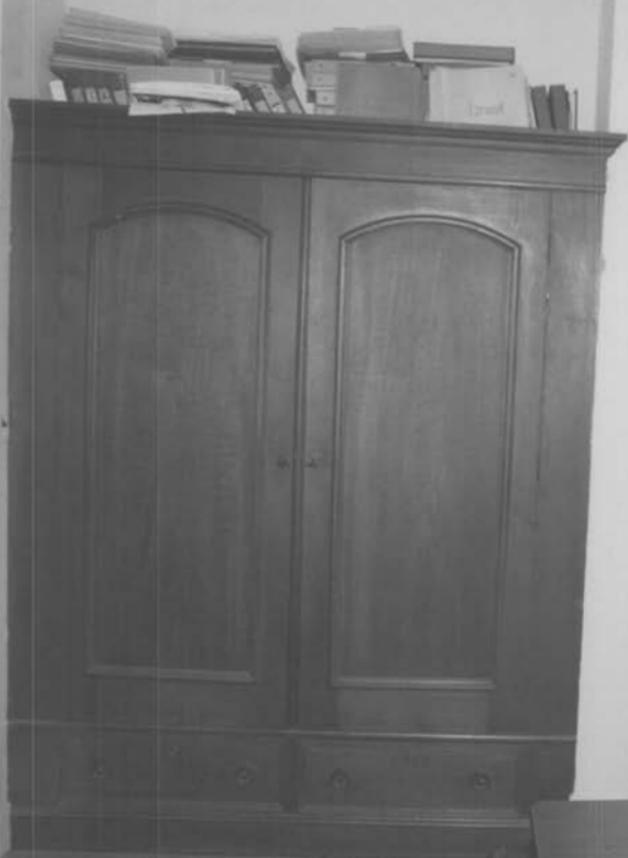
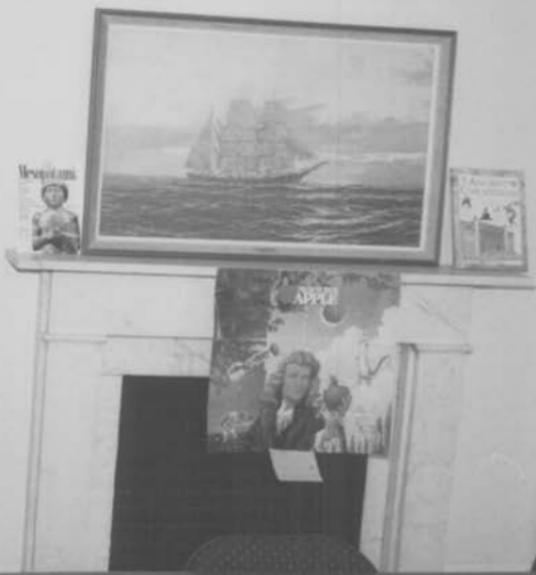
11/13

South chamber, northeast elev

The south chamber has carpeting and ceiling tiles. There is a fireplace on the northeast elevation with a marble mantel and hearth of white marble with gray veining. It has plain pilasters, a plain frieze, and a plain shelf. There are splayed brick jambs. The baseboard has a broken field and a quirked ogee and bevel on top. To the north of the fireplace is a built-in closet of walnut that was made for this space. It has two semicircular-arched doors at the top, each with a sunk, flat panel with a bolection moulding.

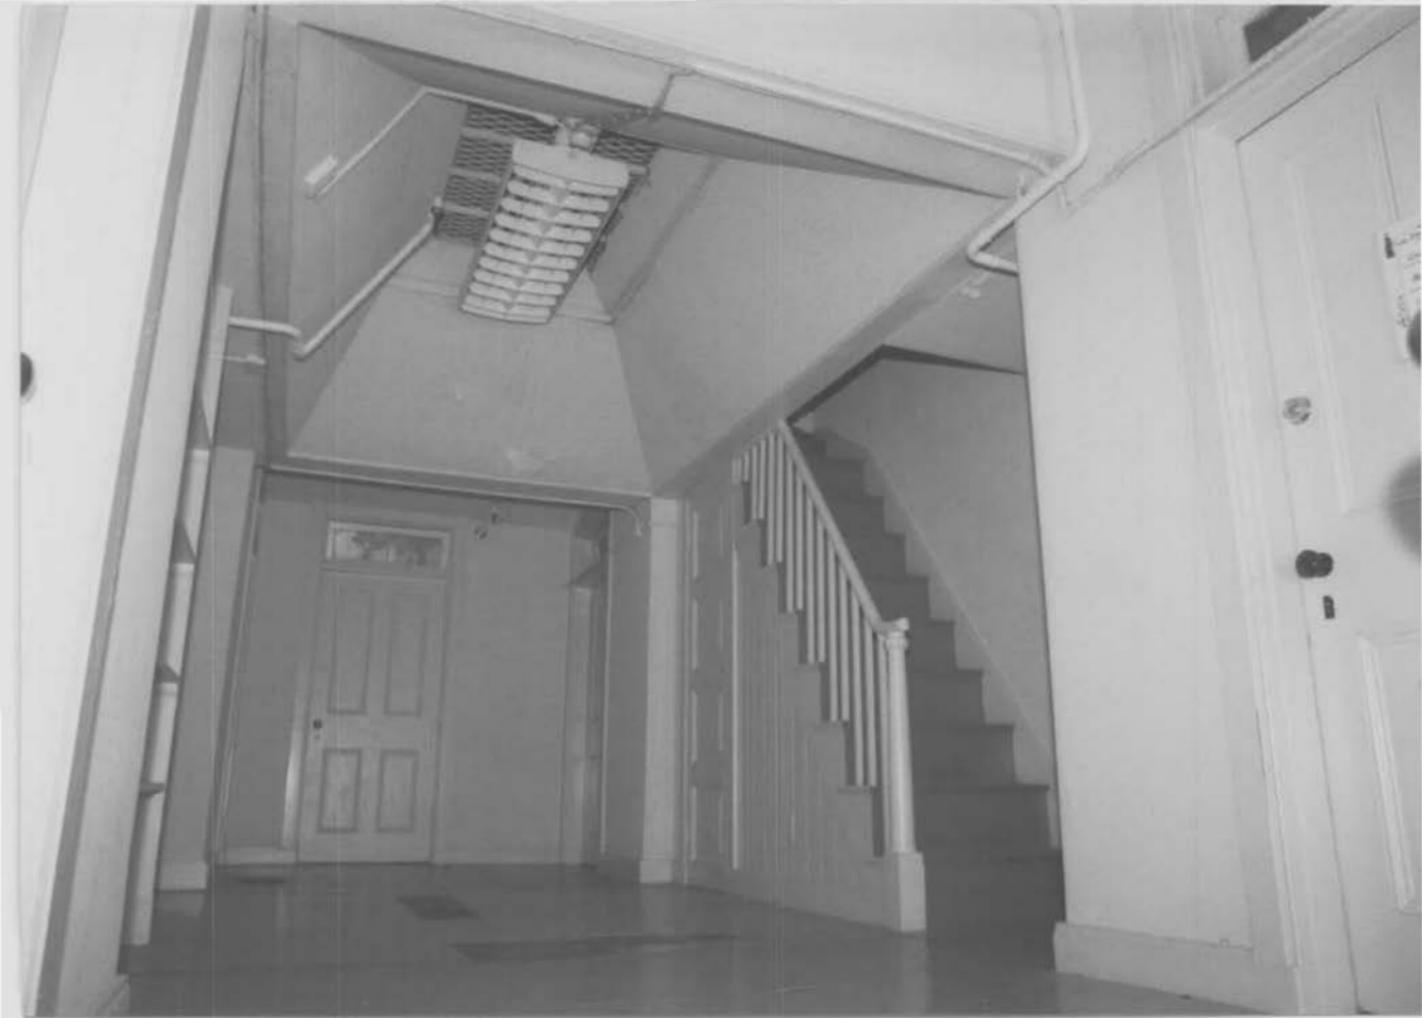
12/13

Attic - center hall, uw. E.

The third story has a center passage that is connected to the stairway on the southwest and has three doors on the northwest, three on the southeast, and one on the northeast. All of the doors are typical four-panel doors, five with mineral knobs and two with brass knobs that probably date to the 20th century. There are two-light transoms on all but the two center doors. The architrave has a broken field with a beaded interior edge and plain corner blocks. The doors originally opened out but now open in. The center of the ceiling has a four-light skylight with a metal grate and plywood over the sash. The walls are sloped up to the skylight. In the center of the southeast wall is a stairway up to the lantern around the skylight. The stair has a plain open stringer
