BA-99
"Dumbarton"
300 Dumbarton Road
Towson
c. 1853, 1923
Private

Maryland Inventory of Historic Properties Form

Inventory No. BA-99

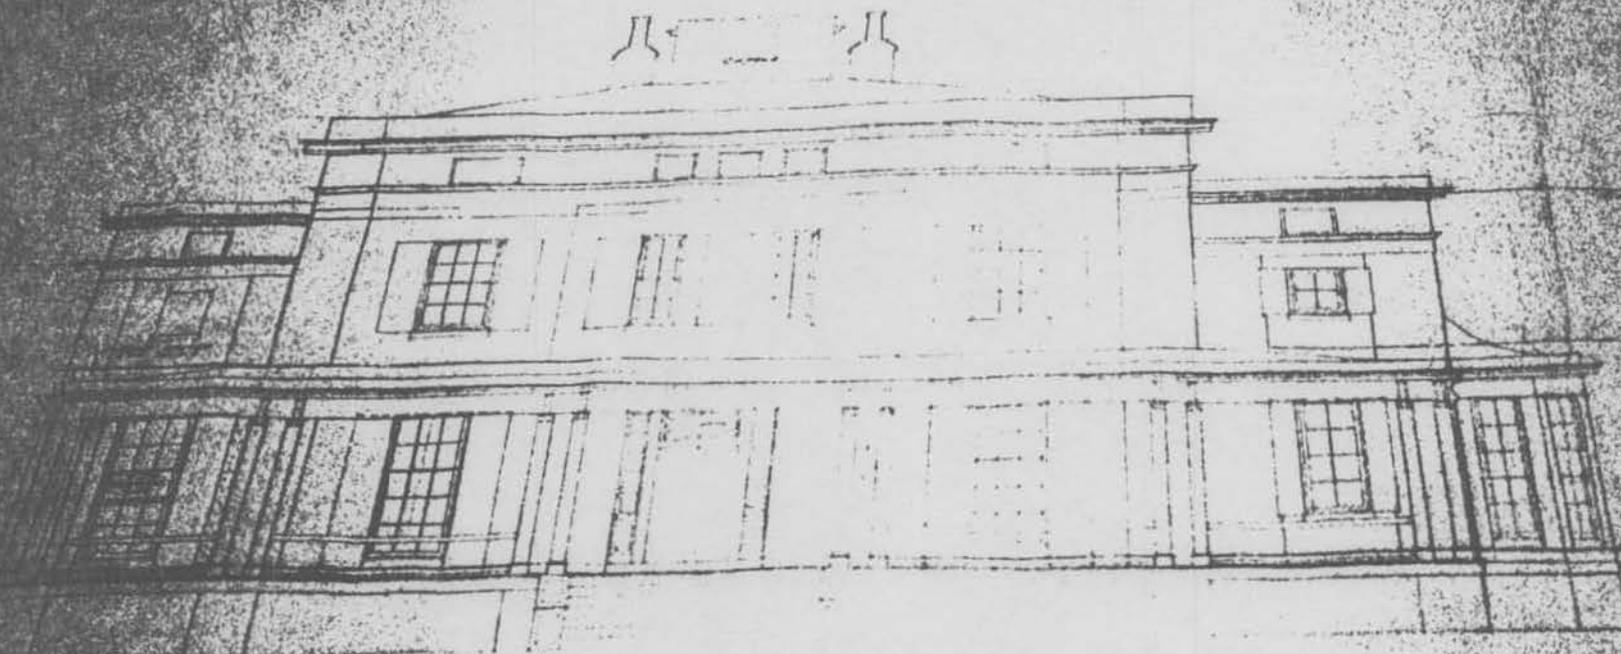
SOUTHEAST ELEVATION.

PLANS DATED 1923, ELEVATED IN SPRING 1924

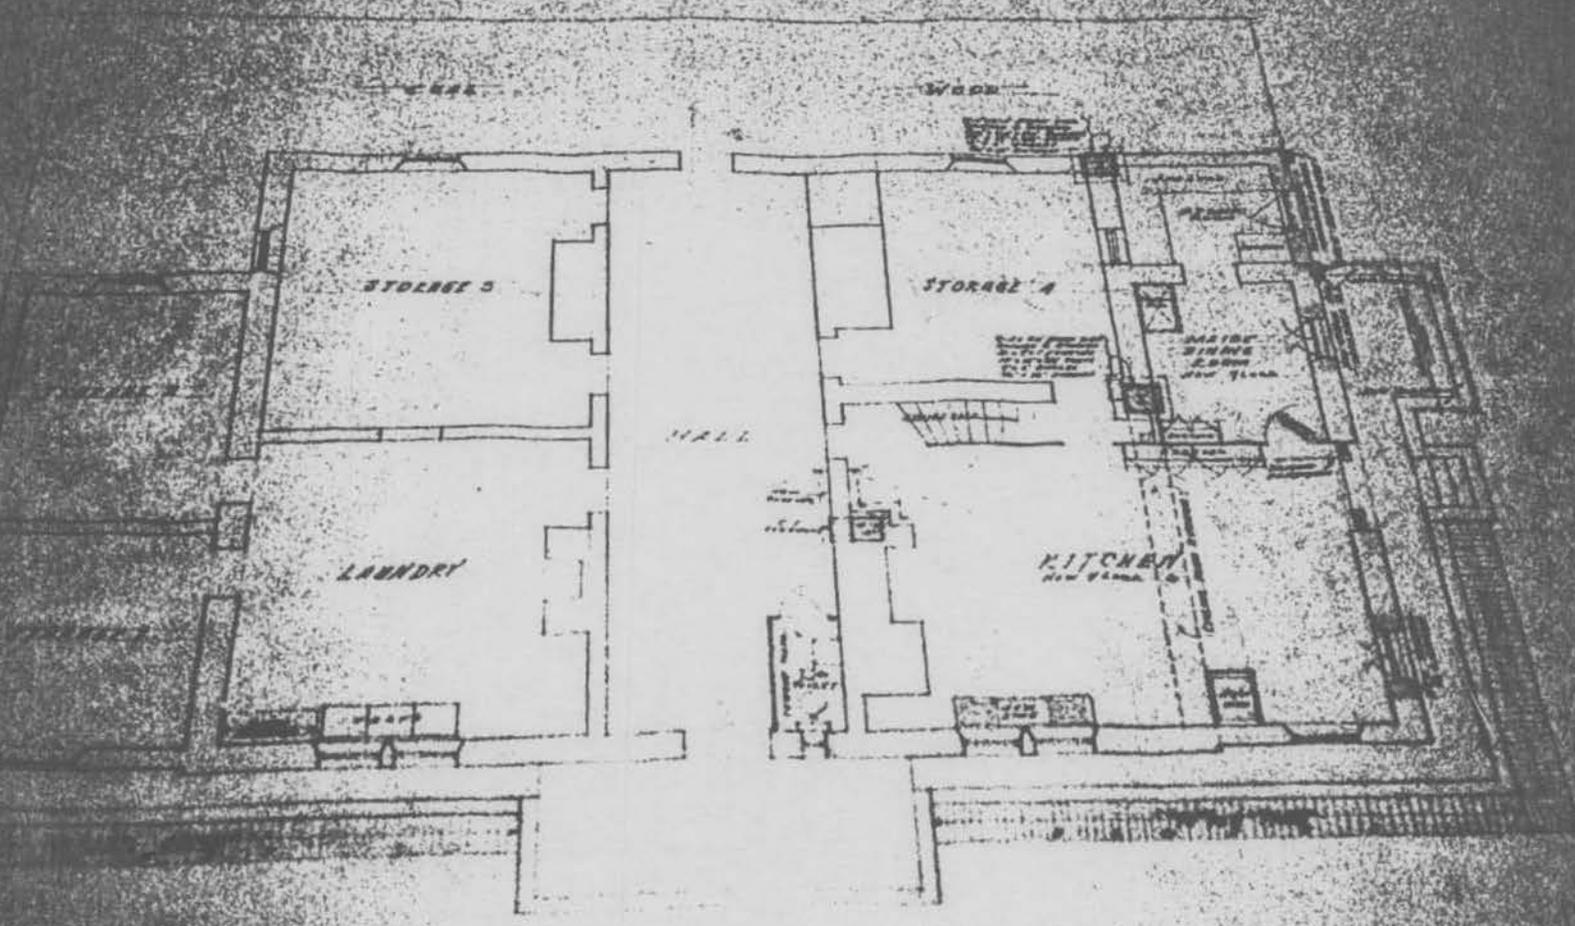
BASEMENT FLOOR PLAN

Basement: The part of the area wall marked to be lowered is to be cut down so that the top of the reset coping will be on a level with the top of the basement window sills. Slope the ground from this coping up to the existing grade as gradually as conditions permit. The foundations of the existing wing, which is to be torn down, is to have a coping to match coping of old wall.
