CAPSULE SUMMARY - RAFF BARN 'A' (CT-1041)

## State Historic Sites Inventory Form

and/or common Raff Barn A

Survey No. CT-1041

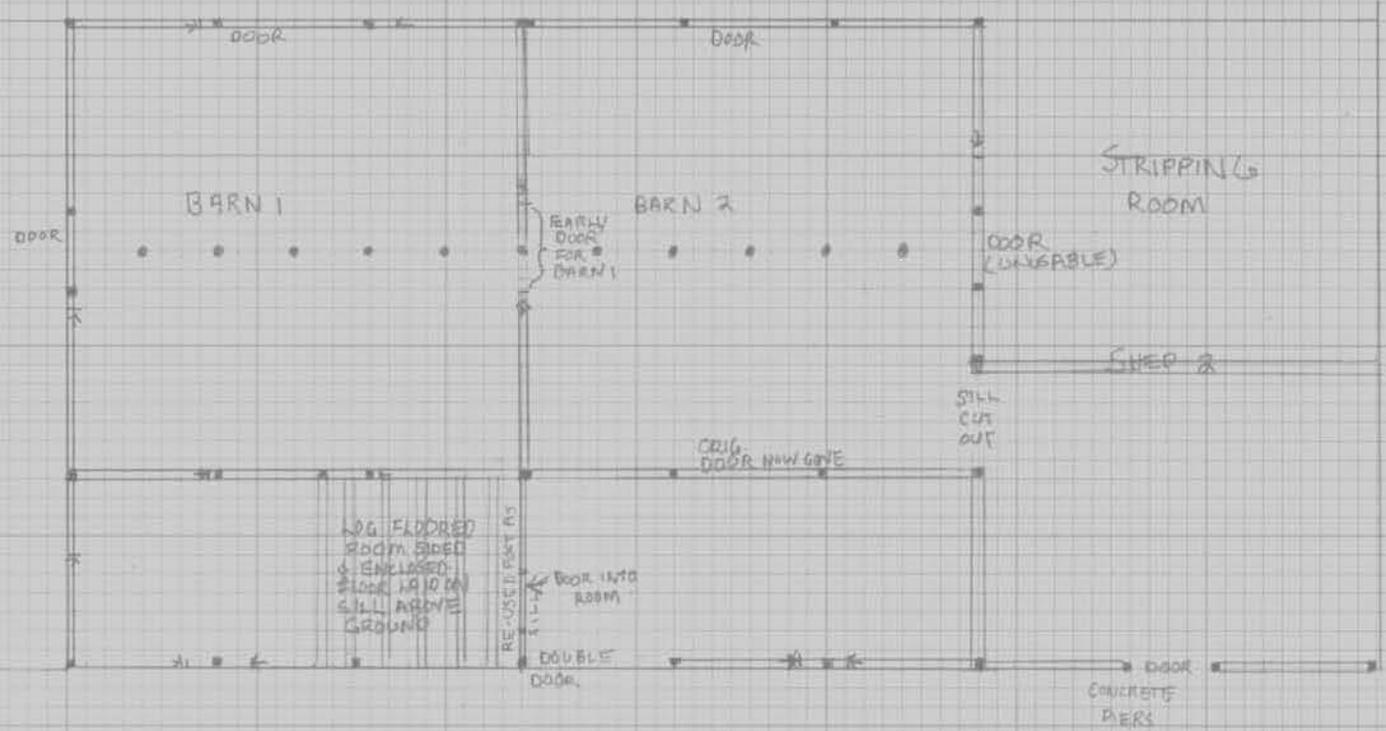
RAFF/(CHANEY) BARN #2014 3/1/90  
CT-1041

X NW side barn  
X E side barn/shed 1  
X Cross sill incl. Shed 1 Room

X N side of barn  
X S side of barn  
S side Shed 1
