CAPSULE SUMMARY -MAIDSTONE BARN 'A' (CT-1062)

historic Maidstone Barn

and/or common Maidstone Barn A

Survey No. CT-1062

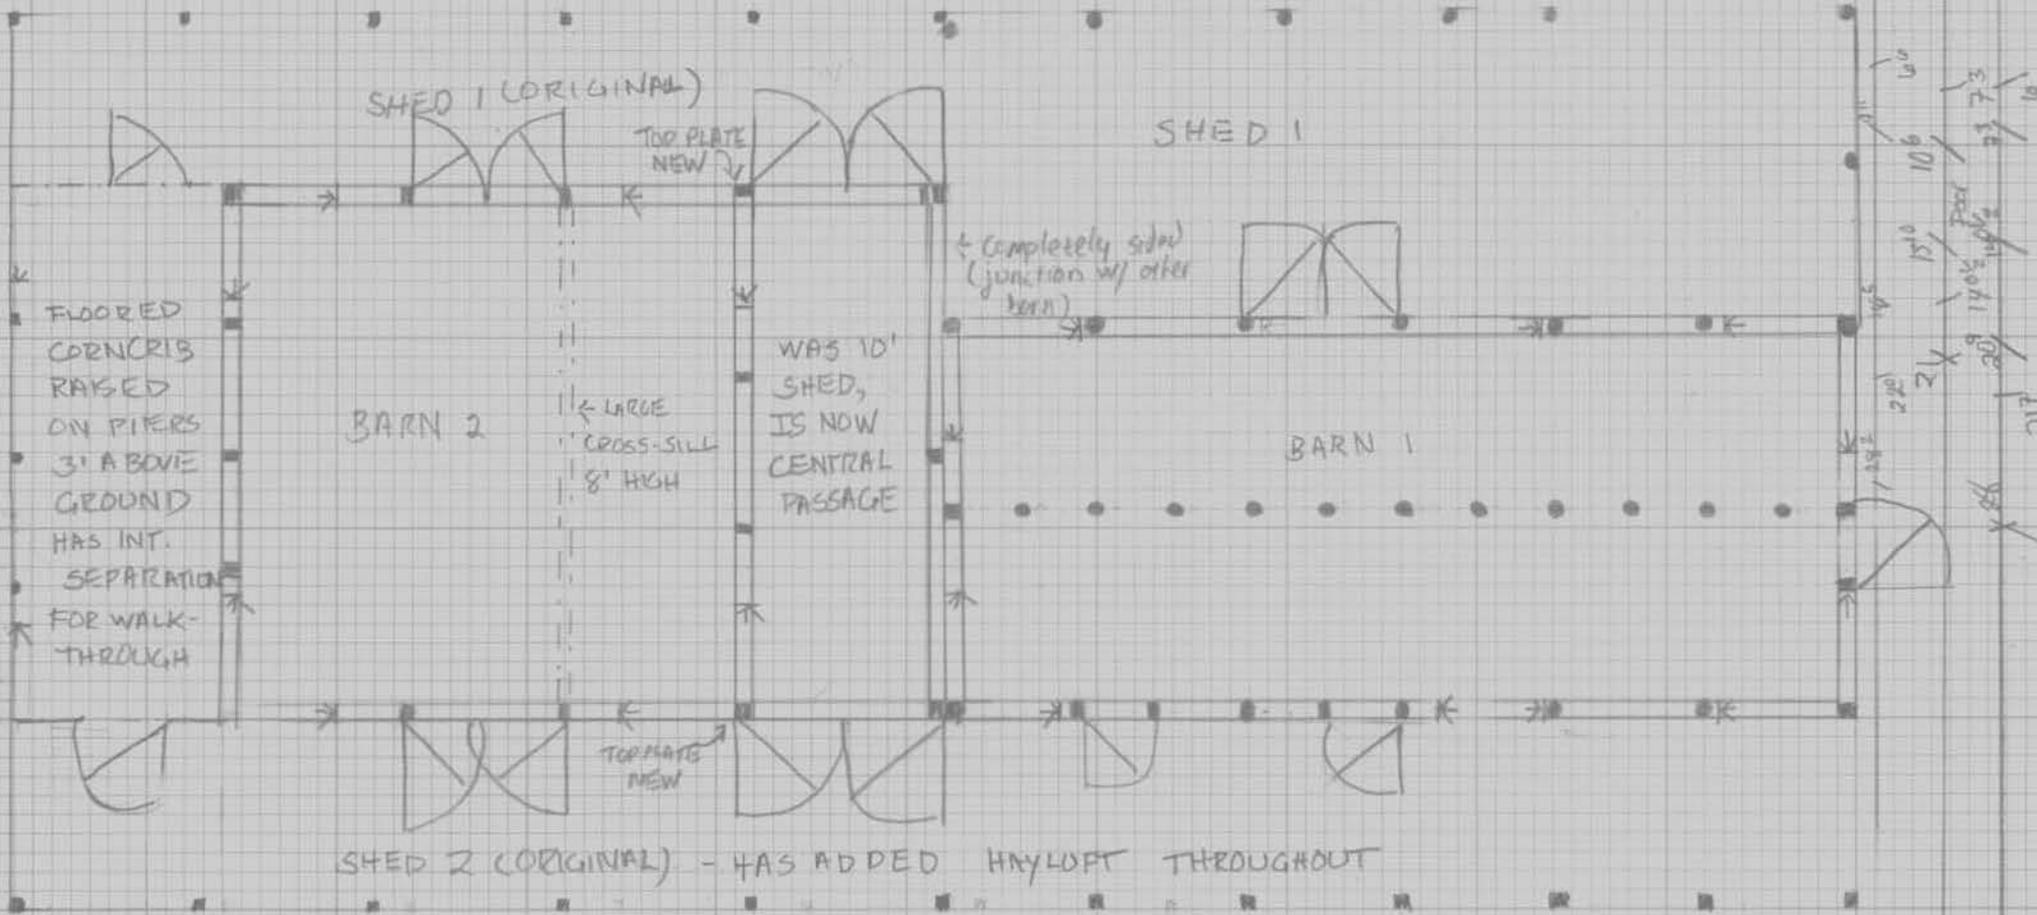
side barn 2
side barn

The original twenty-six by twenty-eight foot barn had entrances along the north and south facades. These doors have early hand-wrought hinges. The bay system of the barn consists of nine, eight, and nine feet. The barn contains nine rooms. The heavy timber frame is supported on large logs. All the timbers are hewn and the posts are joined via mortise and tenon joints with trunnels. Fully mature machine cut nails are visible in the frame. There is a large timber lifted eight feet above ground, that may have once been the original cross-sill. The top plate at the junction with the ten foot wide aisle section, is separate from that in the interior of the barn, and there is evidence of siding along the east wall of the twenty-six by twenty-eight foot barn. Tier poles are laid in an east-west direction, the same as the axis of the roof line and are separated by forty-eight inches vertical distance. The siding is of large vertical boards. The north and south boards are snug and the west side is open for ventilation. There is an early floored corn crib to the west. The roof is steeply pitched. The rafters are on four foot centers and rest on a flat false plate. Shingle nailers are visible under the current metal roofing. Three collars serve to support the roof.

Early or original to the structure were the corn crib area, and the sheds to the north and south. The twelve foot wide south shed is open-air. The posts and tie beams are hand hewn, thereby indicating that this is an early shed, if not original. The posts are earth-fast. The rafters of the barn below their junction with the south shed are not visible, and since it is open-air it is sided, on the south wall of the barn, so it is impossible to determine if this was an original shed. There are shingle nailers in place under the metal roof. The twelve-foot wide north shed is constructed of the same materials as the south shed. The west shed is a corn crib. The corn crib posts are hand hewn and pit sawn. The sills are placed on logs and cinder blocks. The posts and other materials are marked with Roman

numerals in the order of their location in the structure. The crib is floored with wide plank flooring. There are three small doors on the west side through which the corn is inserted. The room is divided by a passage-way from north to south and from door to door. The corn crib door has machine-cut nails and early hinges. The top plate of the ten foot wide east shed is separate, and there is evidence for siding on the east wall of the barn. The east wall of this shed was also entirely sided, and the framing is completely separate from barn B. As such, it appears that the east shed that is now a ten foot wide central passage between the two barns, was a later addition to barn A. This east shed is also constructed of hewn timbers and fully mature machine cut nails.
