CAPSULE SUMMARY - SAYLOR BARN 'A' (CT-1080)

Maryland Historical Trust State Historic Sites Inventory Form

and/or common Saylor Barn A

Survey No. CT-1080

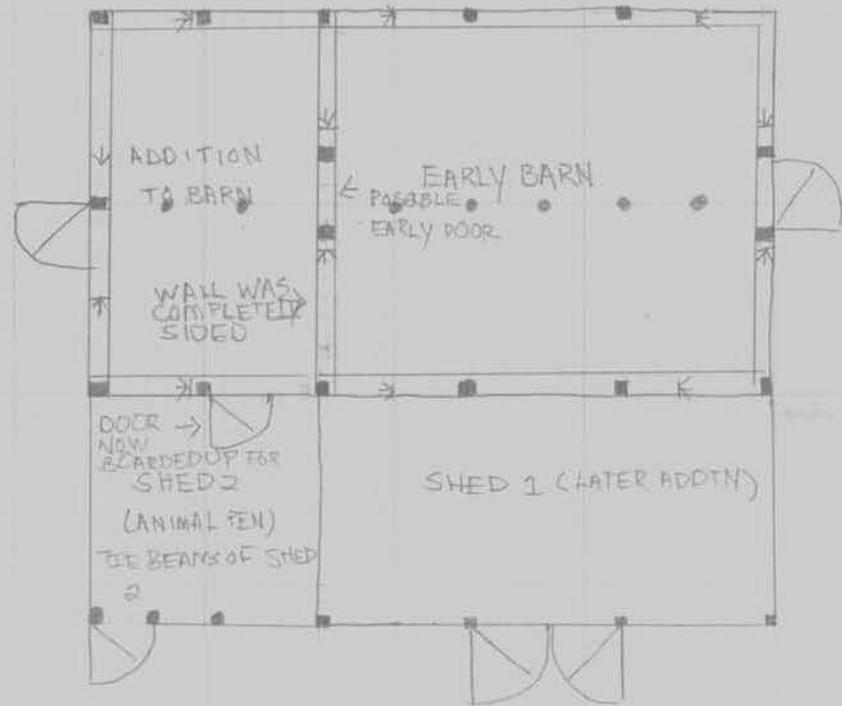
BARN #2053 SAYLOR BARN 4/6/70

1"=10'

The original section of the barn measured twenty-four by twenty feet. There is an door on the east gable end, and there was probably an early door on the west gable end. This original section was divided into three eight foot bays and contained eight rooms. The frame is supported on large unmortared fieldstones. The posts are hewn and pit sawn and joined via mortise and tenon with trunnels. The down braces, nailers, sills, and plates are also hewn and pit sawn. The barn has vertical siding with hinged ventilation doors. There are four of these doors on the north side of the original barn. The east side of the original barn has plain vertical wall siding. The west side of the original barn was once sided, as is evident by the nailing pattern, but this siding has all been removed. The interior siding along the south side of the original barn consists of tight fitting boards on the lower half and horizontal boards on the upper half.

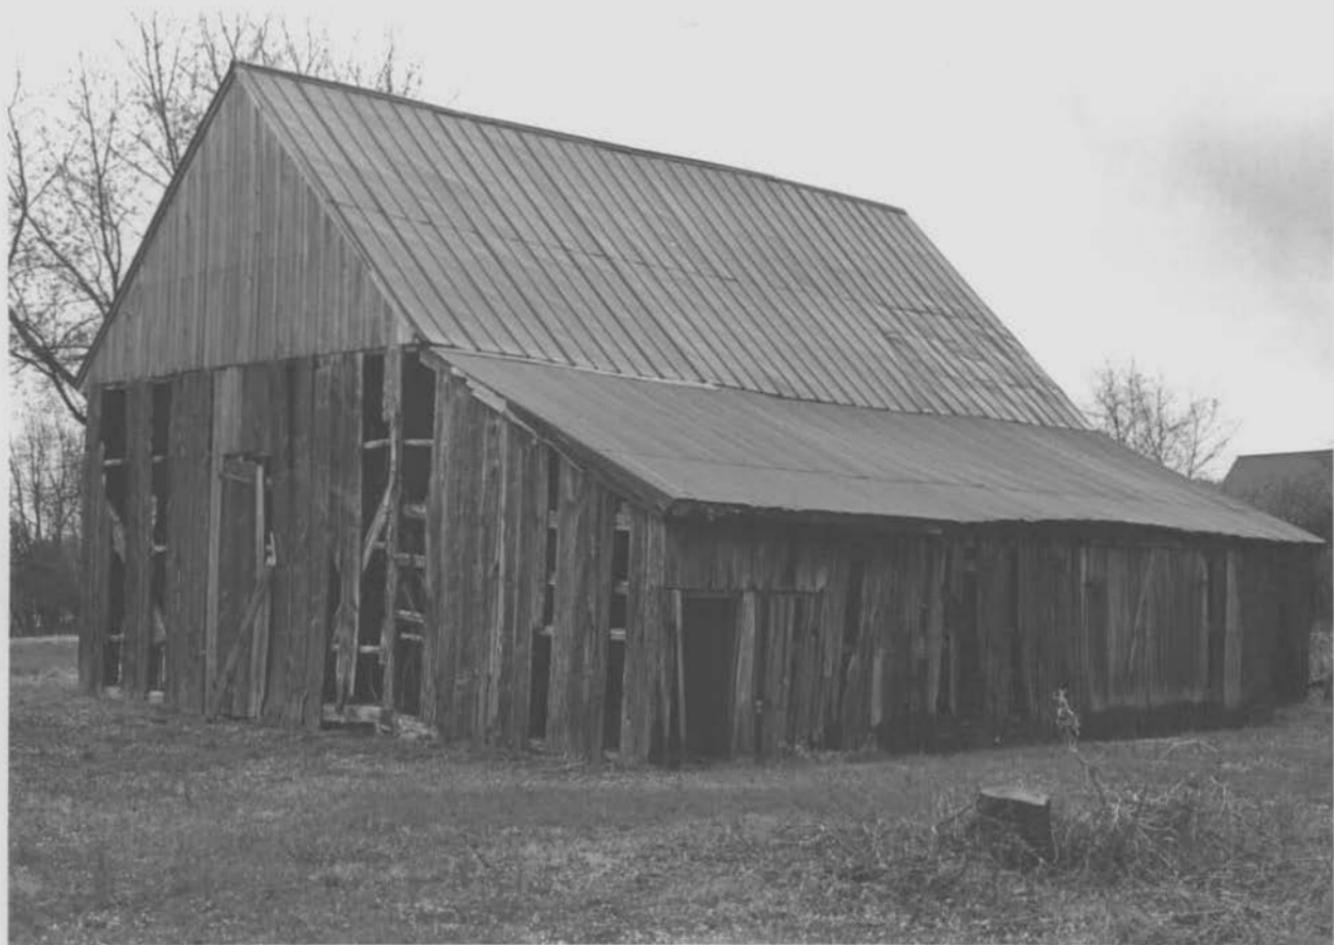
CT-1080

Saylor Barn "A"

Southwest
