CAPSULE SUMMARY CT-1129

Maryland Historical Trust State Historic Sites Inventory Form

and/or common Briscoe Barn B

BARN # 2102 BRISCOE BARN B

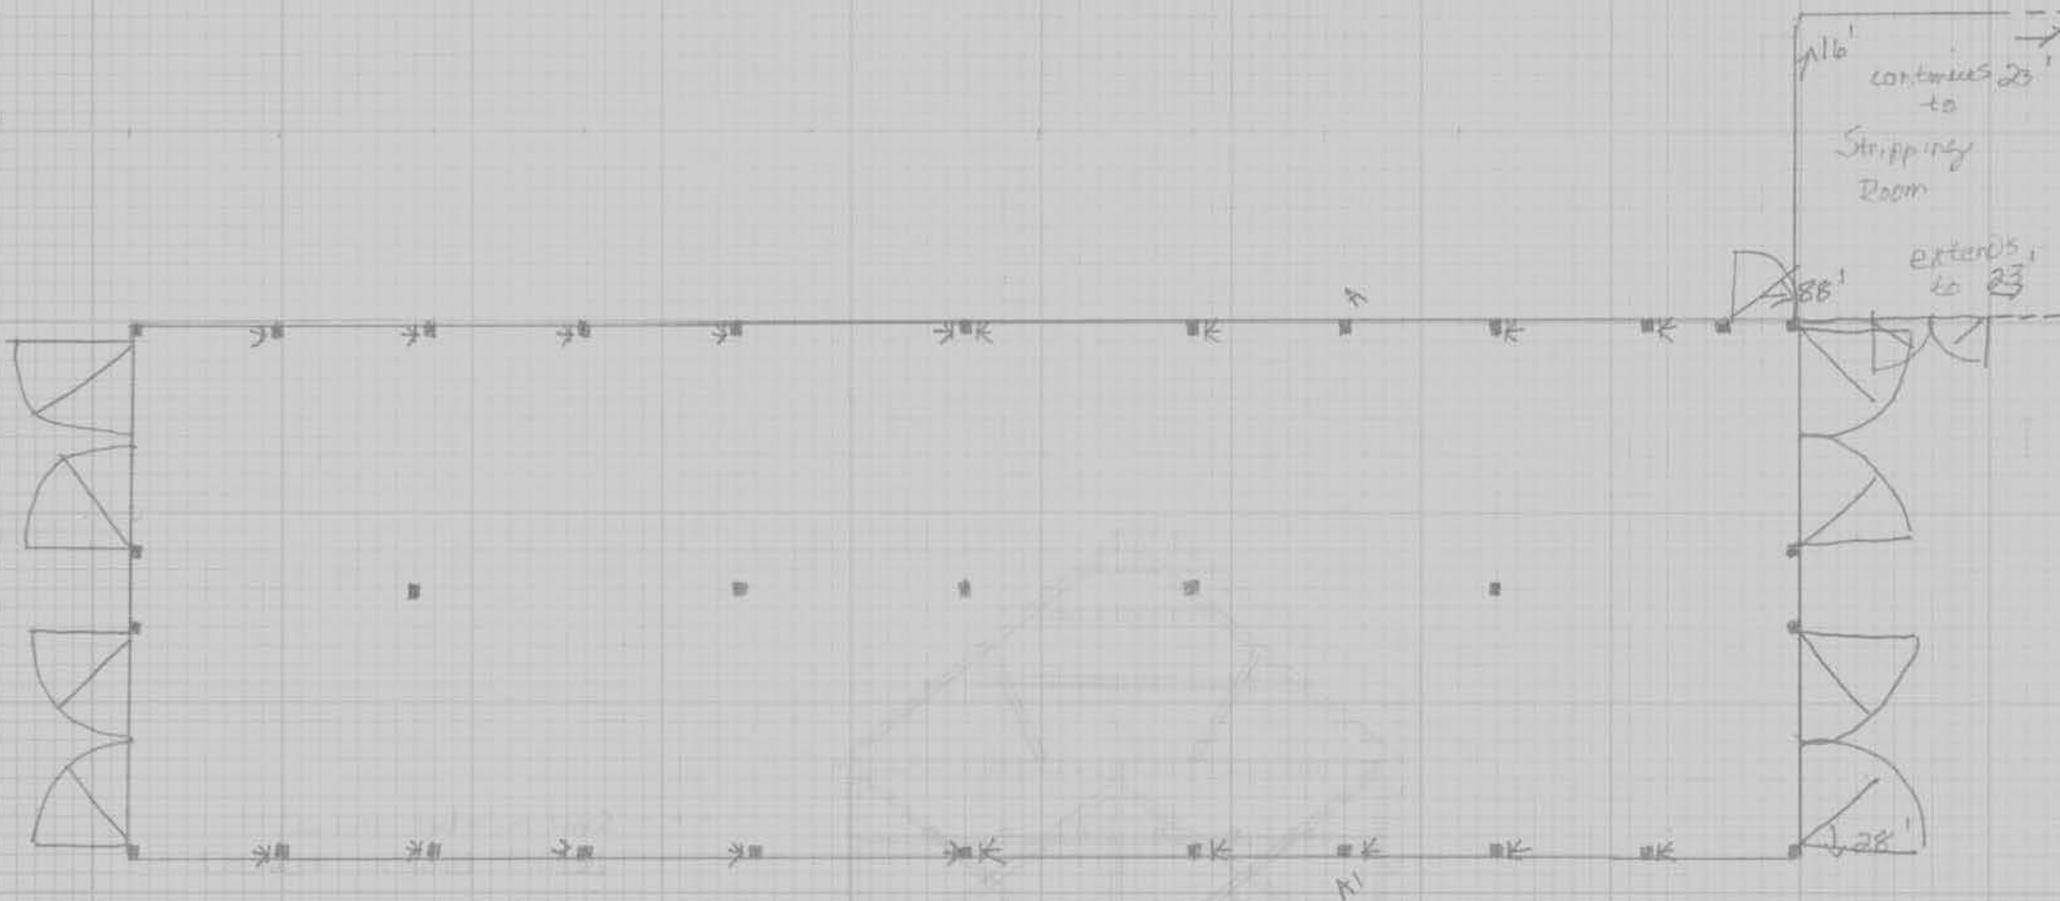
The barn is divided into eight and twelve foot wide bays. There are two sets of twelve foot wide double doors, centered along both the east and west gable ends. The barn frame is supported on concrete block masonry piers. The timbers are of medium weight and circular sawn. The posts are half-lapped and nailed to the plate. All of the other timbers are toe-nailed. All of the nails are wire. Extensive bracing is used in this barn. There are down braces in each bay. There is an unusual internal cross-bracing arrangement. Cross-braces extend across the aisles on both sides of the barn, from the tie beam to the first tier pole level. These cross-braces are formed of double one by six inch timbers that have horizontal rails inserted between. The tier poles rest on these horizontal rails. The tier poles are peeled logs laid lengthwise along the same axis as the barn roof. The vertical distance between the tier poles is fifty inches.

Frame is supported on concrete block masonry piers. Timbers are medium weight and circular sawn. Posts are half-lapped and nailed to the plate. Other timbers are toe-nailed. All nails are wire. Internal bracing formed by double one by six inch timbers with braces inserted between. Vertical wall siding with double plank side-hinged ventilation doors every four feet covers the exterior. Metal corrugated roof. Rafters are on four foot centers and rest on the plate. There is no false plate. The top plate is formed of a circular sawn three by four and one by four nailed together. There are windbraces on each diagonal. Three collars lend additional support to the roof. The tier poles are peeled logs laid lengthwise along the same axis as the barn roof. There are poles down the central axis that are connected by internal cross-bracing, with additional one by six inch horizontal boards connecting them. The vertical distance between the tier poles is fifty inches. There is a concrete block stripping room on the east side of the barn.

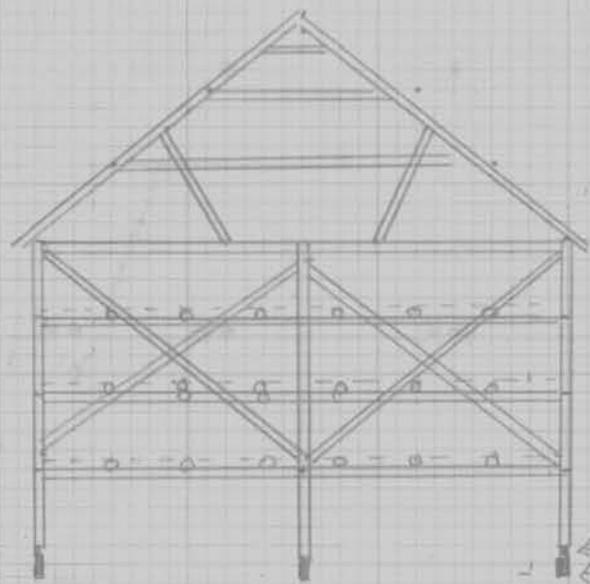
FIG. 10

--- Some member trimmed
behind, bracing inserted
between

← sill
← concrete block

section looking east from A-A'
