CT-128

ROBINSON LOG HOUSE AND BARN

mid 19th c.

INVENTORY FORM FOR STATE HISTORIC SITES SURVEY

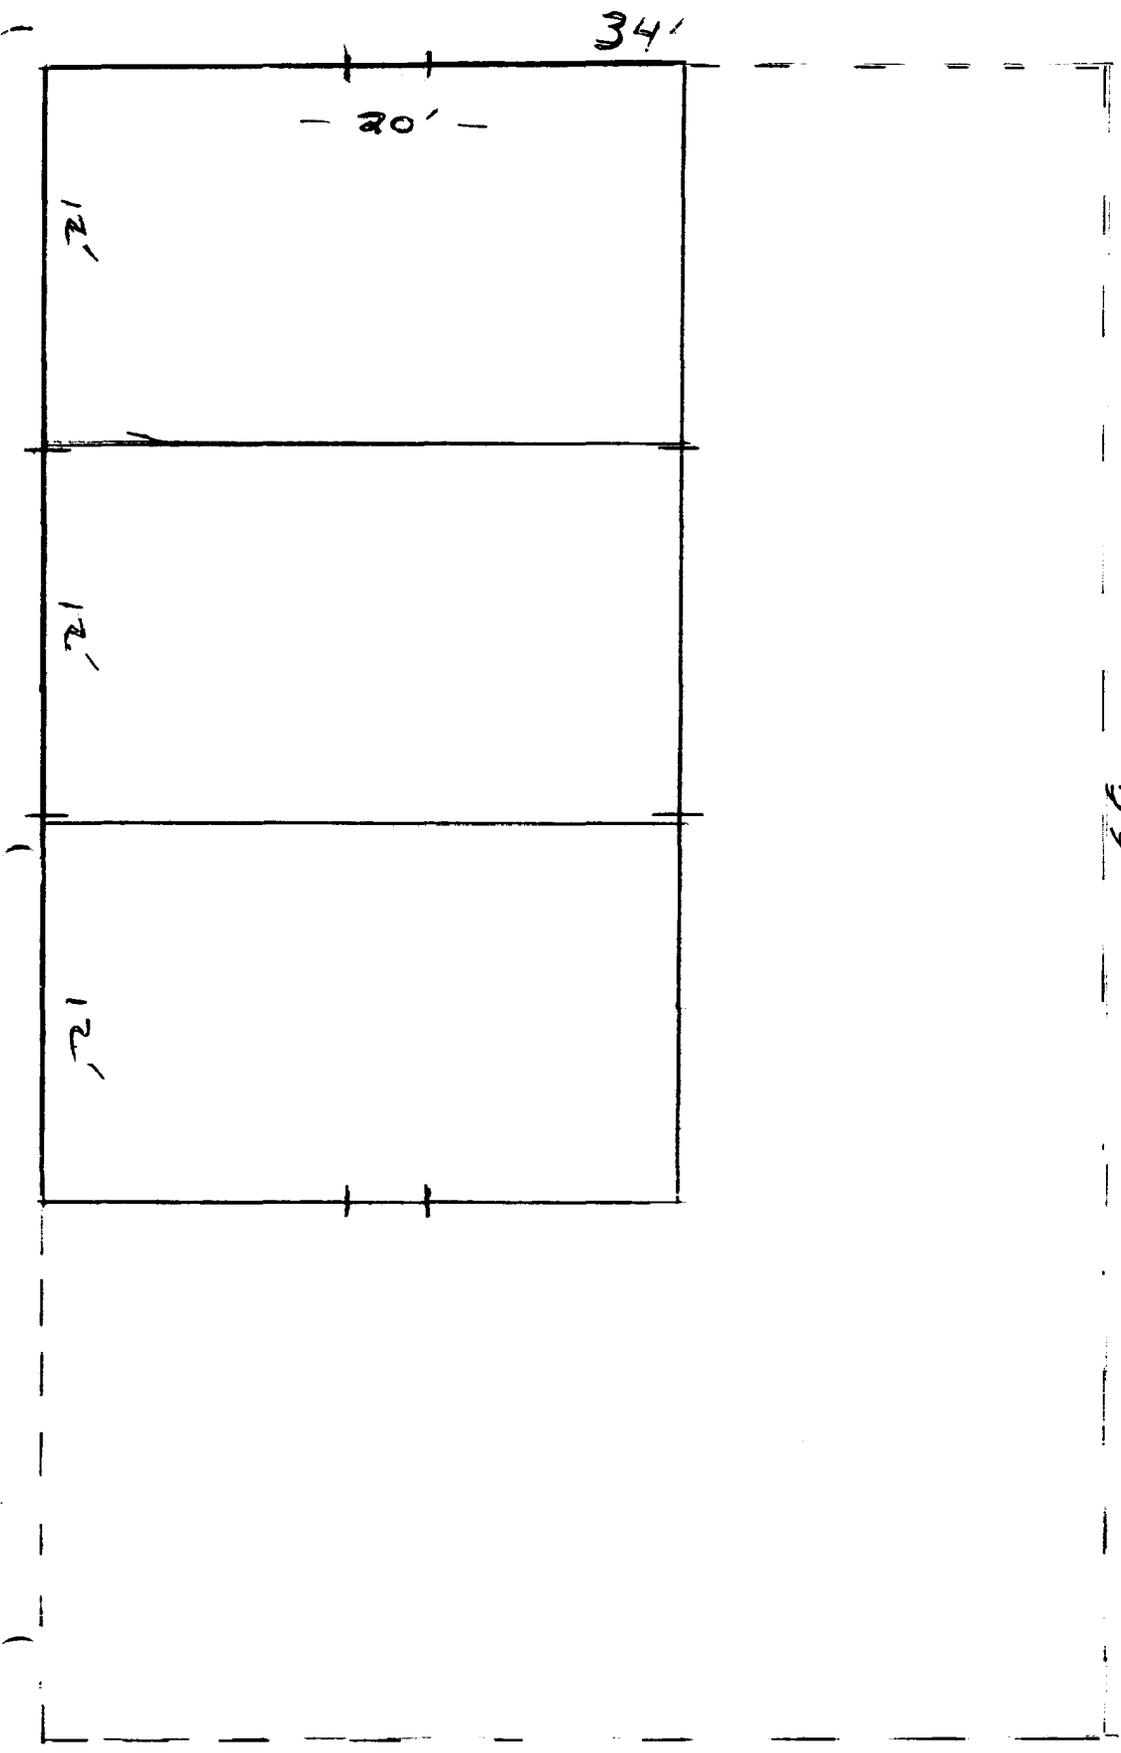
Robinson Log Tobacco BARN

Although it does not fit the tripartite pattern mentioned in the 1800 Essay by William Tatham, this is, nevertheless, a log tobacco barn. On the exterior, the building measures 28' in length and 24'9" in depth. All four walls are built of round logs around 9" thick, V-notched on the ends and laid with 3"-5" spaces inbetween (no chinking). Except for where doors have been cut, all logs are continuous. There are 13 logs to the eaves. The top log is squared so that square-notched rafters may be placed on them.

A 4'x6' door has been cut into the center of the facade and a 3' x 5'4" door has been cut into the center of the north side.

The present gable-end roof is of modern construction.
