CLVT-188B
Brooks Log House, ruin
Island Creek Vicinity
Private

INVENTORY FORM FOR STATE HISTORIC SITES SURVEY

HISTORIC Brooks House, ruin, or Brooks Log House

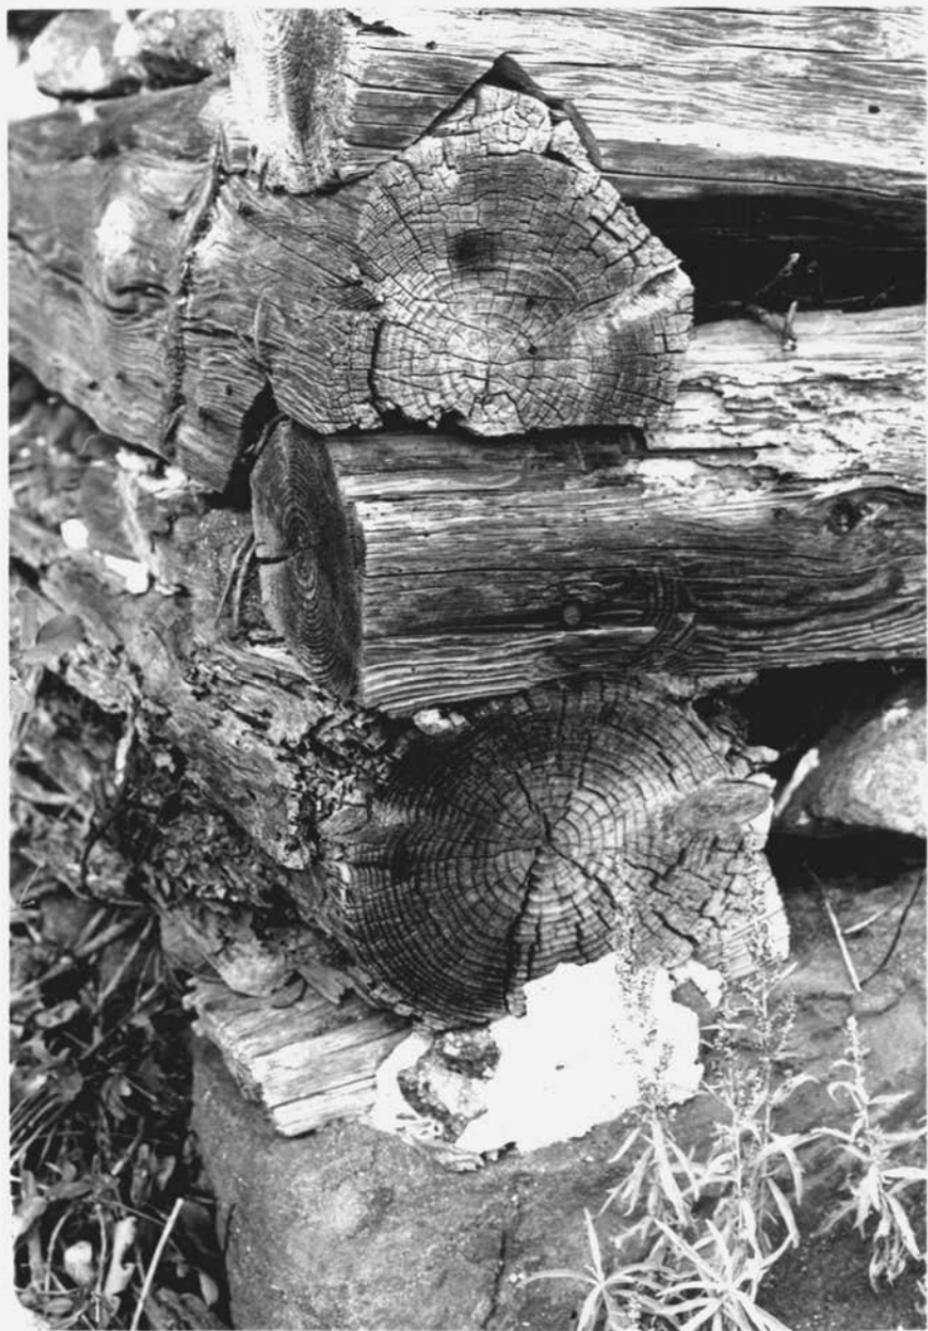
Detail of top

corner w/
wedge ~~bar~~

between

STONE
& SILL.

The house is two stories in height, the first floor being log, and the second, frame. The first floor appears to be the original section, with the second added at some time, most likely near the turn of the century. The log block is three bays in length, arranged in bilateral symmetry. The house is one bay in depth. In terms of structural features, the log walls rest on ferrous sandstone pilings, are V-notched at the corners, and are sheathed with weatherboards attached to vertical boards over the logs, the boards serving the purpose of studs on frame houses, except that they bear no weight. One of the interesting features of the construction of this house is that it shows the wedges which were inserted between the corners of the log sills and the stone pilings in order to maintain a level floor. Also, the window opening on the east gable end is notched down into the log member, and the window frame set into this notch, the frame then serving as a kind of brace. (The slide of that wall shows this clearly.)
