INVENTORY FORM FOR STATE HISTORIC SITES SURVEY

Hinman House

Lower Marlboro

CT-291

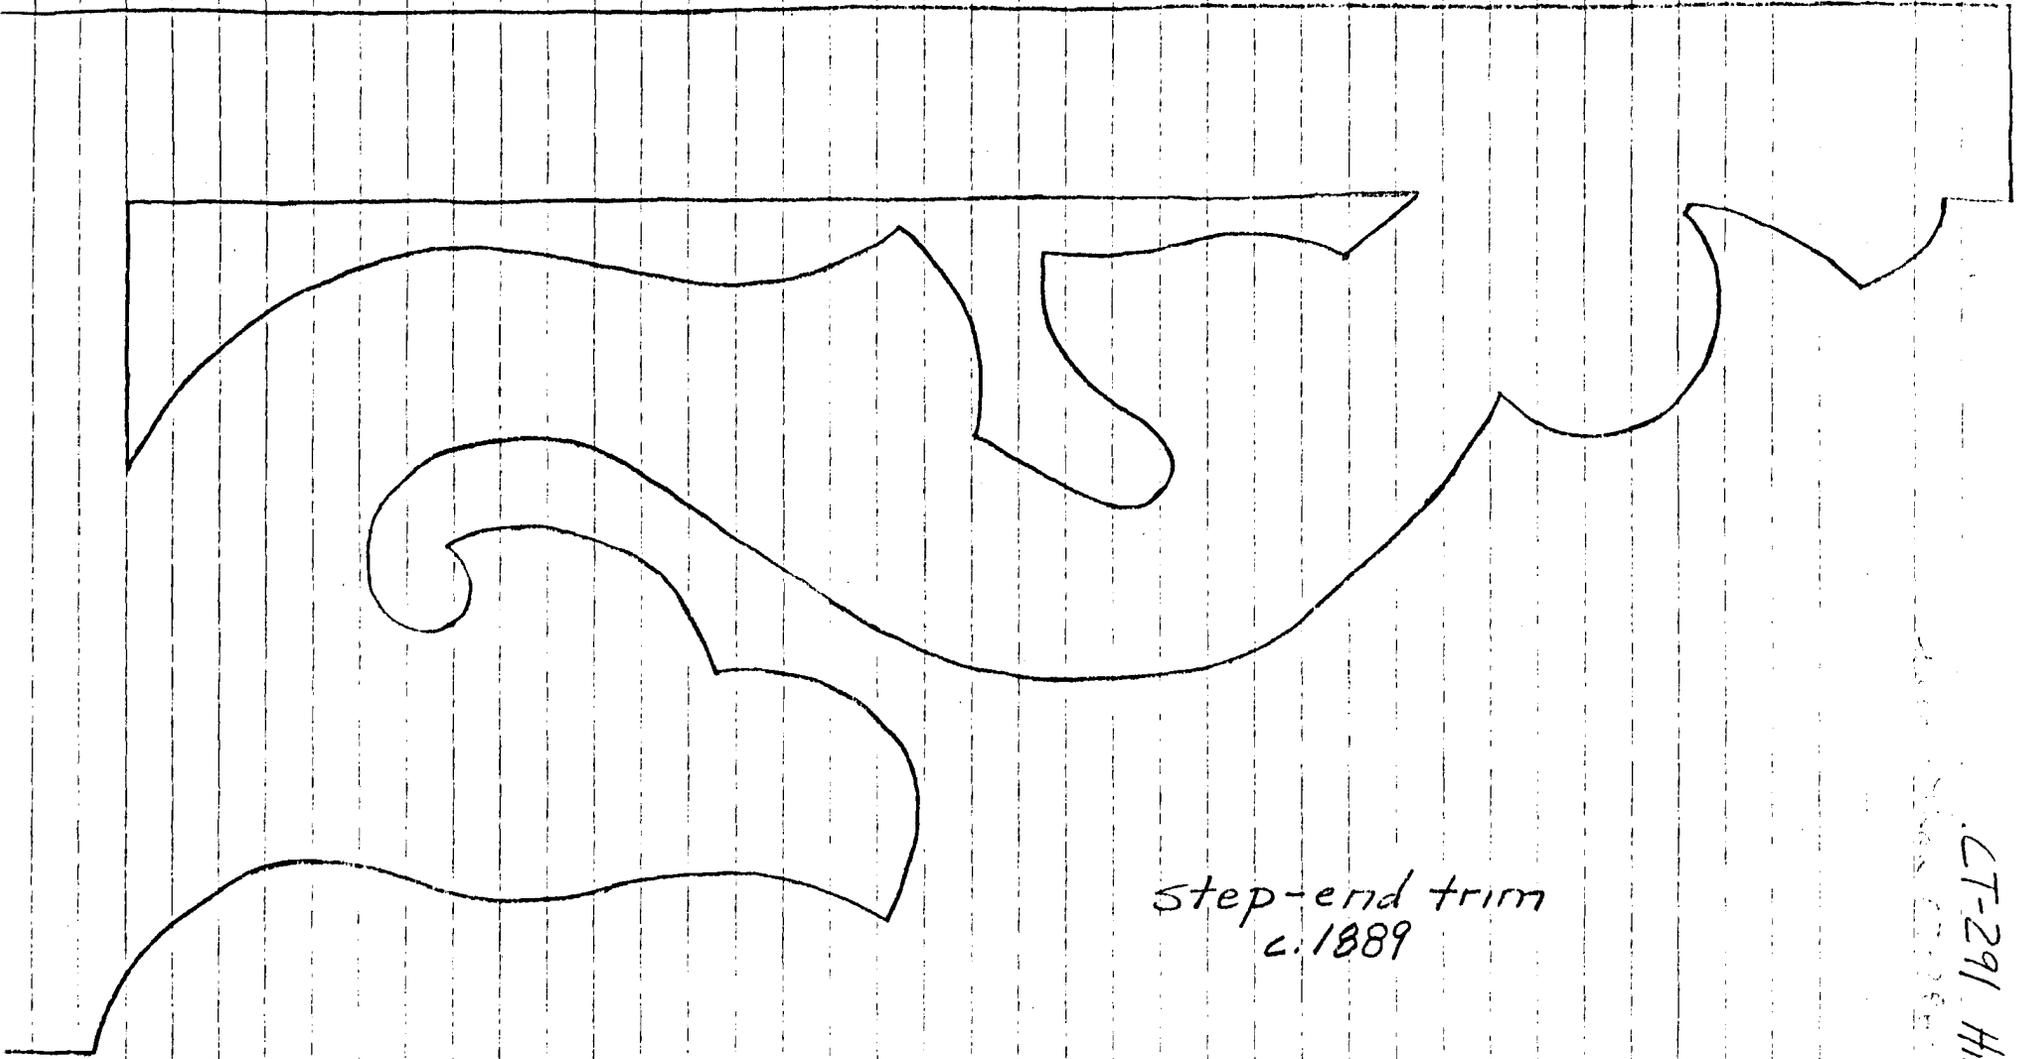
c. 1900 interior architraves

c. 1835
baseboard

c. 1889
baseboard

Step-end trim
c. 1889

After 1889 the house was raised to two full stories, and was re-oriented to face River or Front Street, now Varden Street. The stair was changed to its present appearance, and the front door with sidelights and transom was installed. The posts along the sidelights are chamfered. Panels under the sidelights feature quirk-ogee chamfer moldings. This construction employed circular-sawn members joined by cut nails. Several mantel shelves were installed over stove flues and a quirk-ogee and chamfer baseboard replaced the original. The cross-gable and rear ell date from this period. The stair's scrolled step-ends nearly match those at CT-286 Wilson-Dixon House.

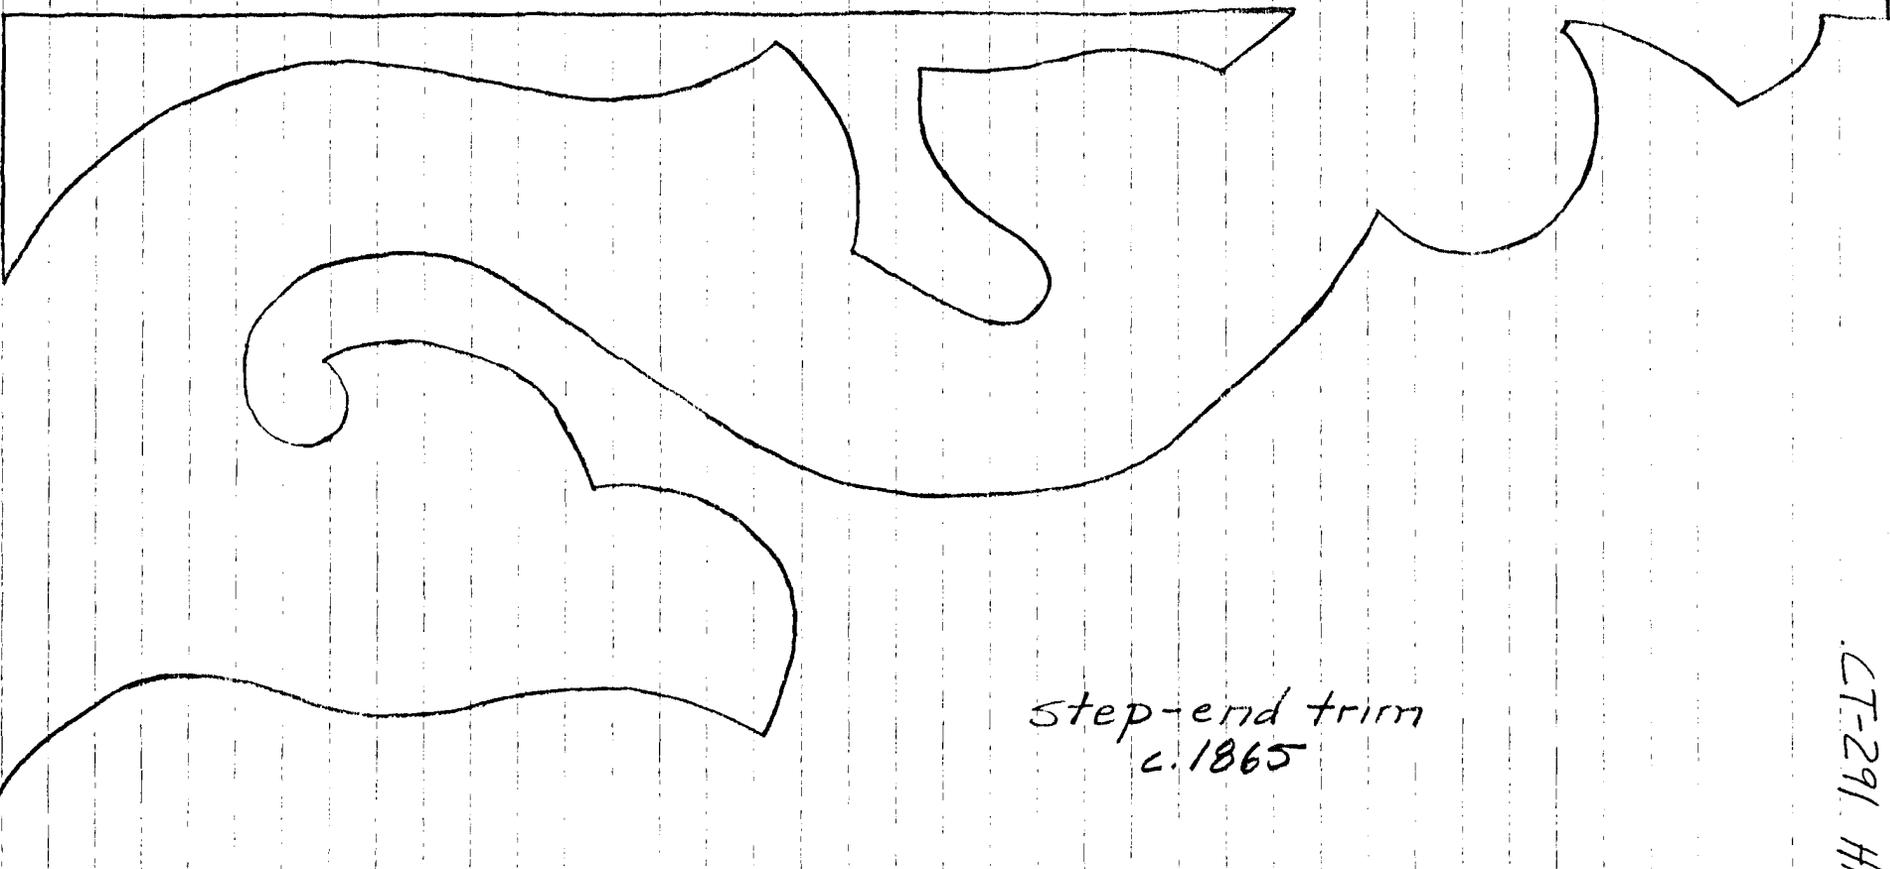
step-end trim
c. 1865

After 1889 the house was raised to two full stories, and was re-oriented to face River or Front Street, now Varden Street. The stair was changed to its present appearance, and the front door with sidelights and transom was installed. The posts along the sidelights are chamfered. Panels under the sidelights feature quirk-ogee chamfer moldings. This construction employed circular-sawn members joined by cut nails. Several mantel shelves were installed over stove flues and a quirk-ogee and chamfer baseboard replaced the original. The cross-gable and rear ell date from this period. The stair's scrolled step-ends nearly match those at CT-286 Wilson-Dixon House.

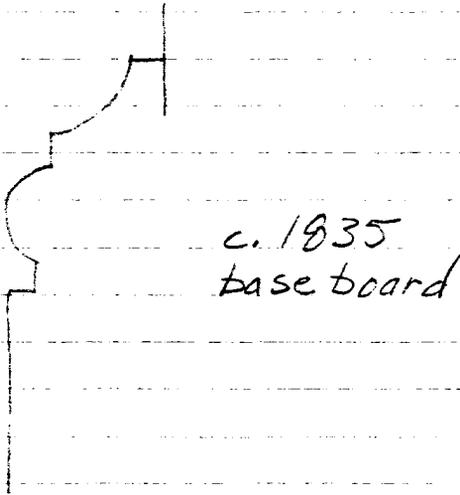
c. 1900 interior architraves

c. 1835
baseboard

c. 1865
baseboard

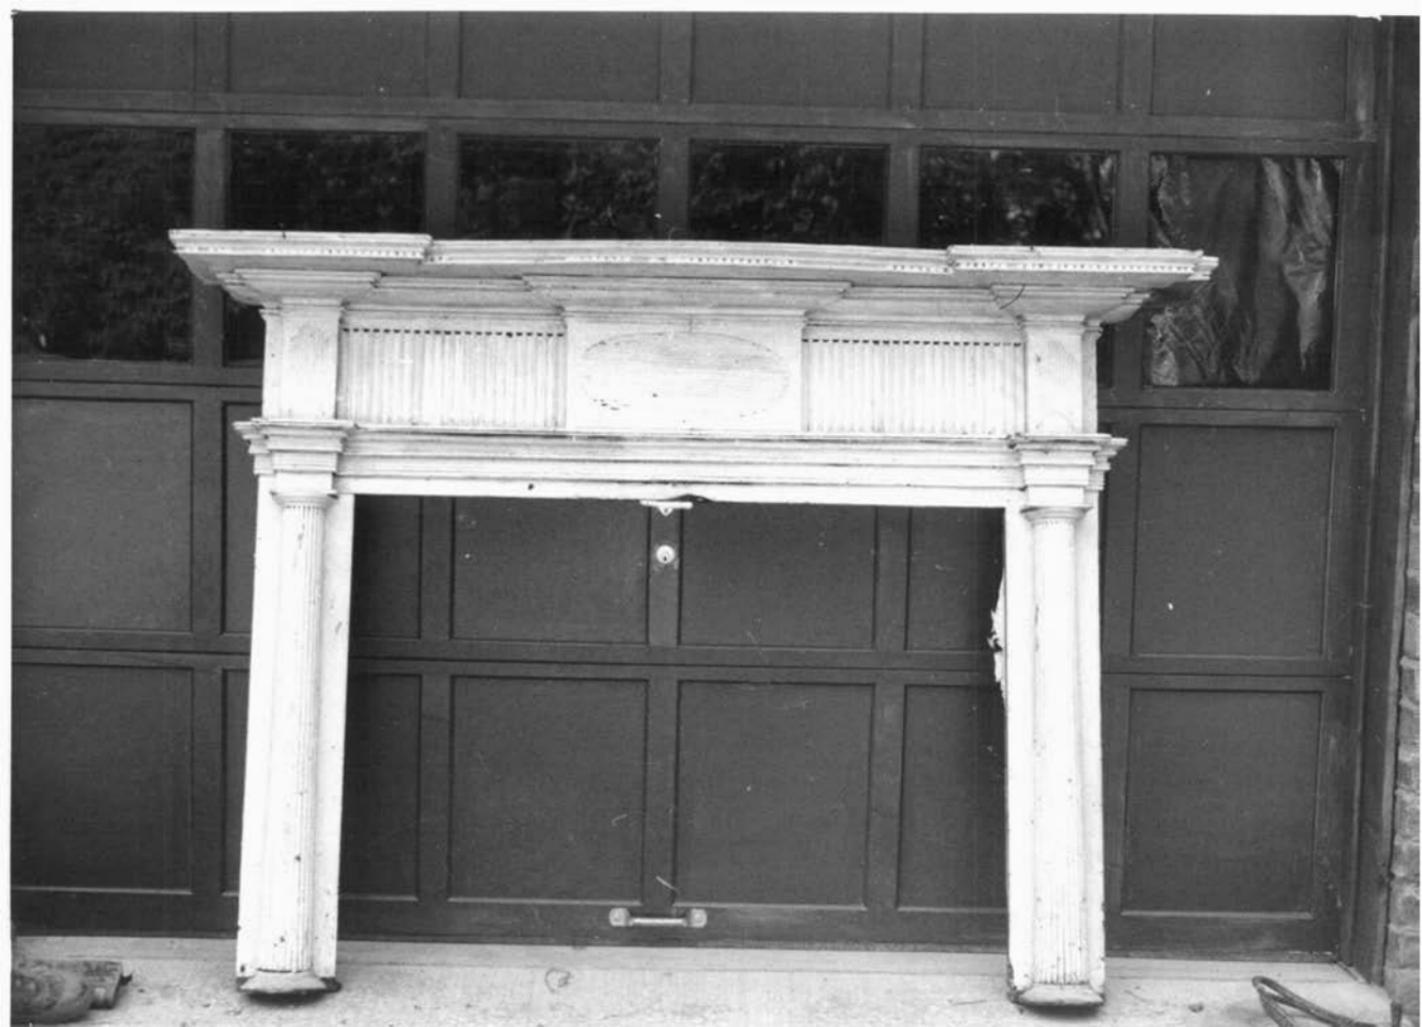
CT-291
Hinman Hs.
front parlor mantel

The hewn ceiling joists in the two parlors are the only other pre-1835 members. The rest of the original 1835 house is built of hand-sawn studs joined with cut nails. A beautiful reeded and fluted mantel, supported by reeded columns; a cavetto-ovolo baseboard; and several 6-panel doors are also survivors of the original 1835 house. At this time the house was one story in height, presumably with a habited loft, and did not include the present ell. This hall and parlor house faced the road leading to Sunderland.
