HALLOWING POINT FARM

INVENTORY FORM FOR STATE HISTORIC SITES SURVEY

Hallowing Point Farm

1. STATE Maryland		HISTORIC AMERICAN BUILDINGS SURVEY	
COUNTY Calvert County		INVENTORY CT-36	
TOWN	VICINITY	2. NAME Hallowing Point Farm	
STREET NO. Hallowing Point		DATE OR PERIOD C. 1820	
ORIGINAL OWNER Ashcom Family	ORIGINAL USE Dwelling	STYLE Maryland Colonial	
PRESENT OWNER T. Ashcom Gurley	PRESENT USE Dwelling	ARCHITECT	
WALL CONSTRUCTION Clapboard	NO. OF STORIES 2-1/2 w/smaller 2-1/2 addition	BUILDER

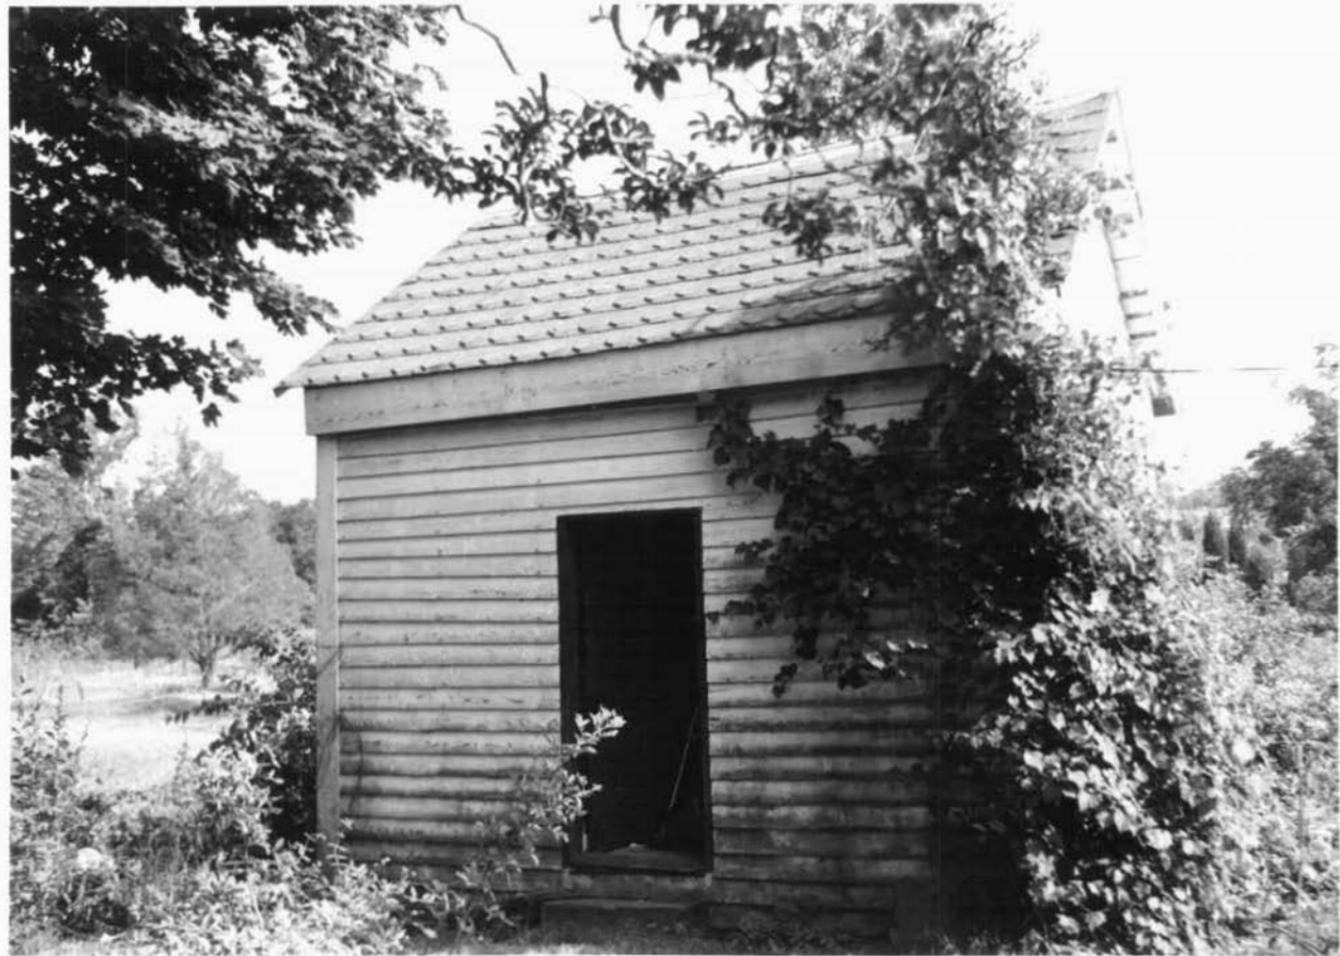
CLVT-36
Hallowings Point
Farm ~~Estates~~

Although it was moved during the first decade of this century, the meathouse has remained in tact. It is possible that the present siding is replacement material. Inside, however, one can see a proper post-and-beam frame made from heavy timbers (well dressed and not rough; surfaces even appear planed) joined by mortise-and-tenon and fixed with trunnels. Thinner studs are placed every 2'. This nearly 15' square, measuring 15' on the east side and 14'8" across the north facade. It is 9' between the ground and plates and is capped by a fairly steep gable end roof.

MEAT USE.

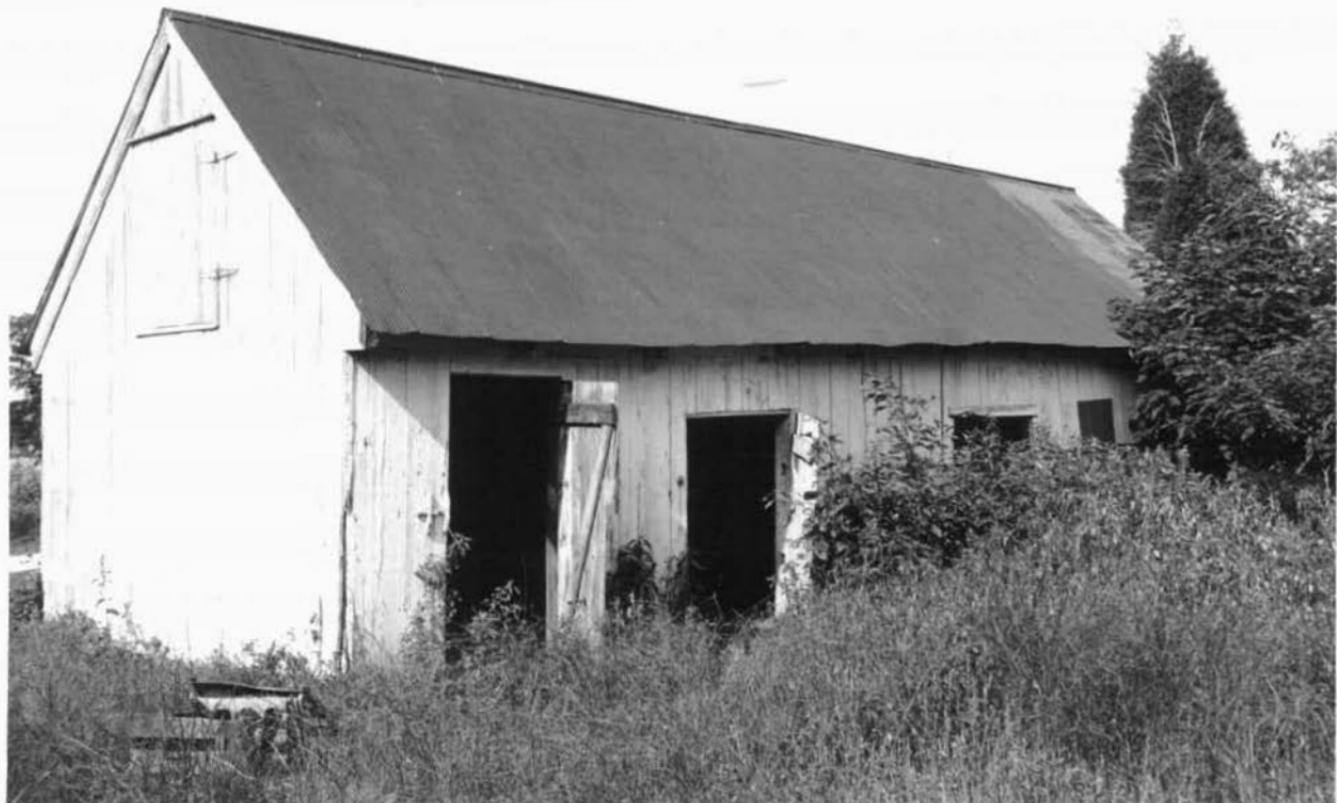
CLVT-36
Stable
B.W.
Hallowing Point

The stable building is 40'6" long, it is 14' deep and there is 8' between the ground and the eaves. The gable-end roof accomodates a loft which is reached by stairs from within. The interior is divided into four bays with three of them to house animals and the fourth on the west end probably being a storage room for tack and feed. The west corner of this

room contains the stairs to the loft. The room is made separate from the rest of the building by a plank partition. The other bays are divided by fences. A 2' passageway runs along the north wall providing access to all four bays.

The loft is finished with a plank floor and has doors in the gable ends for loading and unloading.

The post-and-beam construction of this building is consistent with the frames of early tobacco barns. It is important to realize that the side plates are continuous (40'6") and required considerable labor in processing a very large tree. In the loft the rafters are exposed revealing that the trusses are formed by lap-joining hewn pieces and fixing them with cut nails which appear to have hand fashioned heads. They are quite irregular when compared to the machine cut nails found in the wall of the tack room or the siding.

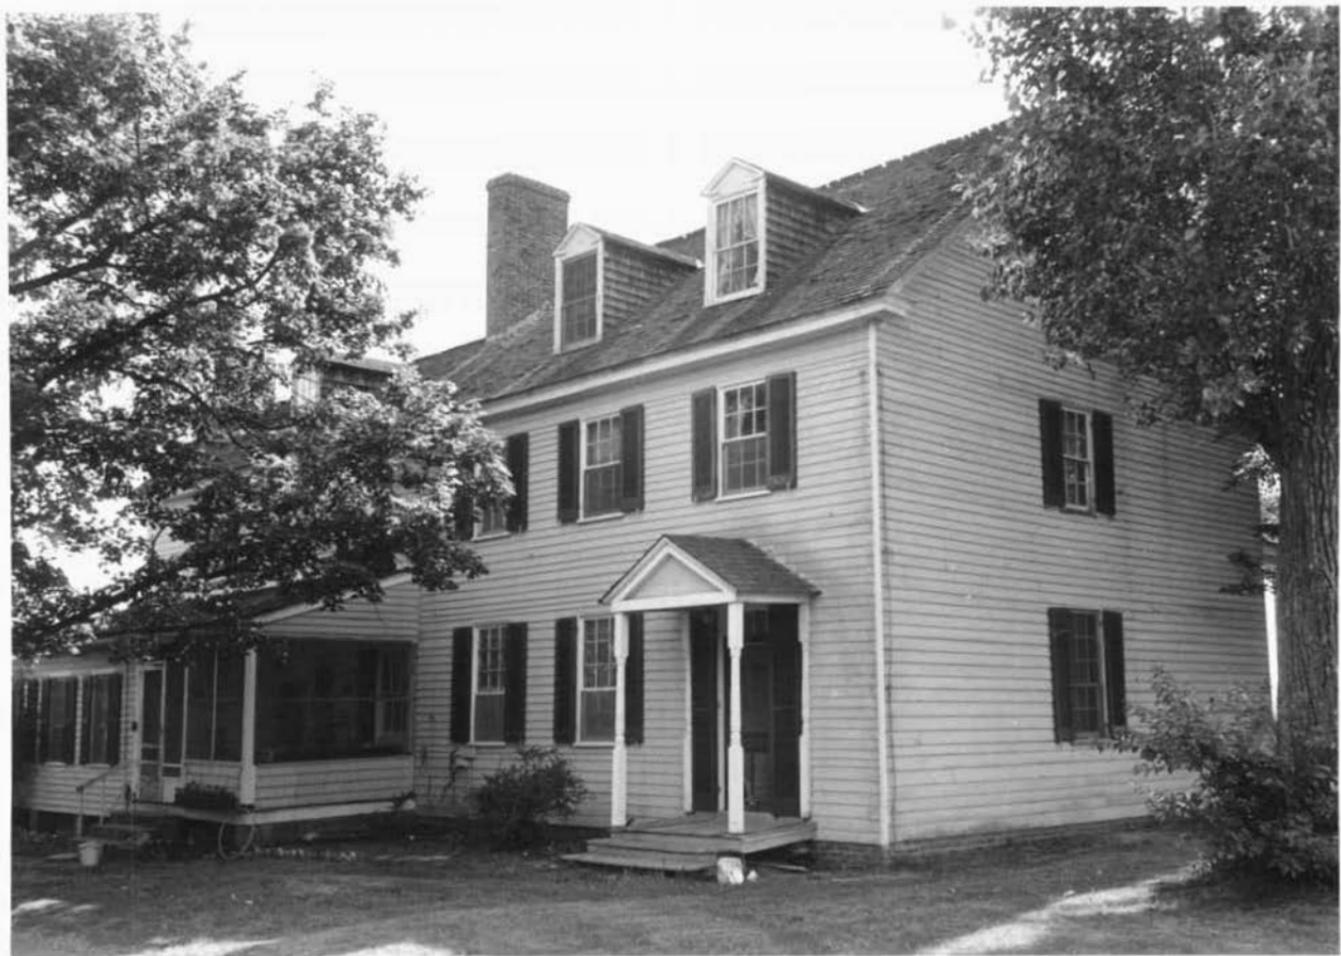
Hallowing Point
farm

The porches or portices that were built are in keeping with the Federal character of the house, however, they are relatively modern additions. It can be seen in accompanying photographs that the fenestration differs in the two wings. The main block has large 6/6 windows with many panes still containing early bubbled glass. The south wing contains 9/6 windows very like those in the mid-nineteenth century addition at "Stonesby" (CLVT-47). A window in the west bedroom on the second floor of the main block has the name "Maggie Sollers" scratched into it with the date "1849". Common to this plan are the double-end chimneys which serve fireplaces in both parlors and the two main bedrooms. Family tradition holds that these chimneys were built with bricks salvaged from the house destroyed by the British.

E.

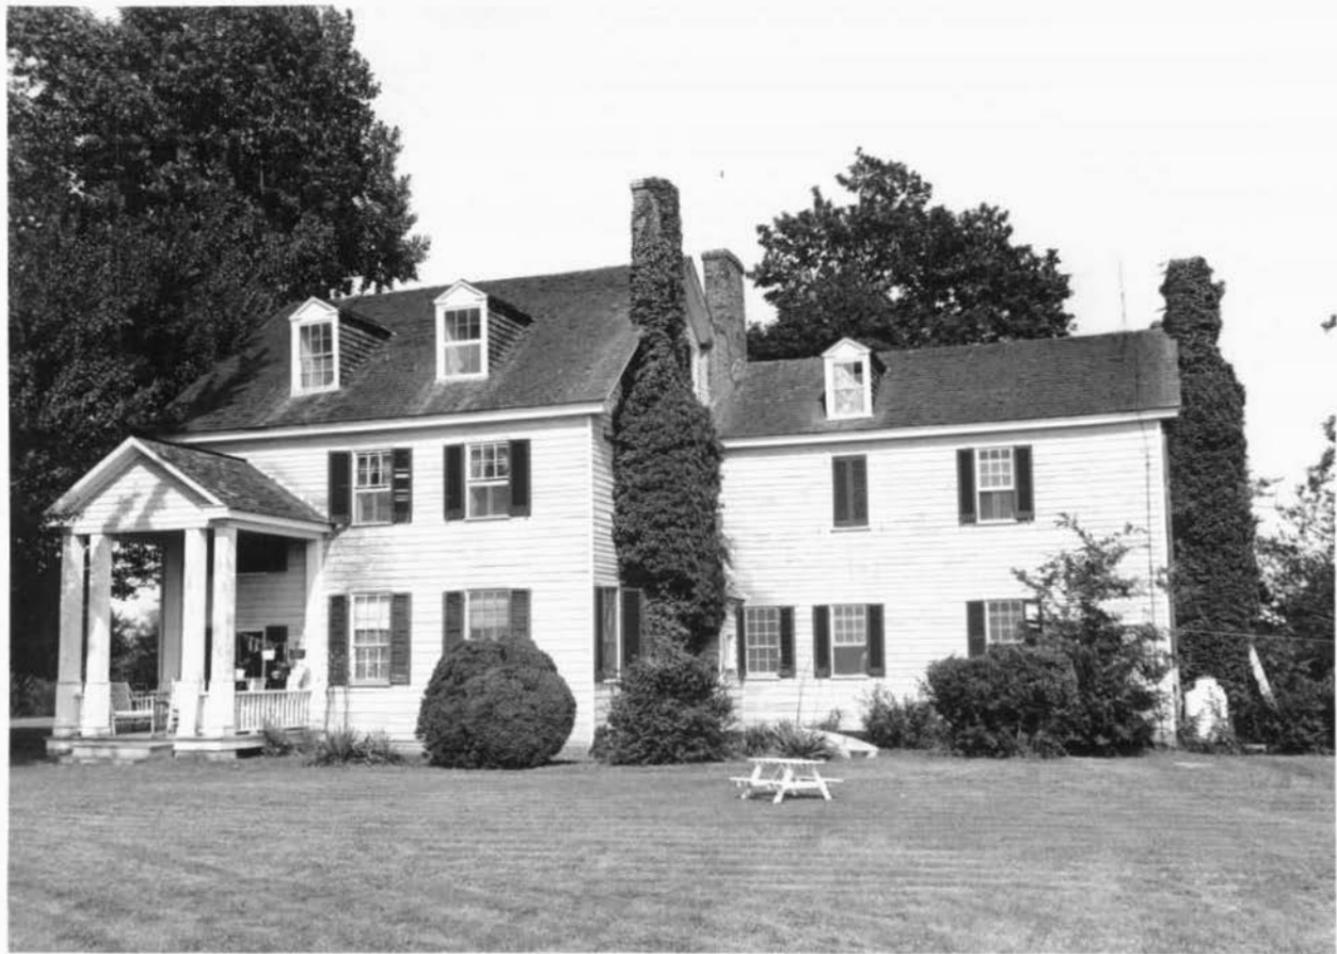
Hallowing Point
farm

W.
