NATIONAL REGISTER OF HISTORIC PLACES  
 INVENTORY -- NOMINATION FORM

MORGAN HILL FARM (preferred); Hill Farm

On Wohlgenuth Road  
 West side of Sollers Road, approximately two miles  
 south of its intersection with Maryland Route 2/4

HISTORIC AMERICAN  
BUILDINGS SURVEY  
SHEET 1 OF 4 SHEETS

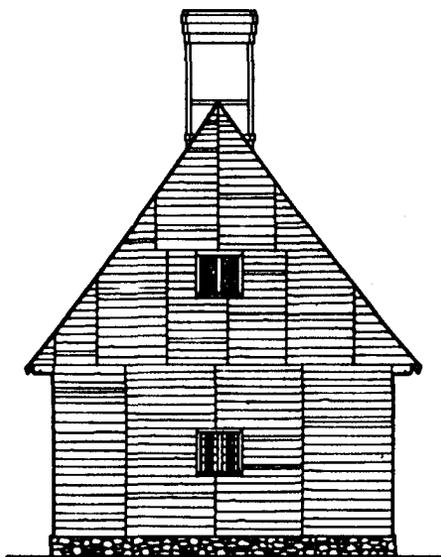
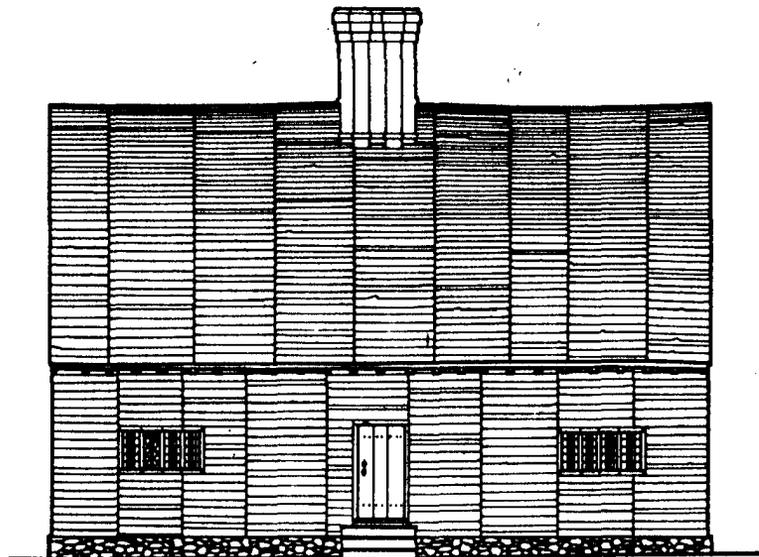
**CONJECTURAL RECONSTRUCTION OF PERIOD I**

- Overall dimensions
- Location of central chimney.
- Position of doorway.
- Probable position and length of windows on South elevation.
- Placement and detailing of tie beams.
- Window frames after two-light coesement found at Holly Hill.

- PERIOD I = C. 1700
- ▨ PERIOD II = C. 1820-50
- PERIOD I POSTS

Note: no window stud mortice  
Possible location of original staircase

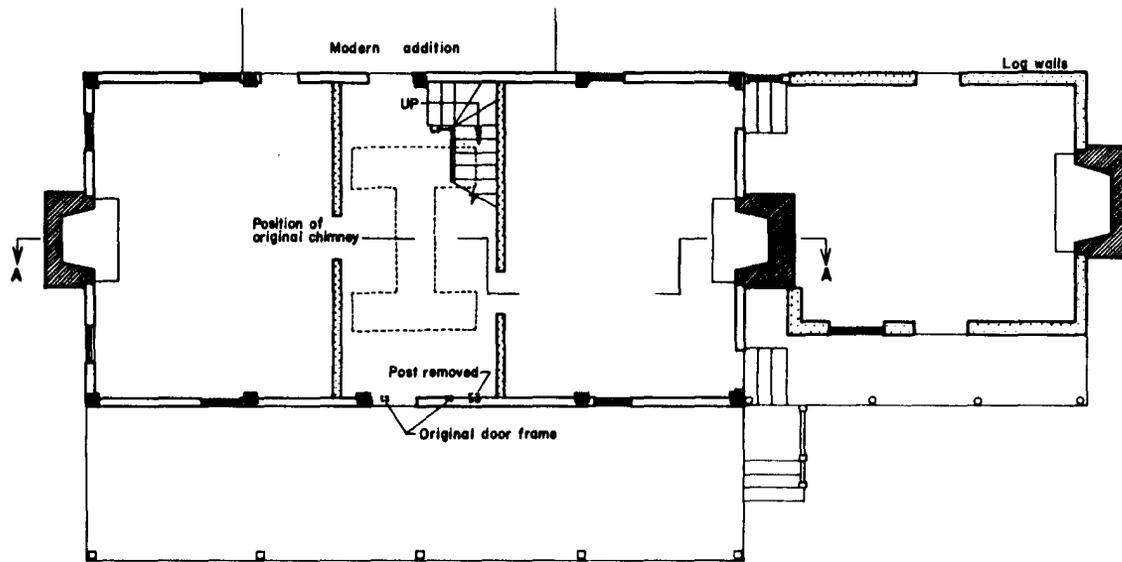
GROUND FLOOR PLAN

**FRAME WALLS**

- PERIOD I = C. 1700
- ▨ PERIOD II = C. 1820-50
- PERIOD I POSTS

**MASONRY**

- ▤ LOCATION OF PERIOD I CHIMNEY
- ▨ PERIOD II = C. 1820-50

The first floor room configuration of Hill Farm (see plan A) consists of a center stair hall flanked by a single room on each side. Until the early nineteenth century, the center of the house was dominated by a massive chimney with expansive back to back fireplaces (see plan B). When the chimney was removed, two new (or altered) partition walls were built to provide for the existing center hall. The stair, which has an open balustrade and unusually designed newells composed of two chamfered posts joined at the top by an arched cap, stands in the northeast corner and rises in two flights to the attic. This stair, though undoubtedly

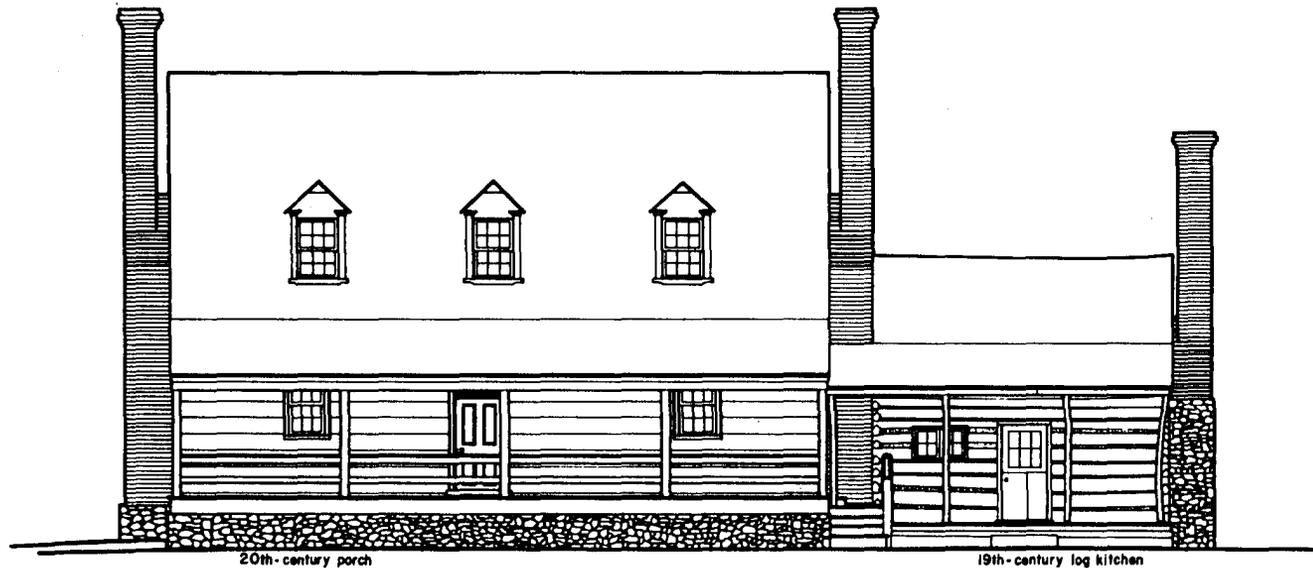
SOUTH ELEVATION

20th-century porch

19th-century log kitchen

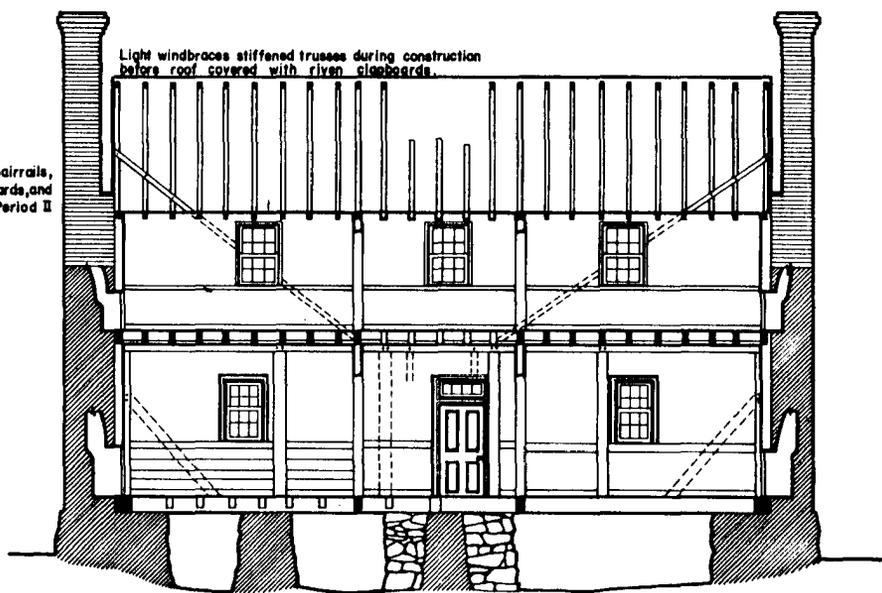
SECTION AT A-A

Light windbraces stiffened trusses during construction before roof covered with riven clapboards.

All chairrails, base boards, and dados Period II

A classic "double raftered" roof--i.e., four rafters to a hypothetical 5 ft. length of clapboards. (There is no certain evidence that the roof was ever clapboarded, although the present shingle lath are 19th-century.) One of the original spacing plank remains on the inside of the south slope rafters approximately halfway between collar beams and apex. The spacing plank is pit sawn. It has scratch marks at exactly 20 inch centers and is nailed through them to the inside of the rafters with rose-headed nails.
