CT-699  
THOMAS MCCREARY LOG HOUSE

# Maryland Historical Trust State Historic Sites Inventory Form

and/or common THOMAS Mc CREADY LOG HOUSE

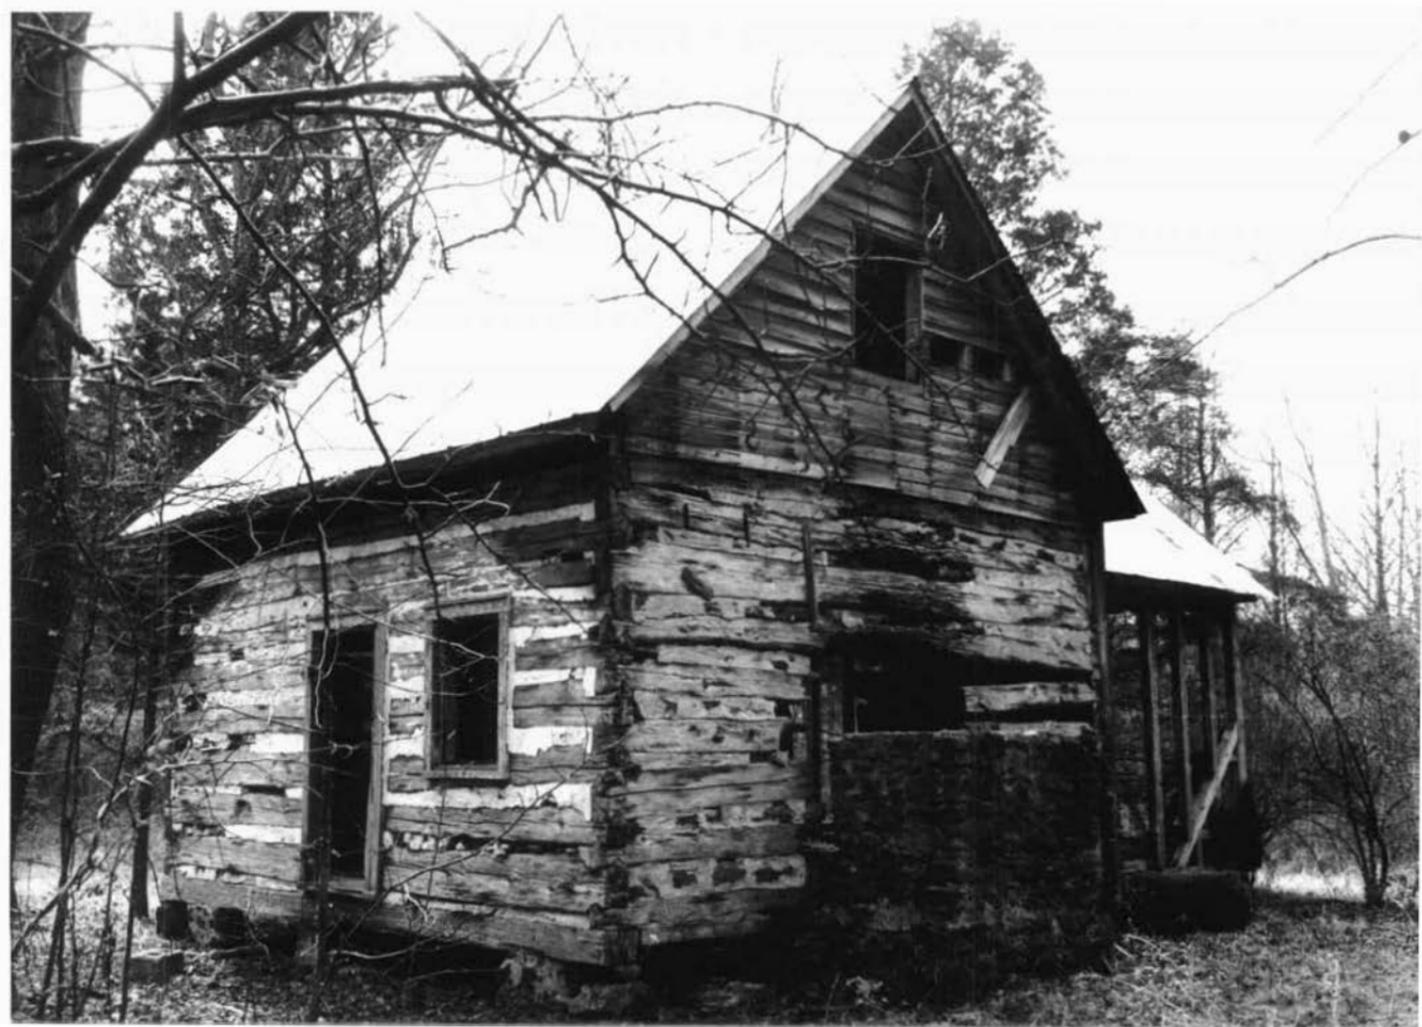
CT-699  
Thomas McCreedy Log House  
Little Cove Point Road  
Cove Point  
Calvert County, MD  
E&N

This one story, two bay log house is joined by a similar-sized frame section at the rear. The east-facing house features a left-hand entrance. The remains of an exterior chimney built of local composite fieldstone exist at the north end.

The V-notched logs are chinked with stone. Lapped weatherboards sheath the gable ends. Metal sheets cover the roof. The house stands on piers of fieldstone and brick.

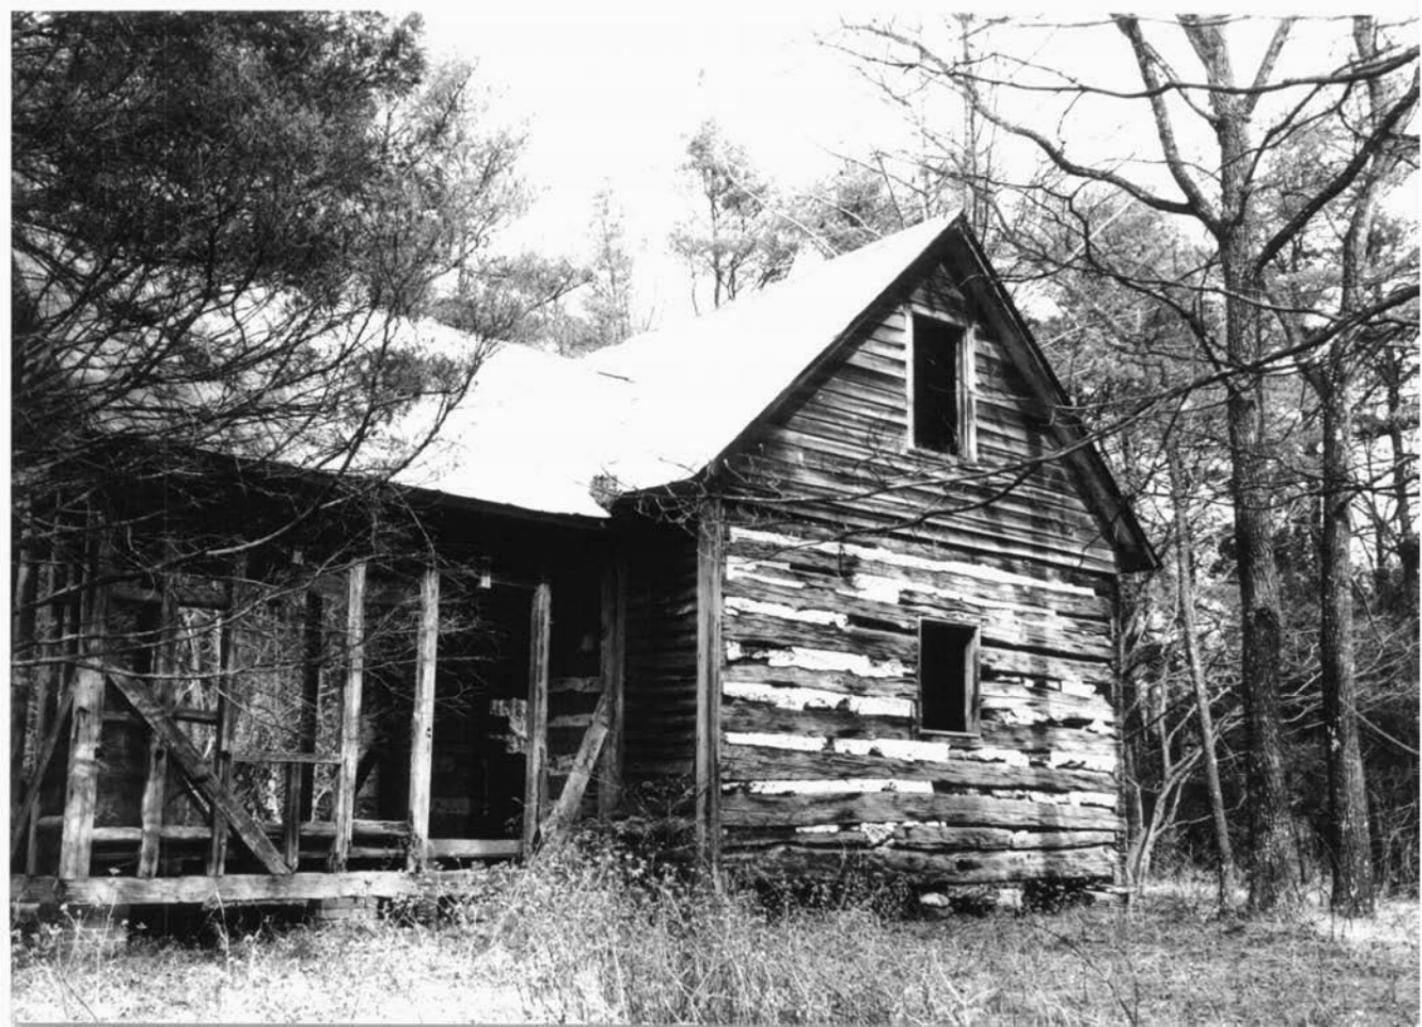
CT-699  
Thomas McCready Log House  
Little Cove Point Road  
Cove Point  
Calvert County, MD  
Wis

On the east facade of the building, facing the road, there is a door opening in the center bay and a window opening in the north bay. A large sandstone chimney is centered on the north gable wall. Fallen brick rubble in the vicinity of the chimney suggests that the upper shaft of the chimney was constructed of brick. A window opening in the center of the upper gable conflicts with the chimney position, and presumably dates to the later alteration. The only opening in the west facade is a single door that opens into the later frame wing.

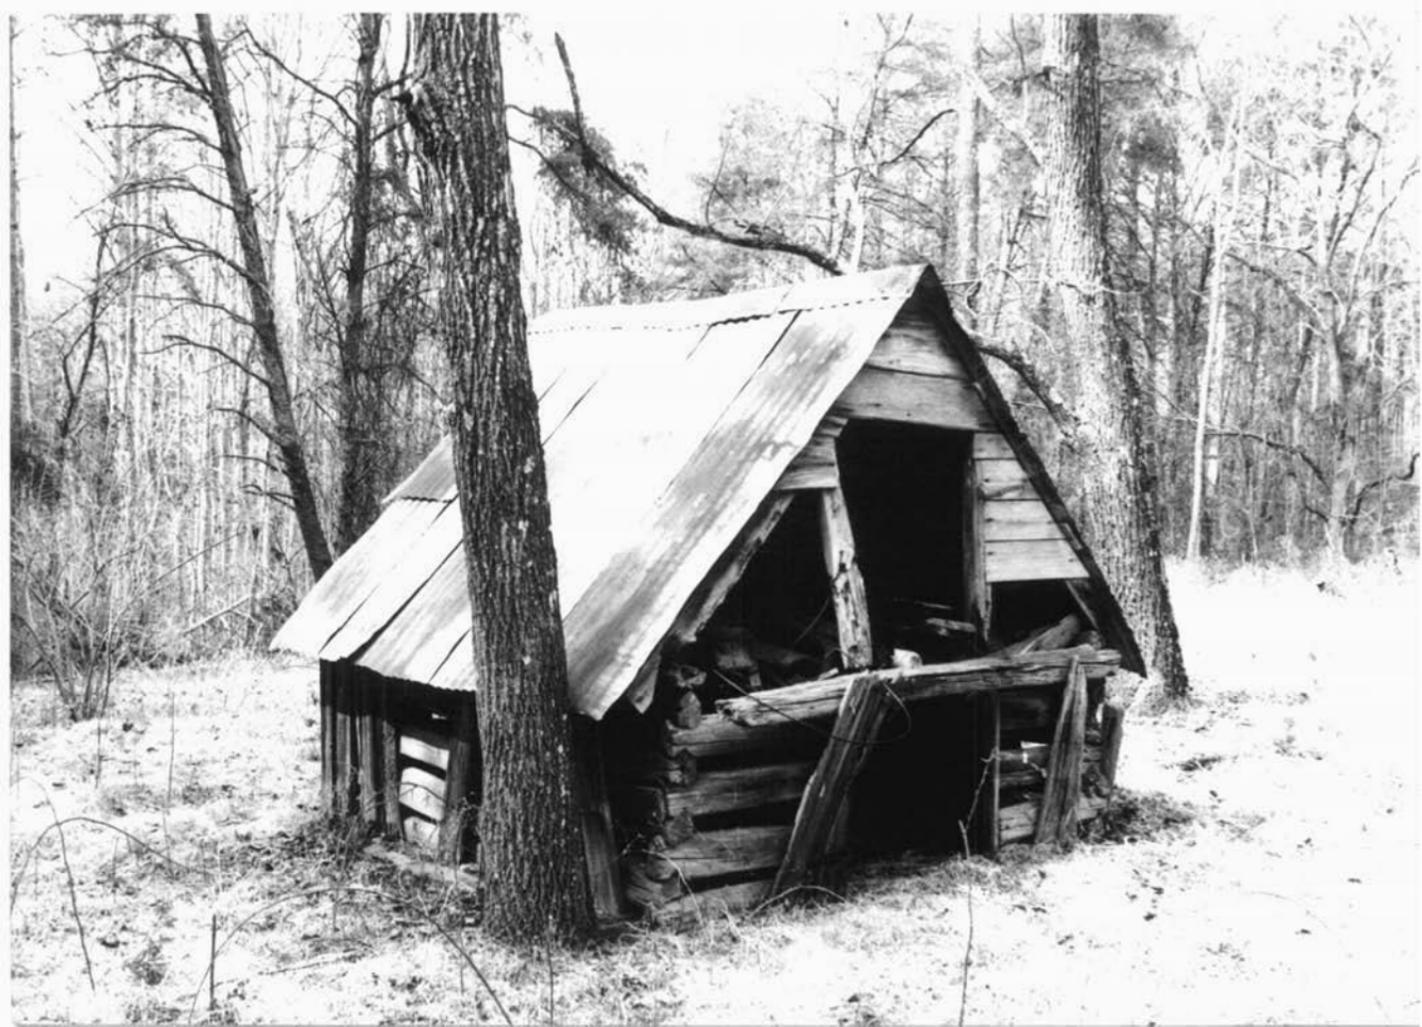
CT-699  
Thomas McCready Log House  
Little Cove Point Road  
Cove Point  
Calvert County, MD  
outbuilding  
S&E

Outbuilding: An extremely small outbuilding approximately 30 yards to the south of the house was probably used as a poultry house or for pigs. It is 8'-4" by 7'-0", of log construction, with a shed roof that slopes from a height of 3'-6" at the front (south) down to a height of 2'-6" at the rear (north). The shed pitch is accomplished simply by using four logs for the rear wall and six logs for the front. The logs are joined at the corners with V-notching, and have been covered with plain, vertical board siding. A door in the east wall is the only opening.

A small log outbuilding stands southwest of the house.
